2 - 96 Bathurst Street, Hull

Type 3 Fire Risk Assessment

Prepared for:	Rebecca Franks, Building Safety Manager
Prepared by:	John Askew, Fire Risk Assessor, Holistic Fire Safety
Date:	07/10/2024
Document Reference:	HFS.HCC.BathurstStreet2.FRA.2.0

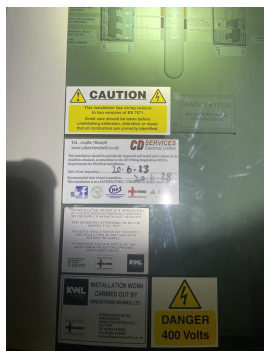
Photo 9

8.2. Are Electrical Installation Condition Report (EICR) labels displayed to indicate the date of the most recent periodic inspection and the date of the next 5-year periodic inspection?

Yes.

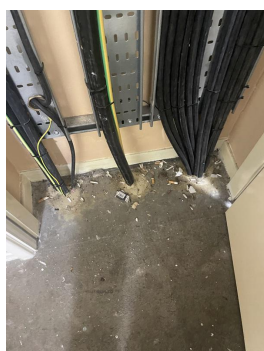
Photo 18

During the assessment, there was evidence of smoking materials in one of the electrical risers. HCC should ensure access to risers is restricted and the no smoking policy within the building strictly enforced.

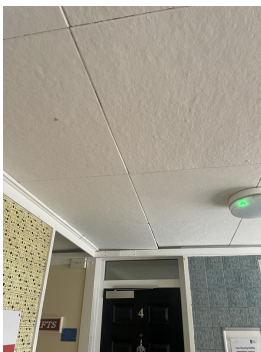
Photo 25

The ceiling of the ground floor reception has ceiling tiles which are typical of those found within other HCC blocks; these tiles are suspected to be of a combustible nature. Although there is a concrete slab which separates floors, should tiles be subjected to ignition, it is foreseeable that they would contribute towards fire growth; as a result and as a low priority action, tiles should be removed / enclosed.

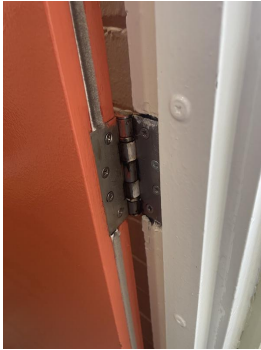
Photo 48

Defects consisted of:

- Worn / leaking hinges requiring replacement
- Strips and seals are consistently over painted and occasionally routed too deep (although gap tolerances are negligible which generally enable brush seals to sit against the frame)

As a result, given minor defects, a specific fire door inspection is to be undertaken to specify what actions are required.

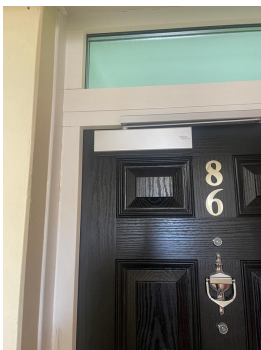
Photo 59

All replacement flat entrance doors are fitted with an appropriate overhead BS 1154 self closing device.

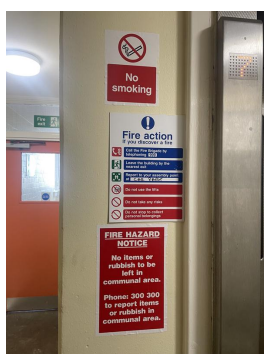
Photo 67

Each residential floor is provided with comprehensive instruction on actions to be taken in the event of fire. Fire action notices are displayed prominently opposite/adjacent lift doors.

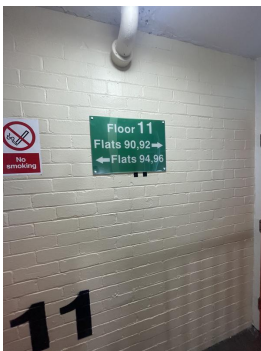
Photo 74

- J. The signs should be sited immediately below the floor identification signs, such that the top edge of the sign is no more than 50mm below the bottom edge of the floor identification sign.
- K. The wording should take the form Flats X-Y, with the lowest flat number first.
- L. The text should be in sans serif typeface with a letter height of at least half that of the floor indicator sign.
- M. The wording should be supplemented by arrows when flats are in more than one direction.
- N. The text and arrows should be on a contrasting background, easily legible and readable in low level lighting conditions or when illuminated with a torch.
