Bayswater Court, Hull

Type 3 Fire Risk Assessment

Prepared for:	Rebecca Franks, Building Safety Manager
Prepared by:	John Askew, Fire Risk Assessor, Holistic Fire Safety
Date:	23/10/2024
Document Reference:	HFS.HCC.BayswaterCourt.FRA.2.0

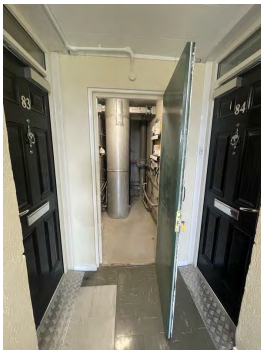
Photo 5

Risers are separated from escape routes by fire resisting construction providing 30 minutes, although fire resisting doorsets are displaying evidence of significant deterioration. There is a single ignition source with electrical breakers, however, there are no other combustible items within the area; therefore fire is highly unlikely to spread to adjacent areas.

It has been confirmed doors are to be replaced, although no set date has been set as they are to be part of a larger programme of works which requires approval from the Building Safety Regulator.

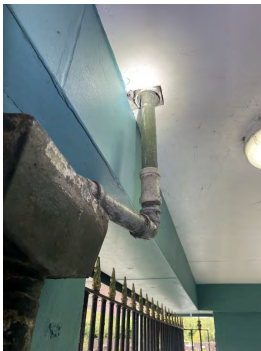
Photo 27

Removal of cement board in resident storage / ancillary areas and above walkways on the ground floor in identical properties has revealed the installation of insulation. It is understood this was originally installed to provide thermal insulation for first floor accommodation above.

It has been confirmed the insulation present is flammable and should be removed. Any replacement should achieve Class A2-s1, d0 or better

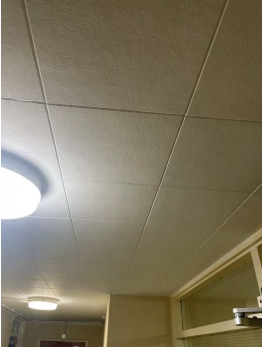
Photo 30

Ceilings within escape routes however are lined with ceiling tiles which are suspected to be of a combustible nature. Although there is a concrete slab which separates floors, should tiles be subjected to ignition, it is foreseeable that they would contribute towards fire growth; as a result, tiles should be removed throughout all areas.

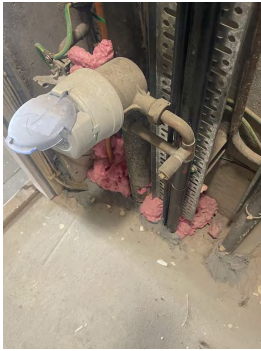
Photo 31

There are circa 60 service risers within the building and breaches/defects are extensive and consistent throughout. As previously described, the majority of services (soil vent pipes, extraction arrangements, heating services) which supply flats pass freely between risers and dwellings without an effective sealing system in place.

Remediation will generally consist of primarily sealing defects with an ablative coated fire batt and mastic system which will be applied in conjunction with an intumescent wrap/fire collar for combustible pipework. Where annular gaps allow, all isolated non combustible services can be sealed using fire rated mastic which is tested to BS EN 1366-3/4 and classified to 13501-2:2017 + A1:2009.

HCC should refer to the compartmentation survey for evidence of breaches and methods of remediation.

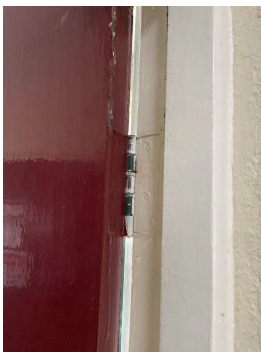
Photo 49

Similar to lobby doors & screens and staircase doors & screens, doors which enclose risers and ancillary accommodation gave evidence of multiple defects.

Although the risk of ignition and fire spread within risers is low, the standard of doors is sub-standard as there are multiple defects throughout the building.

Current provisions are also notional 44mm FD30s doorsets, however defects consist of:

- damaged door leaves
- damaged timber frame
- retrospective installation of door stops
- lack of backfilling/fire stopping between the frame and substrate - steel hinges with no markings
- missing screws from hinges

Given the volume of defects, it is the opinion of Holistic Fire Safety that all riser and ancillary rooms doors are replaced for certificated pre-hung FD30s fire doorsets. HCC have submitted reports to the BSR for work to be carried out on fire doors.

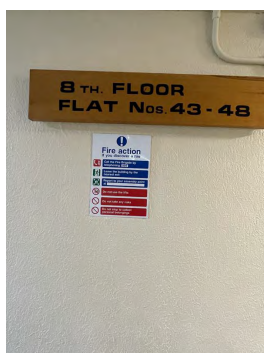
Photo 70

The fire action notice on the eighth floor near to flat 45 did not display the location of the assembly point.

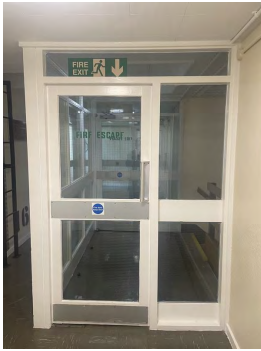
Photo 71

Due to the single means of escape, and the expectation that all residents are familiar with the layout of the building and its communal areas, although some signage is technically incorrect in places, current safe condition signage provided is considered to be satisfactory and it is expected that all relevant persons using the building will understand signage in place.

It is advised that all replacement safe condition escape route signage should be photo luminescent as manufactured by Jailite. Signs should be rigid or semi rigid PVC fixed by 4 x screws in each corner of the sign or with appropriate adhesive.
