GTS1, Hull

Type 3 Fire Risk Assessment

Prepared for:	Rebecca Franks, Building Safety Manager
Prepared by:	John Askew, Fire Risk Assessor, Holistic Fire Safety
Date:	07/10/2024
Document Reference:	HFS.HCC.GTS1.FRA.2.0

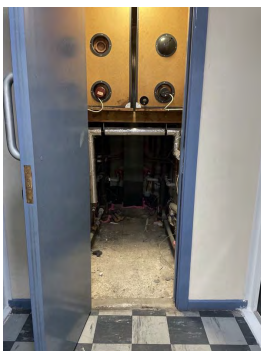
Photo 6

Of the internal flat riser sampled which is in the entrance hallway, the door was 44mm of notional fire resistance with a Georgian wired top light, fitted with two none fire rated hinges and no intumescent strips and cold smoke seals.

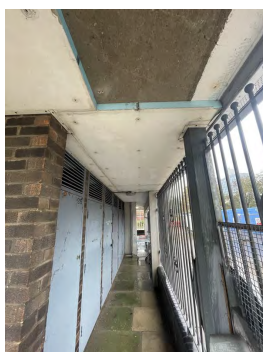
Photo 35

Removal of cement board in resident storage / ancillary areas and above walkways on the ground floor has revealed the installation of insulation. It is understood this was originally installed to provide thermal insulation for first floor accommodation above.

It has been confirmed the insulation present is flammable and should be removed. Any replacement should achieve Class A2-s1, d0 or better.

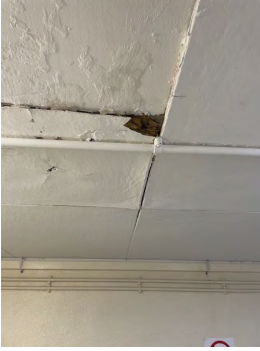
Photo 36

Ceilings within escape routes however are lined with ceiling tiles which are suspected to be of a combustible nature. Although there is a concrete slab which separates floors, should tiles be subjected to ignition, it is foreseeable that they would contribute towards fire growth; as a result and as a low priority action, tiles should be removed / enclosed.

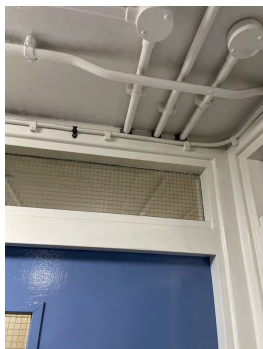
Photo 45

Although breaches were present at the point data cables and conduit pass through fire resisting partitions these appear to have been fire stopped although there was no test evidence to support this. The presence of such defects are not considered to be detrimental to life safety.

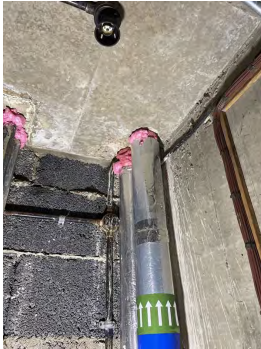
Photo 47

There are circa 70 service risers within the building. Two flats per floor contain internal risers. Breaches/defects are extensive and consistent throughout.

- Combustible plastic pipework entering risers from flats without an effective closing device present.
- Missing sections of masonry where services have been removed.
- Insulated non combustible pipework travelling vertically from riser to riser without an effective closing device present.
- Non combustible pipework entering risers from flats without an effective closing device present.
- Linear gaps between door frame and substrate have been filled with polyurethane expanding foam (this is not a suitable/tested solution for backfilling around timber door-sets).

Remediation will generally consist of primarily sealing defects with an ablative coated fire batt and mastic system which will be applied in conjunction with an intumescent wrap/fire collar for combustible pipework. Where annular gaps allow, all isolated non combustible services can be sealed using fire rated mastic which is tested to BS EN 1366-3/4 and classified to 13501-2:2017 + A1:2009.

HCC should refer to the compartmentation survey for evidence of breaches and methods of remediation.

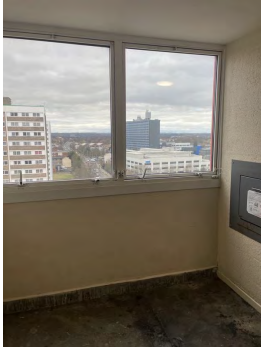
Photo 61

Current guidance states that vents in lobbies or corridors adjoining stairways should be operated automatically, however the installation of Automatic Opening Vent (AOV's) are not considered reasonably practicable. In addition, although current openings do not provide a minimum free area of 1.5 metres squared (m²), current provisions are considered adequate given other mitigation measures in place.

Protected stairways also need means to ventilate any smoke that may enter the stairway during evacuation or fire fighting and allow a route for air to reach ventilated lobbies. A vent of at least 1m² needs to be provided at the head of the stairway for this. Current guidance states in blocks of flats, it is recommended that the vent is operated automatically via an AOV.

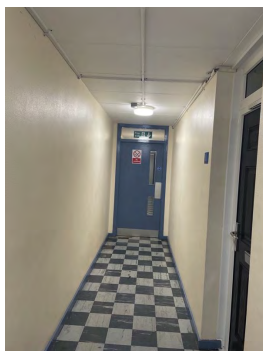
Photo 66

Defects consisted of:

- Worn / leaking hinges requiring replacement
- Strips and seals are consistently over painted and occasionally routed too deep (although gap tolerances are negligible which generally enable brush seals to sit against the frame)
- Gaps above acceptable tolerances
- Some door leaves to staircases were missing 'Fire door keep shut' signs.

As a result, given minor defects, a specific fire door inspection is to be undertaken to specify what actions are required.

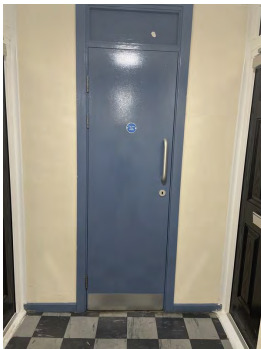
Photo 74

Communal riser doorsets are 54mm, of notional fire resistance with a timber top-light. Leaves were observed to be in good condition and fitted with three BS1935 Grade 13 hinges although these were noted to be leaking and missing screws.

Door frames are fitted with strips and seals however, some were either damaged or missing.

Ancillary accommodation doors are 44mm certified FD30s doorsets and were generally satisfactory although hinges were observed to be leaking.

As a result, given minor defects, a specific fire door inspection is to be undertaken to specify what actions are required.

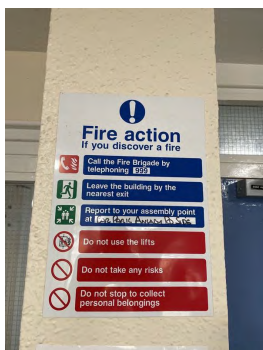
Photo 94

Residential floors are provided with comprehensive instruction on actions to be taken in the event of fire. Fire action notices are displayed prominently opposite/adjacent lift doors although fire action notices were missing on some floors (3rd & 13th).

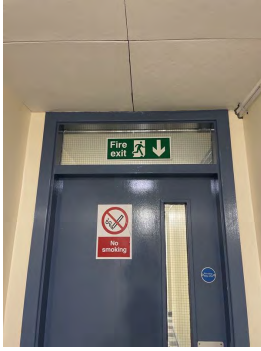
Photo 95

The expectation is that all residents are familiar with the layout of the building and its communal areas, although some signage is technically incorrect in places, current safe condition signage provided is considered to be satisfactory and it is expected that all relevant persons using the building will understand signage in place.

It is advised that all replacement safe condition escape route signage should be photo luminescent as manufactured by Jailite. Signs should be rigid or semi rigid PVC fixed by 4 x screws in each corner of the sign

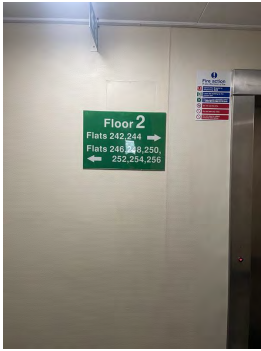
Photo 99

It was noted the Wayfinding signs in the 1st and 2nd floor north stair was missing.
