GTS2, Hull

Type 3 Fire Risk Assessment

Prepared for:	Rebecca Franks, Building Safety Manager
Prepared by:	John Askew, Fire Risk Assessor, Holistic Fire Safety
Date:	07/10/2024
Document Reference:	HFS.HCC.GTS2.FRA.2.0

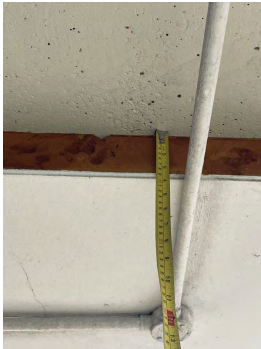
Photo 30

Removal of cement board in resident storage / ancillary areas and above walkways on the ground floor has revealed the installation of insulation. It is understood this was originally installed to provide thermal insulation for first floor accommodation above.

It has been confirmed the insulation present is flammable and should be removed. Any replacement should achieve Class A2-s1, d0 or better.

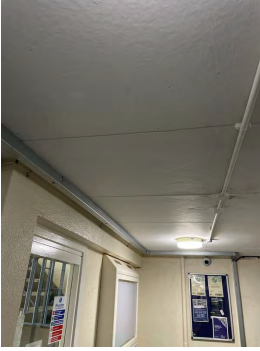
Photo 33

Ceilings within escape routes however are lined with ceiling tiles which are suspected to be of a combustible nature. Although there is a concrete slab which separates floors, should tiles be subjected to ignition, it is foreseeable that they would contribute towards fire growth; as a result and as a low priority action, tiles should be removed / enclosed.

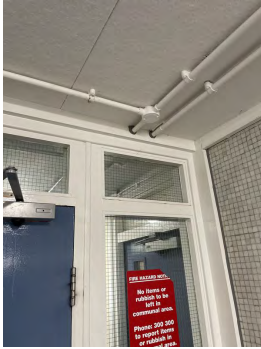
Photo 39

Breaches were present at the point data cables and conduit pass through fire resisting partitions. The majority of these appear to have been fire stopped although there was no test evidence to support this. Remaining defects require fire stopping.

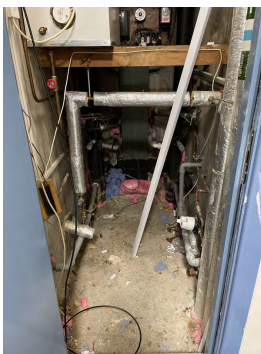
Photo 44

There are circa 70 service risers within the building. Two flats per floor contain internal risers. Breaches/defects are extensive and consistent throughout.

Remediation will generally consist of primarily sealing defects with an ablative coated fire batt and mastic system which will be applied in conjunction with an intumescent wrap/fire collar for combustible pipework. Where annular gaps allow, all isolated non combustible services can be sealed using fire rated mastic which is tested to BS EN 1366-3/4 and classified to 13501-2:2017 + A1:2009.

HCC should refer to the compartmentation survey for evidence of breaches and methods of remediation.

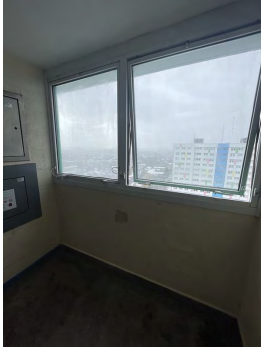
Photo 58

Current guidance states that vents in lobbies or corridors adjoining stairways should be operated automatically, however the installation of Automatic Opening Vent (AOV's) are not considered reasonably practicable. In addition, although current openings do not provide a minimum free area of 1.5 metres squared (m²), current provisions are considered adequate given other mitigation measures in place.

Protected stairways also need means to ventilate any smoke that may enter the stairway during evacuation or fire fighting and allow a route for air to reach ventilated lobbies. A vent of at least 1m² needs to be provided at the head of the stairway for this. Current guidance states in blocks of flats, it is recommended that the vent is operated automatically via an AOV.

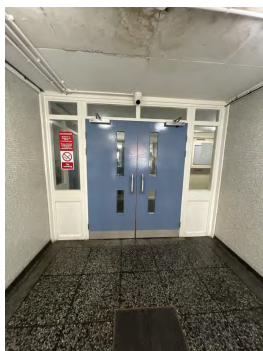
Photo 62

Defects consisted of:

- Worn / leaking hinges requiring replacement
- Strips and seals are consistently over painted and occasionally routed too deep (although gap tolerances are negligible which generally enable brush seals to sit against the frame)
- Gaps above acceptable tolerances
- Some door leaves to staircases were missing 'Fire door keep shut' signs.

As a result, given minor defects, a specific fire door inspection is to be undertaken to specify what actions are required.

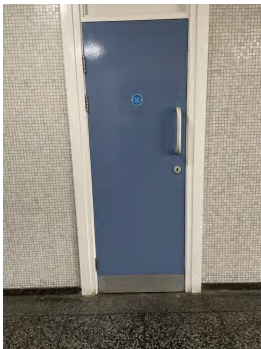
Photo 70

Communal riser doorsets are 54mm, of notional fire resistance with a timber top-light. Leaves were observed to be in good condition and fitted with three BS1935 Grade 13 hinges although these were noted to be leaking and missing screws.

Door frames are fitted with strips and seals however, some were either damaged, missing or painted over.

Ancillary accommodation doors are 44mm certified FD30s doorsets and were generally satisfactory although hinges were observed to be leaking.

As a result, given minor defects, a specific fire door inspection is to be undertaken to specify what actions are required.

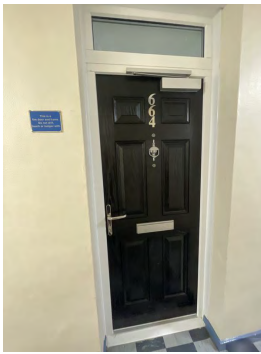
Photo 74

It was noted the door to flats 520 and 578 are fitted with timber doors. It is understood these have been adapted for mobility purposes. Until it can be established that certified doorsets can replace the doors, it is considered acceptable for the doors to remain in situ.

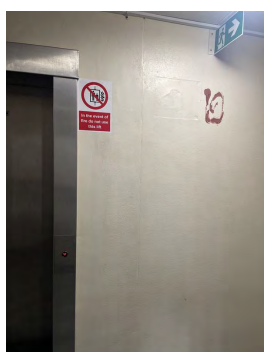
Photo 89

Residential floors are provided with comprehensive instruction on actions to be taken in the event of fire. Fire action notices are displayed prominently opposite/adjacent lift doors although fire action notices were missing on some floors (12th & 13th) had been pushed behind a Wayfinding sign (6th floor) and the location of the fire assembly point had not been completed on floor 1 and in one of the lifts.

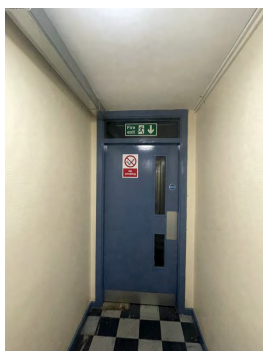
Photo 93

The expectation is that all residents are familiar with the layout of the building and its communal areas, although some signage is technically incorrect in places, current safe condition signage provided is considered to be satisfactory and it is expected that all relevant persons using the building will understand

It is advised that all replacement safe condition escape route signage should be photo luminescent as manufactured by Jailite. Signs should be rigid or semi rigid PVC fixed by 4 x screws in each corner of the sign or with appropriate adhesive.

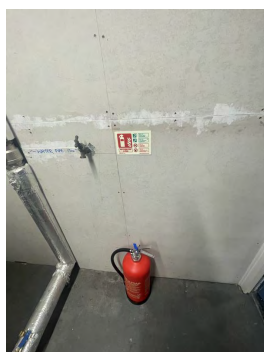
Photo 99

Extinguishers were noted on the floor. Fire extinguishers should be placed on stands or secured to the wall.
