GTS3, Hull

Type 3 Fire Risk Assessment

Prepared for:	Rebecca Franks, Building Safety Manager
Prepared by:	John Askew, Fire Risk Assessor, Holistic Fire Safety
Date:	07/10/2024
Document Reference:	HFS.HCC.GTS3.FRA.2.0

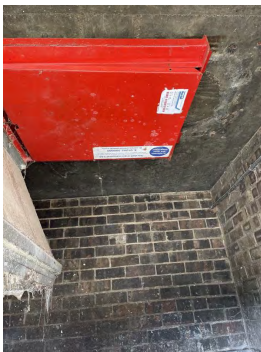
Photo 10

Hopper disposal points on a number of floors were noted to have gaps between the disposal point frame and the wall. This is due to fixings becoming loose resulting in the frame coming away from the substrate.

Attempts have been to seal these up however, this has proved fruitless as the situation keeps recurring. To overcome this, the wall to the hopper disposal point on the 14th floor north stairs has been rebuilt with a new frame as a pilot. This appears to have resolved the problem and a planned programme of works to rebuild the frames to all disposal points throughout the building is to be undertaken.

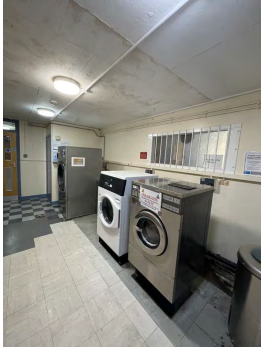
Photo 18

The scheme has implemented a policy within the laundry which includes the removal of lint build-up from tumble driers; at the time of inspection, lint was observed in the filter. The laundry is also provided with automatic fire detection & warning and is enclosed in fire resisting construction however.

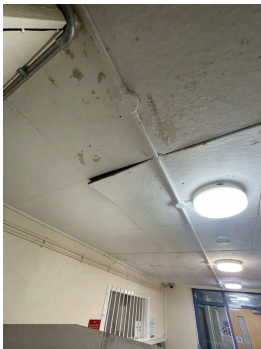
Photo 36

Ceilings within escape routes however are lined with ceiling tiles which are suspected to be of a combustible nature. Although there is a concrete slab which separates floors, should tiles be subjected to ignition, it is foreseeable that they would contribute towards fire growth; as a result and as a low priority action, tiles should be removed / enclosed.

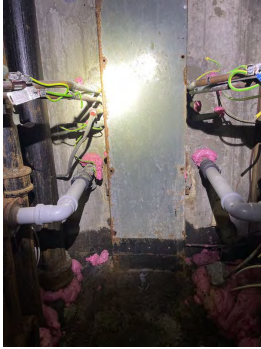
Photo 44

There are circa 70 service risers within the building. Two flats per floor contain internal risers. Breaches/defects are extensive and consistent throughout. The central risers displayed evidence of cable penetrations in toplights which is then encapsulated in plastic conduit in the corridor.

Remediation will generally consist of primarily sealing defects with an ablative coated fire batt and mastic system which will be applied in conjunction with an intumescent wrap/fire collar for combustible pipework. Where annular gaps allow, all isolated non combustible services can be sealed using fire rated mastic which is tested to BS EN 1366-3/4 and classified to 13501-2:2017 + A1:2009.

HCC should refer to the compartmentation survey for evidence of breaches and methods of remediation.

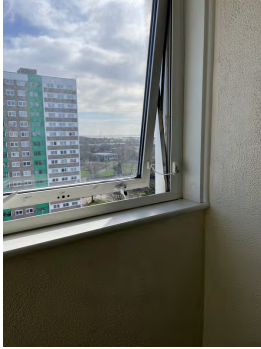
Photo 57

Protected stairways also need means to ventilate any smoke that may enter the stairway during evacuation or fire fighting and allow a route for air to reach ventilated lobbies. A vent of at least 1m² needs to be provided at the head of the stairway for this. Current guidance states in blocks of flats, it is recommended that the vent is operated automatically via an AOV.

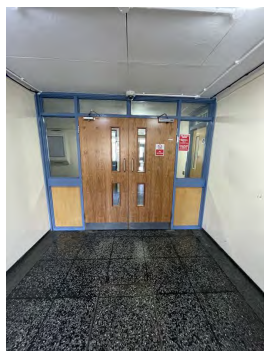
Photo 63

Defects consisted of:

- Worn / leaking hinges requiring replacement
- Strips and seals are consistently over painted and occasionally routed too deep (although gap tolerances are negligible which generally enable brush seals to sit against the frame)
- Some door leaves to staircases were missing 'Fire door keep shut' signs.
- Lobby doors failing to close flush.

As a result, given minor defects, a specific fire door inspection is to be undertaken to specify what actions are required.

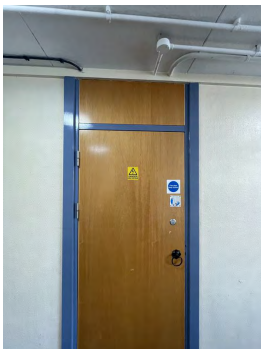
Photo 70

Communal riser doorsets are 54mm, of certified fire resistance with a timber top-light. Leaves were observed to be in good condition and fitted with three BS1935 Grade 13 hinges although these were noted to be leaking and missing screws.

Door frames are fitted with strips and seals however, some were either damaged, missing or painted over. There was evidence of a lack of backfilling/fire stopping between the frame and substrate.

As a result, given minor defects, a specific fire door inspection is to be undertaken to specify what actions are required.

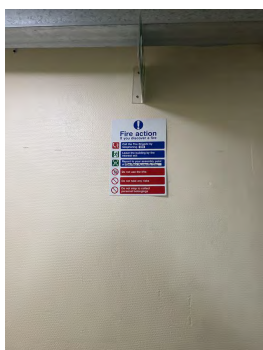
Photo 90

Residential floors are provided with comprehensive instruction on actions to be taken in the event of fire. Fire action notices are displayed prominently opposite/adjacent lift doors although fire action notices were missing on some floors (8th, 11th & 12th) and the location of the fire assembly point had not been completed on the 6th & 13th floors.

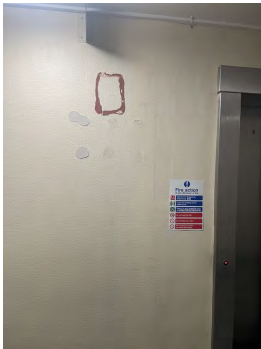
Photo 102

It was noted Wayfinding signs were missing in the 1st, 3rd, 6th, 10th & 13th corridors and the 5th & 6th stairs.

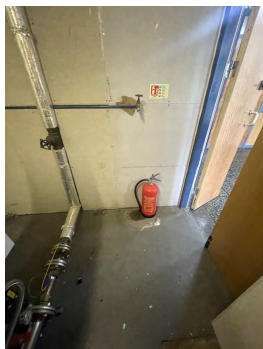
Photo 106

Extinguishers were noted on the floor. Fire extinguishers should be placed on stands or secured to the wall.
