# Muswell Court, Hull

## Type 3 Fire Risk Assessment

Prepared for:	Rebecca Franks, Building Safety Manager
Prepared by:	John Askew, Fire Risk Assessor, Holistic Fire Safety
Date:	17/10/2024
Document Reference:	HFS.HCC.MuswellCourt.FRA.2.0

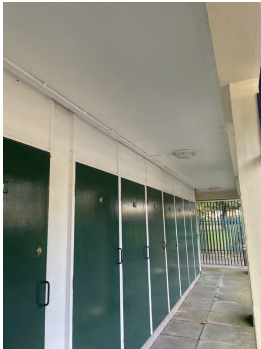
Photo 30

Removal of cement board in resident storage / ancillary areas and above walkways on the ground floor in identical properties has revealed the installation of insulation. It is understood this was originally installed to provide thermal insulation for first floor accommodation above.

It has been confirmed the insulation present is flammable and should be removed. Any replacement should achieve Class A2-s1, d0 or better.

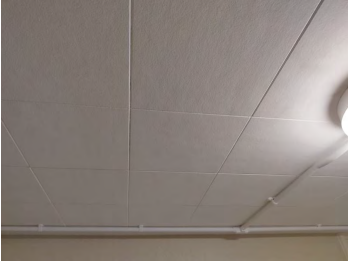
Photo 32

Ceilings within escape routes however are lined with ceiling tiles which are suspected to be of a combustible nature. Although there is a concrete slab which separates floors, should tiles be subjected to ignition, it is foreseeable that they would contribute towards fire growth; as a result, tiles should be removed throughout all areas.

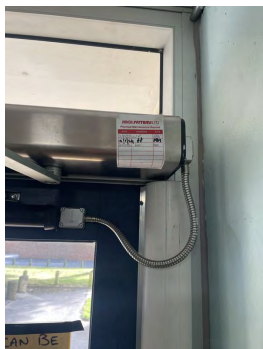
Photo 51

Ground floor lobby doors are electrically operated automatic doors. A nearby maintenance label indicated these were last inspected in July 2024.

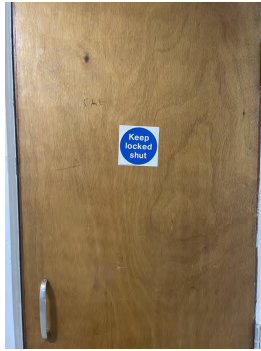
Photo 95

Ancillary room doors were observed to be missing appropriate fire safety signage e.g. 'Fire door keep locked' 'Fire door keep shut'.

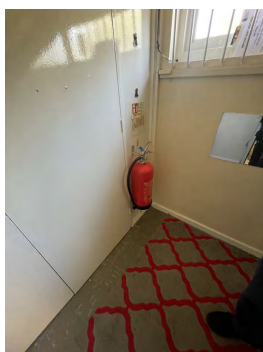
Photo 100

A CO2 fire extinguisher was noted in the cleaner's office which is to be removed.
