# 98 - 192 Valiant Drive, Hull

## Type 3 Fire Risk Assessment

Prepared for:	Rebecca Franks, Building Safety Manager
Prepared by:	John Askew, Fire Risk Assessor, Holistic Fire Safety
Date:	17/10/2024
Document Reference:	HFS.HCC.ValiantDrive2.FRA.2.0

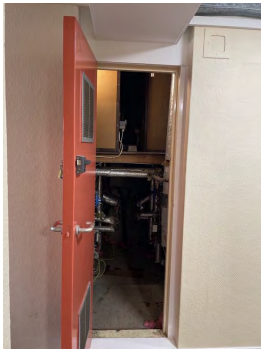
Photo 3

Risers are partially separated from escape routes by fire resisting construction providing 60 minutes, although fire resisting doorsets and fanlights are displaying evidence of significant deterioration/inappropriate construction and ventilation grilles which allow the passage of smoke to enter means of escape in the event of an incident.

It has been confirmed doors are to be replaced, although no date has been set as they are to be part of a larger programme of works which requires approval from the Building Safety Regulator.

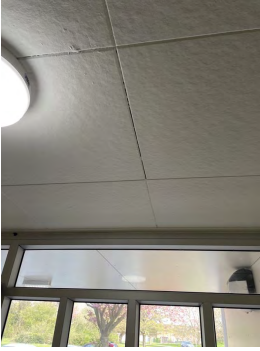
Photo 27

The ceiling of the ground floor reception has ceiling tiles which are typical of those found within other HCC blocks; these tiles are suspected to be of a combustible nature. Although there is a concrete slab which separates floors, should tiles be subjected to ignition, it is foreseeable that they would contribute towards fire growth; as a result and as a low priority action, tiles should be removed / enclosed.

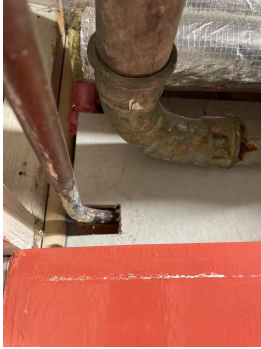
Photo 33

The standard of compartmentation within the water pump room and lift motor room was generally satisfactory with limited evidence of breaches - minor works required however, there is a significant penetration in the pump room where services travel into the adjacent flat (98). It is understood this was created as a result of the replacement of the flat entrance door.

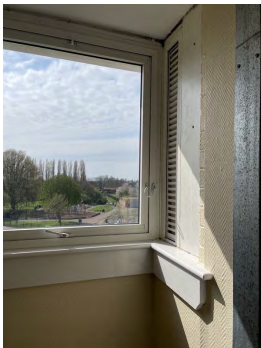
Photo 46

Current guidance states that vents in lobbies or corridors adjoining single stairways should be operated automatically (AOVs), however the installation of AOV's are not considered reasonably practicable. In addition, although current openings do not provide a minimum free area of 1.5 metres squared (m<sup>2</sup>), current provisions are considered adequate given other mitigation measures in place.

Protected stairways also need means to ventilate any smoke that may enter the stairway during evacuation or fire fighting and allow a route for air to reach ventilated lobbies. A vent of at least 1m<sup>2</sup> needs to be provided at the head of the stairway for this. Current guidance states that in blocks of flats with a single stairway, it is recommended that the vent is operated automatically via an AOV.

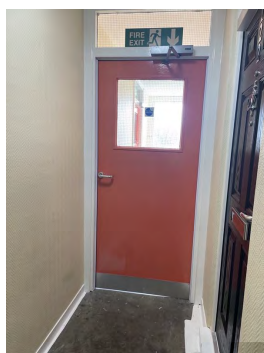
Photo 47

Escape routes are suitably separated and subdivided by fire rated construction which is made up of notional self closing FD30s door assemblies and Georgian wired glazing. Partitions are made up of brick and blockwork. Current provisions are considered adequate to protect means of escape.

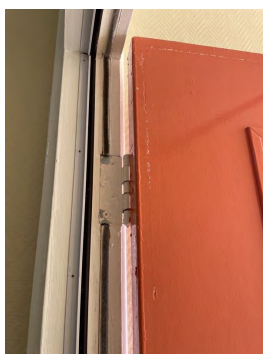
Photo 50

Defects consisted of:

- Painted hinges requiring replacement
- Strips and seals are consistently over painted and occasionally routed too deep (although gap tolerances are negligible which generally enable brush seals to sit against the frame)

As a result, given minor defects, a specific fire door inspection is to be undertaken to specify what actions are required.

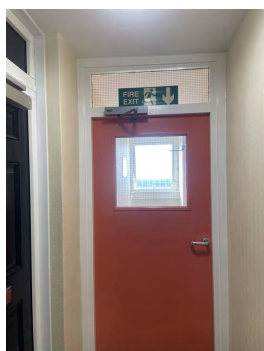
Photo 75

Due to the single means of escape, and the expectation that all residents are familiar with the layout of the building, although some signage is technically incorrect in places (lobby doors with down arrow), current safe condition signage provided is considered to be satisfactory and it is expected that all relevant persons using the building will understand signage in place.

It is advised that all replacement safe condition escape route signage should be photo luminescent as manufactured by Jallite. Signs should be rigid or semi rigid PVC fixed by 4 x screws in each corner of the sign or with appropriate adhesive.

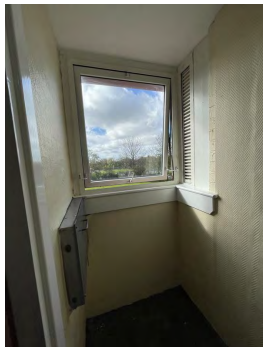
Photo 88

There is no dry riser provided at Block 2.

It was confirmed by HCC representatives that all HRRB's which do not have dry riser facilities are scheduled to have one installed. The dry riser is to be installed which serves all floors with landing valves within the lobby between the staircase door, hopper disposal point and louvred windows on all floors.
