**Spring Bank Conservation Area
Management Plan (North side)**
Draft for Review

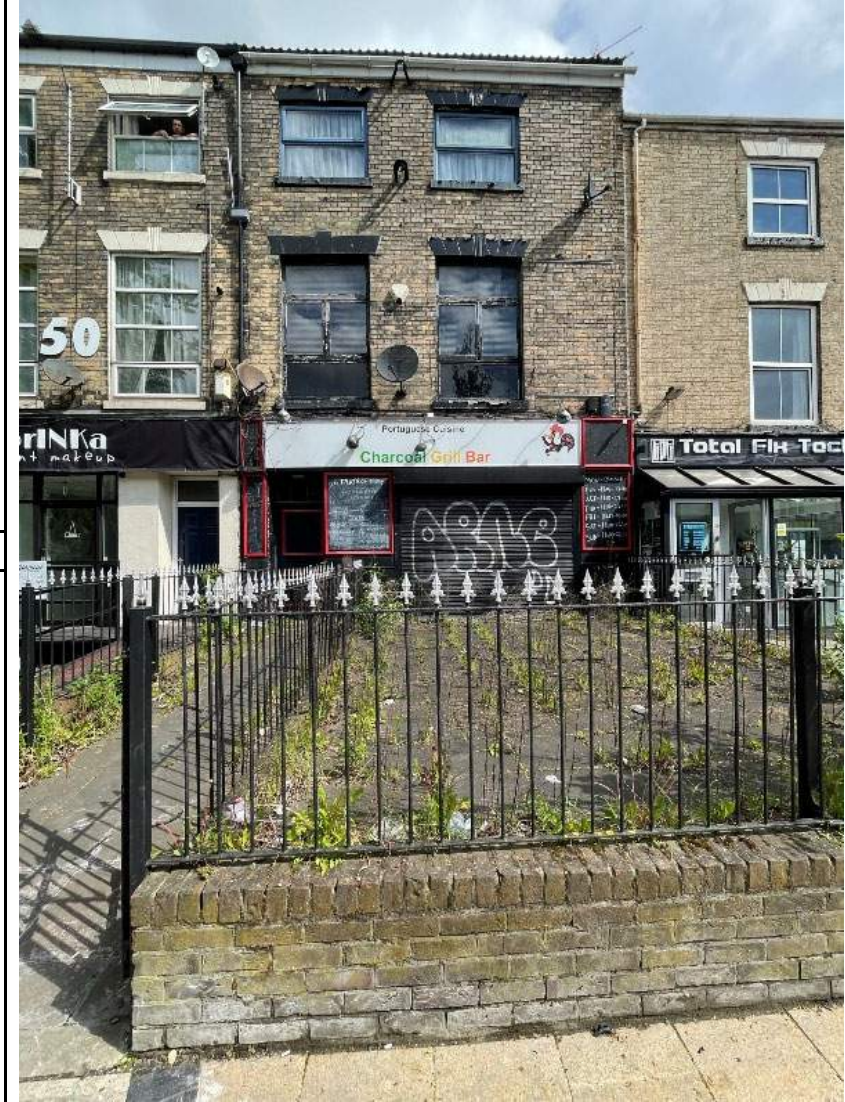
Address: Charcoal Grill Bar, 48

Today, the building has suffered from a series of modifications that have led to the loss of historical features that has been detrimental to the historic character of the Conservation Area. The original sliding sash windows to the first and second floor level have been removed and replaced with timber casement windows that do not reflect the historic proportions of the original windows. These are currently in poor condition. The feature timber brackets and timber gutter to the eaves level have been removed and replaced with a PVC fascia and gutter. The cast iron downpipes have been replaced with PVC downpipes. The slate roof finish has been replaced with concrete pantile roof tiles. The addition of satellite dishes, ariels, brackets and alarm boxes has created visual clutter to the external wall. The low quality timber shopfront is in need of replacement. Externally, the ground level has been elevated to create a raised external seating area and a ramped entrance to provide accessibility to the retail unit with a low level brick wall and iron spearhead railings that do not compliment the simple Georgian style of the building.

Recommended Actions	<p>The recent modifications to No 48 have been detrimental to the character of the Conservation Area. No 48 would benefit from a collective restoration along with the adjacent No 50 Spring Bank as a group.</p> <p>The following works are recommended to restore the historic character :-</p> <ul style="list-style-type: none"> • Removal of the raised external terrace and the lowering of the landscaping to street level • Removal of the existing low level wall and iron railings and replacement with railings that are more appropriate for the simple Georgian style of the building • Removal of the timber casement windows and replacement with new 6 over 6 vertical sliding sash windows to the first floor level and 3 over 3 to the second floor level. • Removal of the concrete pantile roof and replacement with slate roof finish to match the adjacent No 50. • Removal of the PVC gutter, downpipes and fascia and reinstatement of the feature timber brackets, timber gutter and cast iron downpipes. • The removal/ rationalisation of the satellite dishes, alarm boxes, brackets, electrical routes to remove visual clutter from the Spring Bank elevation. • Remove cement mortar to brickwork and undertake lime repointing where required.

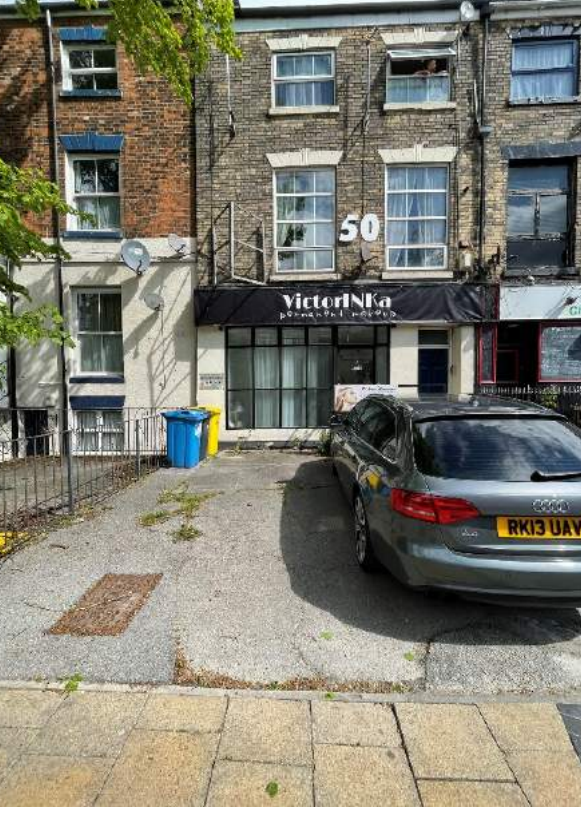
Street: Spring Bank	Address	VictoriNka, 50
Historic Photo 27/6/84	Historic Photo from 04/10/94 (Phil Hampel)	Current Photo – 11/05/2023 (author)

<p>Monitoring Notes</p>	<p>The building appears to be structurally stable from the Spring Bank frontage with no immediate cause for concern, although the building has suffered from a lack of general maintenance. Any works to remove the existing stonework lintels and cills should not be permitted.</p>
<p>Recommended Actions</p>	<p>The recent modifications to No 50 have been detrimental to the character of the Conservation Area. No 50 would benefit from a collective restoration along with the adjacent No 48 Spring Bank as a group.</p> <p>The following works are recommended to restore the historic character :-</p> <ul style="list-style-type: none"> • Removal of the concrete landscape treatment and replacement with a higher quality landscape treatment. • Removal of the uPVC casement windows and replacement with new 6 over 6 vertical sliding sash windows to the first floor level and 3 over 3 to the second floor level.

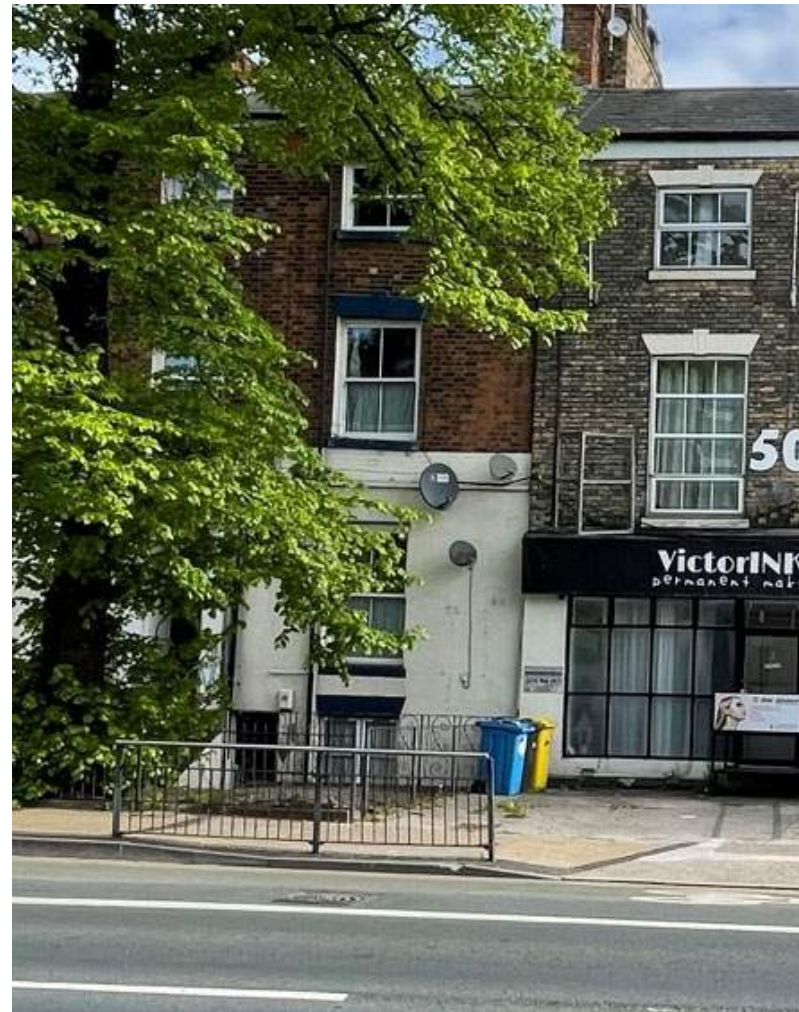
Between 1984-2023 the building has been subject to further changes. The basement level has been converted back to residential use and the window size decreased to improve privacy to the basement apartment. The basement level and first floor level have been rendered (likely to be in a cement render system) to conceal the repair of the brickwork following the reduction in the window size. The windows have been replaced with new uPVC double glazed sash windows. Cast iron rainwater goods have been replaced with uPVC and the deep timber fascias at eaves level have been replaced. The stone steps, iron railings and entrance portico have been retained although would benefit from minor repair works. Highly decorative iron railings have been installed to the boundary which do not compliment the simple Georgian style of the building.

Monitoring Notes	The building appears to be structurally stable from the Spring Bank frontage with no immediate cause for concern, although the building has suffered from a lack of general maintenance. Any works to remove the existing stonework lintels and cills or the removal of any details to the original portico should not be permitted.
-------------------------	--------------------------------------------------------------------------------------------------------------------------------------------------------------------------------------------------------------------------------------------------------------------------------------------------------------------------------------

- Removal of the existing highly decorative iron railings and replace with more sympathetic Georgian railings along with a higher quality landscape treatment.
- Removal of the uPVC casement windows and replacement with new timber framed sash windows.
- Removal of the PVC gutter, downpipes and fascia and reinstatement of the cast iron gutter and cast iron downpipes.
- The removal/ rationalisation of the alarm boxes, brackets, electrical routes to remove visual clutter from the Spring Bank elevation.
- The removal of the cement render to the ground floor and basement level.
- The removal of the paint to the brickwork between first and first floor window cill level.

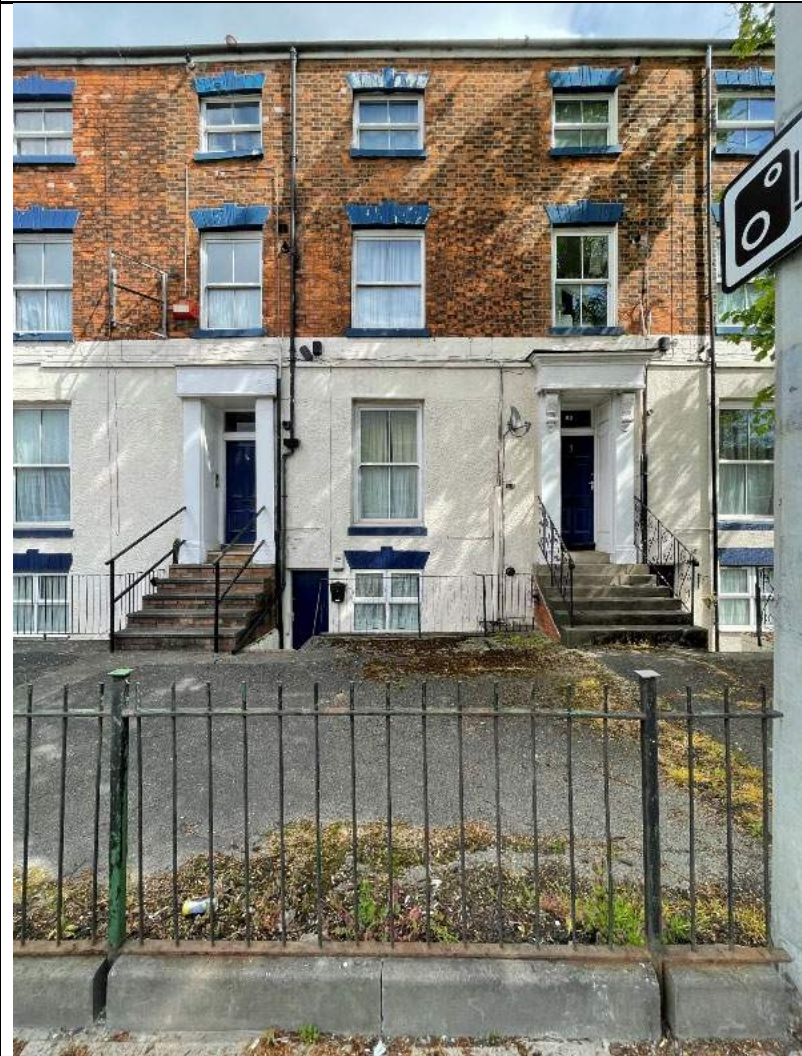
Between 1984-2023 the building has been subject to further changes. The windows have been replaced with new uPVC double glazed sash windows. Cast iron rainwater goods have been replaced with uPVC and the deep timber fascias at eaves level have been replaced. The entrance portico has been retained but has lost some of its historical details including the cornice at the head of the portico. The stone steps have been replaced with concrete steps and the iron railings have been replaced with low quality metal railings.

The building appears to be structurally stable from the Spring Bank frontage with no immediate cause for concern, although the building has suffered from a lack of general maintenance. Any works to remove the existing stonework lintels and cills or the removal of any details to the original portico should not be permitted.

- Removal of the brickwork and stone slab steps and replacement with stone steps
- Removal of the existing handrails and railings and replacement with more sympathetic Georgian railings along with a higher quality landscape treatment to the front garden.
- Removal of the uPVC casement windows and replacement with new timber framed sash windows.
- Removal of the PVC gutter, downpipes and fascia and reinstatement of the cast iron gutter and cast iron downpipes.
- The removal/ rationalisation of the alarm boxes, brackets, electrical routes to remove visual clutter from the Spring Bank elevation.
- The removal of the cement render to the ground floor and basement level and the repair of the brickwork.
- The removal of the paint to the brickwork between first and first floor window cill level.

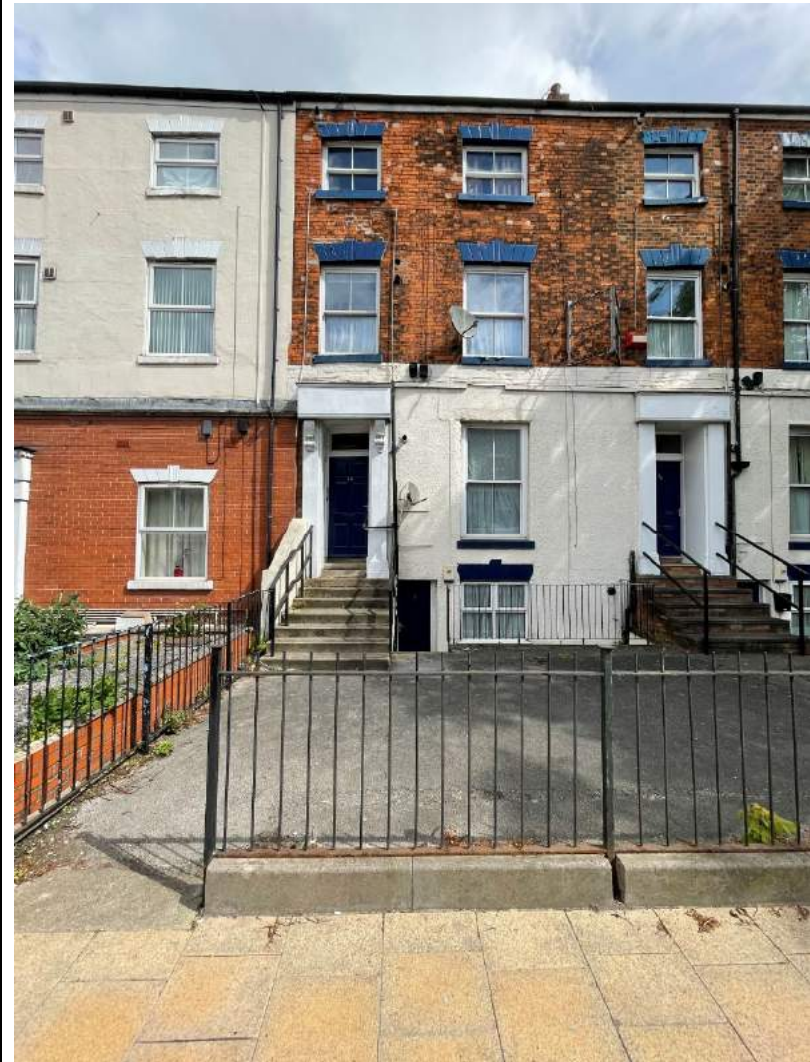
Between 1984-2023 the building has been subject to further changes. The basement level has been converted back to residential use. The basement level and first floor level have been rendered (likely to be in a cement render system) to conceal the repair of the brickwork following the reduction in the window size. The windows have been replaced with new uPVC double glazed sash windows. Cast iron rainwater goods have been replaced with uPVC and the deep timber fascias at eaves level have been replaced. The stone steps, iron railings and entrance portico have been retained although would benefit from minor repair works. Highly decorative iron railings have been installed to the boundary which do not compliment the simple Georgian style of the building.

The building appears to be structurally stable from the Spring Bank frontage with no immediate cause for concern, although the building has suffered from a lack of general maintenance. Any works to remove the existing stonework lintels and cills should not be permitted.

- Removal of the concrete steps and low quality handrail and the replacement with stone steps and replacement with more sympathetic Georgian railings along with a higher quality landscape treatment.
The reinstatement of the cornice detail to the roof level of the portico.
- Removal of the uPVC casement windows and replacement with new timber framed sash windows.
- Removal of the PVC gutter, downpipes and fascia and reinstatement of the cast iron gutter and cast iron downpipes.
- The removal/ rationalisation of the alarm boxes, brackets, electrical routes to remove visual clutter from the Spring Bank elevation.
- The removal of the cement render to the ground floor and basement level.
- The removal of the paint to the brickwork between first and first floor window cill level.

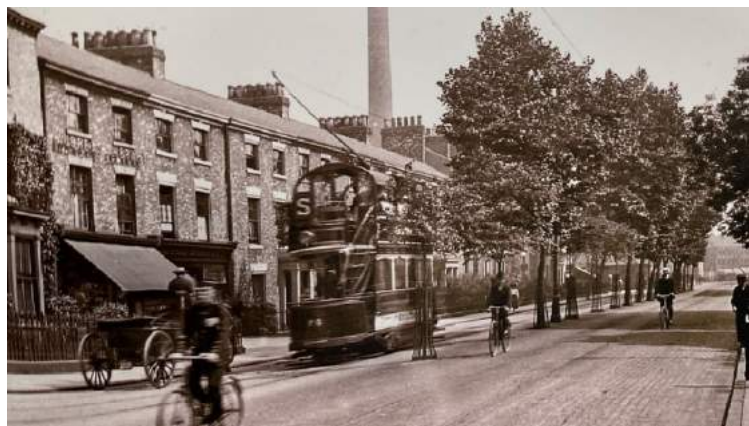
Street:	Spring Bank	Address	58 and 60 Spring Bank
Historic Photo – 1904 (Hull Then and Now, Paul Gibson)		Current Photo – 11/05/2023 (author)

The building appears to be structurally stable from the Spring Bank frontage with no immediate cause for concern, although the building has suffered from a lack of general maintenance. Any works to remove the existing stonework lintels and cills to the upper floor levels should not be permitted.

- Removal of the existing railings and a cohesive boundary treatment provided across the group from No 52-60.
- Undertake works to add further detail to the entrance portico.
- Removal of the cement render to the upper floor levels.
- Removal of the uPVC casement windows and replacement with new timber framed sash windows.
- Removal of the PVC gutter, downpipes and fascia and reinstatement of the cast iron gutter and cast iron downpipes.
- The removal/ rationalisation of the alarm boxes, brackets, electrical routes to remove visual clutter from the Spring Bank elevation.
- Replace concrete pantile roof finish with slate.

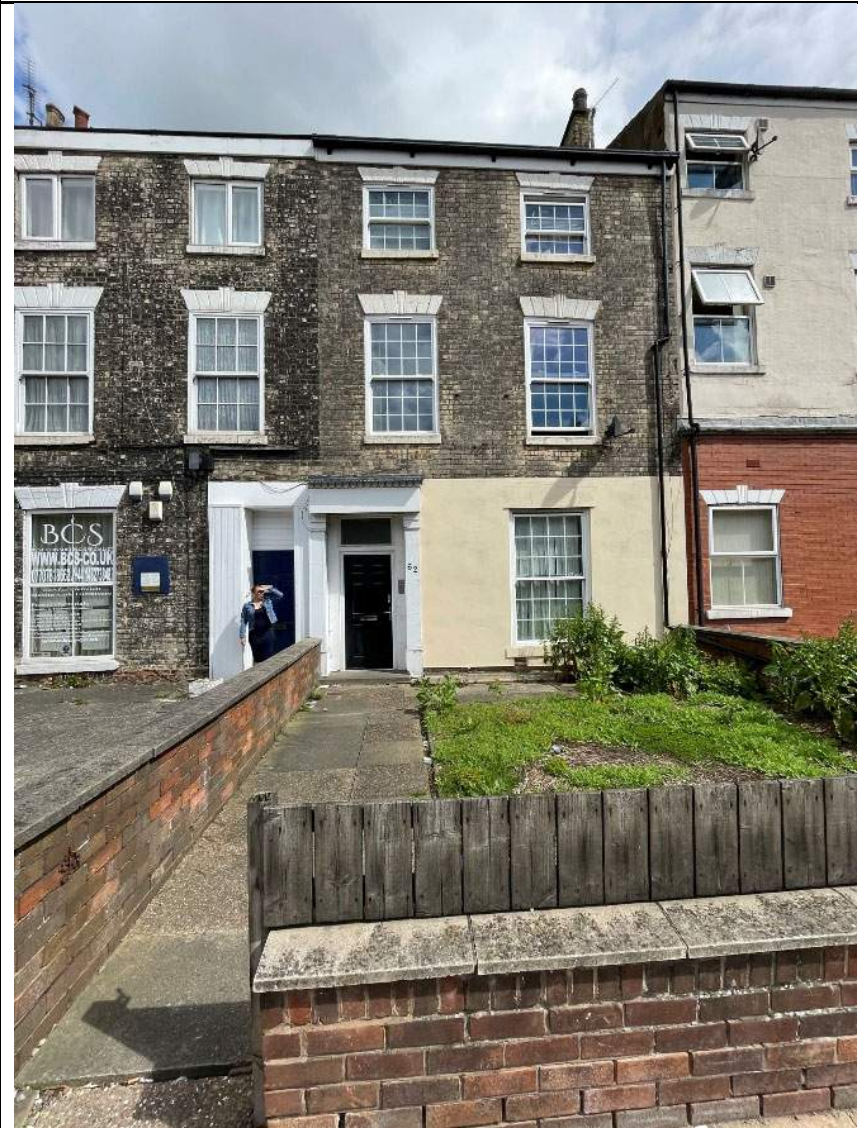
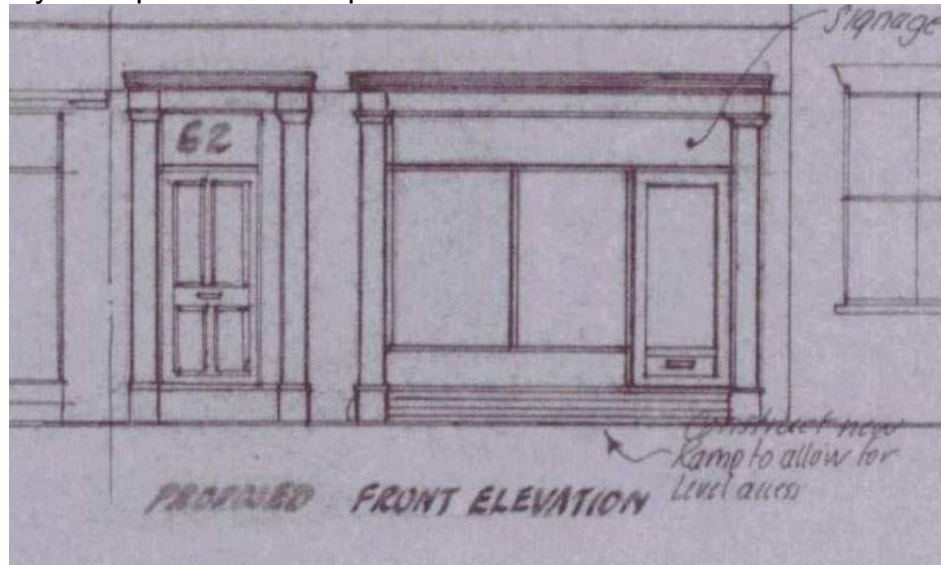
In 2015, the shopfront was removed and the building converted to residential use throughout. This involved the removal of the shopfront and the infill of the shopfront opening to provide a new ground floor window to reflect the proportions of the window above and adjacent to No 64. The infill was finished in render to the ground floor level. The windows were also replaced at this time with Georgian style UPVC sliding sash windows. The proportions to these replacement windows (12 over 12 and 8 over 8) are at odds with the original 6 over 6 / 3 over 3 Georgian design as shown on the 1904 photograph. The slate roof finish has been replaced with concrete pantile roof finish and the cast iron gutters and downpipes removed and replaced with PVC. The deep

Monitoring Notes	<p>The building appears to be structurally stable from the Spring Bank frontage with no immediate cause for concern, although the building has suffered from a lack of general maintenance. Any works to remove the existing stonework lintels and cills to the upper floor levels should not be permitted.</p>
Recommended Actions	<p>The recent modifications to No 62 have been detrimental to the character of the Conservation Area. No 62 would benefit from a collective restoration along with the adjacent No 64, 66, 68, 70, 72, 74 and 76 Spring Bank as a group.</p> <p>The following works are recommended to improve the quality and overall character of building within the Conservation Area :-</p> <ul style="list-style-type: none"> • Removal of the existing low brick wall and timber fence and a cohesive boundary treatment and landscape treatment provided across the group from No 62-76. • Undertake works to reinstate the projecting entrance portico and supporting columns. • Removal of the cement render to the ground floor level and reinstate brickwork frontage. • Removal of the uPVC windows and replacement with new timber framed sash windows with 6 over 6/ 3 over 3 proportions. • Removal of the PVC gutter, downpipes and fascia and reinstatement of the cast iron gutter and cast iron downpipes and reinstatement of the deep timber fascia and overhang at eaves level with timber gutter support brackets with a consistent detail across all buildings in the group to match No 74-76 which has retained the original detail). • The removal/ rationalisation of the alarm boxes, brackets, electrical routes to remove visual clutter from the Spring Bank elevation. • Replace concrete pantile roof finish with slate.

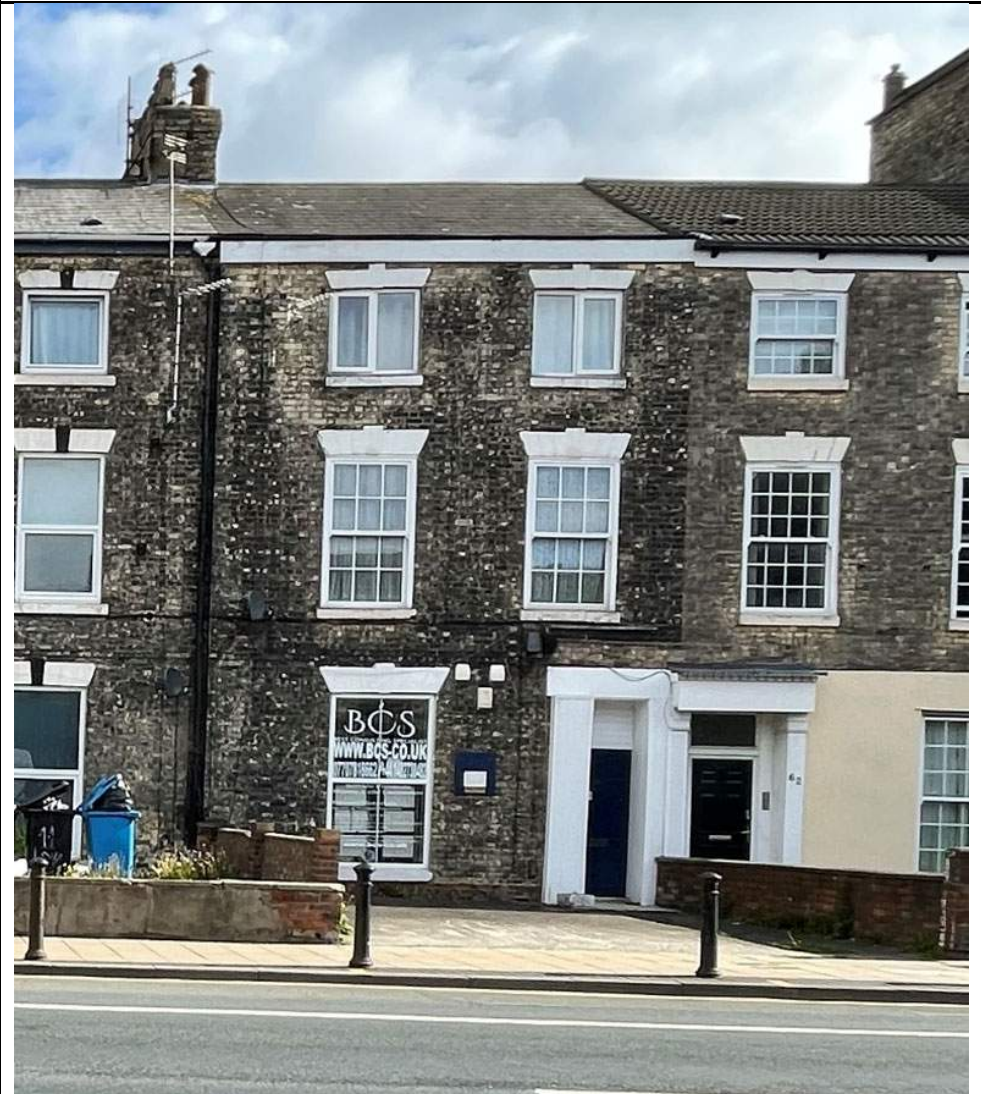
<p>Monitoring Notes</p>	<p>The building appears to be structurally stable from the Spring Bank frontage with no immediate cause for concern, albeit there is historic signs of structural movement evident in the window lintels at second floor which are not level. Any works to remove the existing stonework lintels and cills to the upper floor levels should not be permitted.</p>
<p>Recommended Actions</p>	<p>The recent modifications to No 64 have been detrimental to the character of the Conservation Area. No 64 would benefit from a collective restoration along with the adjacent No 62, 66, 68, 70, 72, 74 and 76 Spring Bank as a group.</p> <p>The following works are recommended to improve the quality and overall character of building within the Conservation Area :-</p> <ul style="list-style-type: none"> • Removal of the concrete slab car parking space and reinstatement of the low level brickwork wall with iron railings to create cohesive boundary treatment and landscape treatment provided across the group from No 62-76.

- Remove the vertical and horizontal timber cladding to the entrance portico and undertake works to reinstate the projecting entrance portico and supporting columns.
- Removal of the uPVC windows and replacement with new timber framed sash windows with 6 over 6 / 3 over 3 proportions.
- Removal of the PVC gutter, downpipes and fascia and reinstatement of the cast iron gutter and cast iron downpipes and reinstatement of the deep timber fascia and overhang at eaves level with timber gutter support brackets with a consistent detail across all buildings in the group to match No 74-76 which has retained the original detail).
- The removal/ rationalisation of the alarm boxes, brackets, electrical routes to remove visual clutter from the Spring Bank elevation.

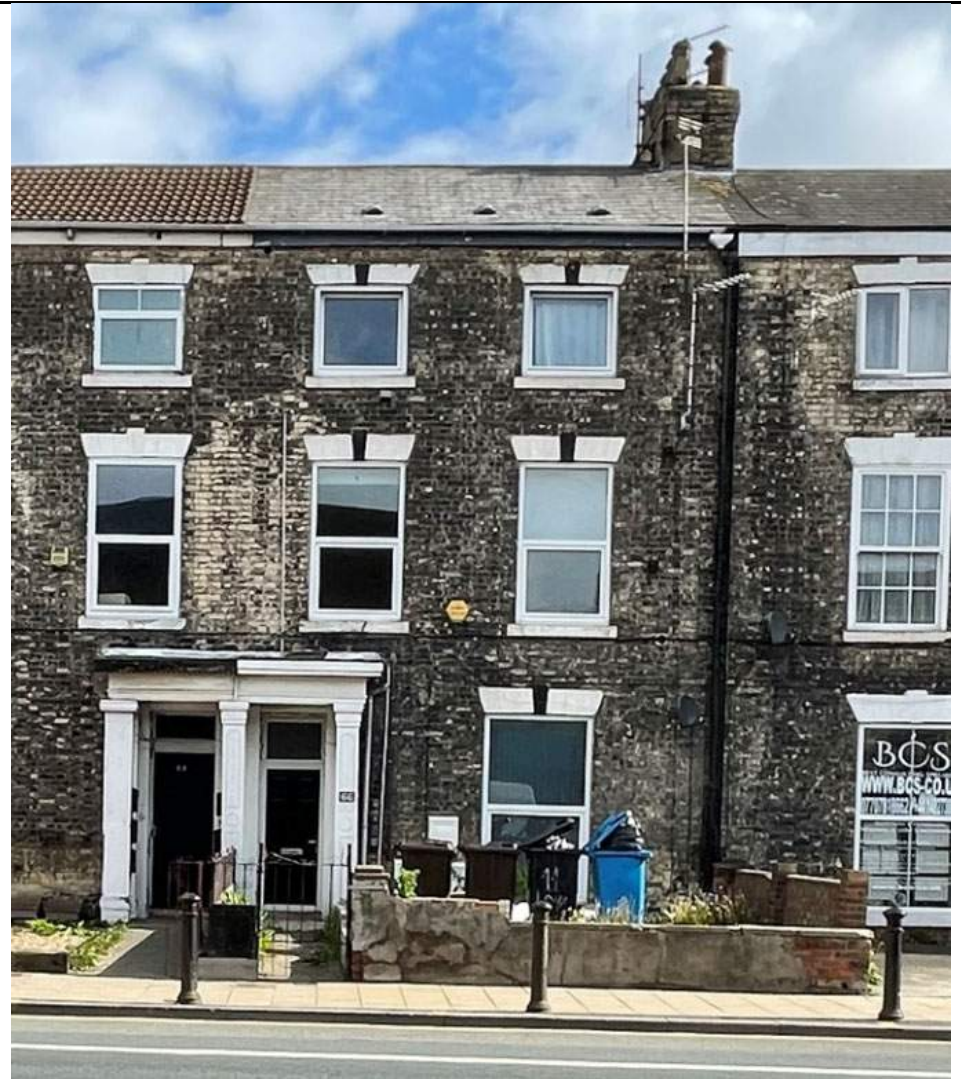
<p>Monitoring Notes</p>	<p>The building appears to be structurally stable from the Spring Bank frontage with no immediate cause for concern. Any works to remove the existing stonework lintels and cills to the upper floor levels or to remove the retained portico, columns and pillasters should not be permitted.</p>
<p>Recommended Actions</p>	<p>The recent modifications to No 66 have been detrimental to the character of the Conservation Area. No 66 would benefit from a collective restoration along with the adjacent No 62, 64, 68, 70, 72, 74 and 76 Spring Bank as a group.</p> <p>The following works are recommended to improve the quality and overall character of building within the Conservation Area :-</p> <ul style="list-style-type: none"> • Removal of the loose grey gravel finish to the garden, removal of the cement render and repair of the low level brickwork wall with iron railings to create cohesive boundary treatment and landscape treatment provided across the group from No 62-76. • Repair the retained entrance portico, pilasters and columns.

- Removal of the uPVC windows and replacement with new timber framed sash windows with 6 over 6 / 3 over 3 proportions.
- Removal of the PVC gutter, downpipes and fascia and reinstatement of the cast iron gutter and cast iron downpipes and reinstatement of the deep timber fascia and overhang at eaves level with timber gutter support brackets with a consistent detail across all buildings in the group to match No 74-76 which has retained the original detail).
- The removal/ rationalisation of the alarm boxes, brackets, electrical routes to remove visual clutter from the Spring Bank elevation.

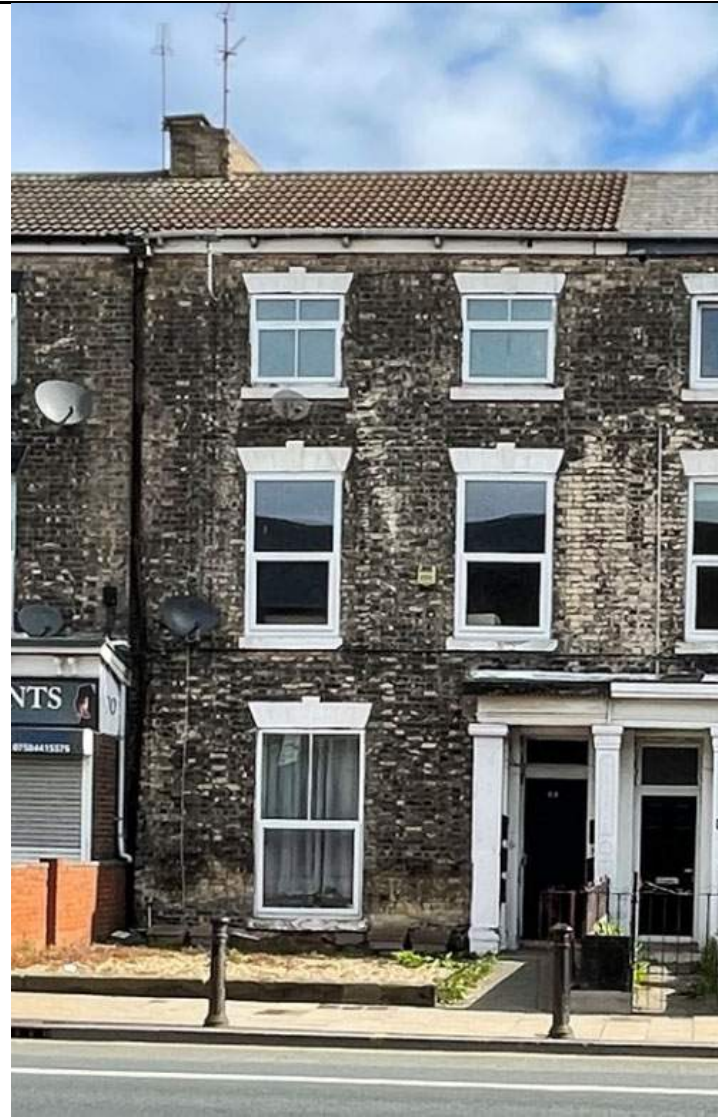
<p>Monitoring Notes</p>	<p>The building appears to be structurally stable from the Spring Bank frontage with no immediate cause for concern with the exception of the roof to the portico which appears to be dropping towards the front face which requires repairs. Any works to remove the existing stonework lintels and cills to the upper floor levels or to remove the retained portico, columns and pillasters should not be permitted.</p>
<p>Recommended Actions</p>	<p>The recent modifications to No 68 have been detrimental to the character of the Conservation Area. No 68 would benefit from a collective restoration along with the adjacent No 62, 64, 66, 70, 72, 74 and 76 Spring Bank as a group.</p> <p>The following works are recommended to improve the quality and overall character of building within the Conservation Area :-</p>

- Removal of the loose buff gravel finish to the garden, reinstatement of the low level brickwork wall with iron railings to create cohesive boundary treatment and landscape treatment provided across the group from No 62-76.
- Repair the retained entrance portico, pilasters and columns.
- Removal of the uPVC windows and replacement with new timber framed sash windows with 6 over 6 / 3 over 3 proportions.
- Removal of the PVC gutter, downpipes and fascia and reinstatement of the cast iron gutter and cast iron downpipes and reinstatement of the deep timber fascia and overhang at eaves level with timber gutter support brackets with a consistent detail across all buildings in the group to match No 74-76 which has retained the original detail).
- The removal/ rationalisation of the alarm boxes, brackets, electrical routes to remove visual clutter from the Spring Bank elevation.

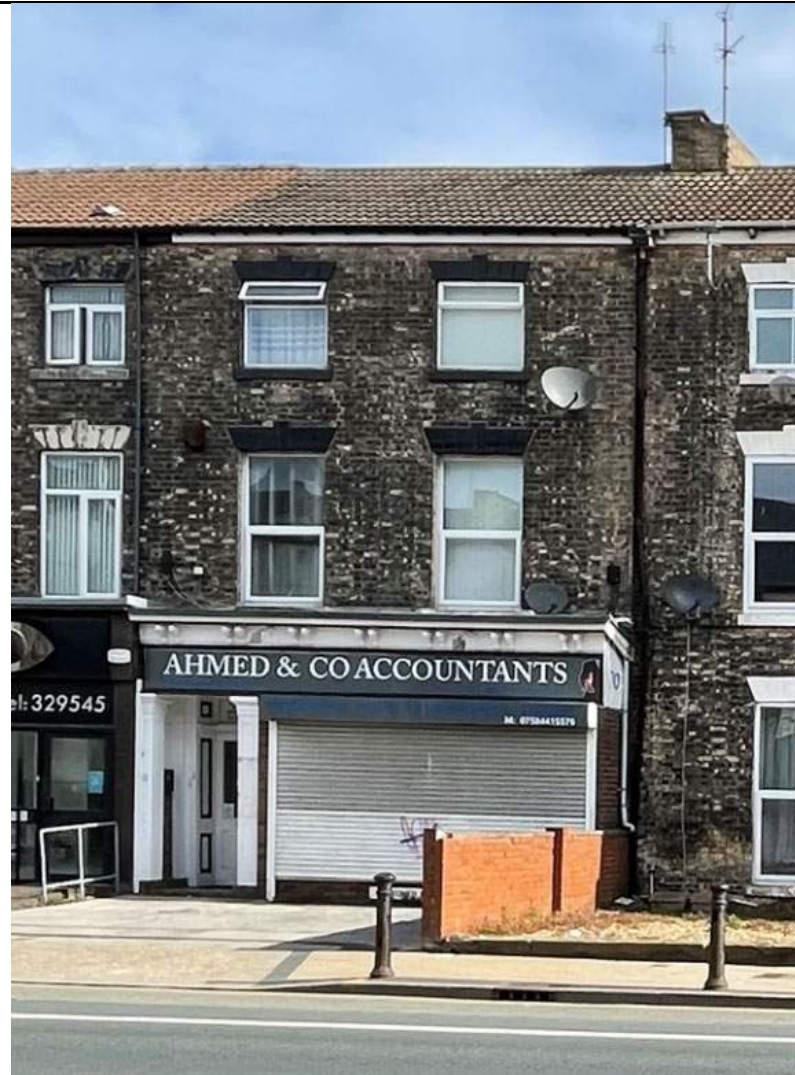
<p>Monitoring Notes</p>	<p>The building appears to be structurally stable from the Spring Bank frontage with no immediate cause for concern. Any works to remove the existing ground floor shopfront, stonework lintels and cills to the upper floor levels or to remove the retained portico, columns and pilasters should not be permitted.</p>
<p>Recommended Actions</p>	<p>The recent modifications to No 70 have been detrimental to the character of the Conservation Area. No 70 would benefit from a collective restoration along with the adjacent No 62, 64, 66, 68, 72, 74 and 76 Spring Bank as a group.</p>

- Repair the retained entrance portico, pilasters and columns.
- Removal of the uPVC windows and replacement with new timber framed sash windows with 6 over 6 / 3 over 3 proportions.

- Removal of the pantile roof finish and replacement with a slate roof finish.
- Removal of the PVC gutter, downpipes and fascia and reinstatement of the cast iron gutter and cast iron downpipes and reinstatement of the deep timber fascia and overhang at eaves level with timber gutter support brackets with a consistent detail across all buildings in the group to match No 74-76 which has retained the original detail).
