Rossett House, Hull

Compartmentation Survey Report

Prepared for:	Rebecca Franks, Programme Manager
Prepared by:	John Askew, Fire Risk Assessor, Holistic Fire Safety
Date:	03/04/2024
Document Reference:	HFS.HCC.RossettHouse.CSR.1.0

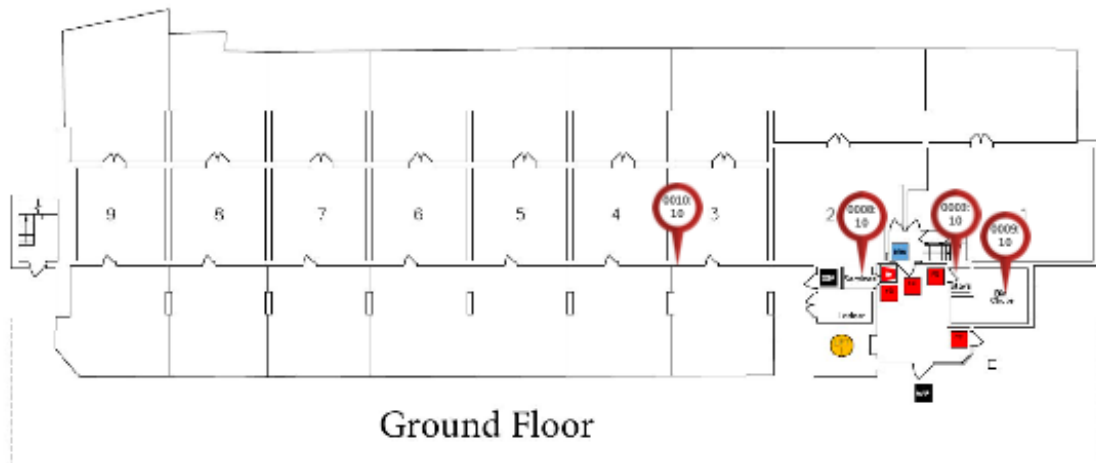
FIGURE 1

Figure 1 below highlights locations of defects on the ground floor at Rossett House.

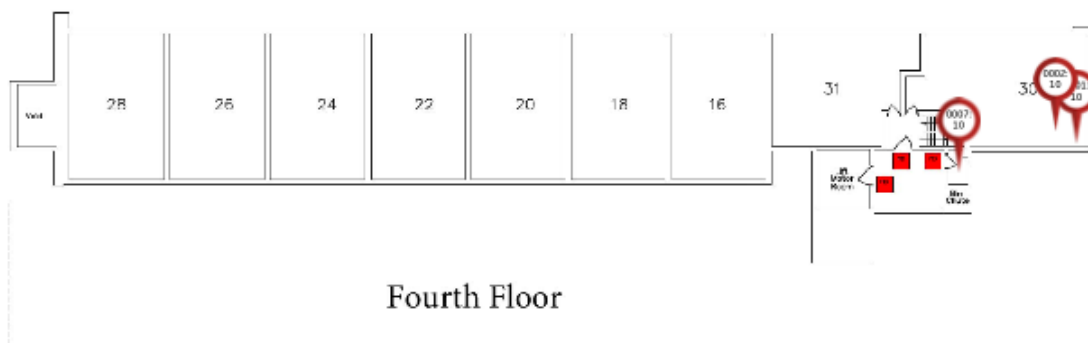
FIGURE 2

Figure 2 below demonstrates locations of defects on the fourth floor in flat 30 at Rossett House. Defects (pin locations) are expected to be consistent.

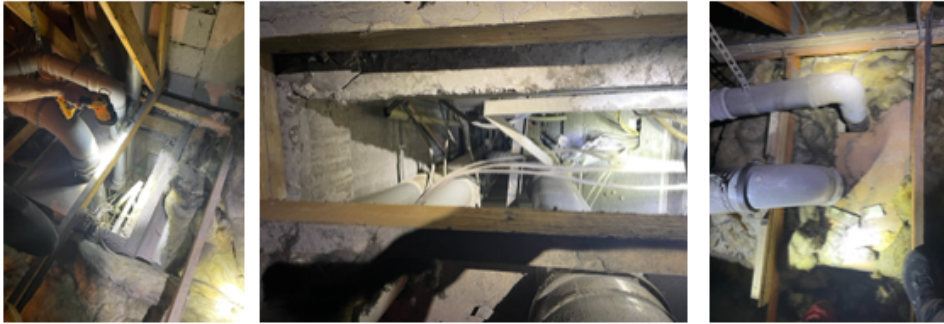
1.1. Roof Space

There are circa x7 ventilation riser shafts in the roof void. These were observed to be open with no fire separation in place which require fire stopping at the top and bottom.

Install a double fire batt, wrap and mastic system or single batt rafter than apply Rockwool compound.

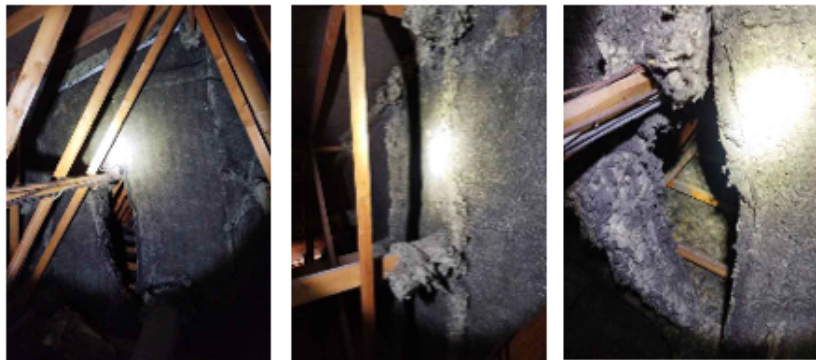
1.2. Roof Space

Fire barriers are provided in the roof void to separate areas at appropriate intervals which have been compromised due to openings which have been made.

Methods of remediation would be to repair or replace the fire barrier.

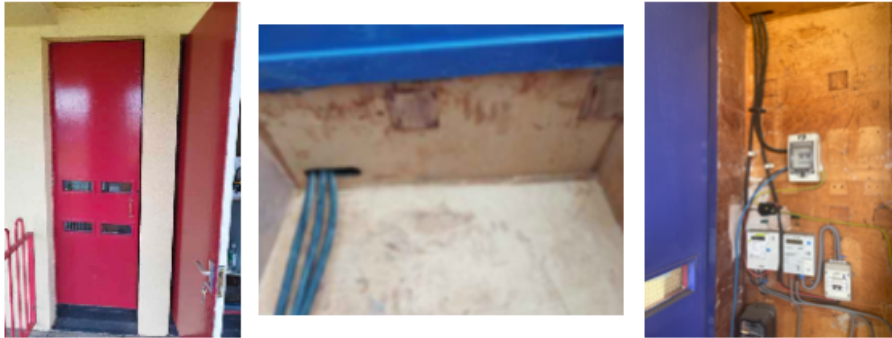
1.3. Ground Floor External Electric Meter Cupboards

Electric meter cupboards located externally on the ground floor gave evidence of cables penetrating timber boarding.

Remediation would involve inserting an ablative coated fire batt and acrylic mastic system and sealing around penetrating services.

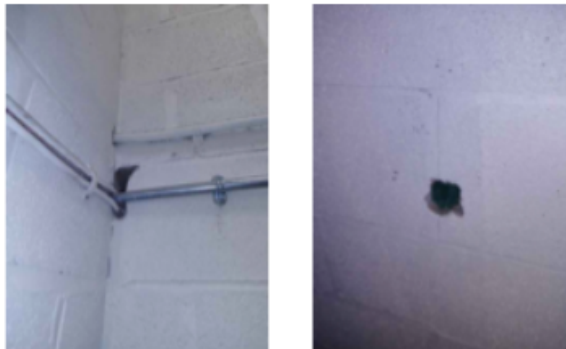
1.4. Ground Floor Cleaners Cupboards

The ground floor cleaners cupboard gave evidence of missing sections of masonry and service cables and conduit penetrating compartment boundaries.

Remediation varies and will be determined by the size of annular gaps, however the following principles should be applied:

- Where the annular gap is <10mm non combustible pipes such as copper and steel pipes should be sealed with a fire rated mastic which is tested to BS EN 1366-3 and classified to 13501-2:2017 + A1:2009.
- Where the annular gap is >10mm, an ablative coated fire batt and acrylic mastic system should be installed.

-
- Should the annular gap around combustible services be <10mm then smoke sealing should be carried out using a fire rated mastic and then a suitable closing device such as intumescent fire collar should be applied.
 - Should the annular gap around combustible services exceed 10mm then an ablative coated fire batt and acrylic mastic system should be used in conjunction with an intumescent wrap system.
