**Avenues and
Pearson Park
Conservation Area
Character
Appraisals**

Character Appraisal 2: Pearson Park

Published by Hull City Council, Kingston upon Hull, UK

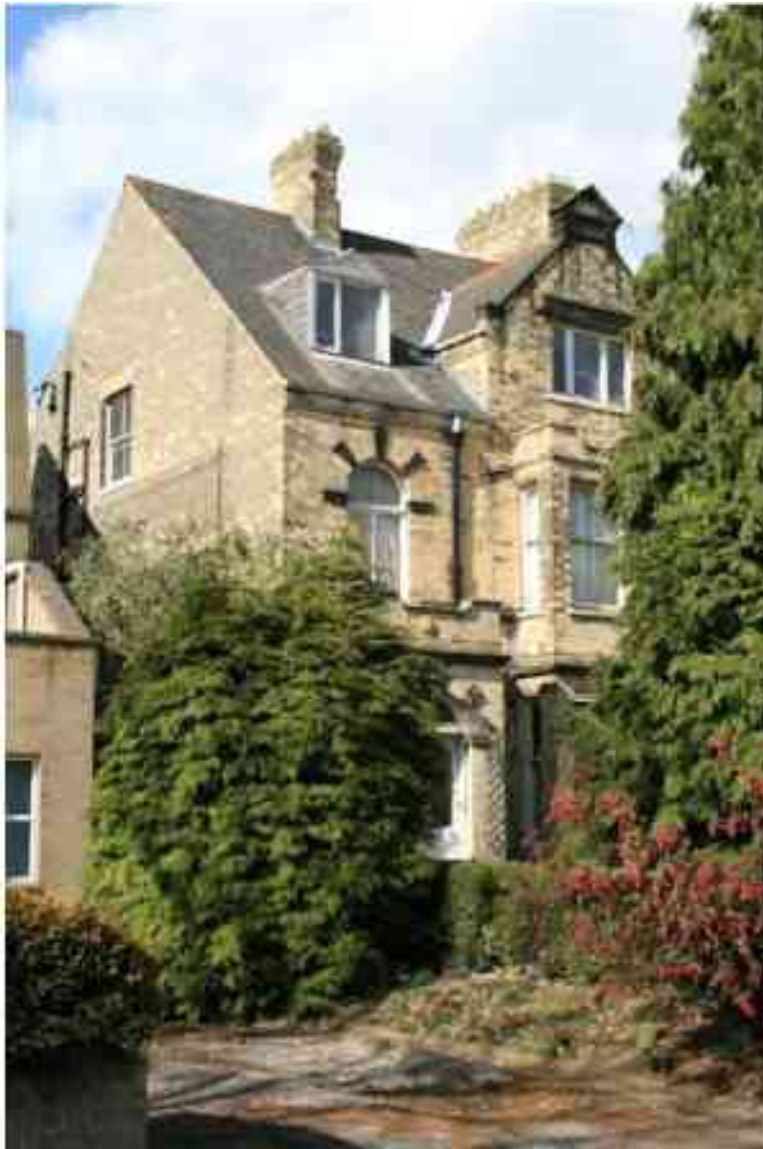
- 7.4.18.3 The two rectangular windows on the ground floor in each house are original timber sash. This window arrangement continues on the first floor in No. 60, whereas in No. 61 the two individual windows have been replaced by one horizontal rectangular timber window in the bay. This confuses the design as the strong vertical line that carries the gaze up the building is disrupted and the harmony ceases. To restore the unity of the two buildings would require the reinstalling of the brick mullion as well as sash windows. The gable end window on the third floor has also been changed for a one-third opener, but this is not as jarring as the window below.

Figure 136 No. 60 angle

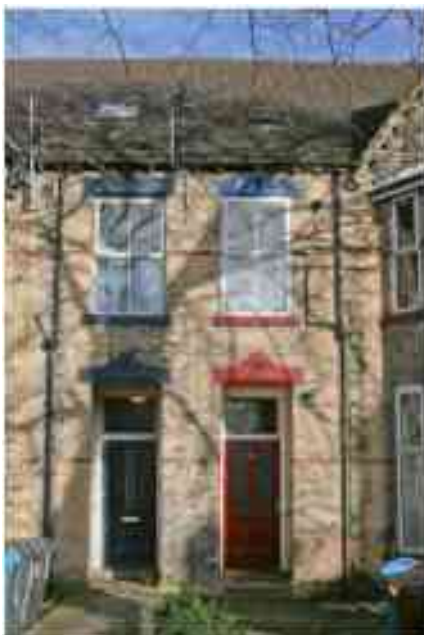
7.4.19.2 Each has lost its original slate roof and had a Velux-style window implanted in its roof, located roughly above the front entrance. Nos. 62 to 64 also have a replacement finish to their bay window roofs: felt and bitumen, rather than lead which is seen on No. 65 and is likely to be the original material used. No. 64 & 65 have finials atop their gable: both appear to be replacing the originals.

Figure 141 Nos. 62 & 63 front doors
