# Hull City Council Flood Investigation Report

## December 2013 City Centre Tidal Surge Flood Event

04 February 2014  
HCCFWMAS190002

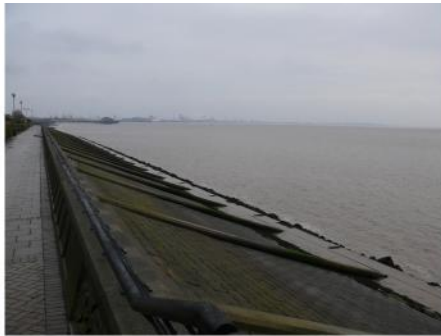
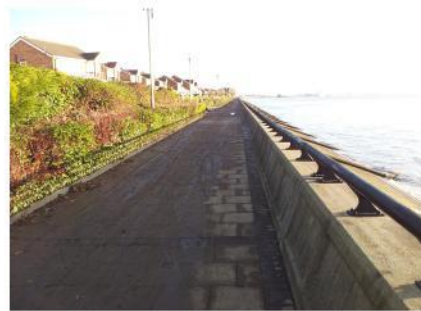
**Victoria Dock, showing riverside defence wall at low tide (left) and evidence of over-topping (right).**

Within the city the defences consist of a mixture of vertical sea walls and concrete revetments. Some of the defences have been raised by the construction of new wave return walls along the length of the crest of the existing structure. To the west, the defences abruptly change from sea walls to natural marshland. Along this length Clive Sullivan Way is on a raised embankment and effectively forms the defence. The defences are varied in age, with the original dock structures dating mainly from the late 19th Century and the early 20th. The area immediately to the west of the Hull Barrier consists of a mixture of different defences, part of the defence along this frontage is formed by the walls of various buildings and warehouses.

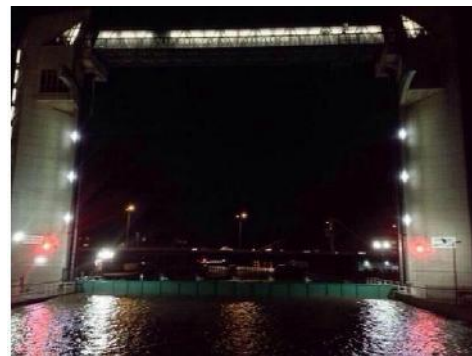
**Hull Tidal Surge Barrier in operation, 5<sup>th</sup> December 2013**

The Hull Tidal Surge Barrier has been in operation since 1980 to prevent high sea levels caused by surge tides overwhelming river defences. It is approximately 30 metres wide and takes roughly 30 minutes to open or close. The Barrier is closed when a predicted tidal level greater than 4.3 metres AOD is forecast. The Environment Agency recently spent £10M refurbishing the barrier to ensure its long term resilience and reliability.

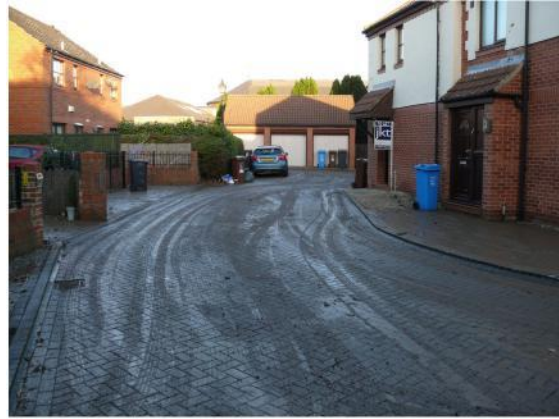
43 properties are known to have flooded in the Wellington Street West area. Residents have confirmed that the flood water did not come overland but was due to surcharging sewerage infrastructure. Further evidence of surcharging gullies was experienced in the Humber Quays area but aside from accumulated silt and debris, no properties were threatened. It is considered that this was due to sewers being

**Evidence of flooding at the Anchorage**

overwhelmed locally due to tidal ingress from the Albert Dock area and the sudden influx of a huge volume of water from the estuary into the sewer.

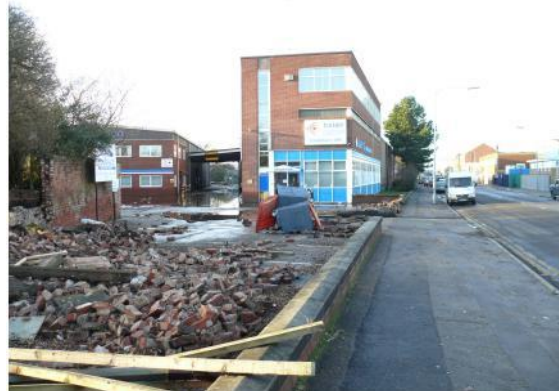
Flood flows passed into the full extent of the English Street, Jackson Street and Lister Street area with only a handful of commercial properties reporting minimal or no damage. Flows into

**Wall destroyed by flood waters, English Street**

the area came quickly and levels were as deep as 1.5m in places. Interviews and CCTV footage have confirmed issues of floating cars, floating heavy debris and pedestrians taking refuge for safety from the rapid flowing water.

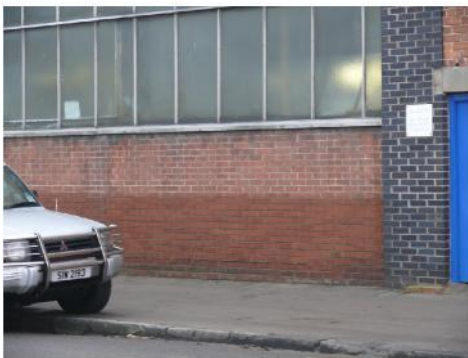
**Water mark, English Street**

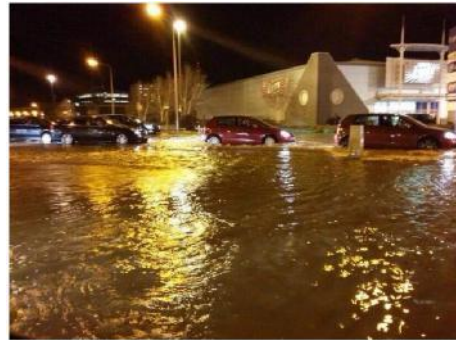
Flood flows passed along Commercial Road, through the Kingston Retail Park and spread to either side of the Mytongate roundabout causing severe traffic disruption on the evening, and delays through into the 6<sup>th</sup> December due to the closure of the A63 – the A63 reopened at midday. The flow route can be seen across the Staples car park and into Myton Street and Anne Street, and flows also passed into the area from the central part of the English Street area via Porter Street.

**Flooding at Kingston Retail Park**

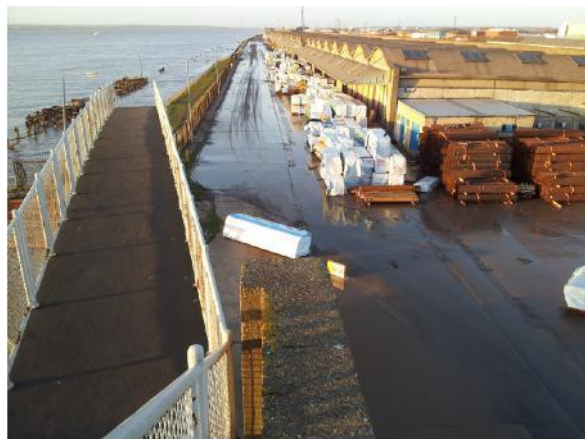
The defence levels by Albert Dock are known to be lower than other parts of the city and the Environment Agency are currently appraising the works required to ensure all defences along the Hull Humber frontage are renewed or replaced to provide a long term protection from flood risk and climatic change. Following approval later this year, prioritised delivery of all works will commence in five year programmes. The raising of the standard of protection on Albert Dock is a high priority to be in the first tranche of works. A temporary defence is also being considered to raise the height of the defence prior to the

**Hull Humber frontage defences**

permanent construction of raised defences.

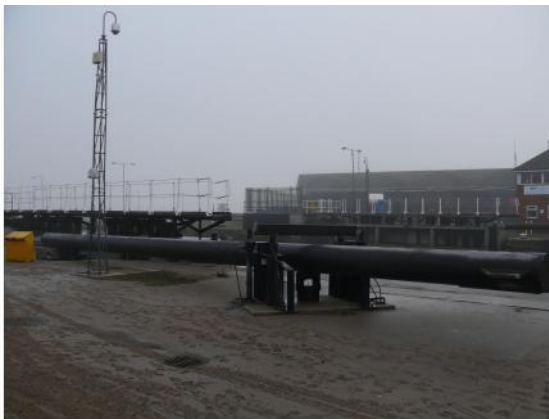
**Albert Dock RHRS**

The lock gates at Albert Dock form an important part of the defence, and the Reverse Head Restraint System (RHRS) has been supplied by the Agency with the intention of ensuring that the lock gates remain closed during extreme tidal levels. ABP operate the lock gates and will in future be responsible for the operation of the RHRS. An attempt was made by ABP to deploy the RHRS on the 5<sup>th</sup> December but they were

unable to apply the vertical bolt locking system and, due to fears that the lock gates would be grossly distorted the RHRS was removed. As the closure mechanism at the base of the gates could not be deployed operatives feared that the gates would buckle and twist at the base of the gate with an increasing water pressure, thereby rendering them ineffective.

An investigation is required to identify the issues observed in the Albert Dock area, the dock side would have overtopped in such a severe event and we need to understand the severity of the event to quantify this and the mitigation effect of the storage in Albert Dock. The EA have already substantially completed this investigation work and have concluded that the amount of water entering Albert Dock over low points in the riverside defences far exceeded that which entered the dock through the lock. Clearly levels built up in the dock in advance of the high tide by water entering the lock as RHRS could not be deployed, and via the low sections on the river wall adjacent to the dock. The operational agreement between ABP and the Environment Agency to safely close the gates and deploy the RHRS has been optimised to ensure that, where possible, the dock can act as a secondary storage feature when levels overtop the dock wall, although as mentioned above using the dock basin as a 'reservoir' would have had no effect on the events of 5 December.
