Hessle Road

Character Appraisal and Management Plan

Published February 2025

4. Between May and June 2024, a survey of the Conservation Area was carried out in order to update the existing Character Appraisal, and adoption of a Management Plan to maintain and enhance the character of the area.

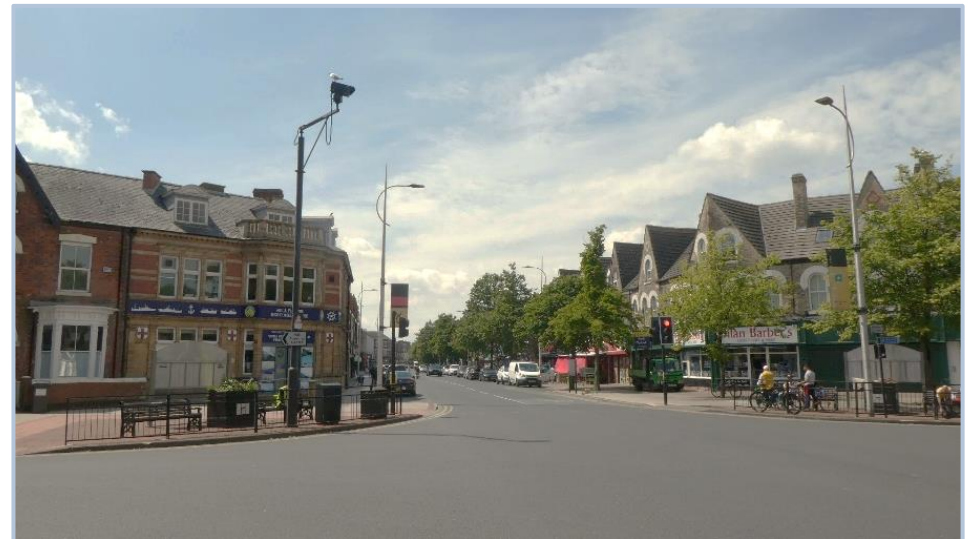
Figure 1. Boulevard Junction (1994 and 2024), more trees planted and minor changes to advertisement quality can be seen.

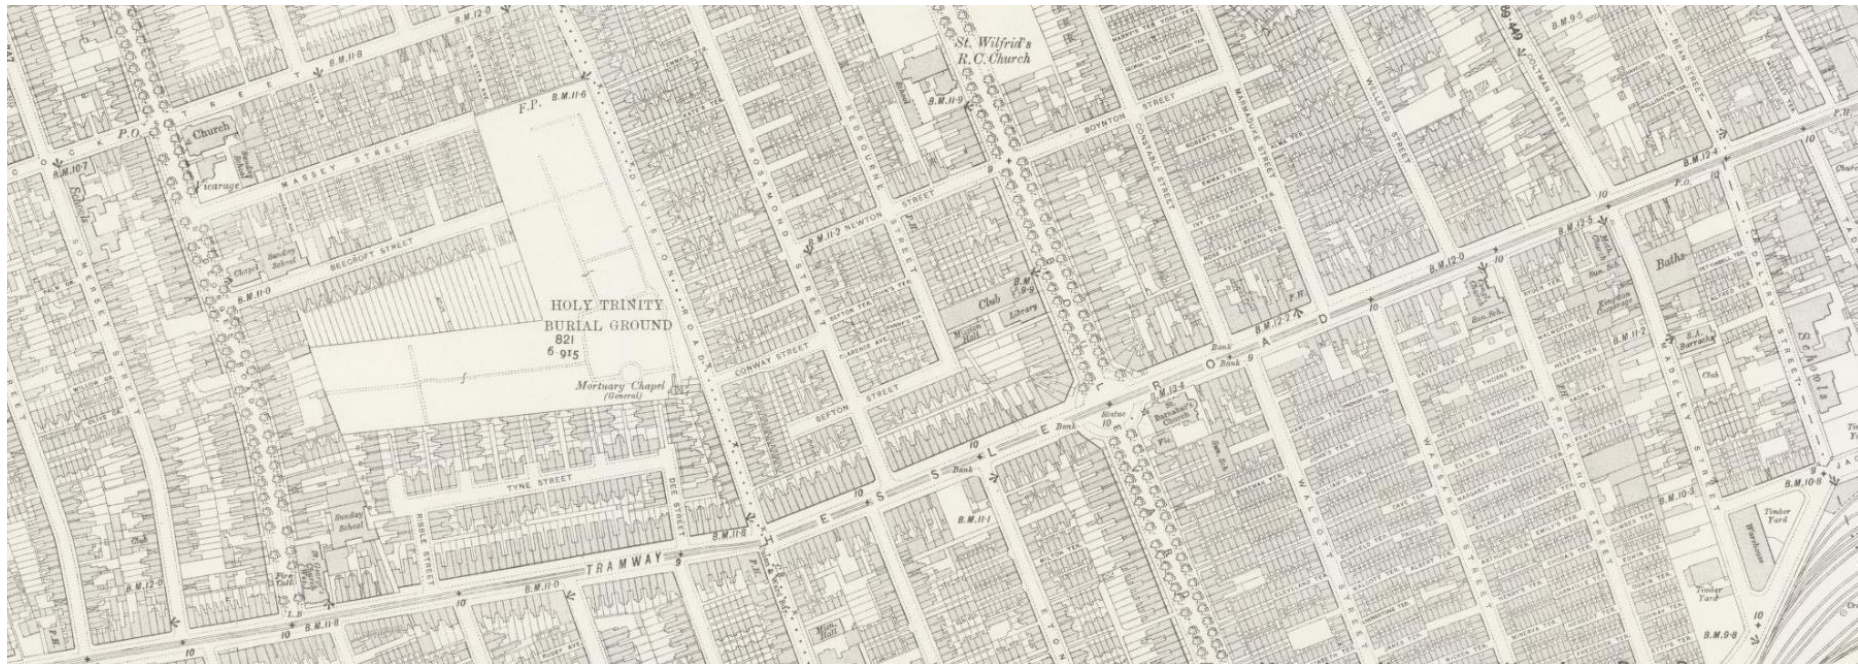
Figure 2. OS Map (1908). Source:Invalid source specified.

Ordnance Survey maps from 1908 (see Figure 2) show the evidence of tramlines and the density of the road. The map also shows evidence of streets which have been lost due to demolition and other new development.

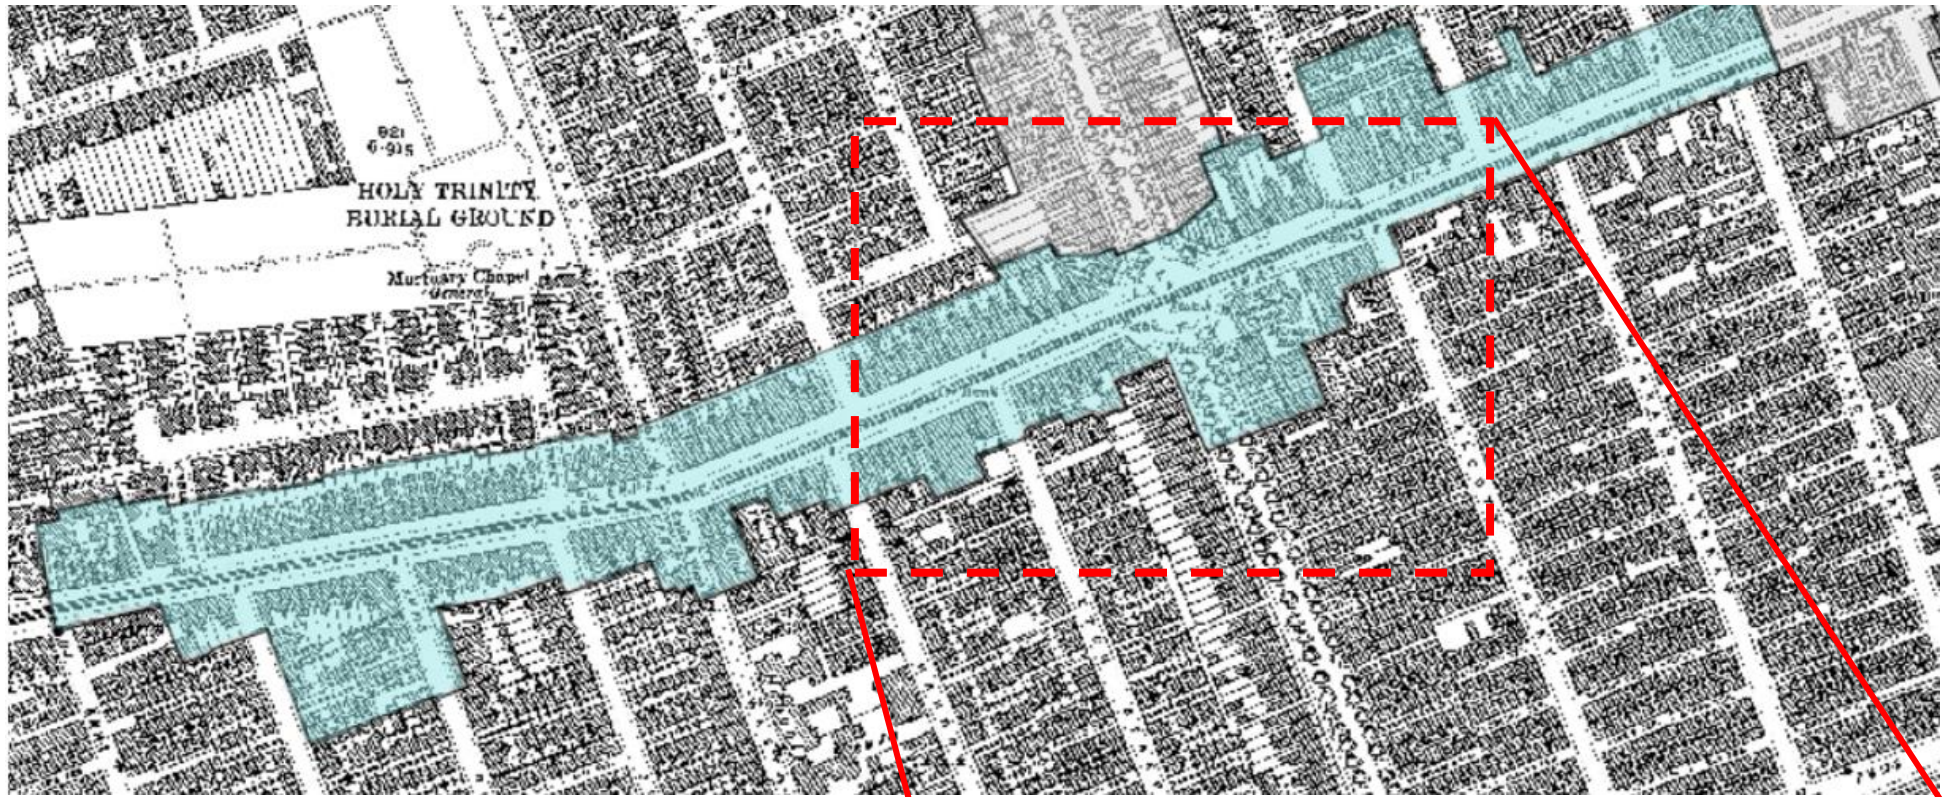
Figure 4. Historic Map (1928). Source: <https://maps.hull.gov.uk/myhull.aspx>

The map shows tram lines along Hesse Road, and highlights the lack of trees, which are a later addition through the road improvement schemes.

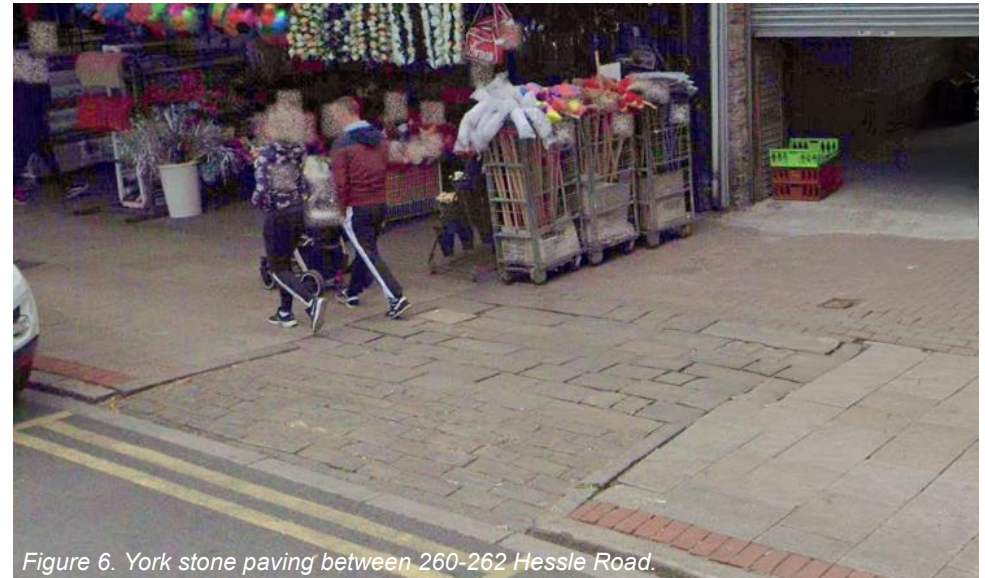
marble and sandstone. Original roof materials include slate and clay tiles; however, these have widely been replaced with concrete tiles. The building thresholds were originally designed with York stone paving but have been widely replaced with concrete paving. Some examples still exist, as shown in

Figure 6. York stone paving between 260-262 Hessle Road.

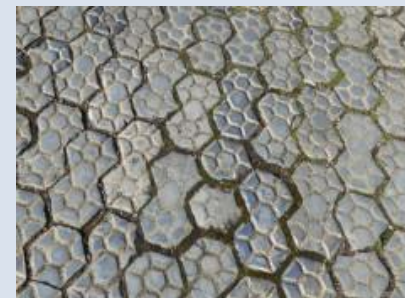
Scoria bricks were a kind of igneous rock, which proved to be durable, waterproof, frost proof and chemical proof, thus making it useful in drainage channels. They were identical in size and thus easily laid on flat roads.

Figure 7. Scoria paving. Source: (Clements Hall Local History Group, 2022)

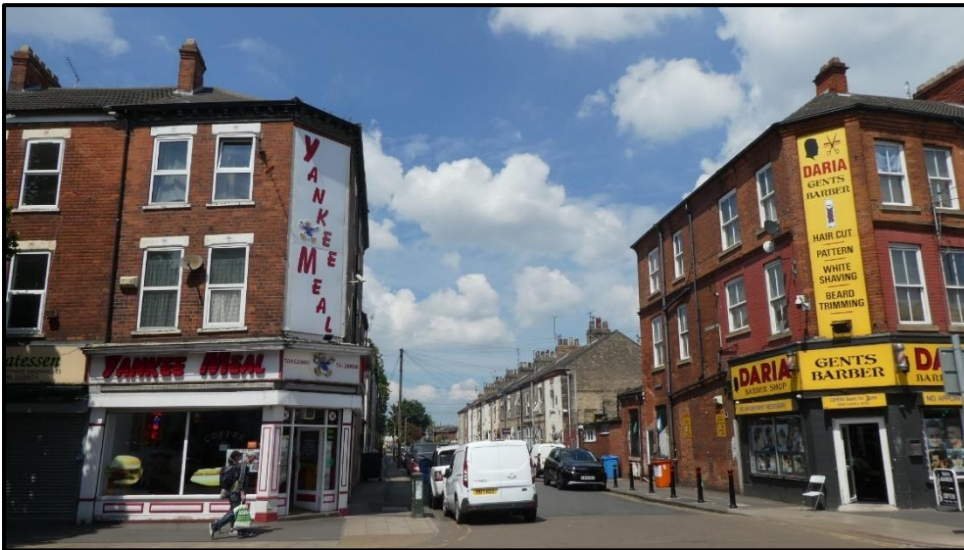
Most buildings along Hessle Road have a rectangular plan with chamfered edges, which are used as advertisement panels in most cases, making the edge of buildings another prominent feature of the character area. The curtilage of buildings along the northern side of Hessle road is formed by a threshold (used as outdoor display areas) and the tree-lined footpath. Buildings to the south-side of Hessle Road have a much narrow footpath.

Figure 8. Building corners used as advertising panels.

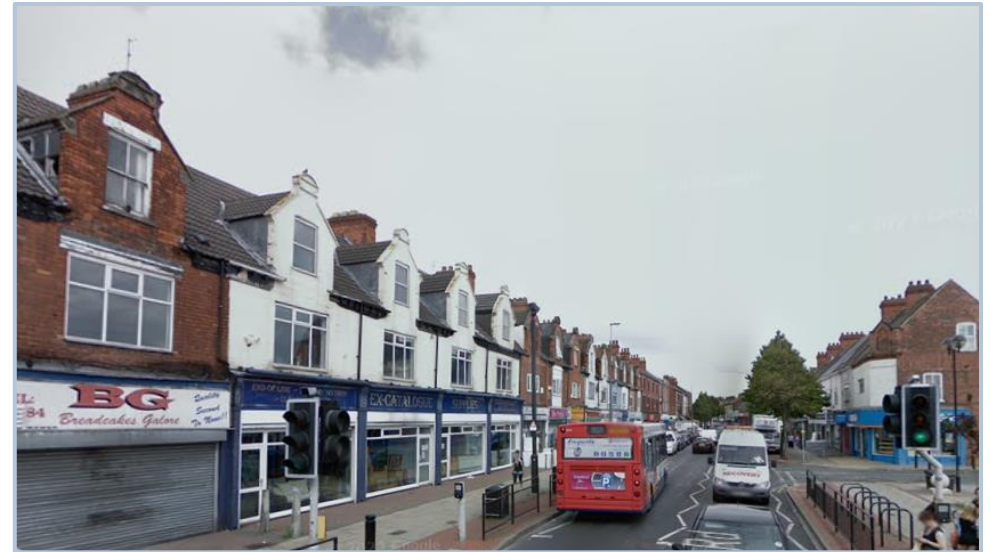
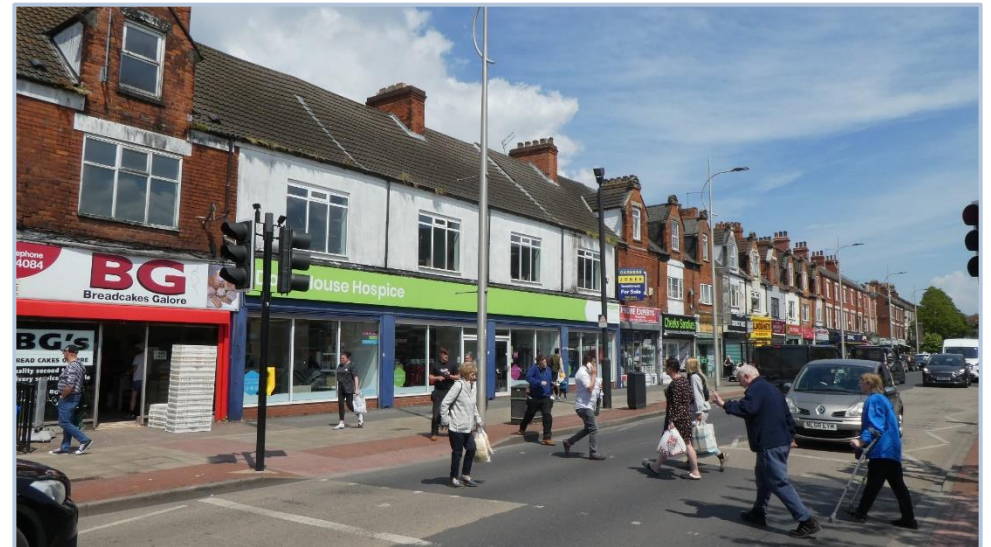
Top floors typically featured sash windows with stone lintels and elaborate cornice details. Hipped roof with slate and clay tiles, and a 6/8 flued chimney was common. A few buildings had gable dormers which are a desirable feature to maintain. Replacement of bay windows and dormers with uPVC windows has negatively affected the character of the area.

Figure 9. Evidence of dormers on 360-390 Hessle Road, now lost. 2008 vs 2024. Source: Google Street View; Stephen Walker.

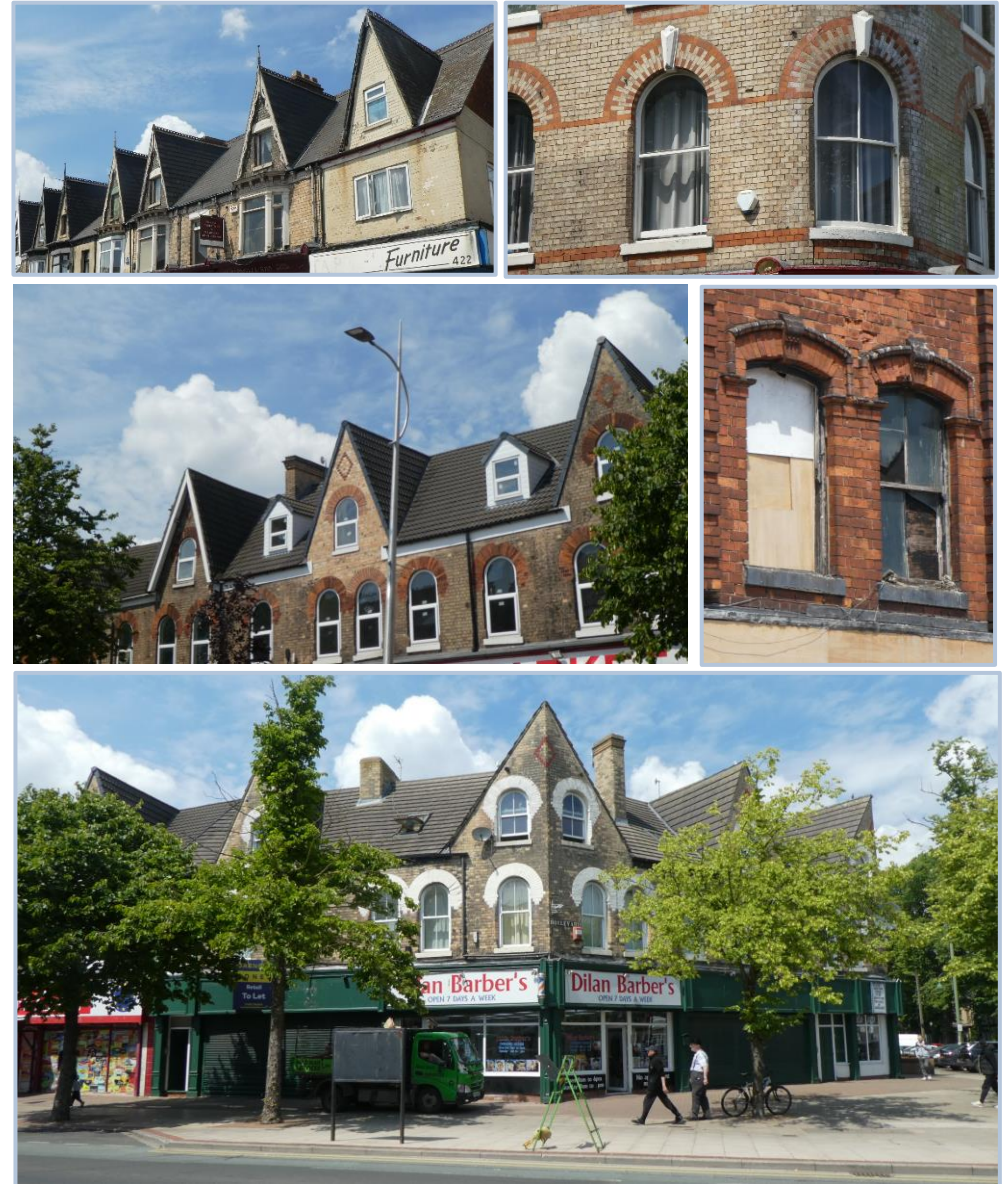
Types of windows found in the area include traditional sliding sash windows, bay windows and dormers. Some buildings such as the Criterion public House also feature curved glass panes.

A small number of original 1x1 or 2x2 sliding sash windows are remaining within the conservation area, featuring elaborate stone lintels. The continued replacement of traditional windows with uPVC lack uniformity in style and do not match the building style and architecture. Transoms and mullions have been eliminated in most replacements, and do not maintain proportions as per adjacent unit windows.

Figure 10. Window types along Hessle Road

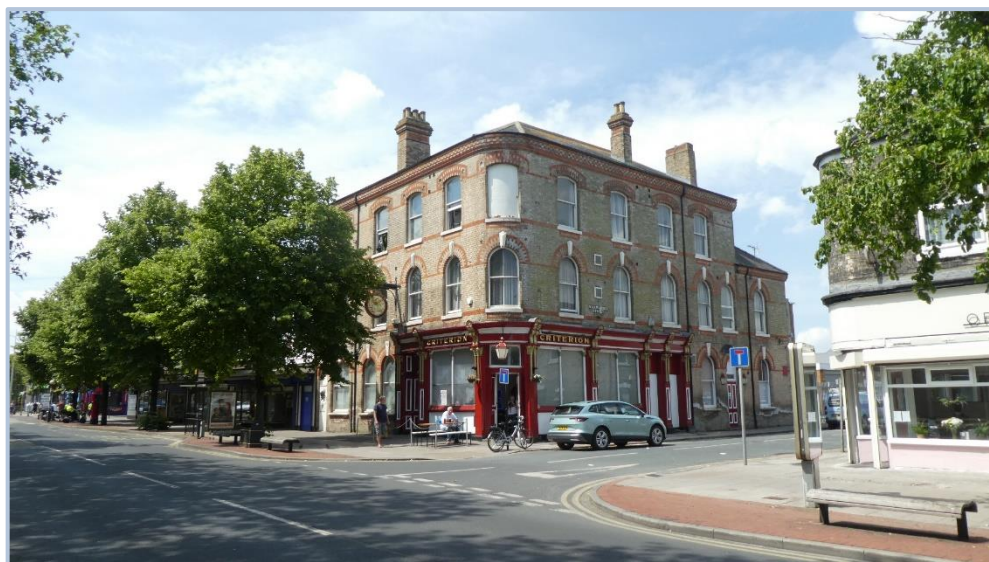
11 - The Criterion Hotel Public House

Grade II listed building, the three-storeyed building was built in 1860, with a few late 1800s alterations. The yellow brick building with red brick and ashlar dressings is topped with hipped and gabled slate roof with 2 ridge and single gable stacks. The window surrounds with elaborate keystones and moulded cornices portray rich architectural detailing. Windows are plain sashes and on the first floor they have round arched heads. The corner bay has a single window flanked to the left are four windows and on the right are five windows. The second storey window surrounds include segmental arches. The ground floor has a restored late 19th century wooden shopfront with panelled pilasters, shaped brackets with segmental pediments and moulded cornice. The 20th century corner door with panelled recess and curved transom has large 2-light windows on either side, with colonettes.

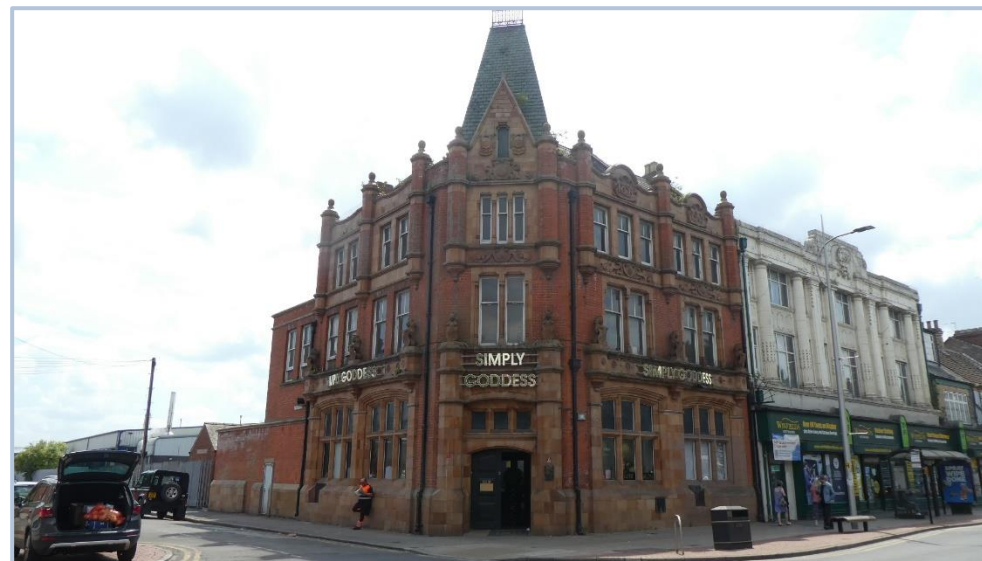
12 - Former Yorkshire Bank

Grade II Listed Building, dated 1901. The façade is brick with Westmorland slate roof with terracotta dressings and faience tiled ground floor, portraying the French renaissance revival style. The corner building has angled corners and three storeys with additional attic space. The corner entrance bay has a 2-light window with stone mullions. Top windows are smaller, three light windows flanked by octagonal pilasters with ball finials. The segmental arched doorway is flanked by octagonal piers topped with finials in the form of heraldic beasts holding shield on which locations of the former bank are inscribed. The fielded panelled double doors with segment headed mullioned over lights, and a relief panel with a dated scroll. Main frontage facing Hessele Road has two pairs of shouldered sashes. Above, 2 groups of 3 sashes divided and flanked by octagonal pilasters with ball finials, under a ramped coped parapet with 2 segmental pediments, each containing an inscribed tablet.

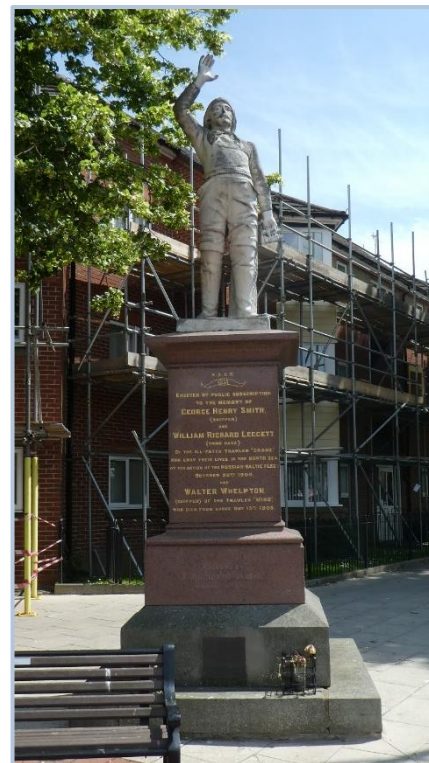
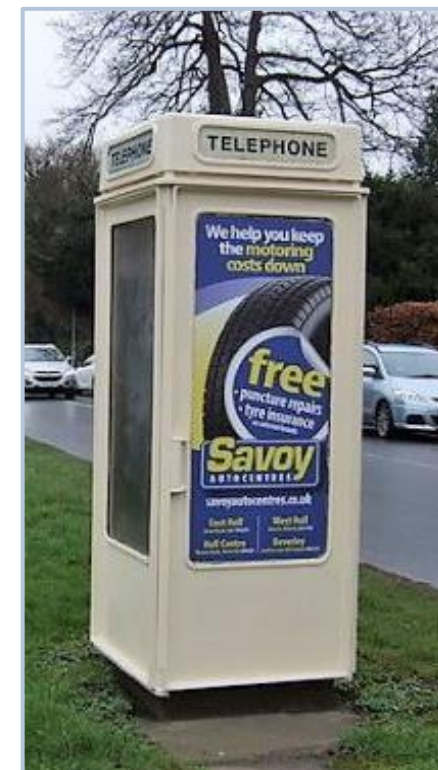
Figure 13. Fishermen's Memorial (left); K8 telephone kiosk (right) on the junction of Boulevard and Hessle Road. Sources: Stephen Walker, Google.com

Memorial statue built in 1906 by Albert Leake, a life size Portland stone figure of a fisherman, on a square pink granite pedestal with plinth, cornice, and inscription on a stepped stone base. The memorial was erected by public subscription in memory of 3 trawlermen killed in 1904 when the Russian Baltic Fleet fired on a group of Hull fishing vessels. This is known as the Dogger Bank Incident and ironically led to an improvement in Anglo-Russian relations.

As a nationally rare survival of a once common telephone kiosk, first introduced in 1968; the K8 is the last generation of the “red public telephone box” and as such makes an important contribution to the understanding of the historic development of the telecommunications industry in England before the introduction and subsequent widespread use of mobile phones; Hull had the only council-run public telephone network in Britain from the granting of a licence in 1902 until 2007, then continuing to be independently run, its independent status

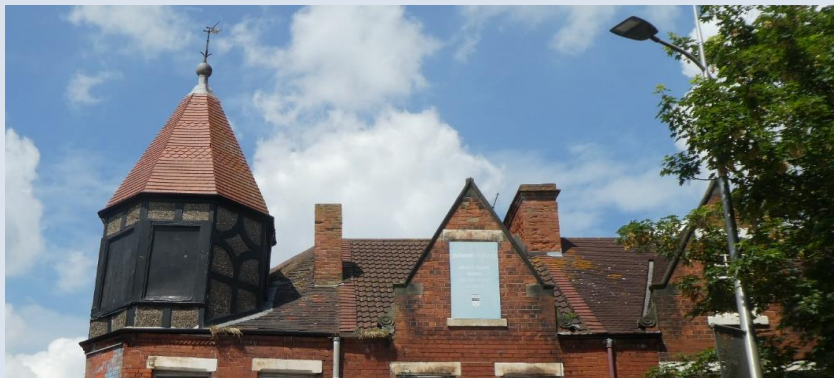
The octagonal turret with mock-Tudor detailing and pebbledash at the corner of Rosamond Street and Hessle Road has fish scale roof tiles and features advertisement panels on three road-facing sides. It is the only one of its kind within Hessle Road Conservation Area boundary.

Figure 14. Turret at 296 Hessle Road

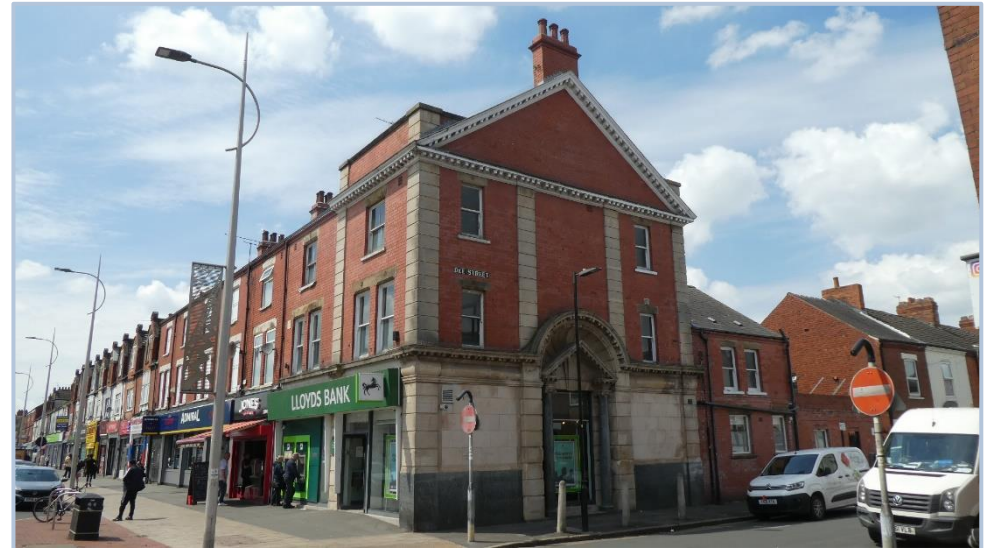
Prominent building at the corner of Dee Street and Hessle Road. The entrance of the building along Eton Street has elaborate decorative features such as black marble external skirting and pilasters that support a large segmental pediment, within which is an inlaid broken pediment. The gault bricked quoins add to the architectural prominence of the red-bricked building.

Figure 15. Lloyds TSB Bank.

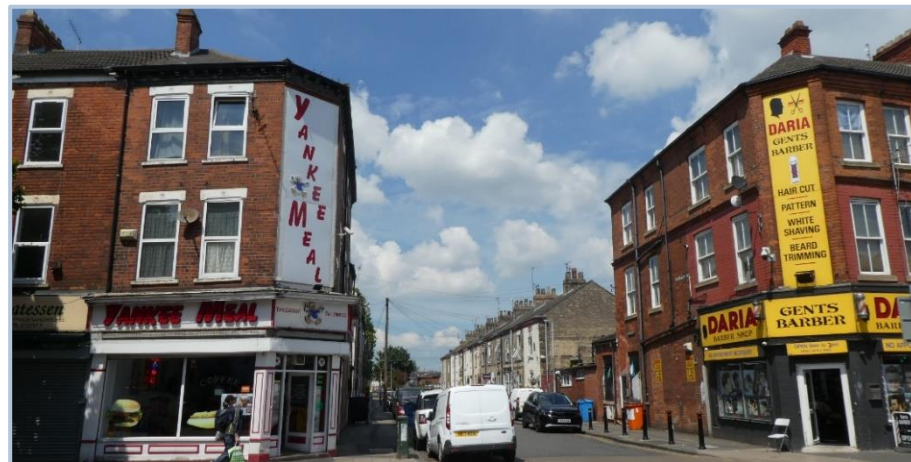
These panels are a characteristic feature of the conservation area, and usage to full potential for displaying advertisements will be encouraged, albeit within the conservation area character limits—the advertisements must be within the area provided, not be oversized, or cover over architectural details. The advertisements should not distract drivers and pedestrians.

Figure 16. Examples of corner buildings with advertisement panels.

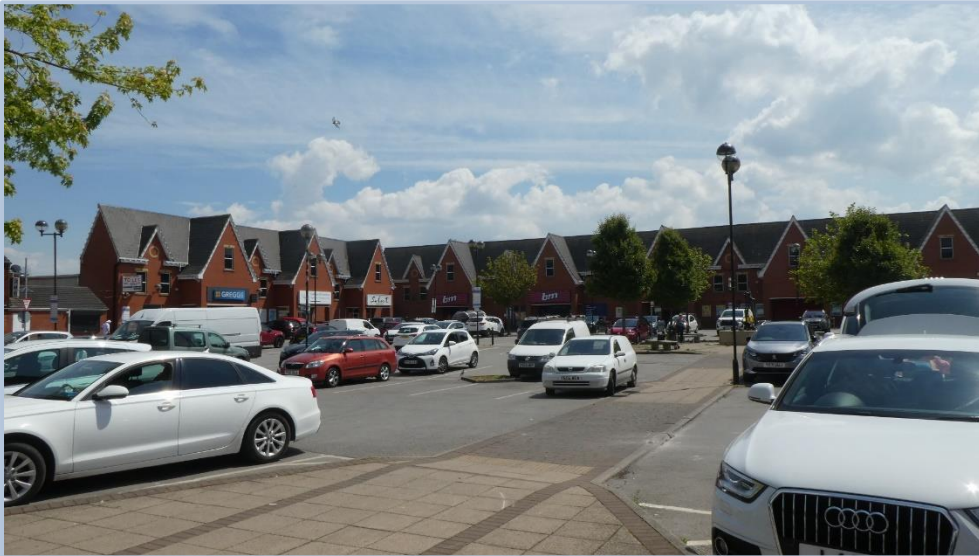
Buildings which portray neutral/negative quality shopfronts but may have good quality replacements on shopfronts, upper-floors and roof are classed as neutral. These buildings may also be modern built but maintain elements of the street such as building line, height, or façade detailing. Examples include Boyes, St. Andrew's Retail Park.

Figure 18. St. Andrew's retail park.

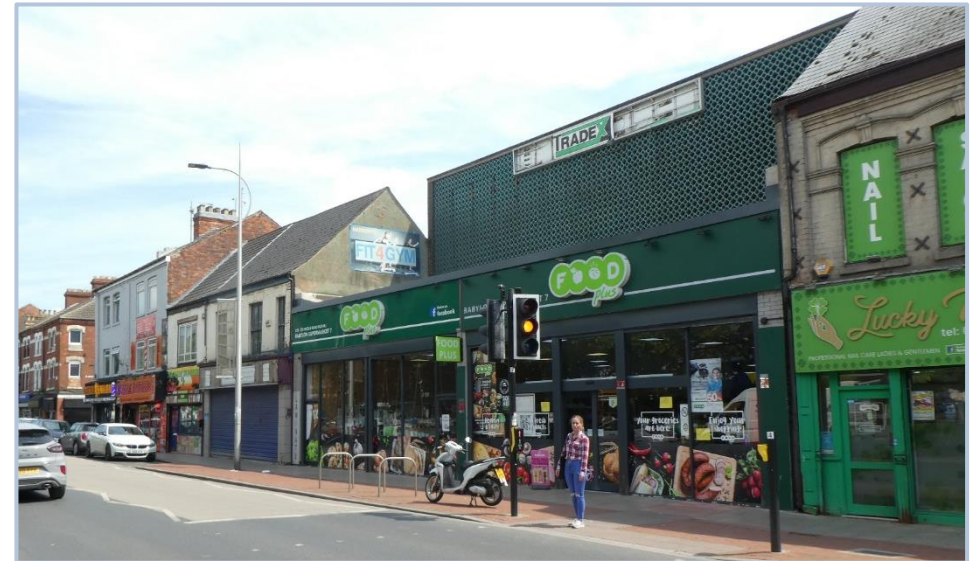
These buildings negatively impact and alter the character of the area as they have no historic or architectural relevance to the conservation area and should be considered for improvement or removal from the conservation area. For example Babylon Supermarket (313-315 Hessle Road) does not contribute to the street scene and breaks up the character of the historic environment.

Figure 17. Babylon Supermarket (313-315 Hessle Road).

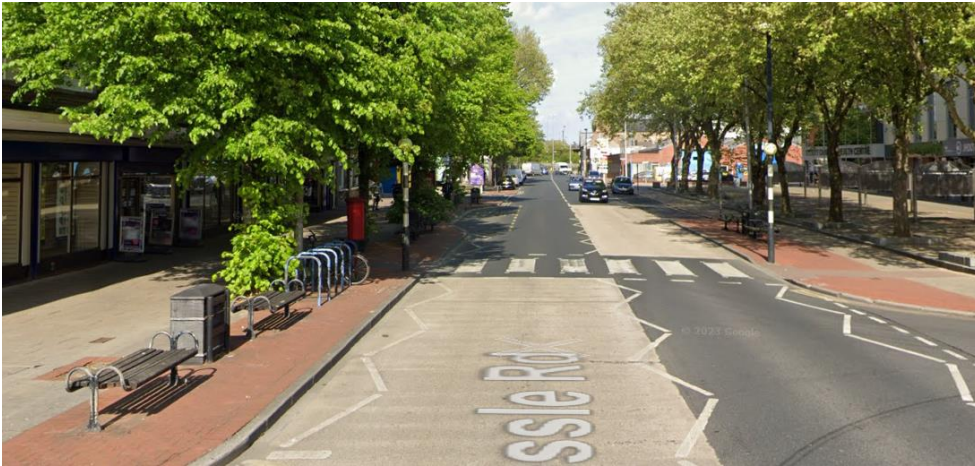
Figure 19. Public seating and bicycle parking. Source: Google Street View.

Street furniture including seating at street corners, bicycle parking spaces, bus stops, litter bins as well as the trees, pedestrianised paths and crossings add to the coherence of the street. The display of goods on shop curtilages encourages interaction with the buildings and surroundings, reflecting old market spaces, making it ideal for a conservation area designation. The wide pavements, street furniture and trees significantly contribute to the aesthetic and functional quality of the street.

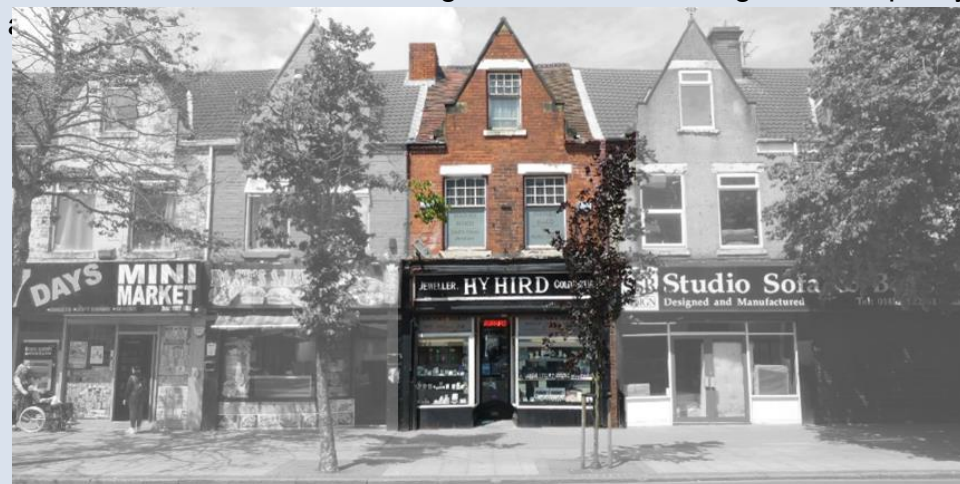
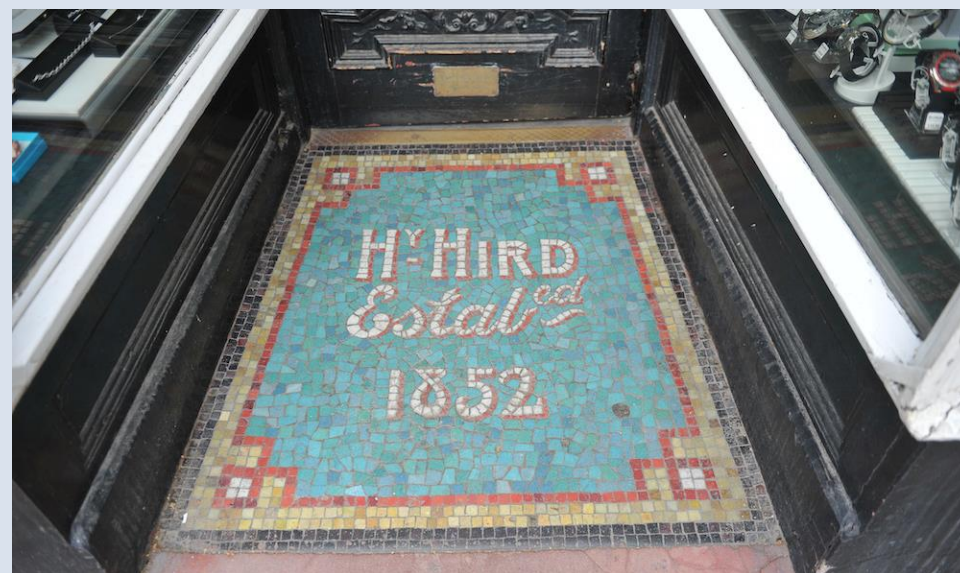
The only original shopfront within Hessle Road Conservation Area, it features timber panelled stallrisers and transom doors. The recessed entrance is retained with original mosaic flooring. Good quality

Figure 20. Positive shopfront-- 270 Hessle Road. Source: Stephen Walker, HCC; (Henry Hird Jewellers, 1852)

- Applications which propose the removal or negative alteration to shop fronts which have been identified as 'positive' (original shopfronts/ good quality replacements) should be considered for refusal. Exemption should be made where clear and convincing justification is given to the removal, replacement, or alteration of a shopfront, where equal or greater interest elements of design to neutral and negative shopfronts is being proposed.

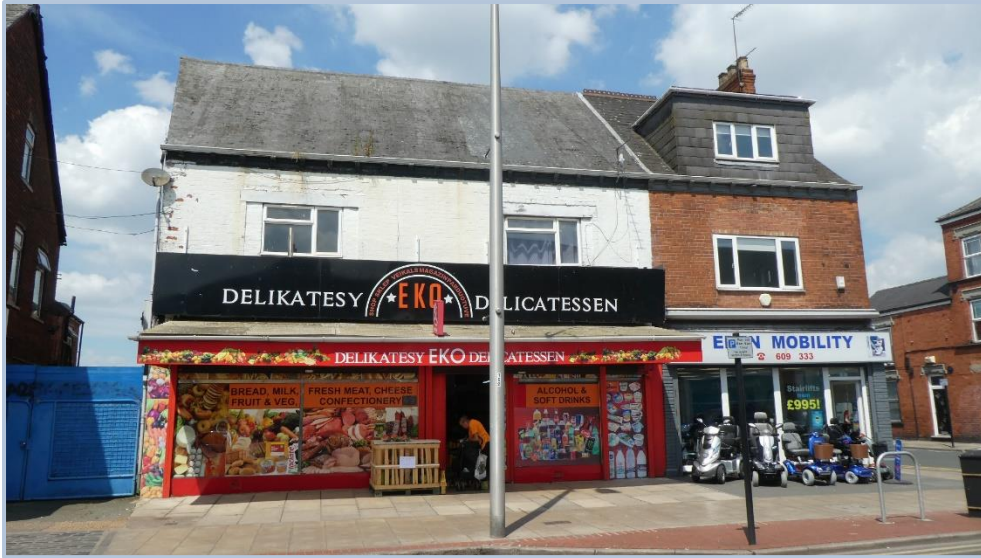
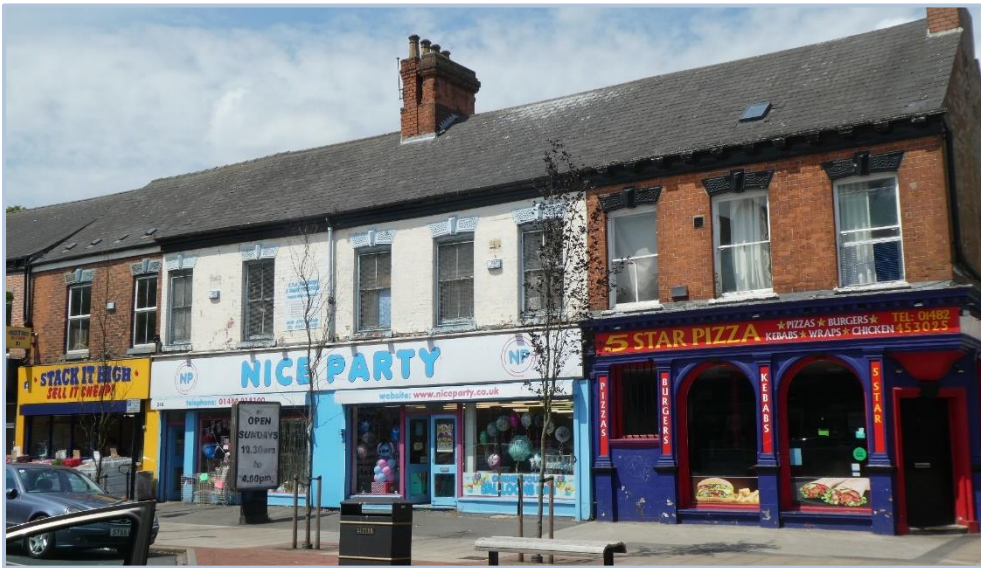
- Loss of stallriser.
- Oversized advertisements
- Loss of uniform appearance through proportions and lack of design detailing.
- Clutter by advertisements on stall-risers, windows and doors.
- Prominent external roller shutters.
- Advertisements extend to multiple units and may hide architectural details.
- Use of modern materials like uPVC windows and aluminium shutters.
- Lack of building maintenance.
- Incoherence to upper floors.
- Loss of roof details such as dormers, chimneys, ridge tiles etc.

Figure 22. Examples of negative elements in shopfronts such as oversized facias and cluttered advertisements.

- Applications for development should seek to opportunities to replace negative and neutral shopfronts with designs which contribute positively to the conservation area and would reinstate the uniform appearance of a row of shops, and/or remove negative elements.

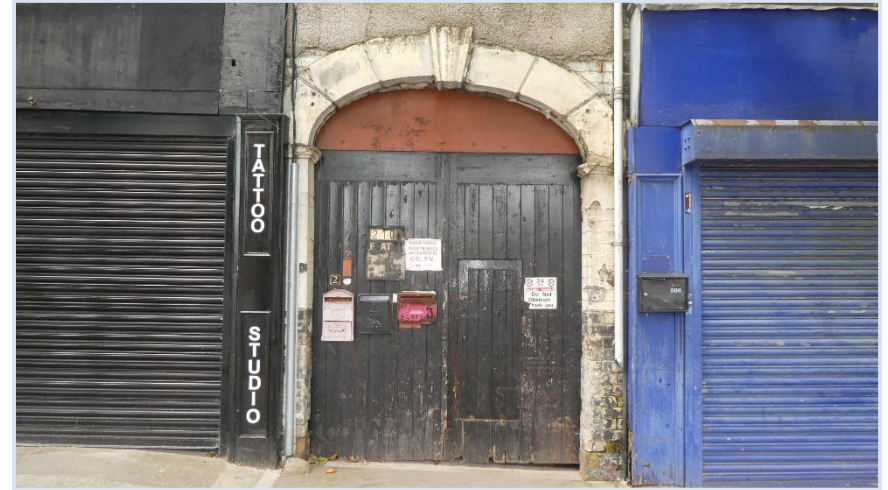
A significant negative trend of the Conservation Area the prominence of external roller shutters. These detract from the quality of the shopfront and architecture of the buildings within the area. Where shops are vacant or have prolonged periods of closure, roller shutters contribute to the 'inactive' appearance of the streetscape. The Conservation area would benefit from the removal of external and solid roller shutters.

Figure 21. Roller shutters detract from the quality of shopfronts.

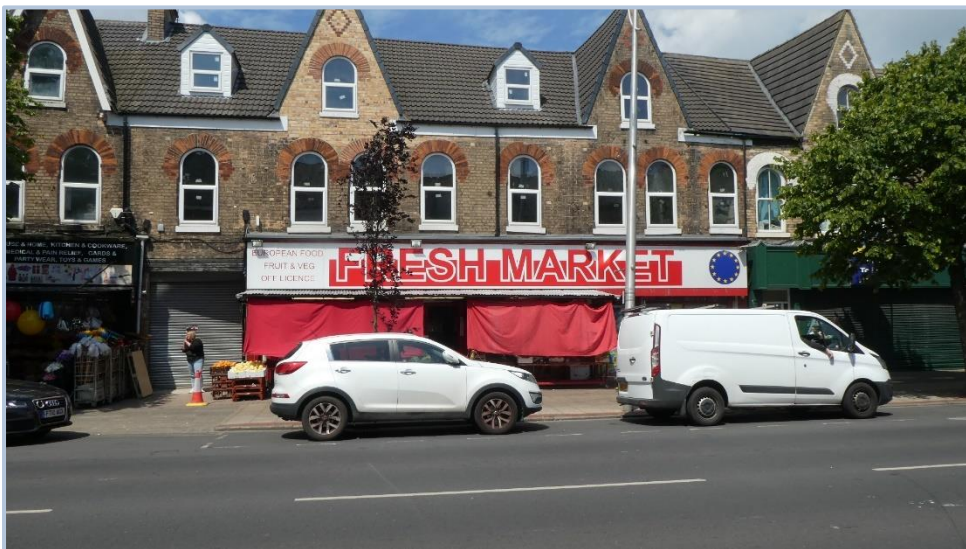
Awnings and canopies were historically a feature of Victorian and Edwardian buildings, but no historic examples survive within the Conservation Area. Where canopies have been introduced (example- 326 Hessle Road), they project forwards of the established buildings and introduce modern materials and poor design quality, thus harming the character and appearance of the Conservation Area.

Figure 23. Negative trends introduced in the conservation area-- oversized advertisements and canopies.

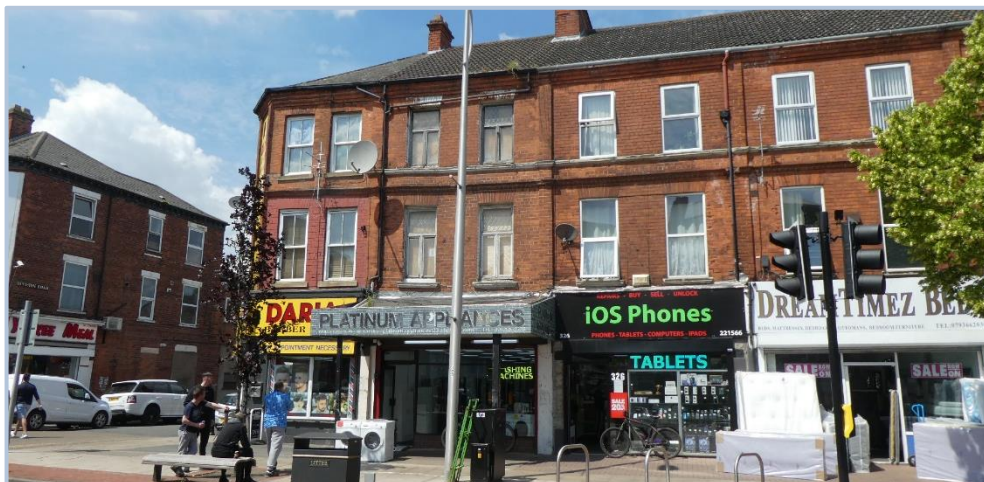
Figure 24. Example of a 'negative' canopy introduced at 328 Hessle Road.

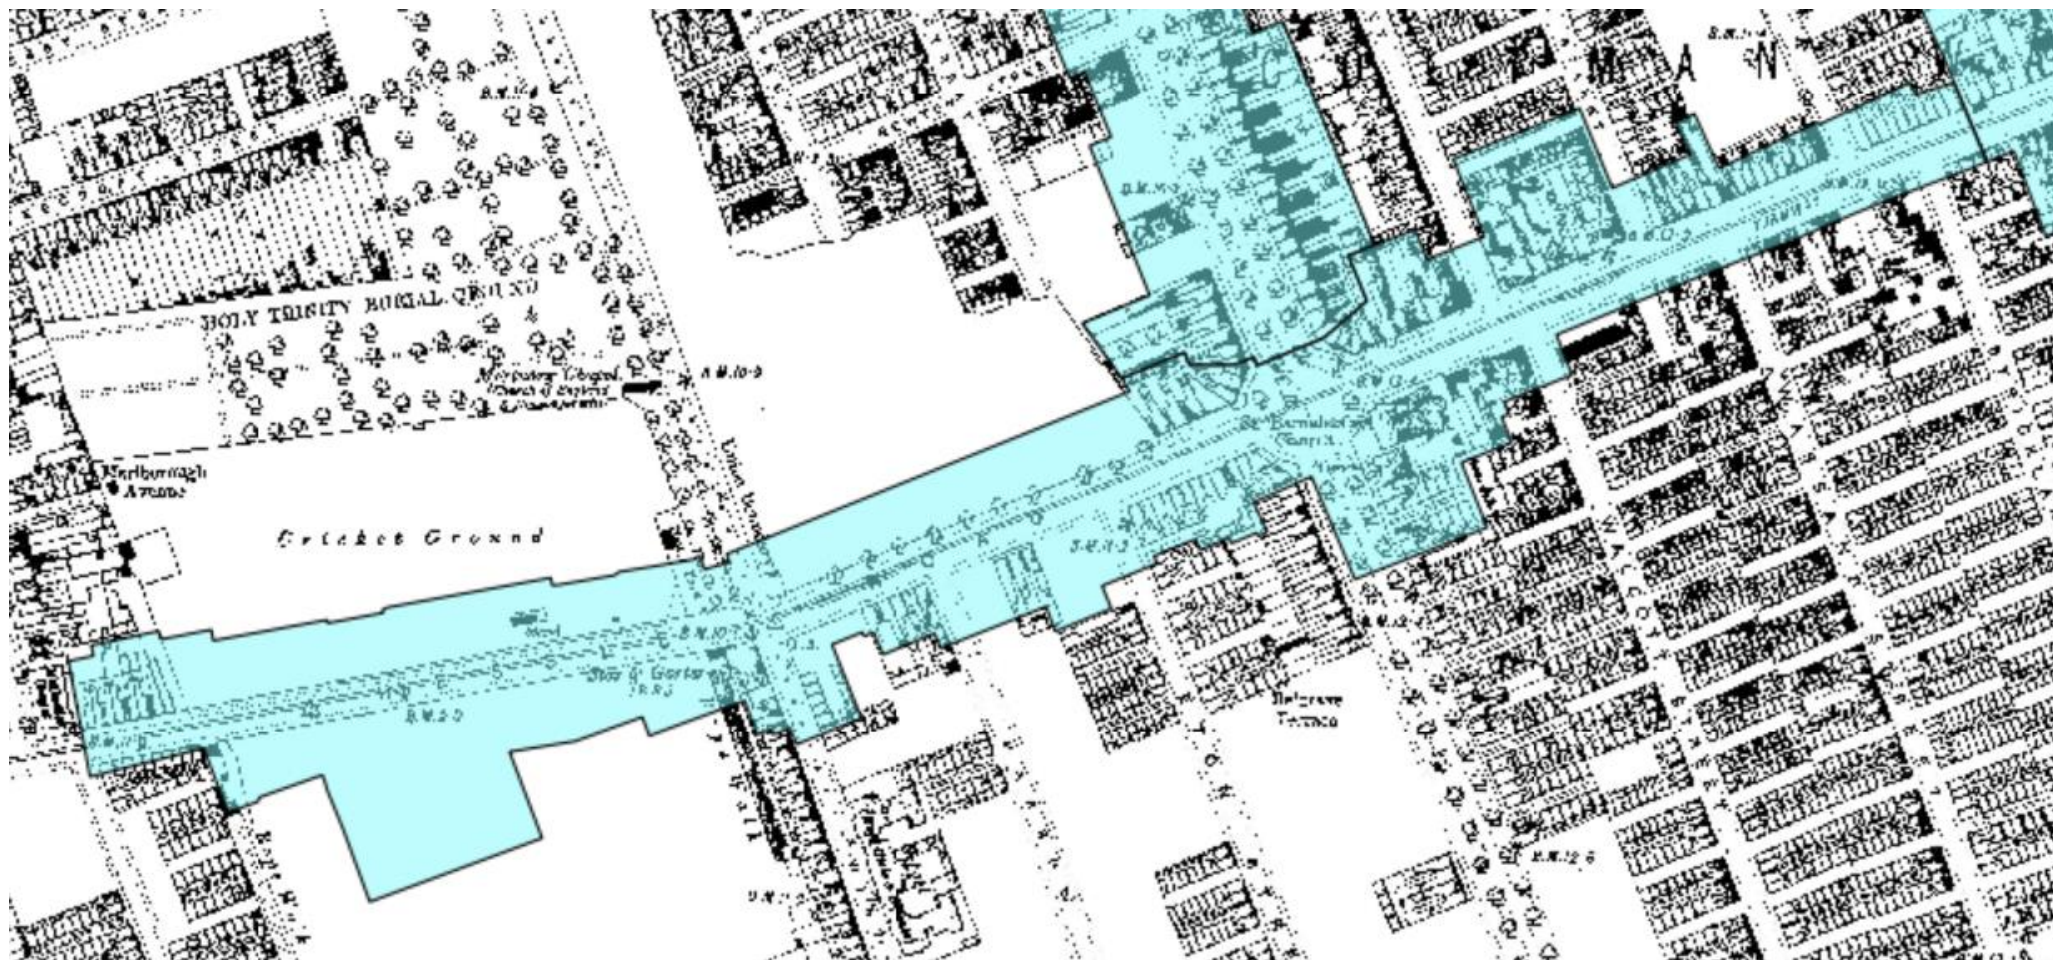
Figure 25. Hesse Road Map (1890) showing former cricket ground, St. Barnabas Church (now replaced by St. Barnabas Court), and tramlines for horse-pulled trams. Source: MyHull maps.

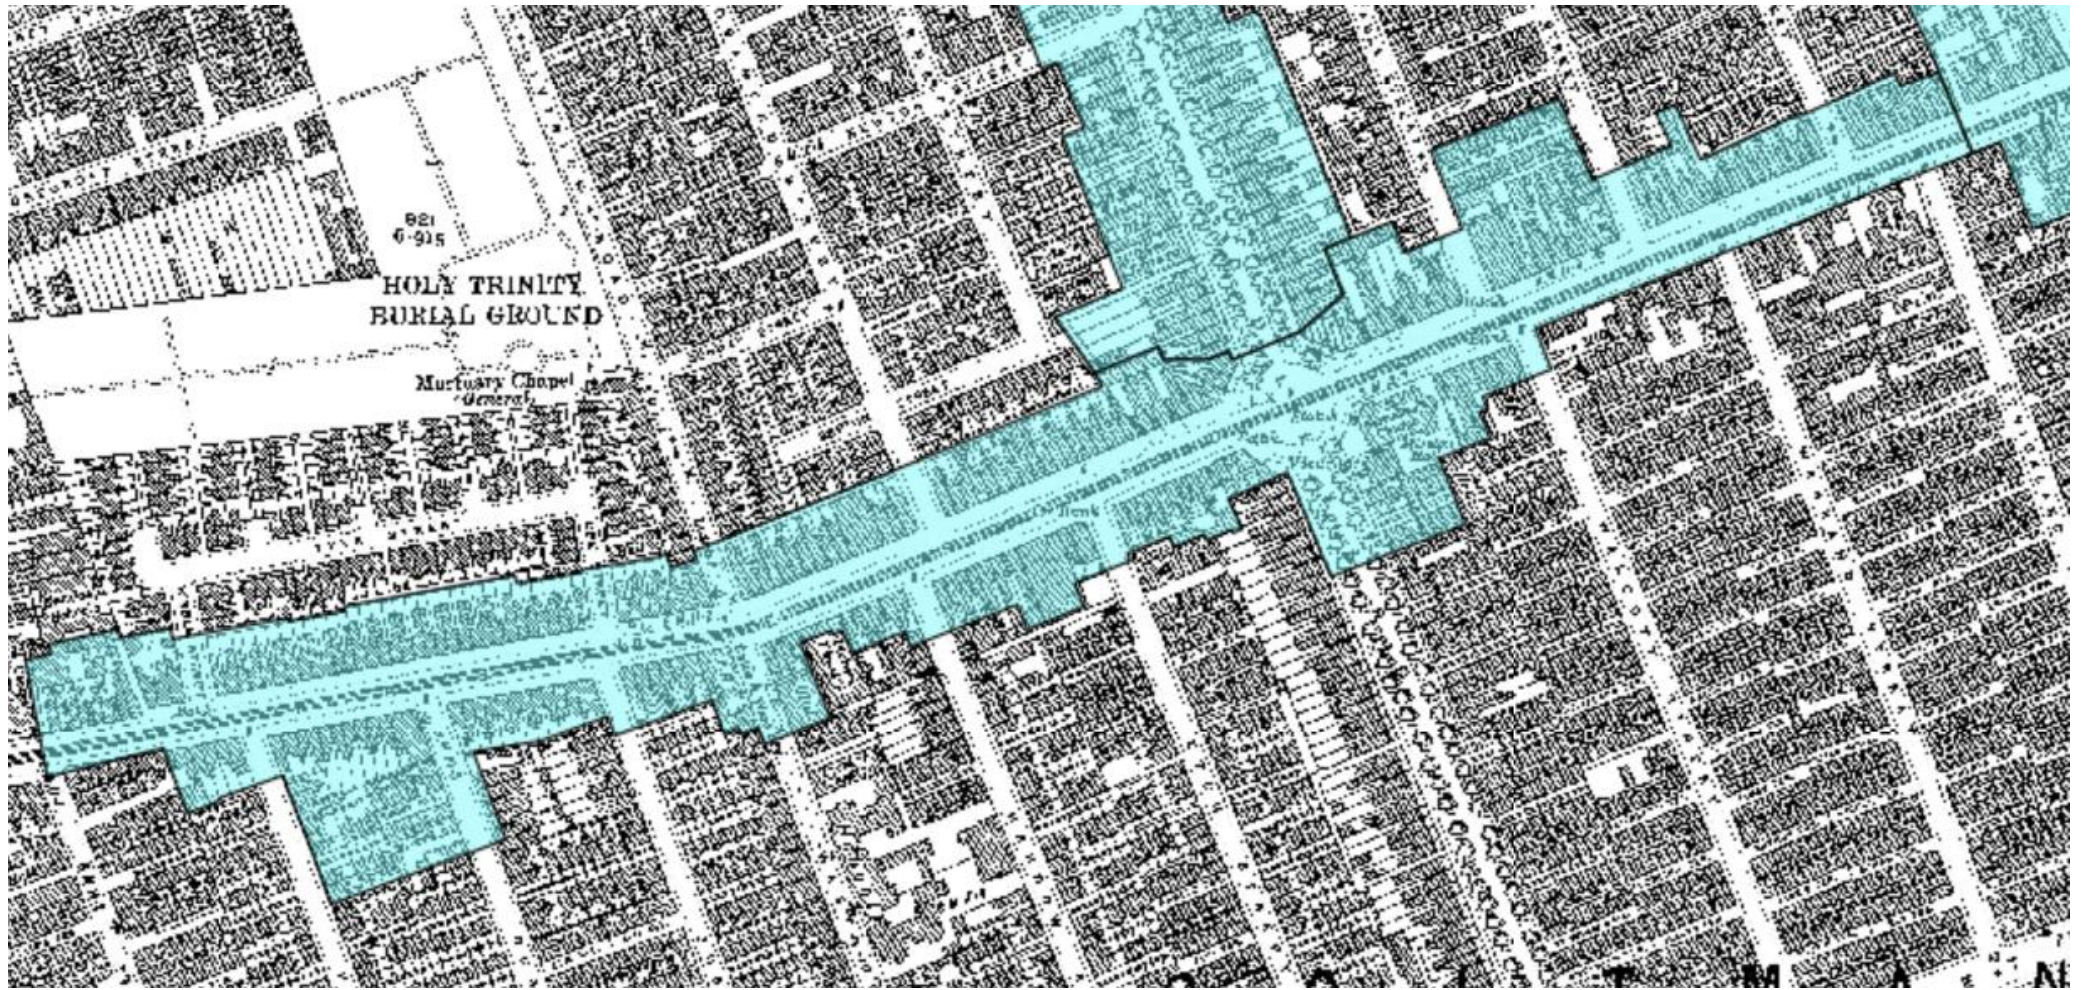
Figure 26. Hessle Road map (1928) shows the extensive developments within the area in the early 1900s. Source: MyHull Maps.

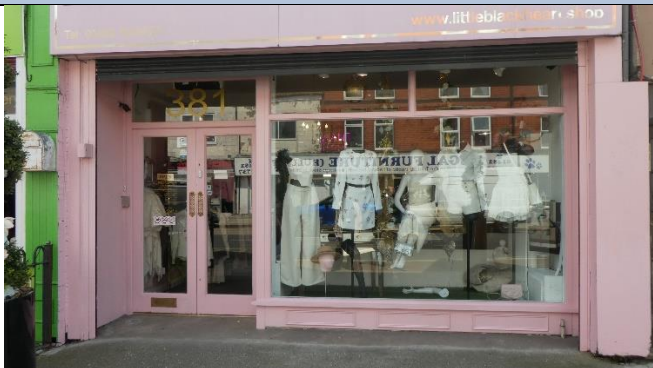
Example of positive enhancements to shopfront—maintains recessed entrance and proportions.

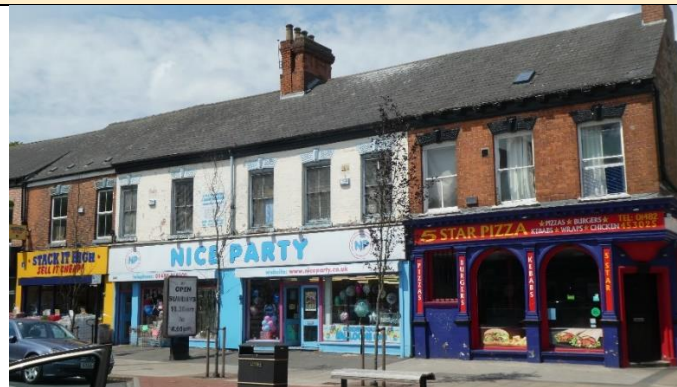
Oversized advertisement, shopfront elements do not replicate original.
