Hessle Road

Character Appraisal and Management Plan

Published February 2025

4. Between May and June 2024, a survey of the Conservation Area was carried out in order to update the existing Character Appraisal, and adoption of a Management Plan to maintain and enhance the character of the area.

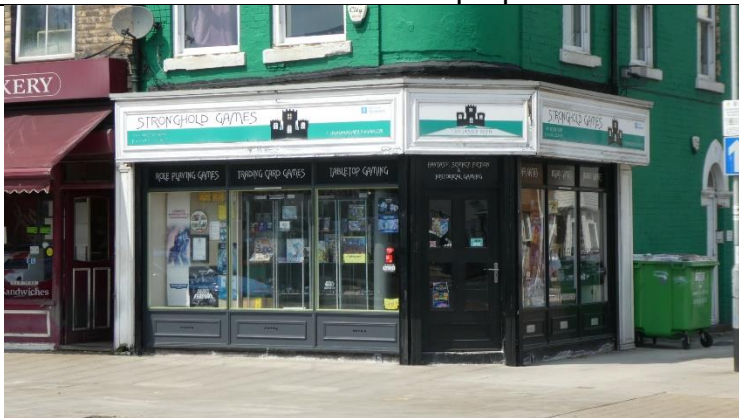
Panelled stallrisers, timber fascia.

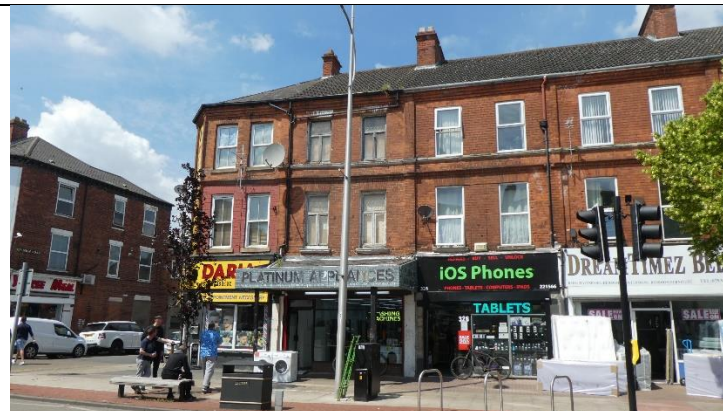
Poor quality advertisements and awnings.
