**Avenues and
Pearson Park
Conservation Area
Character
Appraisals**

Character Appraisal 2: Pearson Park

Published by Hull City Council, Kingston upon Hull, UK

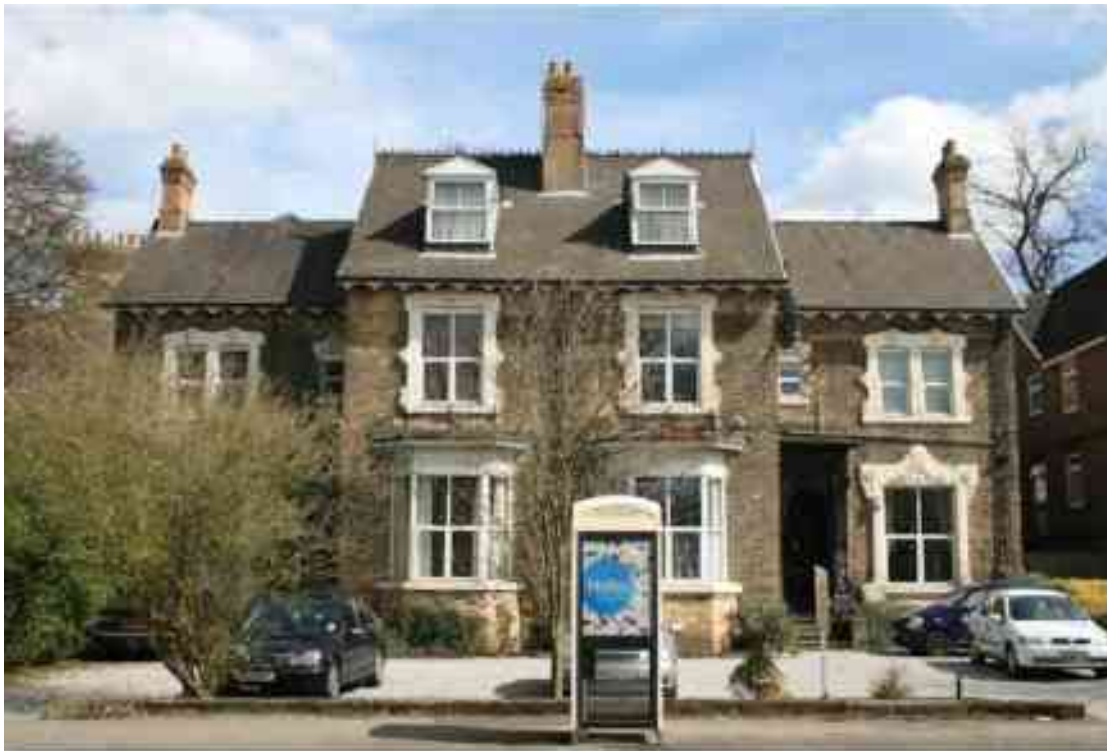
Figure 47 Nos. 2 & 3, or *Leicester Cottage*, front view

7.1.5.1 Pre-1890, the villa has been restored in recent years, and is on the Local Heritage List. The placing of the telephone box is unfortunate as it blocks the view of the property. The ironwork decoration above the bay windows is of particular note, as are the intricate window surrounds. The ridge tiles and carved barge-board are interesting features.

7.1.5.2 The choice of double-glazing has tried to be in keeping with the style; unfortunately it does look out of place. Six satellite dishes are placed on the front elevation, in contravention of national guidelines for conservation areas, and break up the symmetrical form of the houses, as does the dormer window to the rear. The reinstatement of a boundary hedge at the front, as originally intended for the properties, could help to unify the property and provide a place to put the wheelie bins.

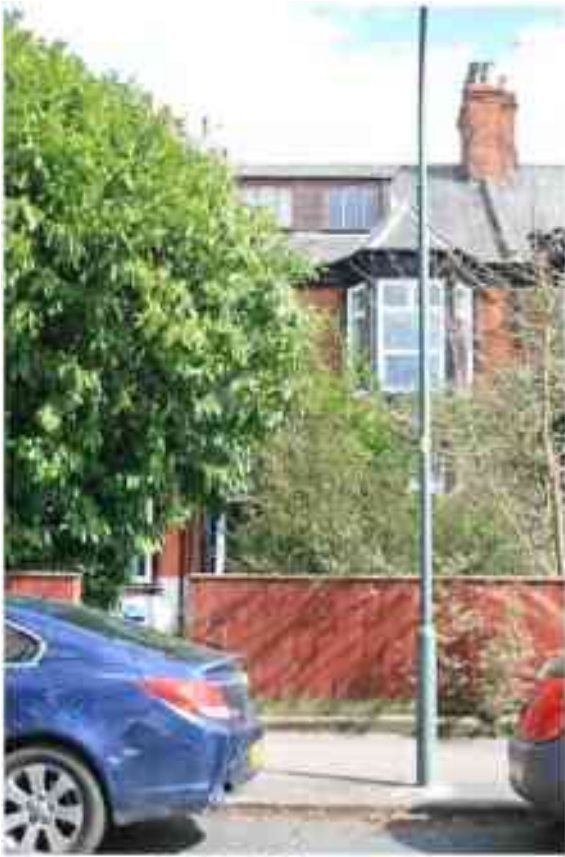
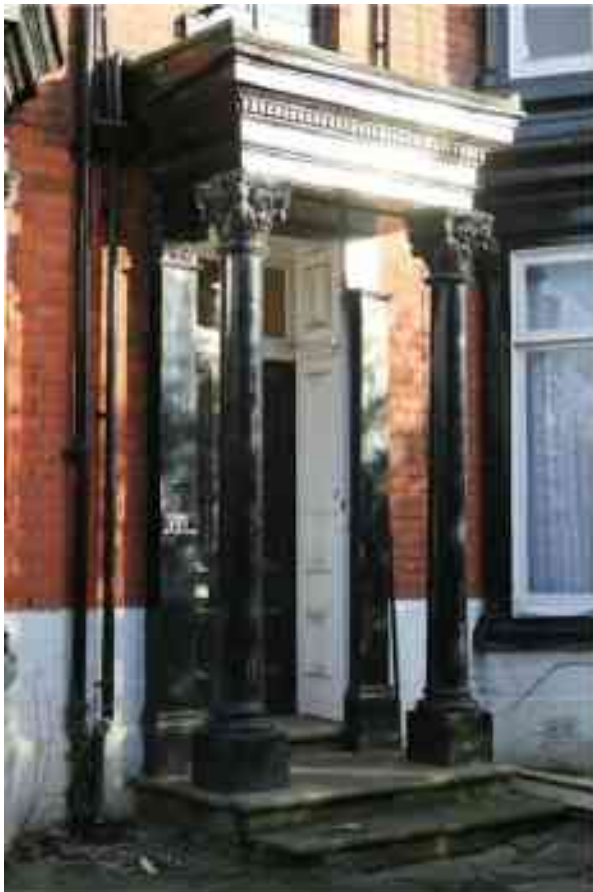
Figure 51 No. 8 front

Figure 52 No. 8 front door

7.1.10.1 Although obscured by foliage and a high fence, neither traditional nor in unity with neighbouring property boundaries, No. 8 still offers some of its original grandeur. The canopied, ornately pillared entrance, original front doors, capped columns on all of the double bays, dentil moulding above the lower bays, decorative fascia and gutter blocks, slated conical roofs above the bays and original chimney pots are worthy features, adding considerable value to the over-all appearance.

7.1.10.2 However, the original front elevation has been spoilt by three of the front facing bay windows having UPVC replacements installed, with hinged storm-proof openings, which detract from the remaining timber casement windows of a differing design. The addition of a plank-faced dormer window does not bring any harmony to the building, disrupting the roofline.

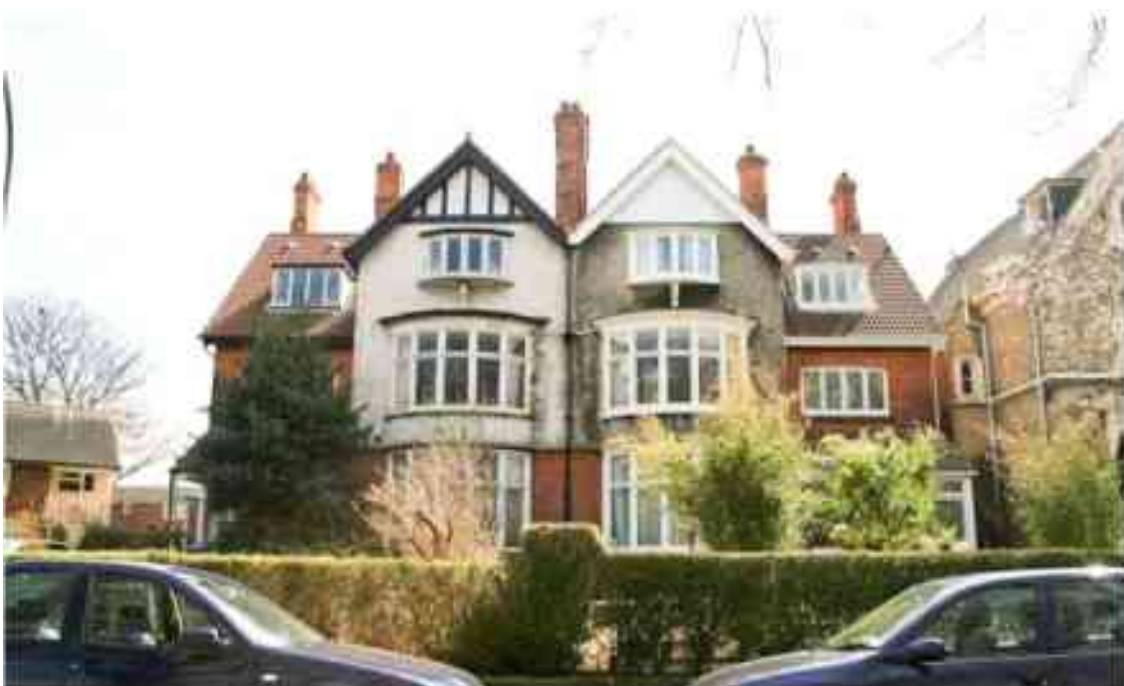
Figure 57 Nos. 15 & 16 angle

7.1.14.1 These are semi-detached houses, possibly late Edwardian. No. 15 is partially obscured by a tree in front of the doorway. This residence has retained the black and white paintwork on the mock-timbered gable, but other timber windows are in need of attention. The projecting porches of both houses have been enclosed in glazed timber frames. They each retain the pebbledash facade to the proud frontage, original windows, tall chimneys and boundary treatment in the form of low stone kerb and hedging. Previously, iron railings would have risen from the stone edging.

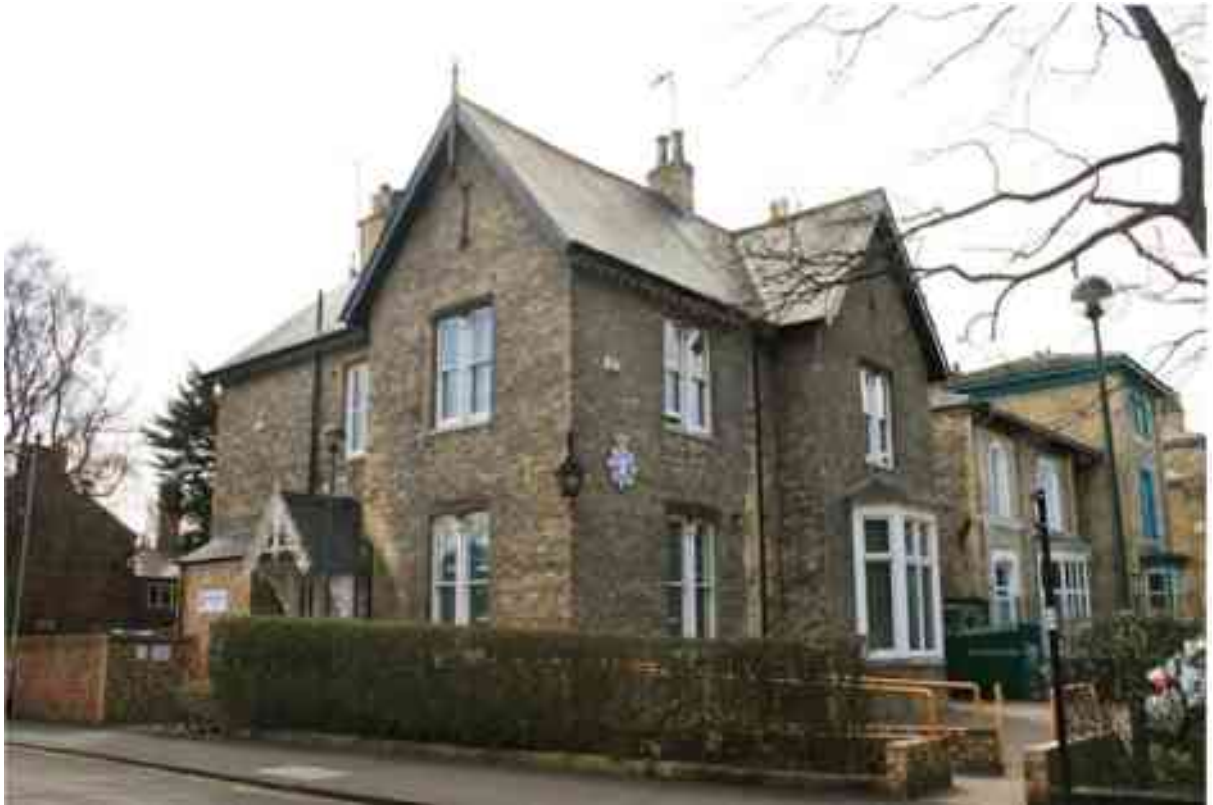
Figure 62 Police Station or *Keysell Villa* – diagonal

7.2.3.1 The ornately carved timber porch of the Police Station stands next to a small extension of the same building. With a slate roof and bricks in similar colour, this recent addition is not too conspicuous. Centre columns on the windows still remain, as do the barge-boards, finials and chimney pots. The fascia boards look too plain for this building and ridge tiles would not look out of place, although there are none to be seen. A modern access ramp to the porch is largely concealed behind a hedge.

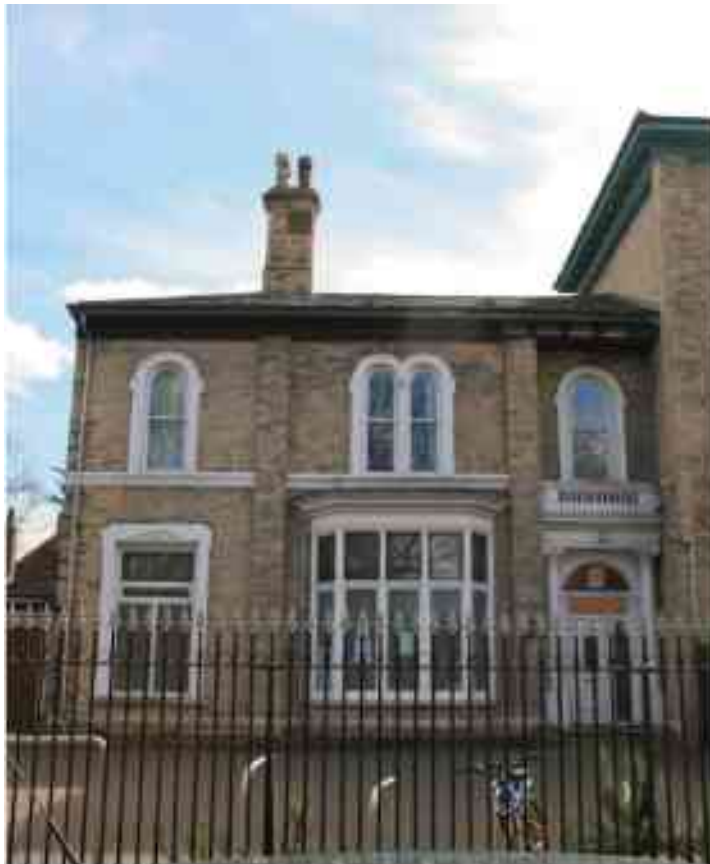
Figure 65 No. 20 Mosque

7.2.4.2 The most obvious and interesting features are the Ionic doorcase with balcony above; and the simple, elegant windows with Georgian-inspired arches. One window to the first floor has a mullion with a detailed capital. The original door space has been in-filled with a UPVC replacement of inappropriate dimensions, losing the balance and solidity of the original design. The large, ground floor bay window and adjacent rectangular window, with splendid frieze detailing above, have also been replaced with timber frames in an untraditional layout that is not sympathetic to the overall design. Plastic drainpipes and signs, similar to the Police Station's next door, detract from the building's unified atmosphere. The frontage has a black and gold 6ft high steel fence, 'Sheffield' style bicycle stands, and bricks in a herringbone pattern are laid where the front garden would once have been. Number 20 has been a mosque since 1990 and in Spring 2011 Hull City Council approved planning permission for an extension to this building.

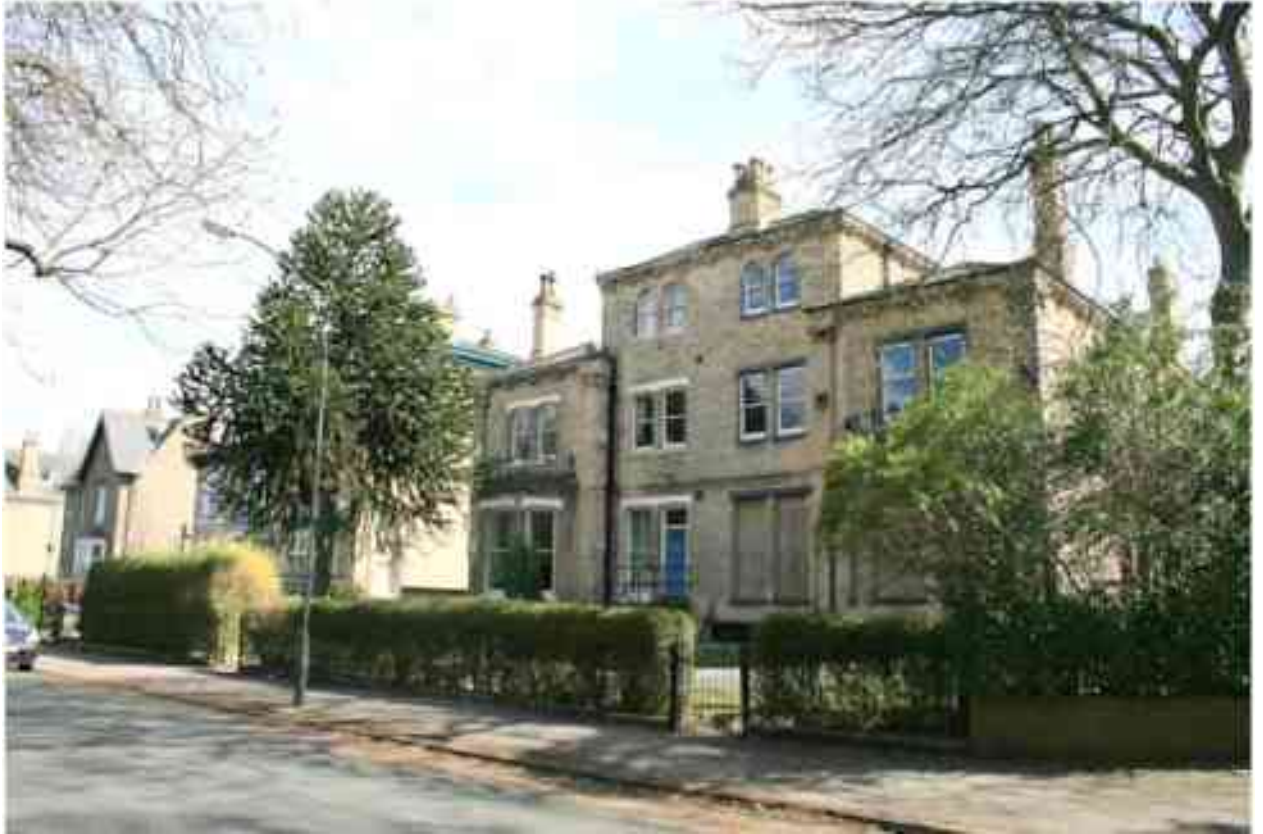
Figure 69 Nos. 21 & 22 street view

- 7.2.5.3 The ground floor bay window on No. 21 appears intact, with intricate wrought iron balustrades providing a mock balcony. This ironwork is also in place on No. 22, but unfortunately all the ground-floor windows on the front of this property were boarded up at the time of writing.
- 7.2.5.4 Privet hedges are along the front boundaries of both properties with No. 21 displaying a finial-topped steel fence, and No. 22 bow-topped steel railings. Driveways are next to each property. With a front doorway having been created on No. 21, cumbersome railings with steps have also been added, detracting from the simple grandeur that once prevailed. A support, sitting between the two properties, braces the front wall with the ground, bringing into question the stability of the structure. Dignified chimneys rise from either side of the building, completing the composition.

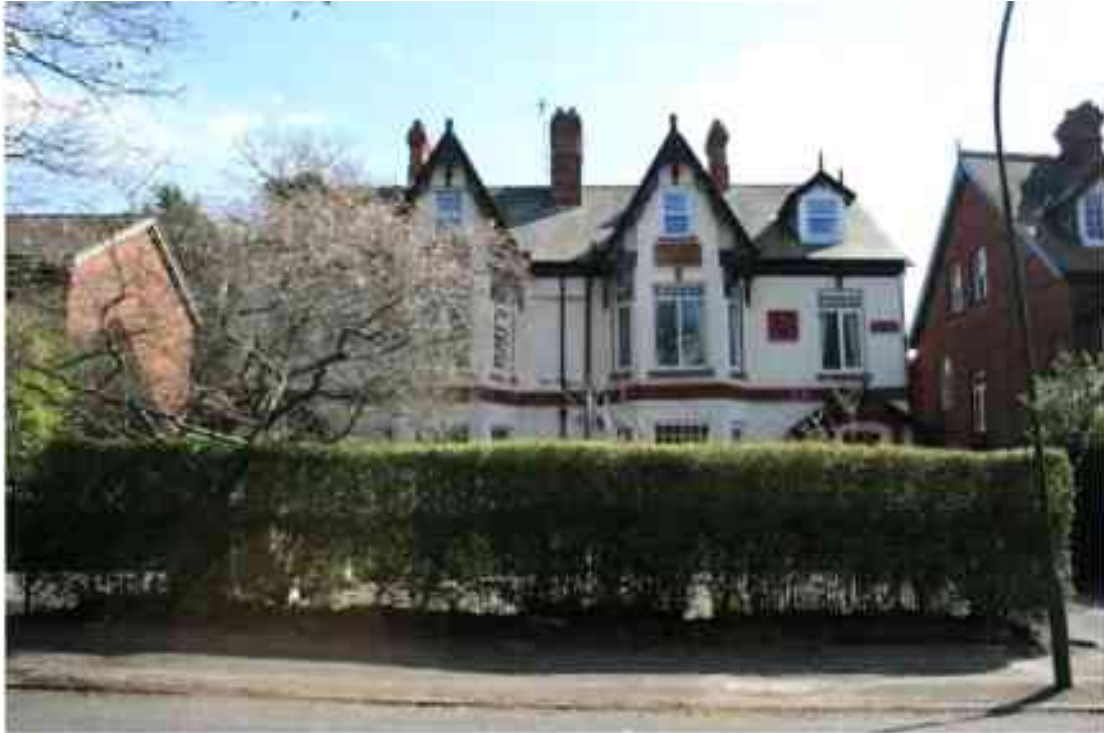
Figure 73 Nos. 29 & 30 or *Lake View Manor*

7.2.7.1 Formerly known as *Saxby House*, this property was built in 1891. The two-into-one property is currently a residential home. ‘The original brick has been painted over but the porch and terracotta relief and owl medallions survive’ (Ketchell). Windows have been replaced with UPVC substitutes but the roof remains slate with decorative barge-boards and finials mainly still intact. The door internal front door of No. 29 is an inappropriate modern replacement. The plethora of wires, guttering and tall metal chimneys interrupt the composition and detract from the original workmanship. The front garden is now deteriorating tarmac.

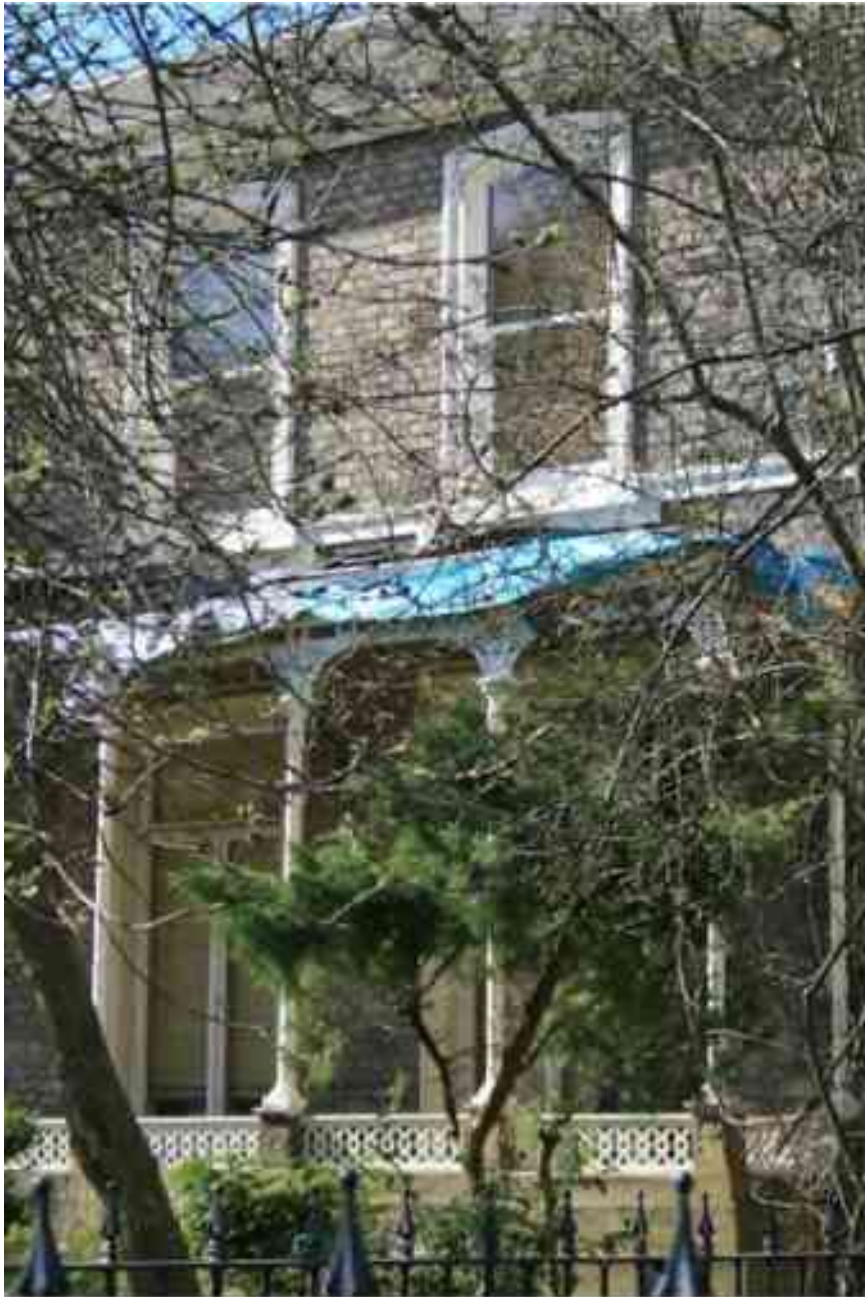
Figure 122 No. 54 verauda

- 7.4.13.3 The most striking feature is the Regency-inspired balcony: 'fine ironwork... made as delicate as gossamer, roofed in curving metal like a Chinese pagoda' (Observer's Book of Architecture, 1954). Large rectangular windows are located underneath the pagoda area which itself has a concrete base with decorative pillars and miniature fence. This ironwork is painted white, as are the decorative plaster surrounds on every window.

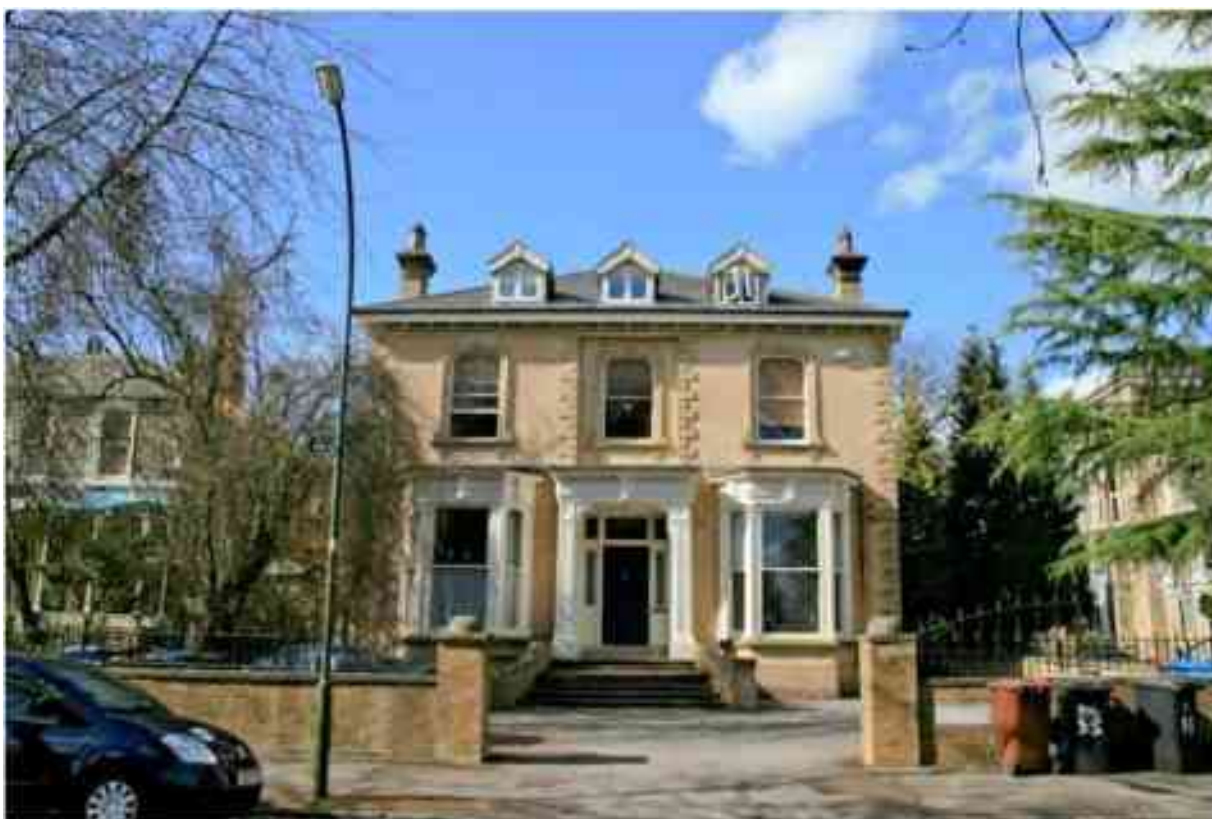
Figure 123 No. 55 or Welwick House

7.4.14.1 Possibly named after a village of the same name in the local South Holderness district, towards the east coast, *Welwick House* is a three-storey symmetrical detached villa. Two large bay windows, with restrained but elegant carving, stand either side of the grand, shallow-stepped front entrance. Recent restoration leaves the brickwork appearing sandstone in colour. To the first floor three equally-spaced rectangular windows have carved stone surrounds with unusual curved top corners, a central top motif and embellishments on the bottom corners. The curved shaping at the top is replicated in the timber sashes.

7.4.14.4 The front garden has been replaced by tarmac for vehicular parking. A wall with large steel gates joins the property to the park. This appears to be a later addition.

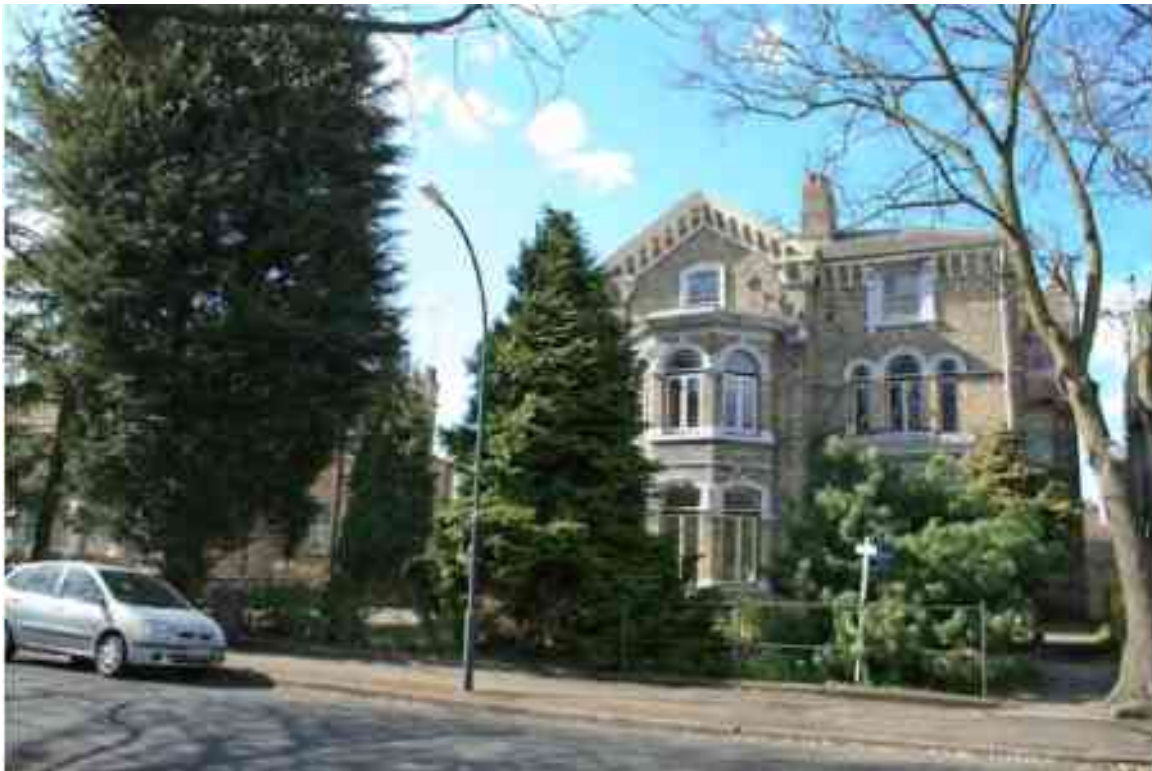
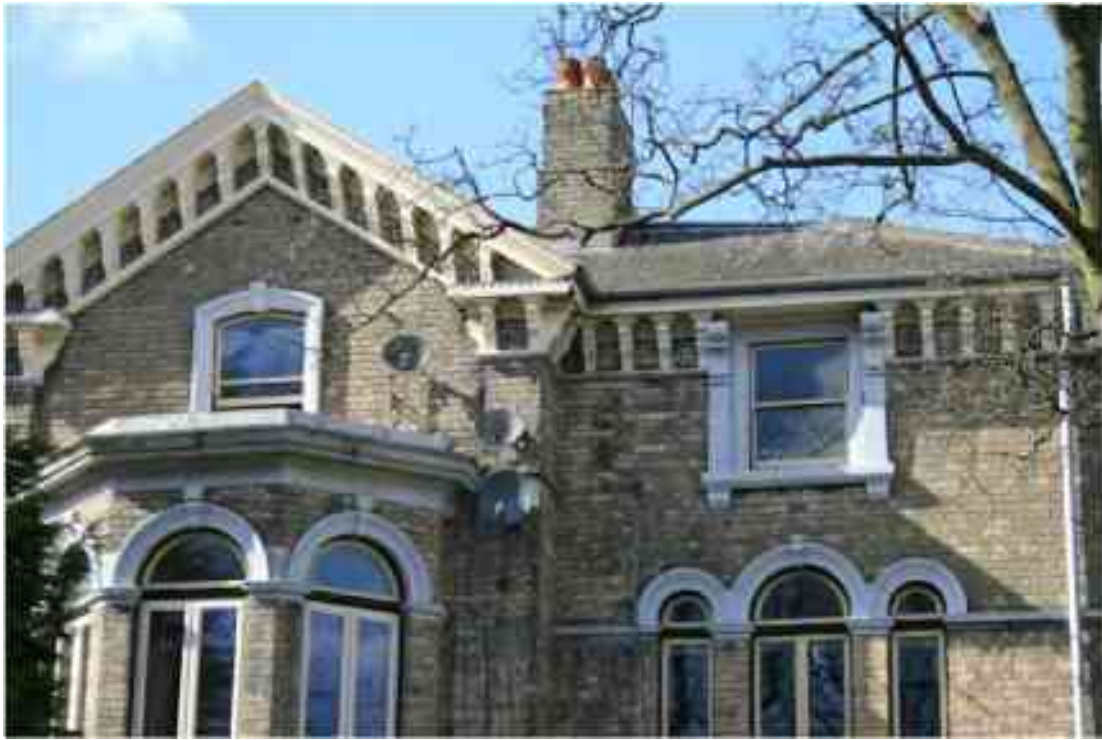
- 7.4.15.2 The overhanging eave on this gable end is a striking feature with its rich timber corbelling and stone beading which is continued across the front elevation. The grey PVC guttering and fascia board on the recessed frontage are unwelcome modern appendages, as are the white replacement UPVC first-storey bay windows which jar with the rest of the colour scheme.
- 7.4.15.3 To the right of this protruding frontage is a three-storey rectangular section that hosts a rectangular window, flush to the roof, on the second floor; an Italianate triptych of semicircular windows on the first floor; and a triptych of segmented arched windows on the ground level. This section is finished with a shallow-hipped roof.

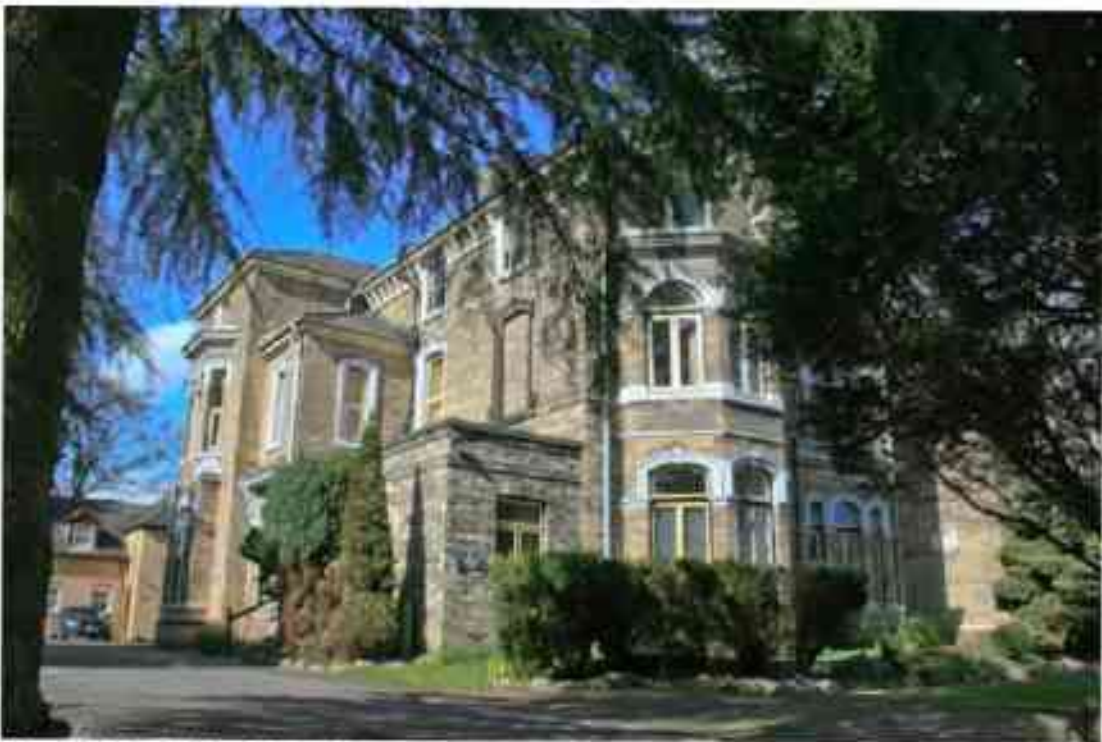
Figure 128 Side of No. 56 through trees

7.4.15.4 To the left of the ground-floor bay window is an out-of-character, flat-roofed extension. Above this is an unpainted stone window surround where a window once was, now replaced by bricks. The alteration and extension do not look new and similar bricks have been used to minimise disturbance.

7.4.15.5 To the back of the property, a new-build annexe-type dwelling is visible and is not an attractive addition to Pearson Park House. Satellite dishes, aerials and wires clutter the front of the property. Next to the front lawn, poorly maintained iron railings about the pavement and evergreen foliage does much to provide privacy, blocking the view of the villa. Throughout, ornate stonework painted white accentuates arches and surrounds windows to provide reference points.

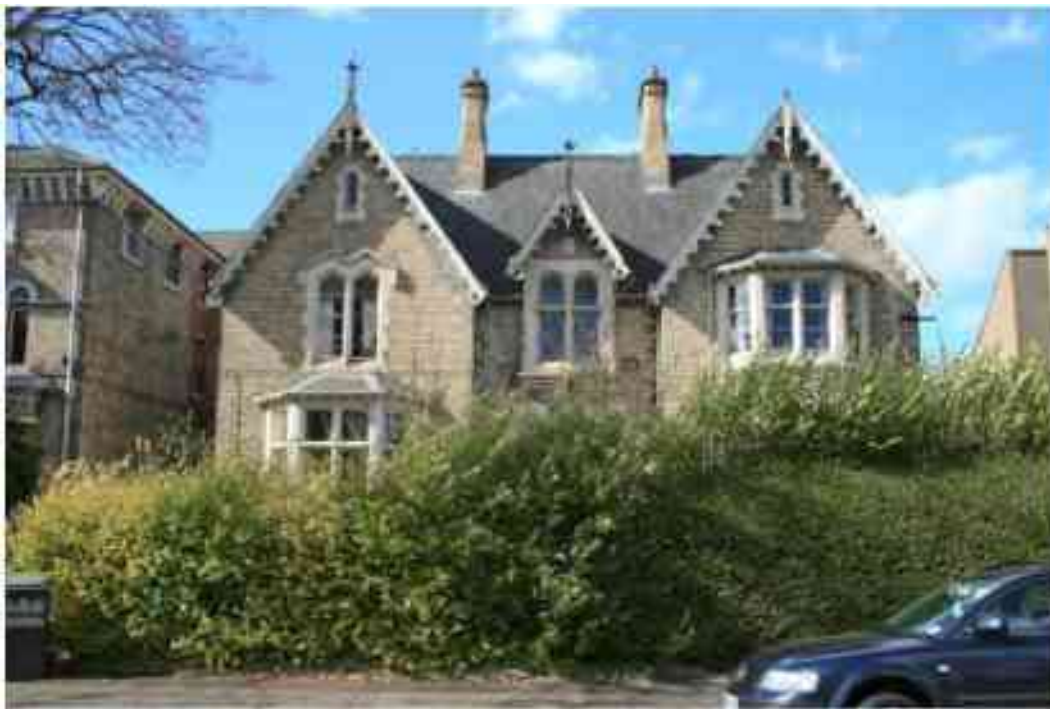
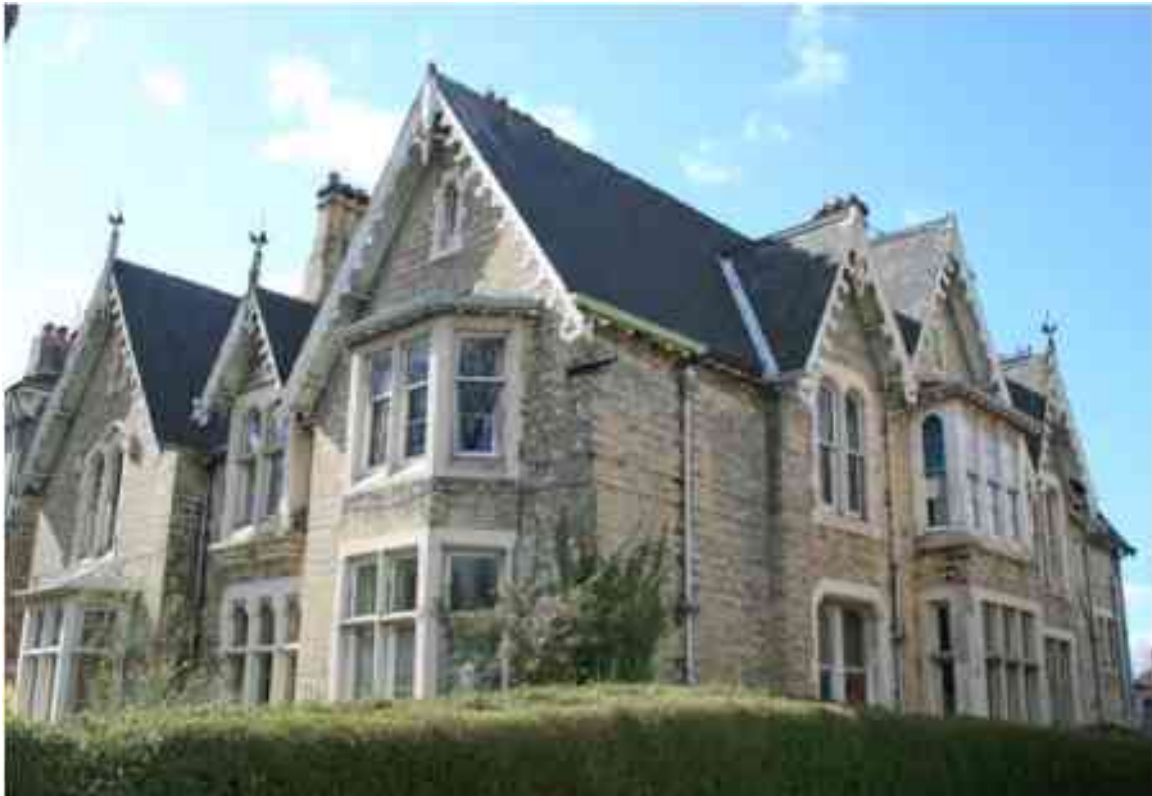
7.4.16.1 The steeply pitched slate roofs, strong vertical lines of the windows and highly ornate barge-boards are characteristic of the Gothic Revival style. The barge-boards are finely crafted and, although in need of repair, balance with the visually heavy stone window surrounds. There are two types: flush with the brickwork, with straight and castellated edging; and relief which provides depth through catching the light and casting shadow. The front face is comprised of two gable ends, separated by a recessed wall meeting the hipped roof which bridges the gables. On this bridge sits a smaller gable tiled in slate, with barge-board. This window is comprised of two vertical glazed panels with stone mullion; and semi-hexagonal arches are atop both glazed verticals. In the triangular space between the window and roof is a stone shield, integral to the brickwork. Underneath this sits a larger window with three vertical sections with similar stone mullions. Each vertical has curved top corners pointing inwards that then reach up again before an abrupt horizontal top. The stonework has decorative motifs above the two centre mullions.

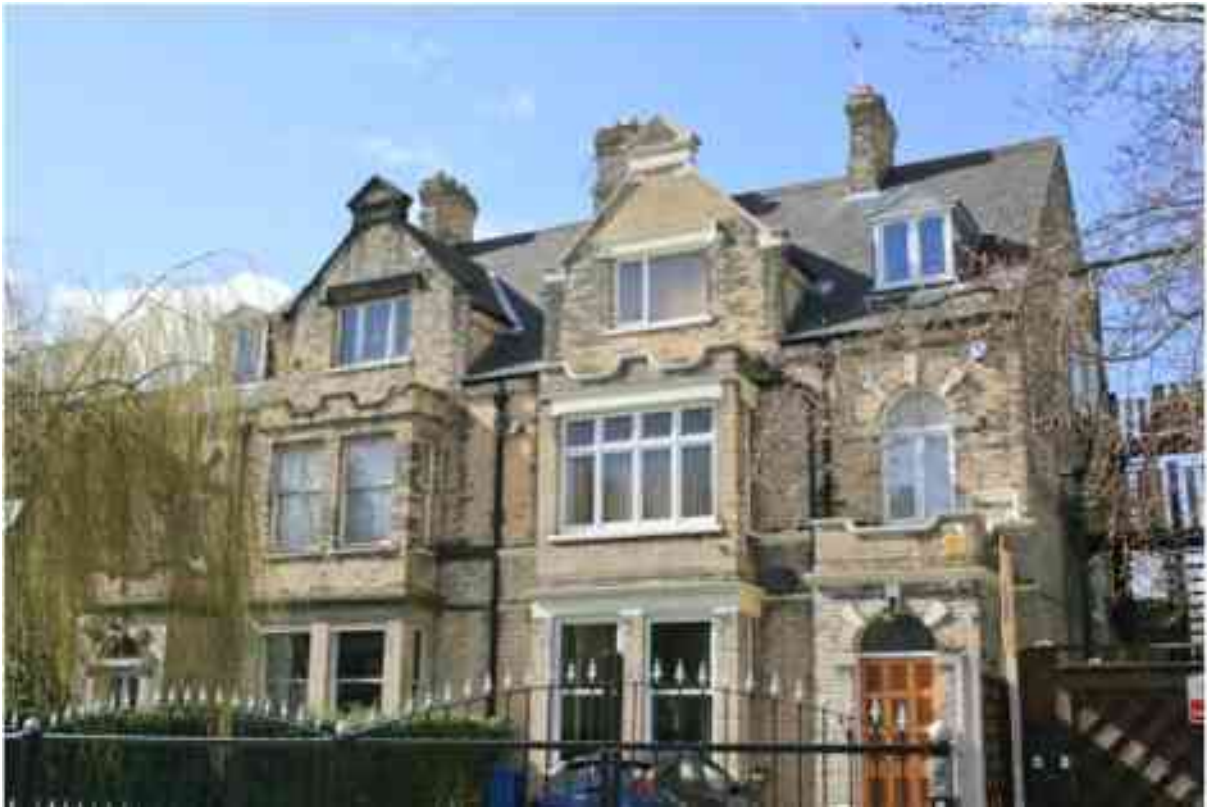
Figure 135 Nos. 60 & 61 closer

- 7.4.18.3 The two rectangular windows on the ground floor in each house are original timber sash. This window arrangement continues on the first floor in No. 60, whereas in No. 61 the two individual windows have been replaced by one horizontal rectangular timber window in the bay. This confuses the design as the strong vertical line that carries the gaze up the building is disrupted and the harmony ceases. To restore the unity of the two buildings would require the reinstalling of the brick mullion as well as sash windows. The gable end window on the third floor has also been changed for a one-third opener, but this is not as jarring as the window below.

7.4.18.4 On the corner above the front door the name plaque of No. 61 reads 'Woodville'. The plaque on No. 60 is virtually illegible ('Ryo...') as the stone has weathered severely. This could be due to pointing using incorrect materials which can accelerate damage to stonework. The stonework on No. 61 is painted cream and is well-maintained, although this is not necessarily how it would have looked originally. As the lintels and sills next door are unpainted, it is likely the original materials were celebrated and left exposed.

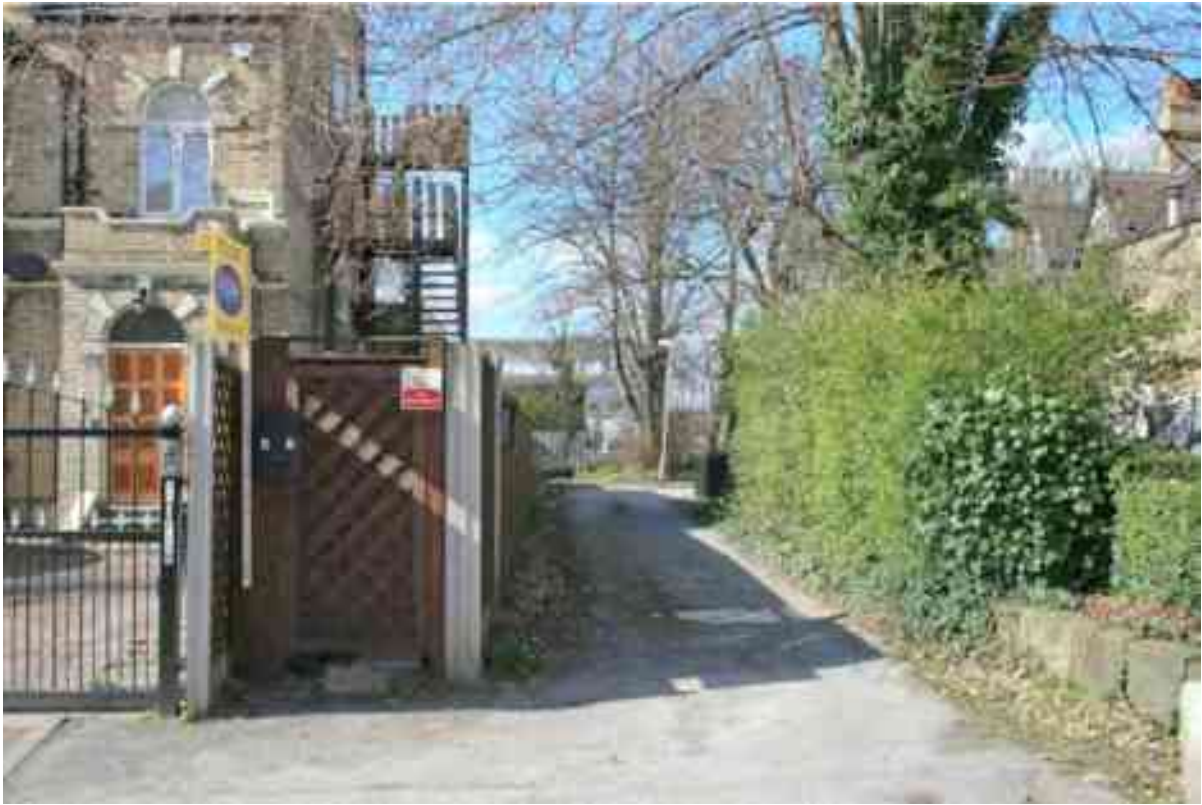
Figure 138 No. 61 with Umfoot

7.4.18.5 A very large fire escape on the side of No. 61 is clearly visible from the front and possibly provides access to flats but currently resembles New York tenements, uncharacteristic of Pearson Park. While necessary for safety in Houses of Multiple Occupation, fire escapes are unsightly additions to houses of this era.

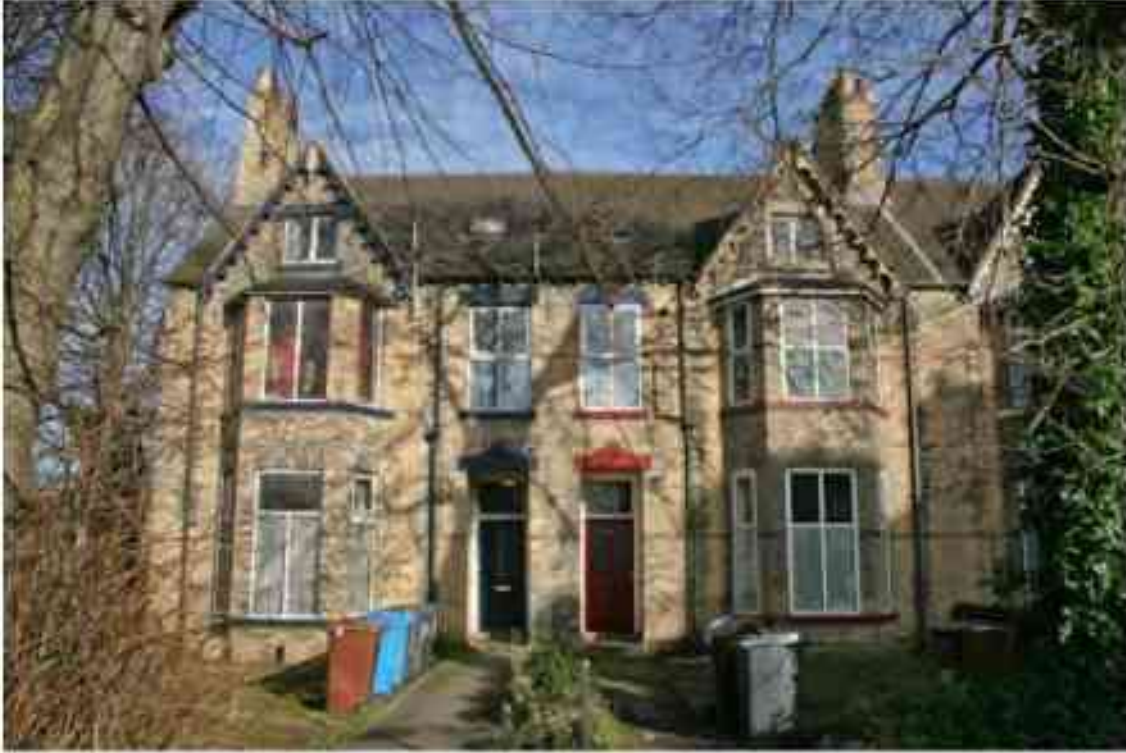
Figure 140 Nos. 62 & 63 front

7.4.19.2 Each has lost its original slate roof and had a Velux-style window implanted in its roof, located roughly above the front entrance. Nos. 62 to 64 also have a replacement finish to their bay window roofs: felt and bitumen, rather than lead which is seen on No. 65 and is likely to be the original material used. No. 64 & 65 have finials atop their gable: both appear to be replacing the originals.

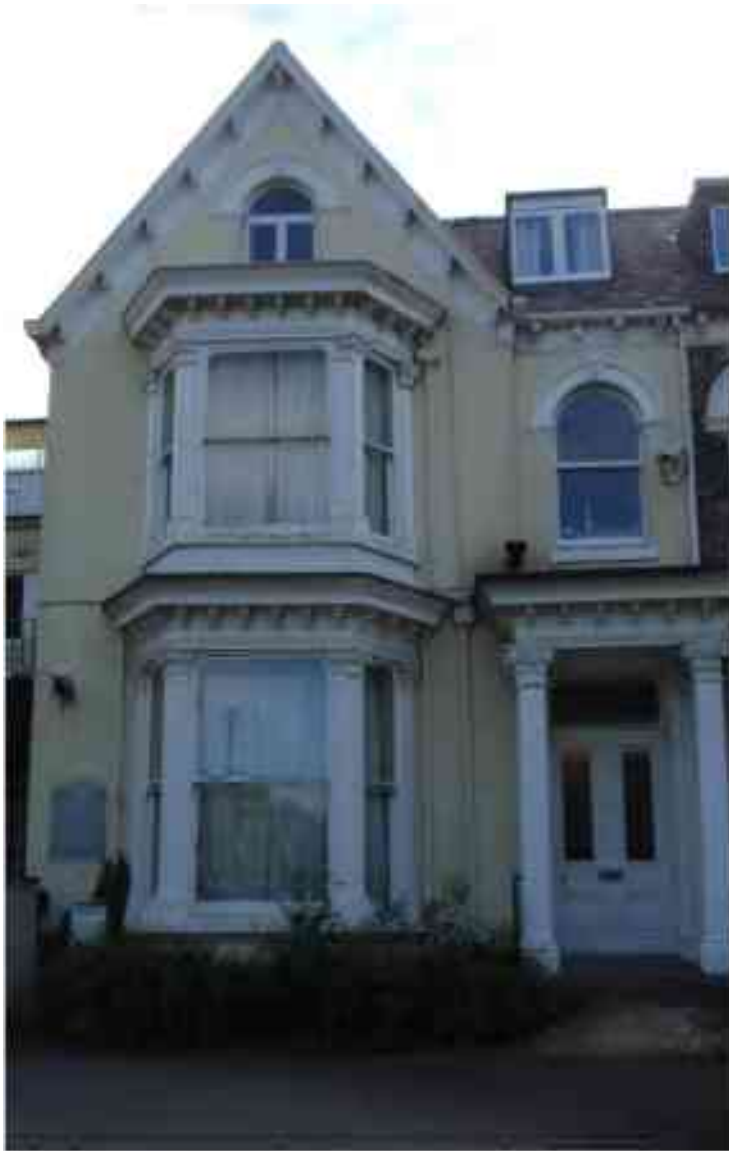
Figure 156 No. 72 front

- 7.4.25.4 No. 72 has a rendered veneer and still retains the look of a three-storey villa with two-storey bay windows intact. These have ornate corbels which are replicated on the grand front porch, hosting columns with Corinthian capitals. The mullions of the timber bay windows have similar decorative capitals, with detailed curved corners at the tops of the timber-framed sash windows. The front door has the original timber door with panels. Above this is a semicircular arched sash window similar to the adjoining No. 74. The dormer window above is out of line with the rest of the composition. In the gable end, above the bay windows, is a semicircular arched window with stucco detailing over the arch. The replacement window frame is not original in its design.

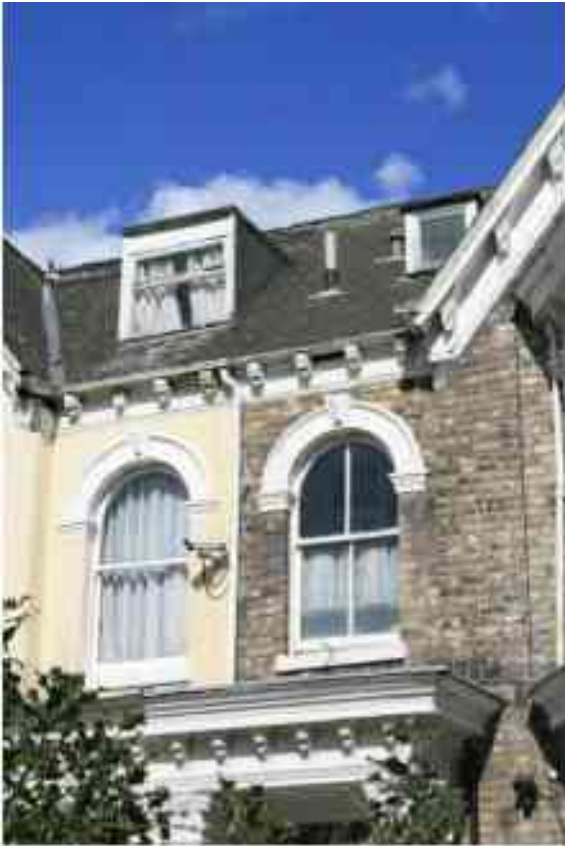
Figure 158 Nos. 72 & 74 arched window detail

7.4.26.2 No. 74 is very similar to No. 72 with matching gutter blocks, front porch and window frames. Significant differences are that the buff-grey brick construction is still visible; the house name sign remains on the corner as does a tall, corbelled chimney; the sash windows have the same curved top corners but have, unlike next door, six panes of glass with three muntins instead of the more common four panes and two muntins. The first-floor bay is the same, but the arched windows above the bay and front door have a traditional Victorian four-pane design.

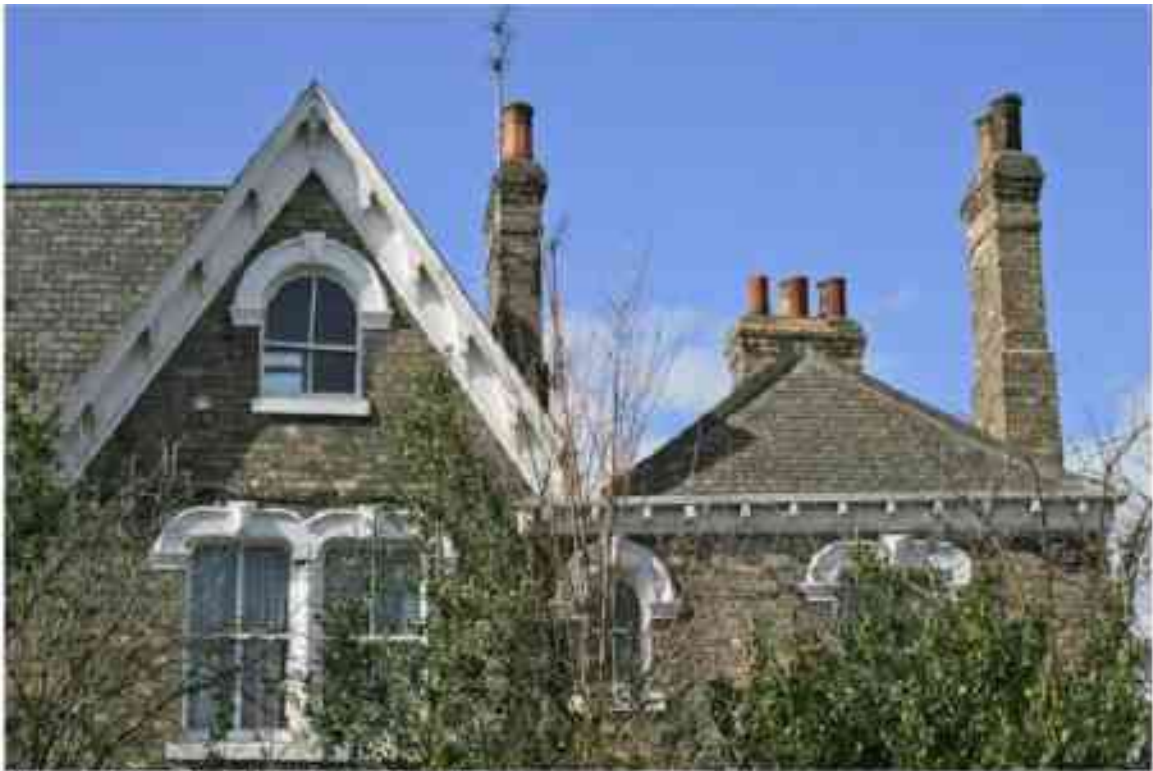
Figure 159 Nos. 73 & 74 roof detail

7.4.26.3 The gable on No. 73 creates a hip and valley roof with No. 74. Next to the gable of No. 73 appears a hipped end with a tall chimney either side. This arrangement, as with the windows below, is unusual. Changes have been made to the original design of No. 74: the altered brickwork and lack of stone lintel suggests the removal of a bay window on the ground floor. Queen Anne style stucco is on all the arched and curved-corner rectangular windows apart from the inappropriately modern ground floor horizontal rectangular window and doorway of No. 74. Poorly maintained modern brick walls and steps denote the separate doorways. Both properties are hidden from view by trees and shrubbery.

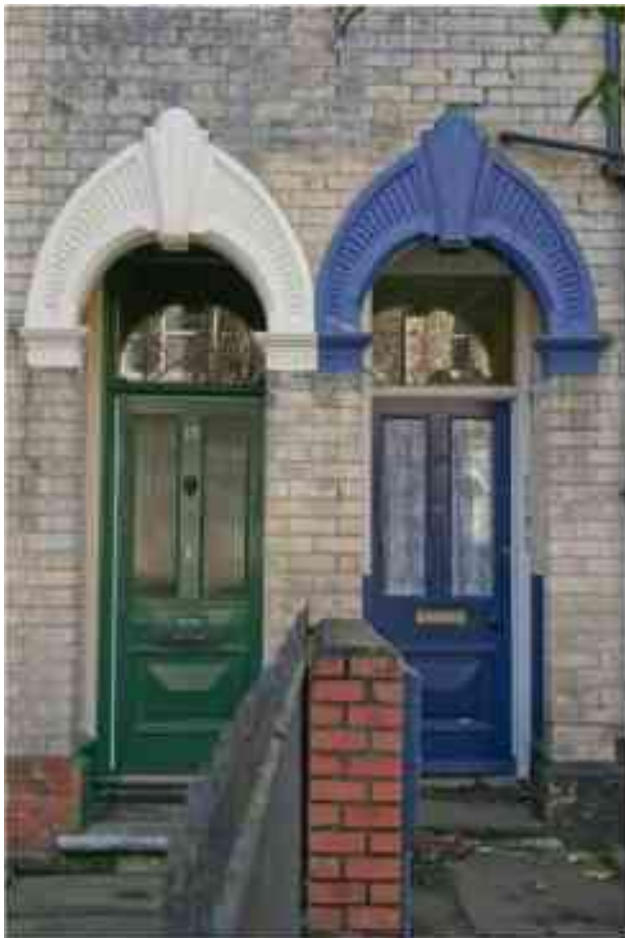
Figure 168 Nos. 13 15 Pearson Ave front doors

- 7.5.5.4 Nos. 11 and 15 have blue-painted stonework with contrasting window frames in white, whereas No. 13 is cream in colour with green frames. No. 13 retains the original front door whereas the barge-board has been replaced with a less impressive, plain timber counterpart.
- 7.5.5.5 Nos. 13 and 15 have front gardens enclosed by privet hedges set behind stone railing plinths, whereas No. 11 is left bare.
