**Avenues and
Pearson Park
Conservation Area
Character
Appraisals**

Character Appraisal 2: Pearson Park

Published by Hull City Council, Kingston upon Hull, UK

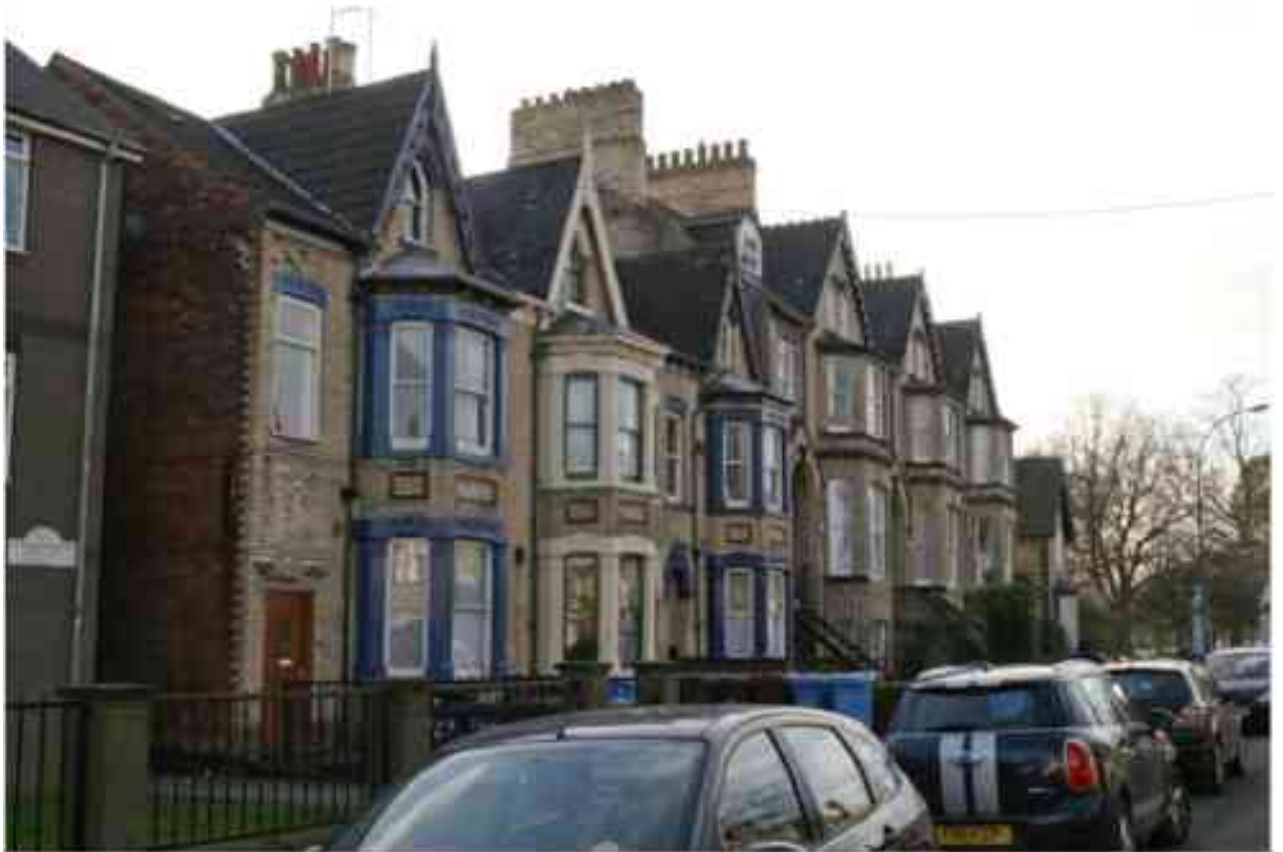
Figure 169 Nos. 11 to 21 Pearson Ave

7.5.6.2 This terrace adjoining Nos. 11 to 15 is suffering significantly with subsidence. The weight of the chimneys appears to be where the buildings are under pressure and it is remarkable that they have changed shape so much without severe repairs being needed on the facade. The doorways resemble certain medieval buildings with their distorted appearance.

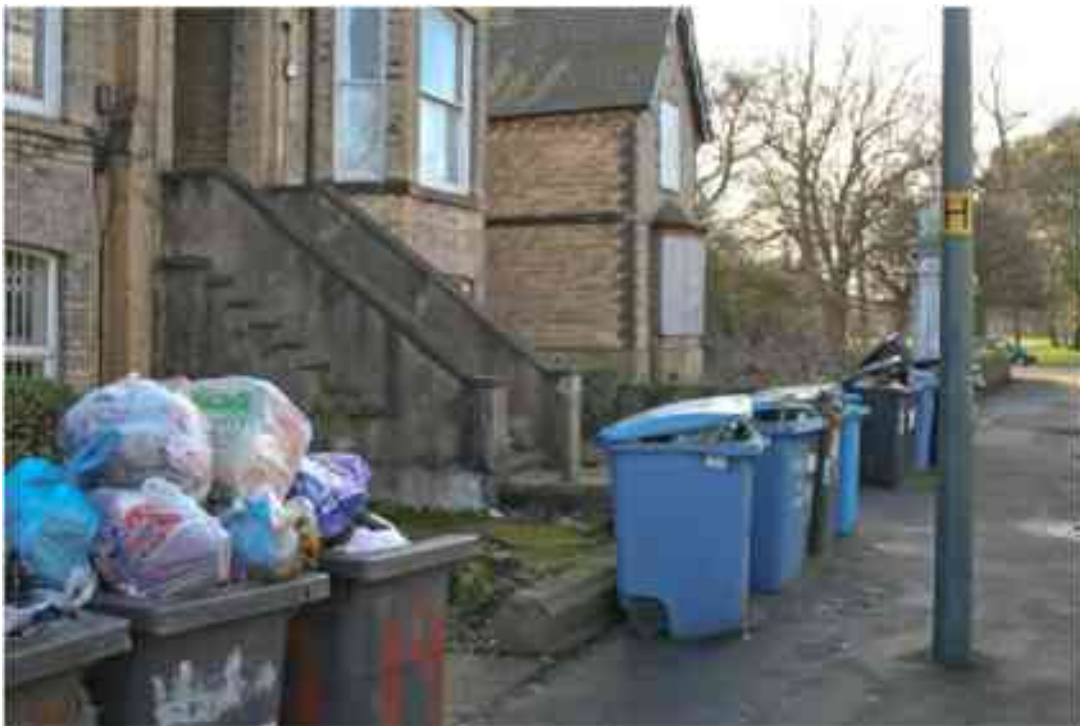
Figure 172 Nos. 19 & 21 Pearson Ave wheelie bins

7.5.6.4 An obvious problem at the front of these properties is the disposal of waste. The street is spoilt considerably by waste bins that clutter the pavement and this is exacerbated by waste spilling out on to the street, despite attempts to keep the piles of debris tidy.

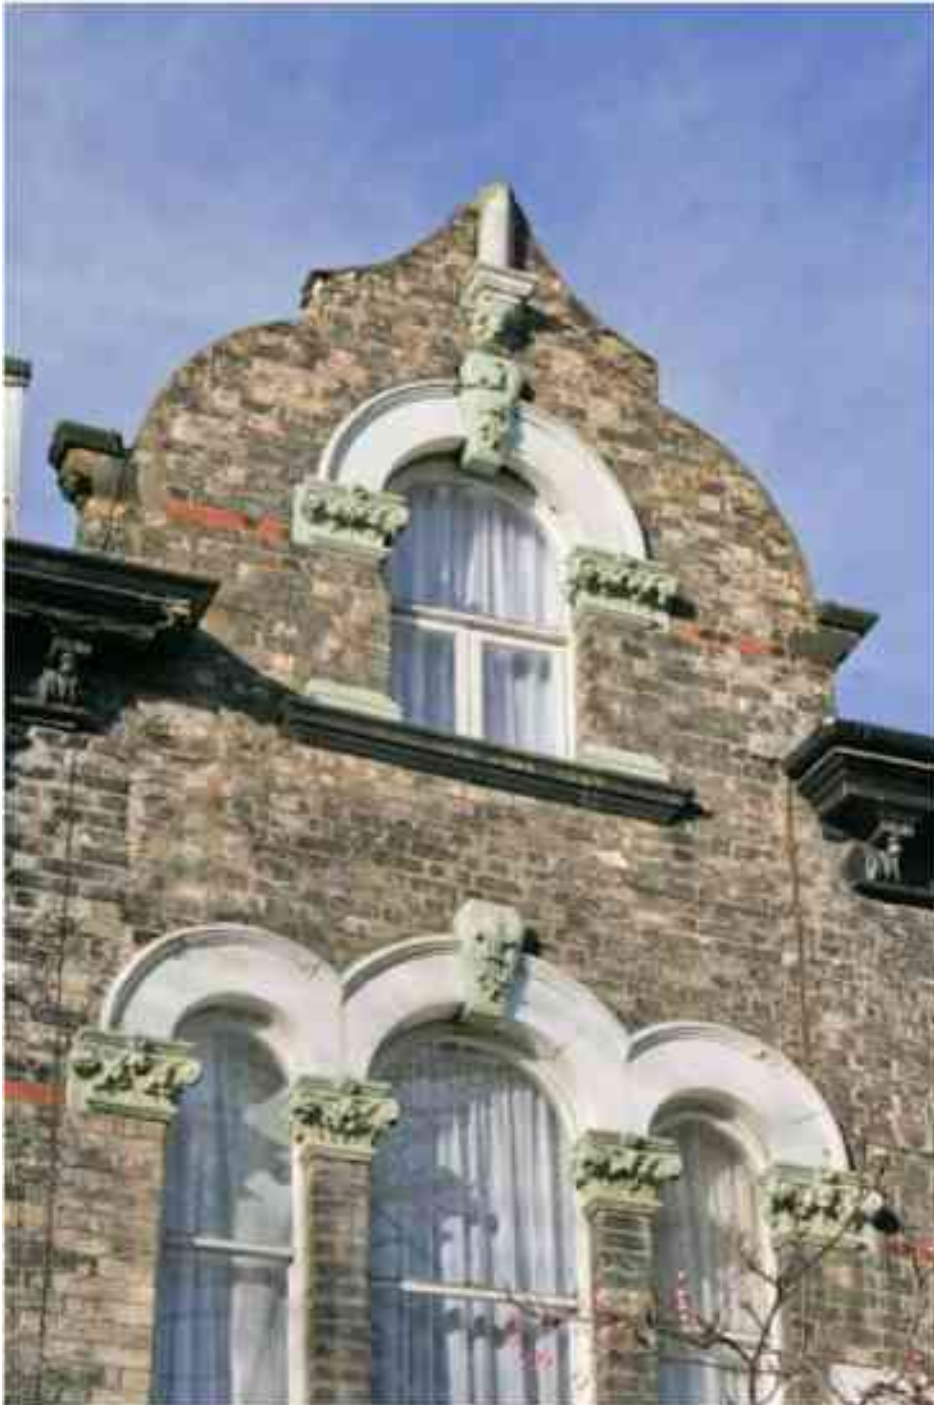
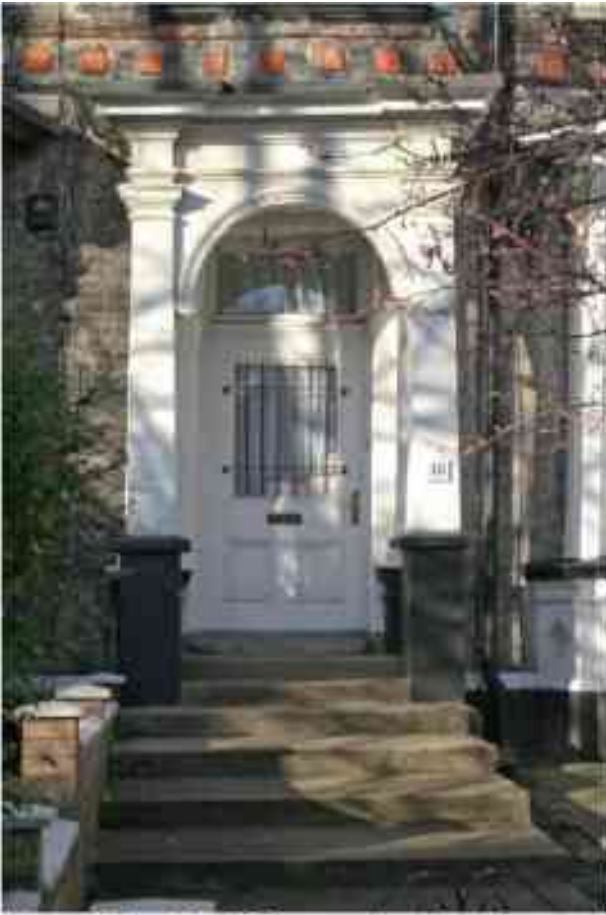
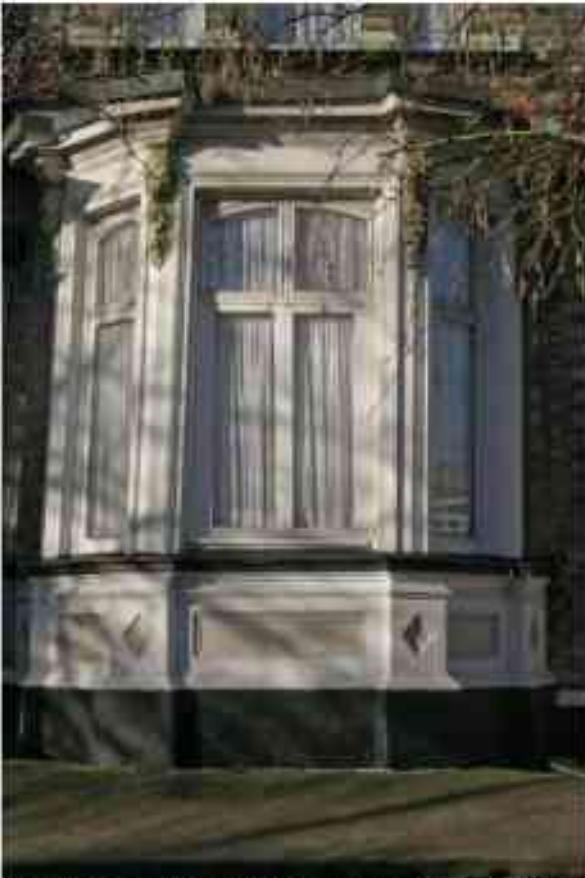
7.5.9.1 The stonework is painted white with capitals a light green colour. The front porch and door appear intact but with a steel grill over the door glazing. The front steps and stonework below the bay window have been preserved well. A modern wall surrounds the front paved area which is not in keeping with the period or traditional materials. A dormer window above the entrance is unappealing and ill-fitting to the Victorian style and quality. The original sign for the terrace name is situated towards the right on the first floor and is worthy, like all the original features highlighted, of preservation.

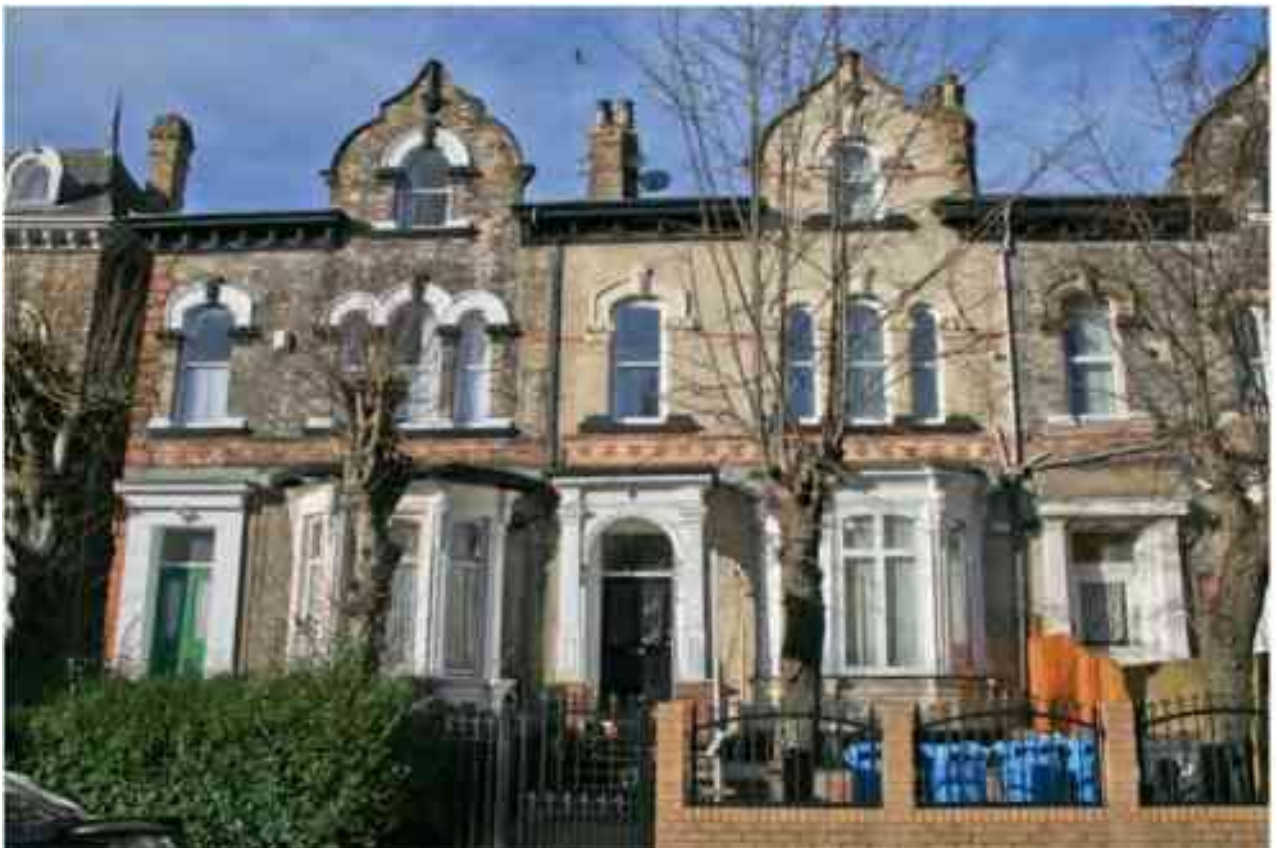
Figure 179 Nos. 18 to 14 Pearson Ave

7.5.13.1 The end terrace property appears to be in very good condition with all original features intact apart from the front porch, the removal of which disrupts the continuity of the terrace. The installation of a CCTV camera adds to the visual detriment. Wheelie bins clutter the path.

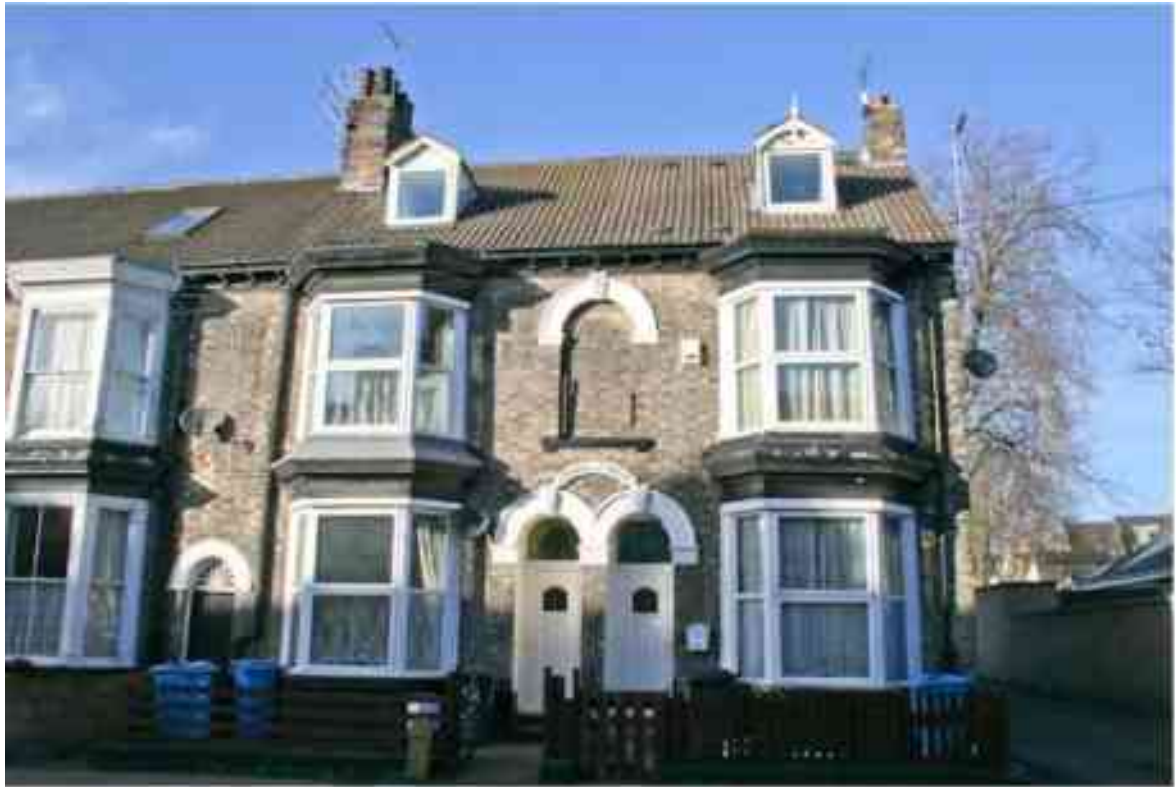
7.5.16.2 Nos. 2 & 4 have UPVC replacement glazing and front doors. In the central arched window, splinters of wood from a modern sign have been left. Below this is the hand-written house name sign.

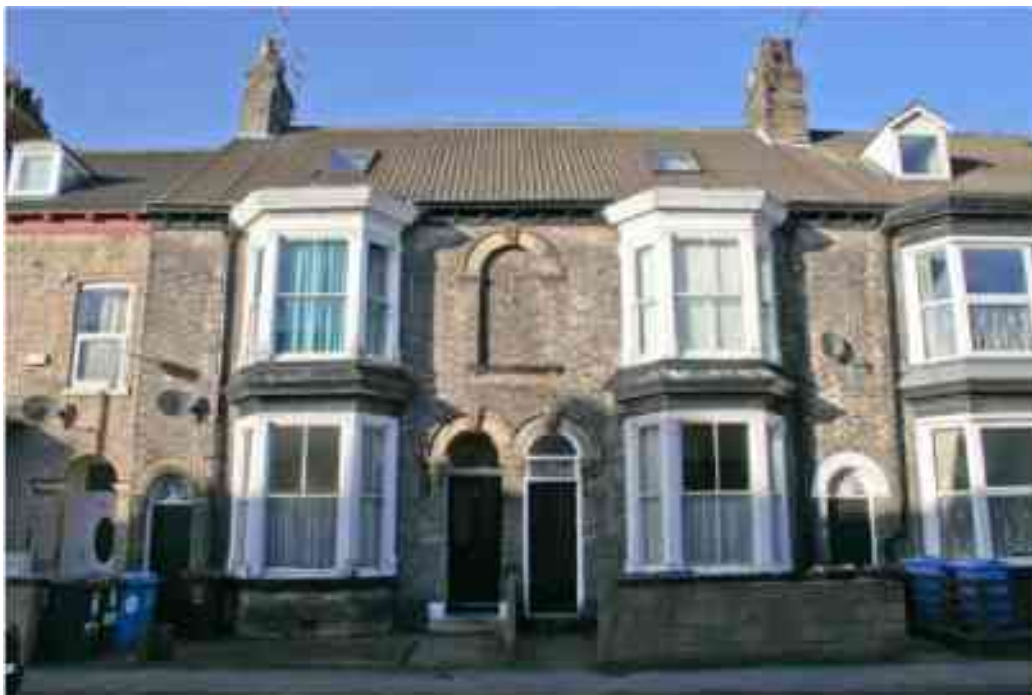
Figure 199 Nos. 6 & 8, Grove Street, front

7.5.17.1 These differ from Nos. 2 and 4 as the horizontal timberwork at the top of the bays is painted white rather than the usual black. The rest of the timber-framed sash windows are white: this plays an important role visually, with symmetry being an important part of the design. The satellite dishes on either side of the bays interrupt the concordance, as does the additional glazing at the entrance to No. 6. These properties have porches that are integral to the building and this installation of frame and glazing flush with the exterior wall creates aesthetic imbalance. The roofline of the terrace is imbalanced by a mixture of dormer and Velux-style windows and the loss of the tall chimney pots, at the end of the terrace at No. 2.

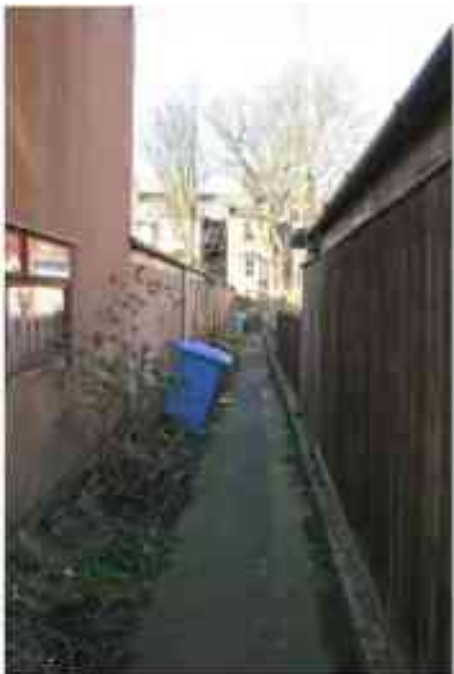
Figure 202 West View snicket

- 7.5.19.1 This is a terrace of six houses in a cul-de-sac that is reached via a snicket from Grove Street. The sign, minus the 'W' is located on the corner of No. 14, but the houses are not easily seen. A tall fence next to No. 14 blocks the view of this area and the snicket is unkempt with little direct sunlight reaching the path, leaving a light layer of green vegetation. Wheelie bins are balanced precariously and there is not room for two people to pass comfortably.

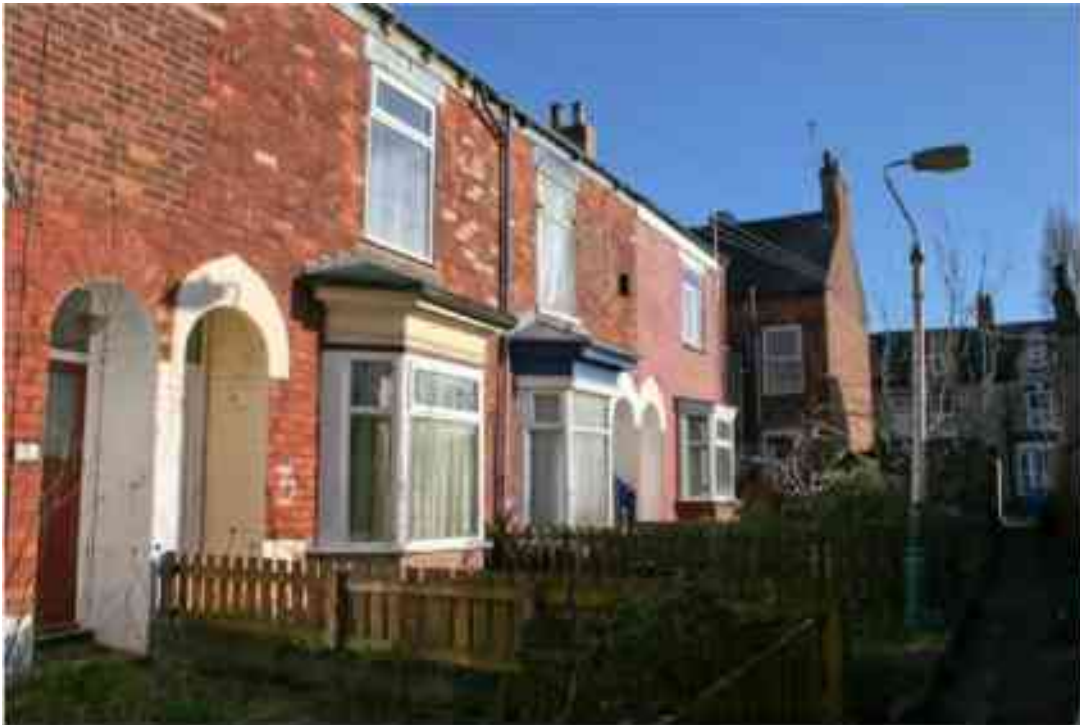
Figure 204 West View Nos. 4 to 1

7.5.19.2 The houses are compact but still with details that are worthy of conservation. Red brick in construction, the only property to retain a slate roof is No. 5. No. 6 appears to be in need of repair on the top end corner. No. 1 is the house nearest to Grove Street. The red-painted front elevation at No. 1 does not contribute to the unity of the terrace.

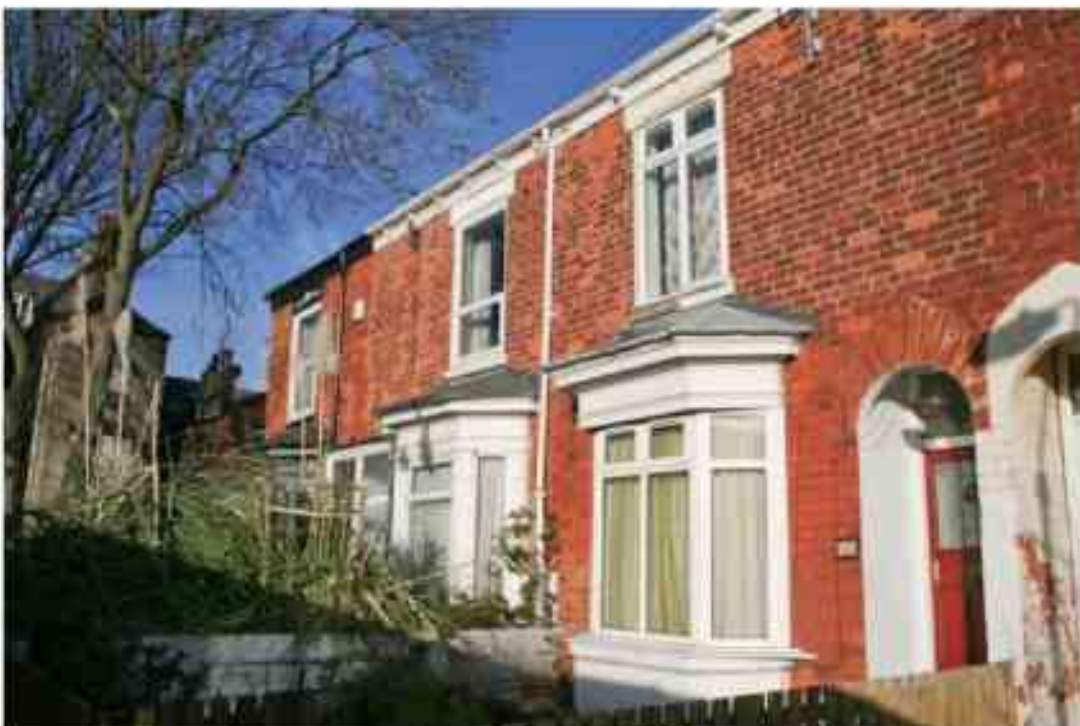
Figure 205 West View Nos. 8 to 6

7.5.19.3 Each property has a ground floor bay window and single rectangular window above. All the houses appear to have replacement windows: mainly UPVC. The doorways are recessed to form an integral porch underneath an equilateral pointed arch created from brick. These are retained on most, with the exception of No. 5, which has been covered with a 1960s style wooden porch with rippled-effect glazing adjoining the bay window.

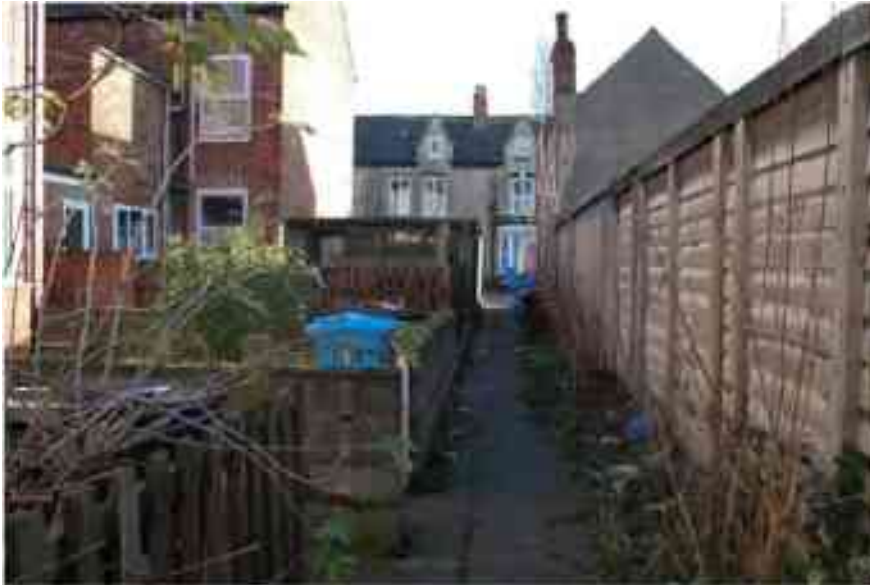
Figure 206 View of Grove Street from West View

7.5.19.5 The front gardens are a mixture of concrete and exuberant planting, with the surrounds varying from breeze blocks to timber fences. The view from this terrace is the back of the row of garages and the backs of Pearson Park villas.

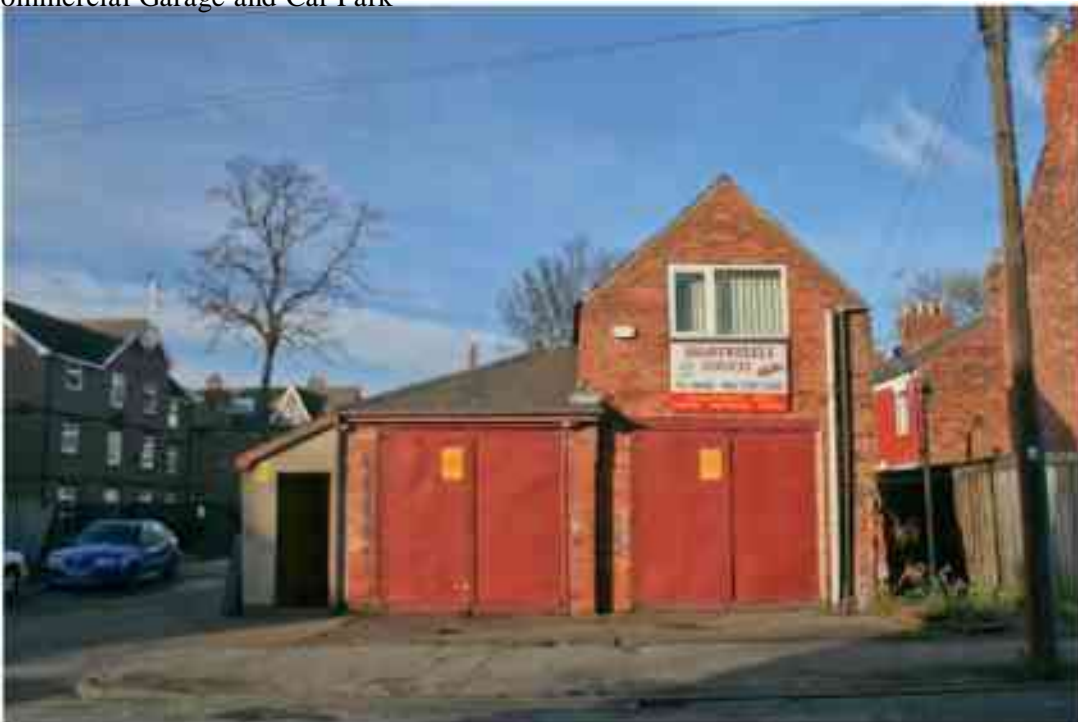
Figure 207 Commercial Garage front, Grove Street

7.5.20.1 This detached commercial premises sits between the alley connecting Grove Street with Pearson Park and the snicket to West View. To the left and behind the premises is a car park with garages stretching in a north-south direction, parallel with West View.
