2 - 96 Bathurst Street, Hull

Type 3 Fire Risk Assessment

Prepared for:	Rebecca Franks, Building Safety Manager
Prepared by:	John Askew, Fire Risk Assessor, Holistic Fire Safety
Date:	07/10/2024
Document Reference:	HFS.HCC.BathurstStreet2.FRA.2.0

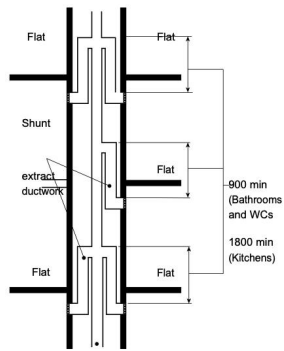
Photo 7

Fire dampers are provided in ductwork at the point extraction exits bathrooms in residential dwellings and enters central shafts. Bathrooms sampled (Flat 80) gave evidence of x2 vents (high/low level) which have dampers installed which are activated via a fusible link.

Although dampers do not restrict the spread of smoke in the early stages of a fire, it would prevent spread of flames and hot gases.

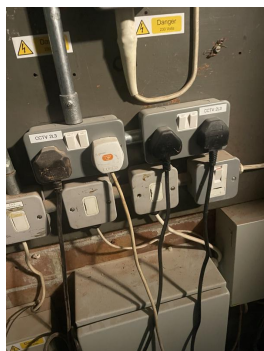
Photo 10

Portable appliances within ground floor ancillary accommodation were not displaying PAT labels.

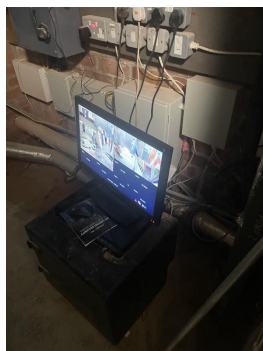
Photo 11

Whilst portable appliance testing (PAT) is not a legislative requirement, it is a requirement of Health and Safety at Work legislation under the Electrical at Works Regulations 1989, to

periodically check electrical equipment for safe use. Any item which is connected to the main supply falls under Regulation 3 & 5 which places a legal responsibility on the owner, as the duty holder, to ensure that all supplied electrical equipment used within the property is safe and not in a position where they may cause danger to staff or residents.

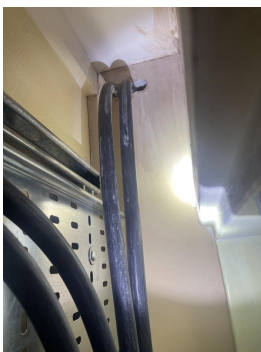
Photo 29

Breaches were present at the point data cables and conduit pass through fire resisting partitions. The majority of these appear to have been fire stopped although there was no test evidence to support this. Remaining defects require fire stopping.

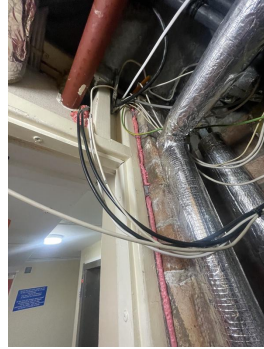
Photo 37

There are x2 service riser shafts within the building which are partially compartmented at all floor levels creating x24 enclosures. Following comprehensive inspections and sampling, breaches/defects are extensive and consistent throughout all areas.

- Non compliant air transfer grills at the head of service riser doors
- Services passing through service riser fanlights without appropriate fire stopping in place
- Combustible plastic pipework entering risers from flats without an effective closing device present.
- Missing sections of masonry where services have been removed
- Combustible plastic pipework which travels vertically from riser to riser without an effective closing device present.
- Insulated non combustible pipework travelling vertically from riser to riser without an effective closing device present.
- Non combustible pipework entering risers from flats without an effective closing device present.
- Linear gaps between door frame and substrate and door heads have been filled with polyurethane expanding foam (this is not a suitable/tested solution for backfilling around timber doorsets).

Remediation will primarily consist of sealing defects with an ablative coated fire batt and mastic system applied in conjunction with an intumescent wrap/fire collar for combustible pipework. Where annular gaps allow, all isolated non combustible services can be sealed using fire rated mastic which is tested to BS EN 1366-3/4 and classified to 13501-2:2017 + A1:2009.

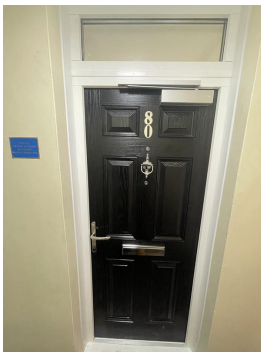
Photo 57

No evidence of certification has been provided, however handover packs are expected to be held by HCC compliance teams.

Door-sets have BM Trada Manufacturers plugs installed within the edge of the door leaf, however there is no evidence to suggest that doorsets have been installed by BM Trada certified installers.

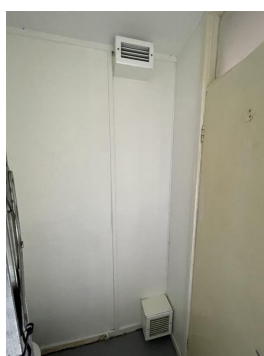
Photo 75

Fire dampers are provided in ductwork at the point extraction exits bathrooms in residential dwellings and enters central shafts. Bathrooms sampled (Flat 80) gave evidence of x2 vents (high/low level) which have dampers installed which are activated via fusible link.

It was confirmed that accessible dampers which are located in service risers are subjected to inspection and testing every four years. As dampers are activated via fusible link, there are no moving parts and therefore no requirement for inspection.
