Bayswater Court, Hull

Type 3 Fire Risk Assessment

Prepared for:	Rebecca Franks, Building Safety Manager
Prepared by:	John Askew, Fire Risk Assessor, Holistic Fire Safety
Date:	23/10/2024
Document Reference:	HFS.HCC.BayswaterCourt.FRA.2.0

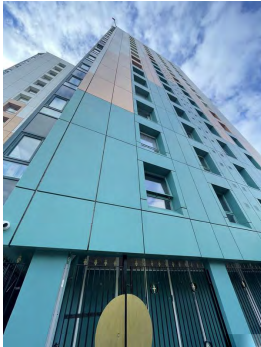
Photo 3

Taking into consideration developments within the sector surrounding external wall systems, Holistic Fire Safety feel it would be prudent to undertake further surveys to confirm provisions. Surveys will provide assurances to the Building Safety team that external wall systems are compliant without exposing occupants to unnecessary risk.

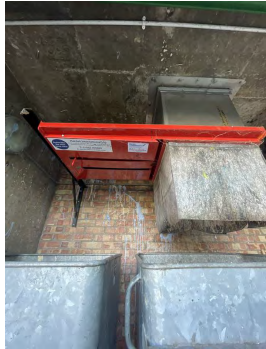
Photo 9

There are x2 refuse chutes provided at Bayswater Court, both are located in permanently ventilated areas and separated from escape routes by fire resisting construction providing 30 minutes. The refuse chute has undergone refurbishment and provides adequate protection at all floor levels with self-closing, intumescent lined hopper disposal points and an automatic isolation shutter which is activated by means of fusible link at

the base of the chute. The base of the chute is accessed externally.

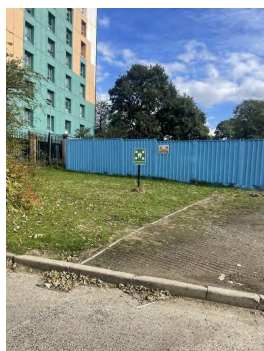
Photo 10

The assembly point at Bayswater Court is located on a grassed area to the front of the building which is defined as a suitable location.

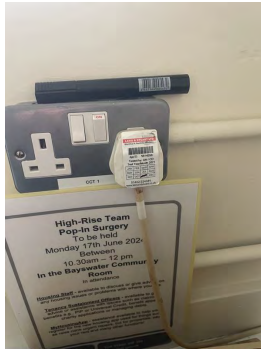
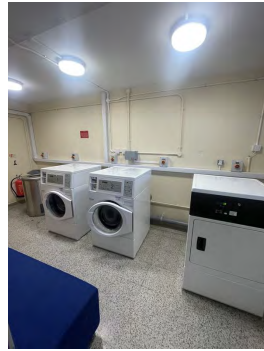
There is a laundry situated on the ground floor with a number of electrical washing machines and dryers; all of which were confirmed to be periodically inspected.

The scheme has implemented a policy within the laundry which includes the removal of lint build-up from tumble driers; at the time of inspection, filters were clean. The laundry is also provided with automatic fire detection & warning and is enclosed in fire resisting construction.

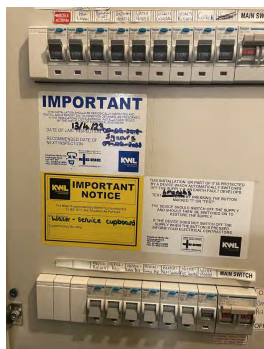
Photo 14

Samples taken within Flat 45 (expiry 04/28) gave satisfactory test frequencies.

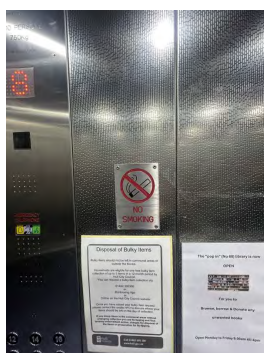
Photo 15

The building complies with current no-smoking legislation with signage displayed prominently throughout the building at all levels. Signage displayed is clearly visible and complies with the Smoke free (signs) Regulations 2012.

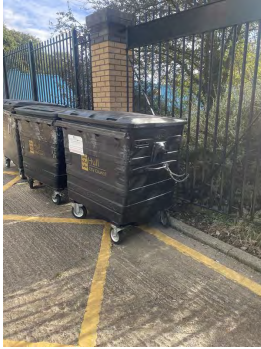
Photo 22

The immediate area around the building was sterile; waste bins were contained within the refuse chute area which is enclosed in a roller shutter and walkways around residents sheds were sterile. Additional waste bins were visible, however they were located clear of the main building and chained to an immovable object.

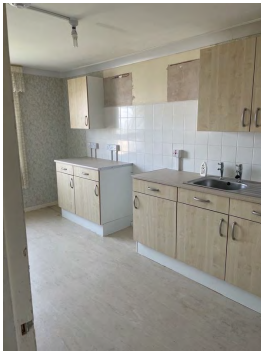
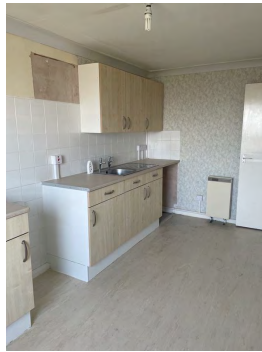
Kitchens are provided with notional FD20 doorsets, heat detection and cooking facilities are remote from the entrance door and do not prejudice the escape route from any point in the flat other than the lounge.

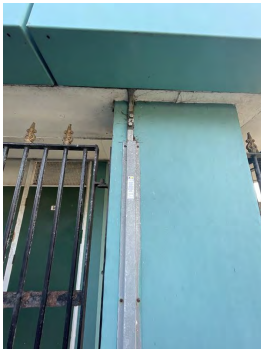
Photo 25

It was confirmed verbally and via physical inspection that a lightning protection system (LPS) is in place.

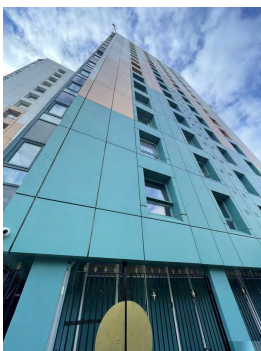
Photo 26

Taking into consideration developments within the sector surrounding external wall systems, Holistic Fire Safety feel it would be prudent to undertake further surveys to confirm provisions. Surveys will provide assurances to the Building Safety team that external wall systems are compliant without exposing occupants to unnecessary risk.

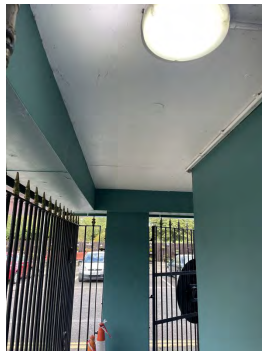
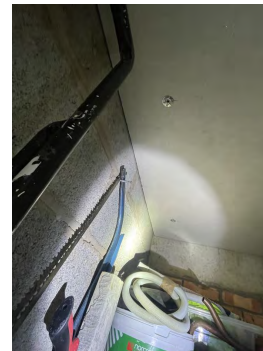
It has been confirmed the insulation present is flammable and should be removed. Any replacement should achieve Class A2-s1, d0 or better

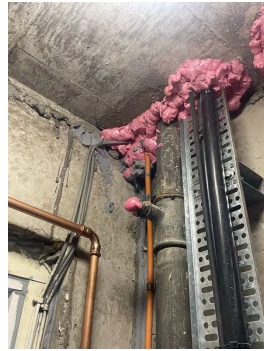
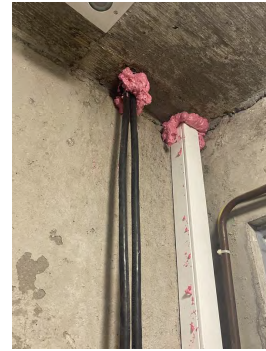
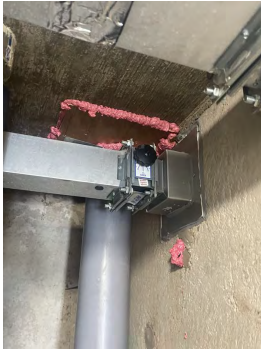
There are circa 60 service risers within the building and breaches/defects are extensive and consistent throughout. As previously described, the majority of services (soil vent pipes, extraction arrangements, heating services) which supply flats pass freely between risers and dwellings without an effective sealing system in place.

Remediation will generally consist of primarily sealing defects with an ablative coated fire batt and mastic system which will be applied in conjunction with an intumescent wrap/fire collar for combustible pipework. Where annular gaps allow, all isolated non combustible services can be sealed using fire rated mastic which is tested to BS EN 1366-3/4 and classified to 13501-2:2017 + A1:2009.

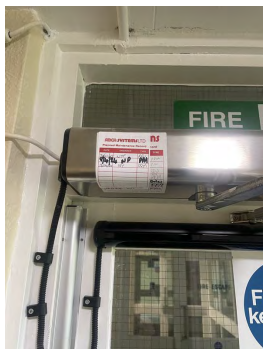
Photo 41

Ground floor lobby doors are electrically operated automatic doors. A nearby maintenance label indicated these were last inspected in September 2024.

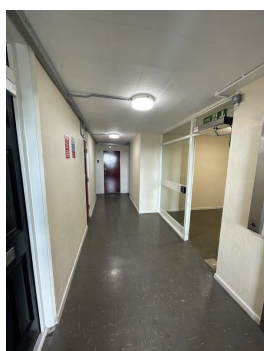
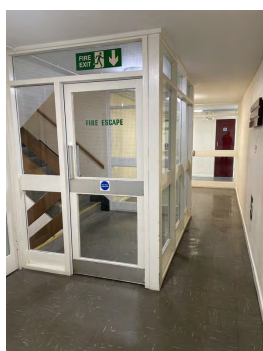
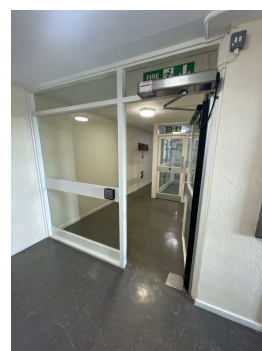
If fire resisting doorsets are inspected in isolation then defects which are present suggest wholesale replacements are the appropriate course of action to take, such a decision would be further justified by the fact that lobbies are not provided with provisions for smoke control and occupants are generally considered more vulnerable than this typically residing within residential dwellings.

As changes to fire resisting doors and curtain walling will require approval from the BSR, it is proposed a site meeting is scheduled with HCC, HFS and HFRS to discuss options on a way forward.

In the interim, a specific fire door inspection is to be undertaken to specify what actions are required.

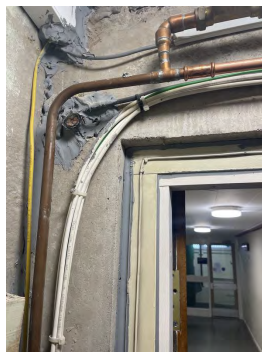
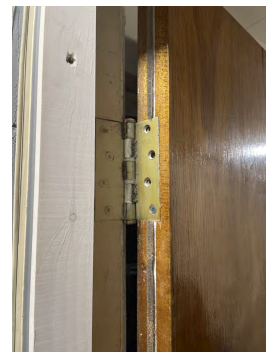
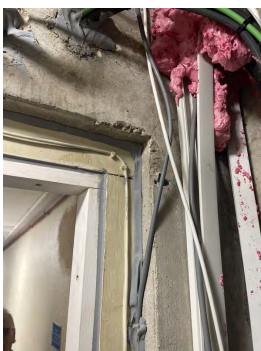
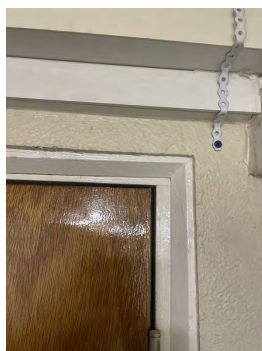
Similar to lobby doors & screens and staircase doors & screens, doors which enclose risers and ancillary accommodation gave evidence of multiple defects.

Although the risk of ignition and fire spread within risers is low, the standard of doors is sub-standard as there are multiple defects throughout the building.

Current provisions are also notional 44mm FD30s doorsets, however defects consist of:

- damaged door leaves
- damaged timber frame
- retrospective installation of door stops
- lack of backfilling/fire stopping between the frame and substrate - steel hinges with no markings
- missing screws from hinges

Given the volume of defects, it is the opinion of Holistic Fire Safety that all riser and ancillary rooms doors are replaced for certificated pre-hung FD30s fire doorsets. HCC have submitted reports to the BSR for work to be carried out on fire doors.

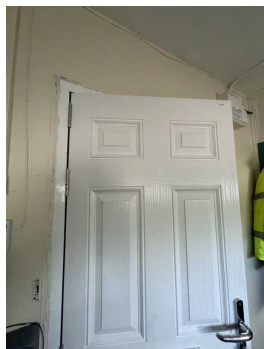
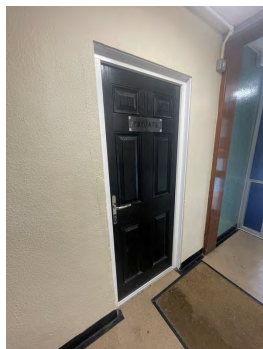
The staff office and cleaners cupboard on the ground floor are not provided with self closing devices which should be fitted.

As described previously, there are varying standards of self closing devices on communal doors ranging from pivot hinges, electronic open/closers to cater for mobility impaired residents and traditional overhead mounted devices. All doors sampled returned flush within their rebate when opened, however there was no consistency; as a result, HCC should define standards throughout the building.

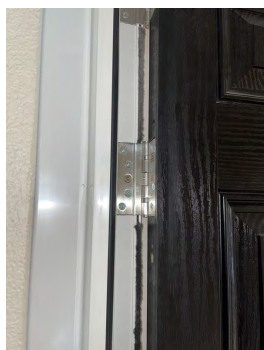
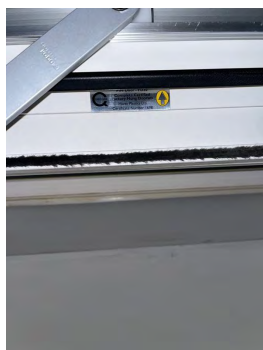
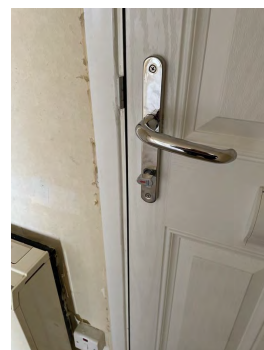
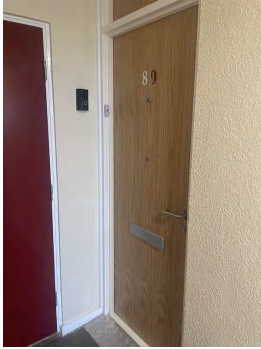
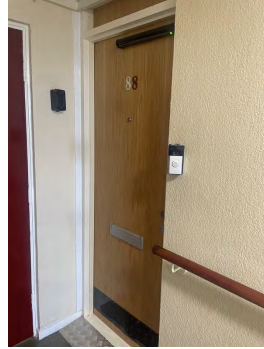
All flat entrance doors have been replaced with third party certified FD30s fire doorsets, which meet the requirements detailed in the ADBVol: 1 Appendix C1 2a for fire resistance and smoke control from both sides, and are fitted with an appropriate positive action self-closing device (BS 1154) and a single action mechanism which does not require the use of a key.

Timber doors are fitted to flats 80 and 88. It is understood these have been fitted with assisted openers/closers for mobility purposes. Until it can be established that certified composite doorsets can be used for this purpose, it is considered acceptable for the doors to remain in situ.

HCC should confirm the installers installations specifications.

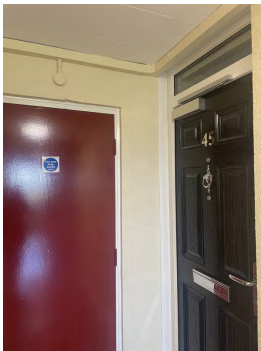
Photo 61

All replacement flat entrance doors are fitted with an appropriate overhead BS 1154 self closing device.

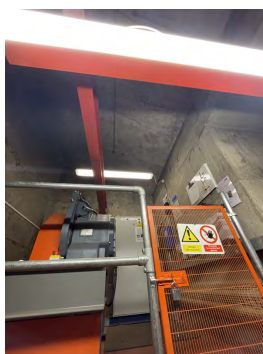
Photo 62

BS 5839:2019 + A1:2020 states that communal areas of the scheme should be provided with a Grade A system which is in accordance with recommendations of BS 5839-1:2017 for a category L4/5 system. It is advised variations should be applied so that coverage spans the laundry, lift motor room etc. Such provisions would not only assist with meeting current guidance, but they would also compliment a smoke control system which is also required.

Given the building height, it is not practicable for an activation to sound throughout communal areas as this could lead to panic and confusion. Simultaneous evacuation from communal areas of the building could also compromise firefighting operations as responding fire crews are likely to require access to the staircase.

It is therefore proposed that additional automatic fire detection and warning is installed throughout communal areas and identified risk rooms. An activation within isolated risk rooms should notify those within the area, however, an activation in escape routes should be operated as a silent system, whereby should an activation occur, it does not produce an audible sound, and it directly notifies the alarm receiving centre.

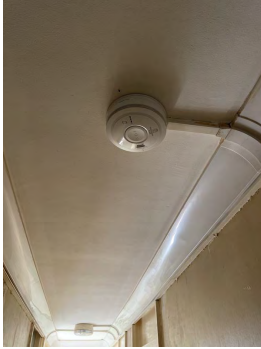
Photo 63

As described previously, the current level of automatic fire detection and warning is not considered adequate for the purpose group and building type. Detection which meet the requirements of a Grade A system which is in accordance with recommendations of BS 5839-1:2017 for a category L4/5 system should be installed throughout communal areas of the block.

HCC confirmed that as part of future proofing of their HRRB's, as a baseline install within void properties, a Grade D1 LD2 fire alarm system is installed. HCC are also working on a system which sends key information to the cloud. e.g. the system will identify issues and in the event of an activation - HCC will be automatically notified. HCC do not currently have sufficient resources to monitor activations however, plans are being put in place to achieve this.

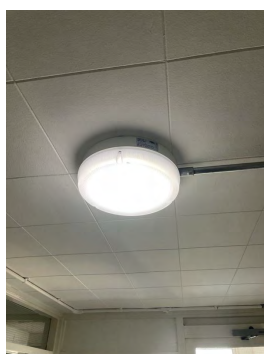
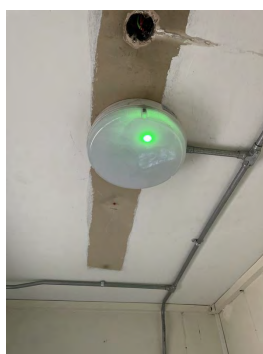
Luminaires are provided with test switch keys which are located at various places and are tested monthly internally.

Provisions appear to be in accordance with BS 9999 Table 8

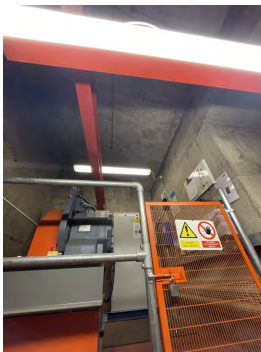
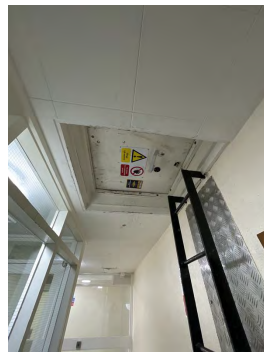
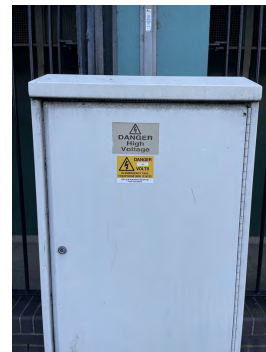
Hazard warning signage is in place on the external face of risk areas such as the lift motor room and the external electrical substation. Each individual ESU within the building is also provided with hazard warning signage to warn both occupants and responding fire crews.

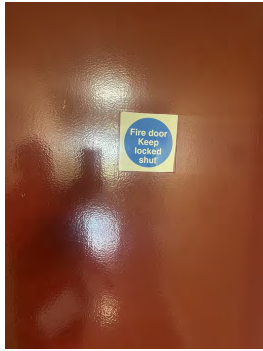
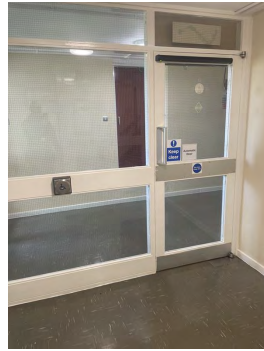
Mandatory signage prescribing a specific behaviour is displayed prominently on all fire doors where necessary (including flat entrance doors) throughout the building.

- Fire doors which are accessible from either side have 'Fire door keep shut' signs attached to both sides of the door leaf
- Fire doors where access is restricted, has 'Fire door keep locked' sign to the open facing leaf of the door only
- Doors fitted with electromagnetic hold open devices are fitted with 'Automatic fire door, keep clear' signage on both faces of the door leaf.

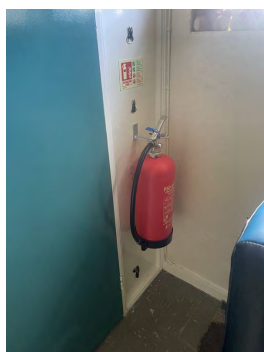
Photo 78

Extinguishers are not present within means of escape.

Extinguishers provided are composite P50 foam extinguishers.

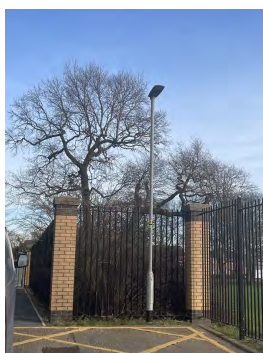
Photo 79

All immediate hydrants are within 90 metres, and are 100mm diameter and are the responsibility of the local water undertaking, via Humberside Fire and Rescue Service, who maintain each hydrant on a two year flow test programme.

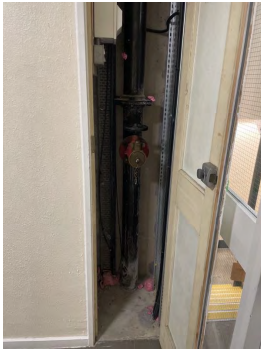
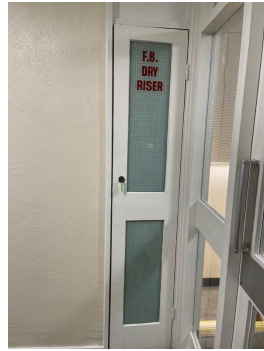
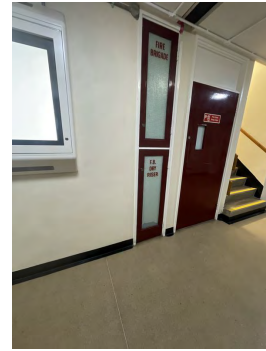
The inlet valve is located adjacent to the stair on the ground floor and landing valves are located in the lobby which separated flats and the protected stair. Such provisions increases firefighter safety in the event of an incident.

A dry riser enclosure had an electrical distribution board located within it, it is strongly advised that this is reviewed as it is foreseeable that water spray/mist could be produced when charging hose/the dry riser.

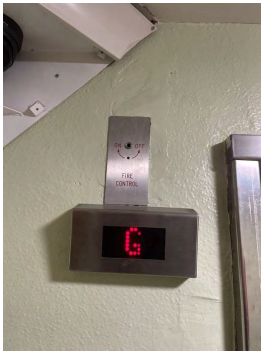
Photo 83

Lifts at Bayswater Court are not designated firefighting lifts, however there is an agreement in place that lifts would be utilised by HFRS in the event of an incident.

Signage within communal areas clearly states that lifts are not to be used in the event of an incident by relevant persons.

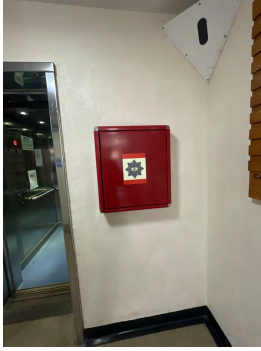
Photo 84

The SIB is located on entry to block on the west side of building adjacent to the lift on the ground floor. Consideration is to be applied as to whether its location is the most suitable. It is the opinion of the assessor that its current location is acceptable, however, HCC may wish to relocate to the external face of the building to ensure the responding emergency services can gain access to the building.

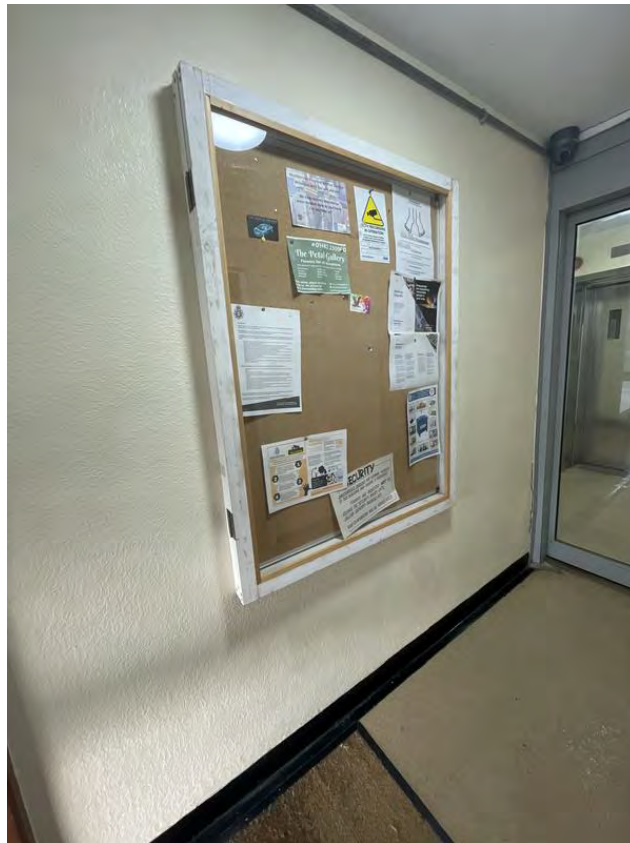
Photo 86

HCC are currently in the process of producing a 'Welcome Pack / Resident Information Pack'; these safety packs are to cover the contents stated below along with resident duties, HCC obligations, key contacts within HCC and how to report defects / incidents etc.
