GTS1, Hull

Type 3 Fire Risk Assessment

Prepared for:	Rebecca Franks, Building Safety Manager
Prepared by:	John Askew, Fire Risk Assessor, Holistic Fire Safety
Date:	07/10/2024
Document Reference:	HFS.HCC.GTS1.FRA.2.0

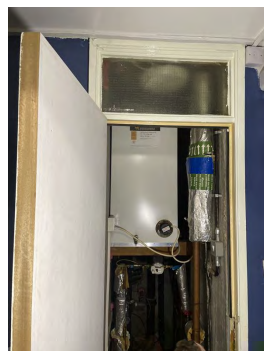
Photo 7

Risers are a mix of larger and smaller enclosures which can be described as single & double risers. (700x2200 single risers & 1020x2200 double risers). All risers display minor defects in compartmentation

Risers in common areas are separated from escape routes by fire resisting construction providing 60 minutes, fire resisting doorsets are notional 54mm with timber toplight, all observed to be in reasonable condition. There are electric service units present in some service risers and electric supply to immersion heaters, however, there are no other combustible items within the area; therefore fire is highly unlikely to spread to adjacent areas.

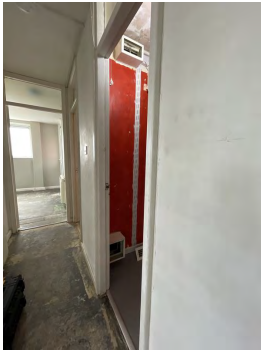
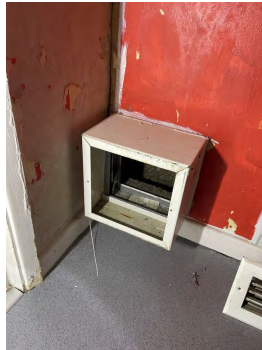
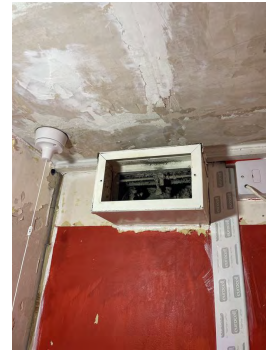
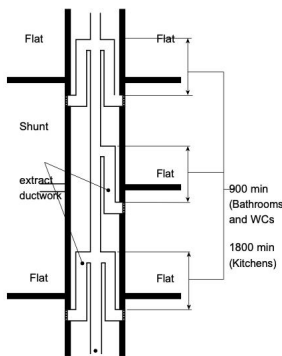
Fire dampers are provided in ductwork at the point extraction exits bathrooms in residential dwellings and enters central shafts. Bathrooms sampled (Flat 402) during the previous assessment gave evidence of x2 vents (high/low level) which have dampers installed which are activated via a fusible link. Although dampers do not restrict the spread of smoke in the early stages of a fire, it would prevent spread of flames and hot gases.

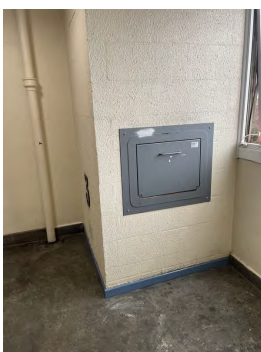
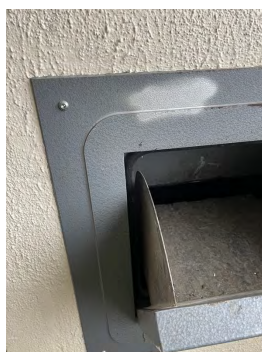
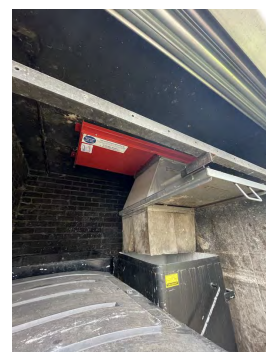
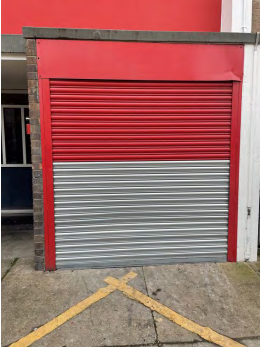
The refuse chutes have undergone refurbishment and now provide adequate protection at all floor levels with self-closing, intumescent lined hopper disposal points and an automatic isolation shutter which is activated by means of fusible link at the base of the chute. The base of the chute is accessed externally.

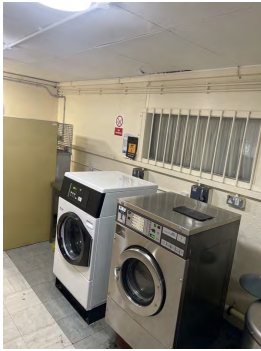
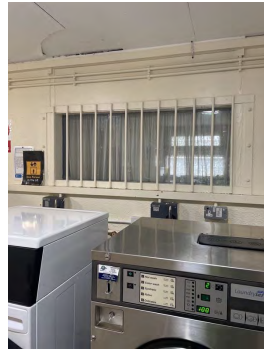
The scheme has implemented a policy within the laundry which includes the removal of lint build-up from tumble driers; at the time of inspection, filters were clean. The laundry is also provided with automatic fire detection & warning and is enclosed in fire resisting construction however, there is a glass partition between the laundry and caretakers office which is suspected to be none fire rated glazing - Section 17.

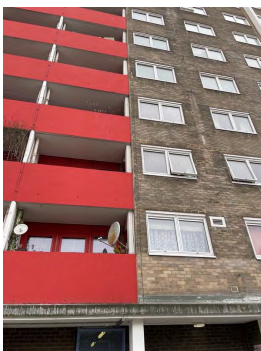
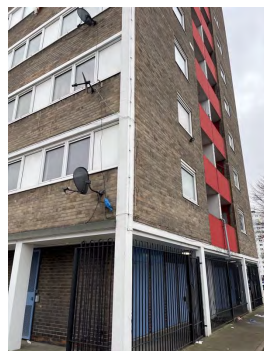
Taking into consideration developments within the sector surrounding external wall systems, Holistic Fire Safety feel it would be prudent to undertake further surveys to confirm provisions. Surveys will provide assurances to the Building Safety team that external wall systems are compliant without exposing occupants to unnecessary risk.

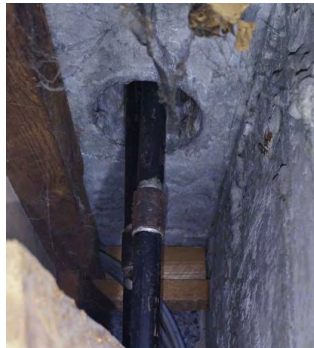
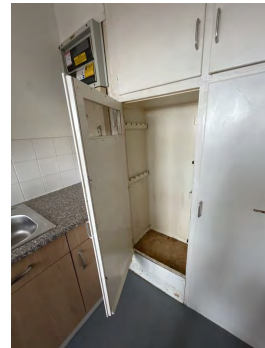
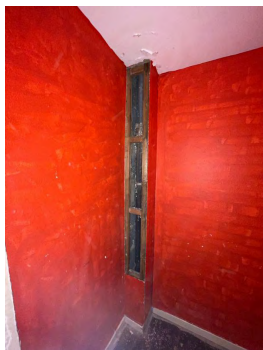
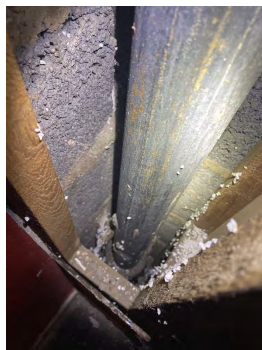
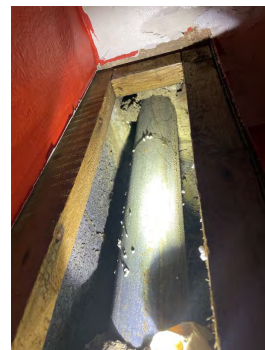
Within the kitchen, there are 3 metal pipes penetrating the floor with service cables and 2 metal pipes penetrating the ceiling. These are concealed behind kitchen units with access very restrictive. To remediate this would involve dismantling the kitchen units due to the restrictive nature and access issues. It is recommended that upon any refurbishment of kitchens, remediation of these areas should take place. It is felt the presence of such defects are not considered to be immediately detrimental to life safety.

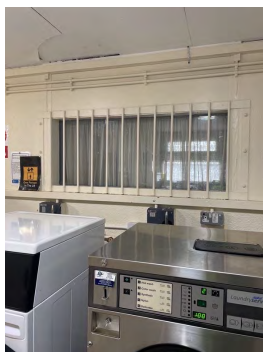
Photo 46

The glazing between the laundry and caretakers office is not suspected to be fire resisting. A fire in the laundry would affect the caretakers office and vice versa therefore, the glass requires replacing with fire rated glass alternatively, install gypsum-based plasterboard or cement board to compartment area.

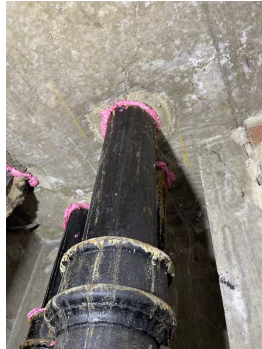
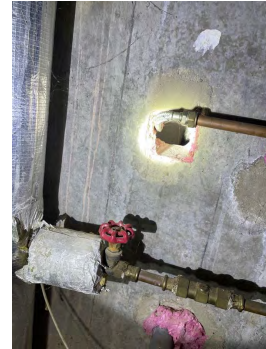
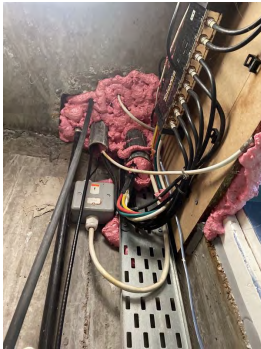
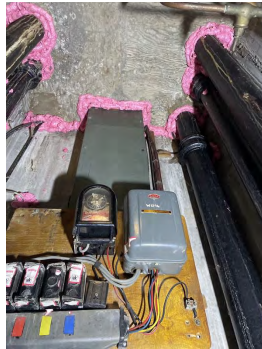
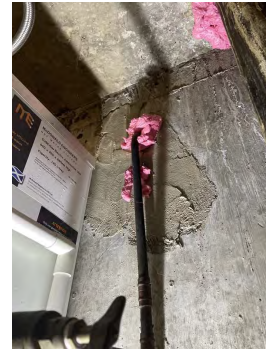
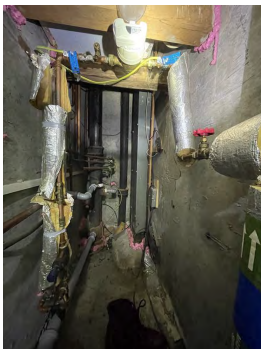
There are circa 70 service risers within the building. Two flats per floor contain internal risers. Breaches/defects are extensive and consistent throughout.

- Combustible plastic pipework entering risers from flats without an effective closing device present.
- Missing sections of masonry where services have been removed.
- Insulated non combustible pipework travelling vertically from riser to riser without an effective closing device present.
- Non combustible pipework entering risers from flats without an effective closing device present.
- Linear gaps between door frame and substrate have been filled with polyurethane expanding foam (this is not a suitable/tested solution for backfilling around timber door-sets).

Remediation will generally consist of primarily sealing defects with an ablative coated fire batt and mastic system which will be applied in conjunction with an intumescent wrap/fire collar for combustible pipework. Where annular gaps allow, all isolated non combustible services can be sealed using fire rated mastic which is tested to BS EN 1366-3/4 and classified to 13501-2:2017 + A1:2009.

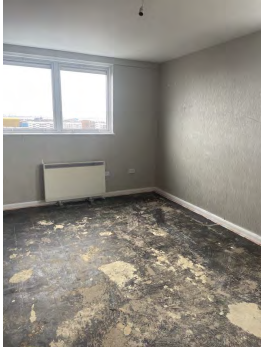
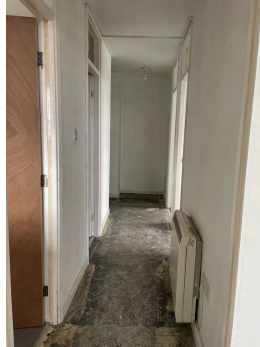
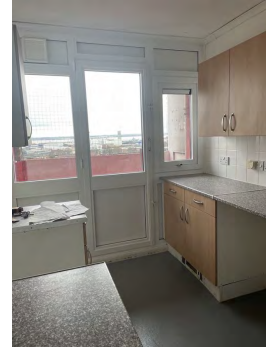
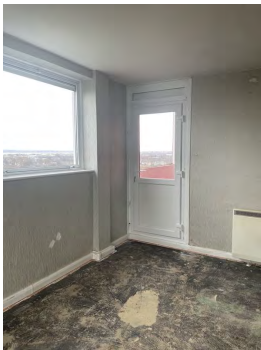
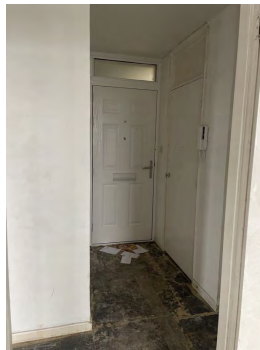
Residential flats are a mix of single and two bed occupancies whereby all habitable rooms discharge onto the internal hallway. Entry into the flat is made via a certificated FD30s fire doorset before the hallway provides access to bedrooms, bathroom, kitchen and lounge. An open balcony is accessed from the lounge and kitchen.

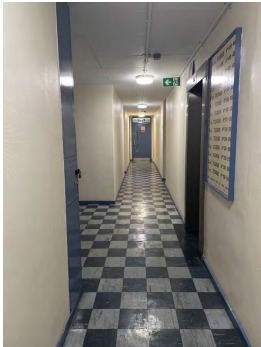
Photo 60

Each floor corridor is separated at the centre by a certified FD30s fire door. Travel distance from the flat furthest from the cross corridor door is 14m.

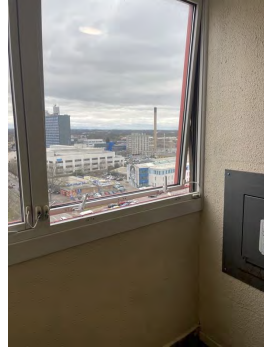
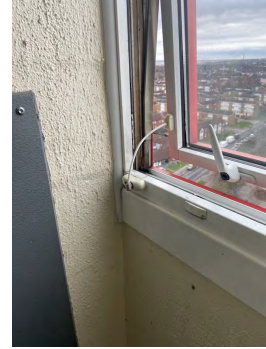
Protected stairways also need means to ventilate any smoke that may enter the stairway during evacuation or fire fighting and allow a route for air to reach ventilated lobbies. A vent of at least 1m² needs to be provided at the head of the stairway for this. Current guidance states in blocks of flats, it is recommended that the vent is operated automatically via an AOV.

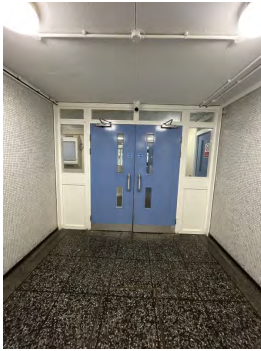
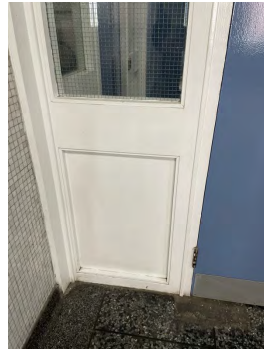
Escape routes are suitably separated and subdivided by fire rated construction which is made up of certified self closing FD30s door assemblies and Georgian wired glazing. Partitions are made up of a part glazed system and fibre board lower panels. Current provisions are considered adequate to protect means of escape.

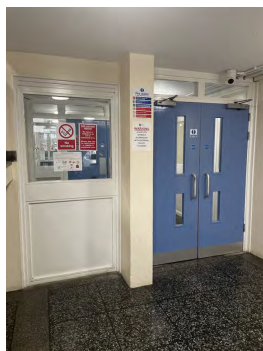
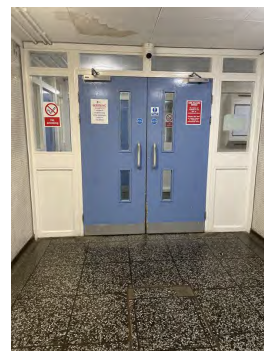
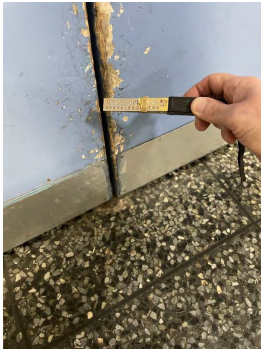
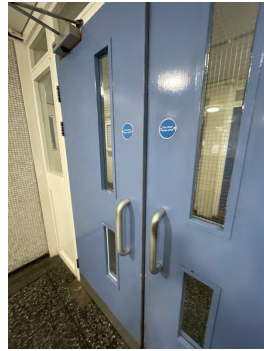
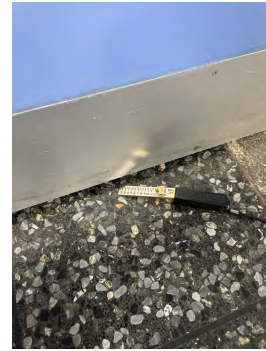
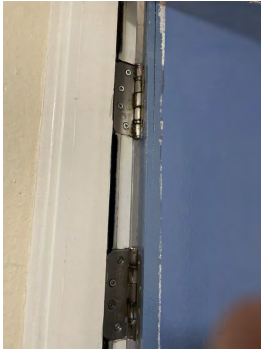
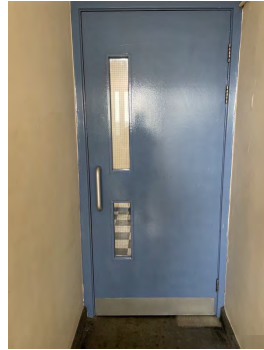
As detailed previously every flat is separated from the common escape stairway by a certified FD30s fire door. All doors which form part of escape routes are self-closing, certified FD30 fire doorsets which are considered to be in excellent condition considering their age and usage; however general maintenance and remediation is required.

- Worn / leaking hinges requiring replacement
- Strips and seals are consistently over painted and occasionally routed too deep (although gap tolerances are negligible which generally enable brush seals to sit against the frame)
- Gaps above acceptable tolerances
- Some door leaves to staircases were missing 'Fire door keep shut' signs.

As a result, given minor defects, a specific fire door inspection is to be undertaken to specify what actions are required.

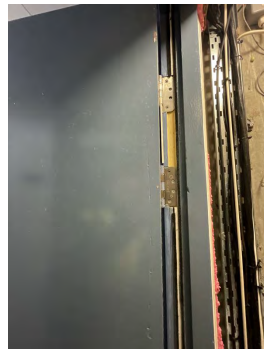
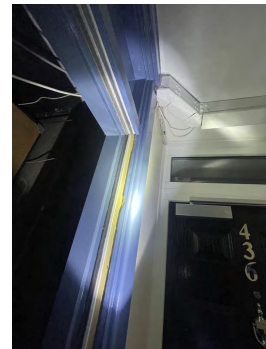
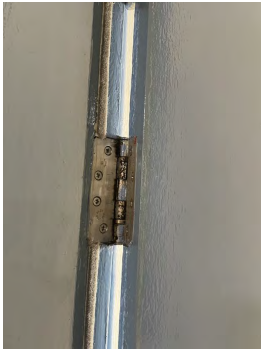
Communal riser doorsets are 54mm, of notional fire resistance with a timber top-light. Leaves were observed to be in good condition and fitted with three BS1935 Grade 13 hinges although these were noted to be leaking and missing screws.

Door frames are fitted with strips and seals however, some were either damaged or missing.

Ancillary accommodation doors are 44mm certified FD30s doorsets and were generally satisfactory although hinges were observed to be leaking.

As a result, given minor defects, a specific fire door inspection is to be undertaken to specify what actions are required.

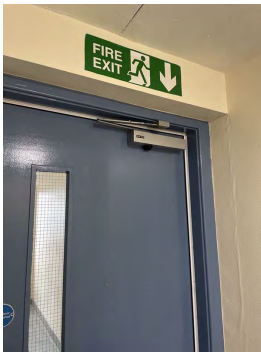
Photo 78

All doors are fitted with suitable self-closing devices.

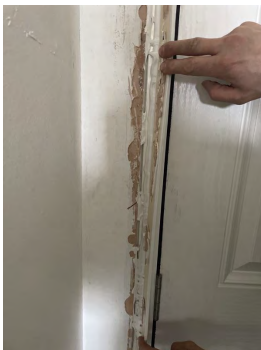
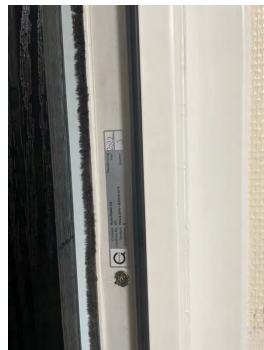
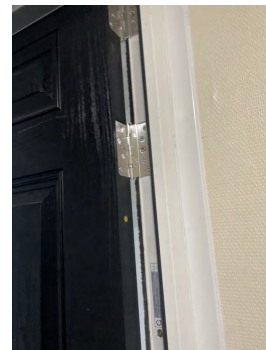
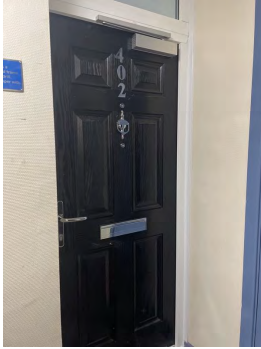
All flat entrance doors have been replaced with third party certified FD30s fire doorsets, which meet the requirements detailed in the ADBVol: 1 Appendix C1 2a for fire resistance and smoke control from both sides, and are fitted with an appropriate positive action self-closing device (BS 1154) and a single action mechanism which does not require the use of a key.

Door-sets have BM Trada Manufacturers plugs installed within the edge of the door leaf, however there is no evidence to suggest that doorsets have been installed by BM Trada certified installers.

Removal of architrave gave evidence of satisfactory backfilling/fire stopping between the doorframe and substrate with 4-6mm linear gaps sealed by fire rated mastic.

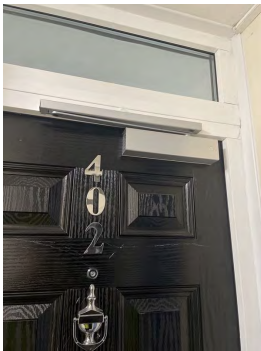
Photo 83

All replacement flat entrance doors are fitted with an appropriate overhead BS 1154 self closing device.

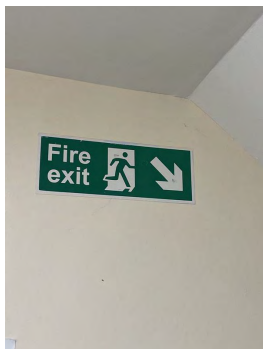
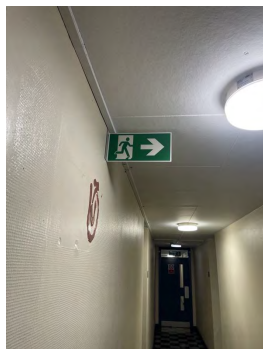
Fire safety signage is generally to a satisfactory standard both internally and external to the premises with reasonable provisions for hazard warning signs (risk rooms), mandatory signage for fire doors, information signage detailing emergency arrangements and prohibition signage for smoking. Fire safety signage is generally in accordance with the Health and Safety (Signs and Signals) Regulations together with BS 5499-4: 2013 and BS EN 7010.

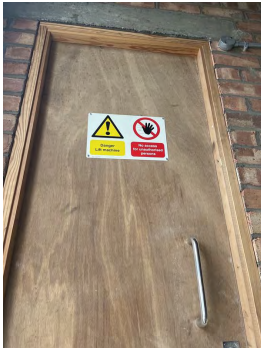
Photo 96

Hazard warning signage is in place on the external face of risk areas such as the lift motor room and the external electrical substation. Each individual ESU within the building is also provided with hazard warning signage to warn both occupants and responding fire crews.

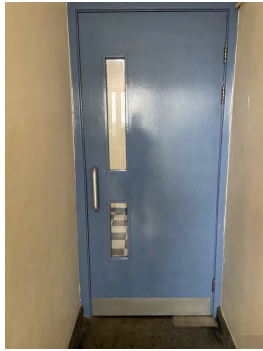
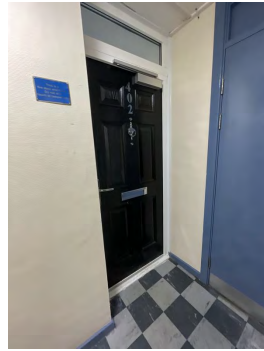
'Fire door keep shut' signs were not displayed on some communal doors.

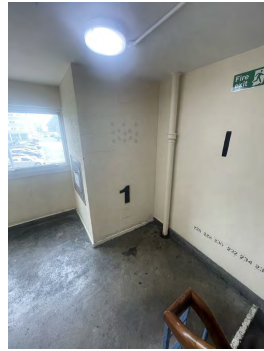
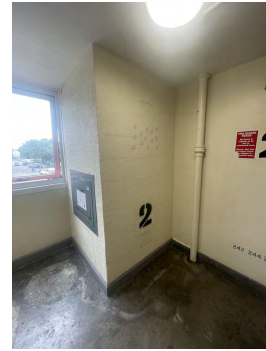
It was noted the Wayfinding signs in the 1st and 2nd floor north stair was missing.

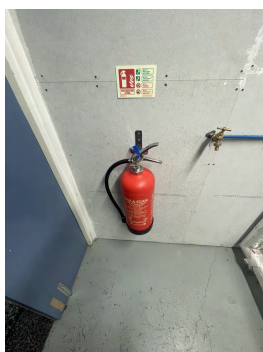
Photo 102

Extinguishers are not present within means of escape.

All extinguishers provided are composite P50 foam extinguishers.

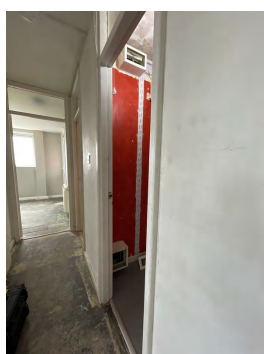
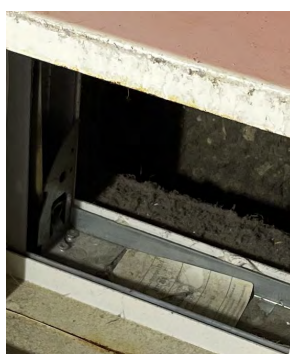
Fire dampers are provided in ductwork at the point extraction exits bathrooms in residential dwellings and enters central shafts. Bathrooms sampled (Flat 402) gave evidence of x2 vents (high/low level) which have dampers installed which are activated via fusible link.

It was confirmed that accessible dampers which are located in service risers are subjected to inspection and testing every four years. As dampers are activated via fusible link, there are no moving parts and therefore no requirement for inspection.

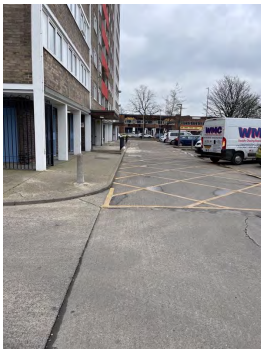
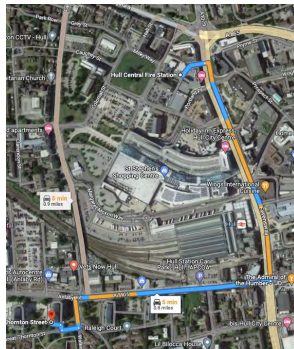
Current provisions provide a minimum of 3.7m in width and 4m in height to allow for unrestricted access for pumping and high reach appliances (ADB Vol 1. B5 Table 13.1).

There are no obvious signs of weight restrictions or anything that could impact appliance approach and positioning. The nearest point at which a fire appliance could position to the building is <18 meters.

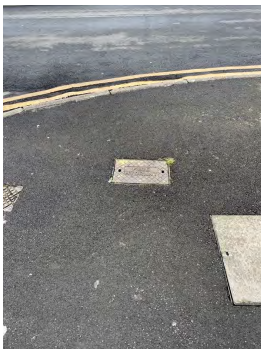
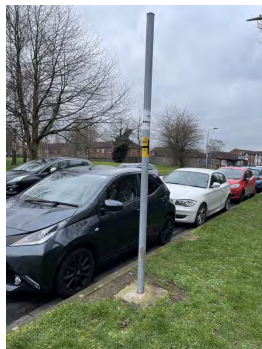
All immediate hydrants are within 90 metres, and are 100mm diameter and are the responsibility of the local water undertaking, via Humberside Fire and Rescue Service, who maintain each hydrant on a two year flow test programme.

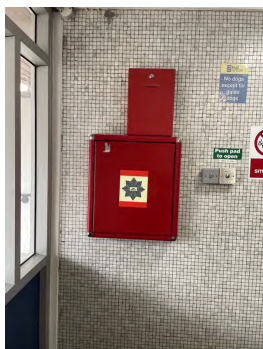
Photo 110

The SIB is located in the ground floor lobby on entry to block on the south east side of building. It has been agreed by all relevant parties that its location is the most suitable - internally.
