GTS2, Hull

Type 3 Fire Risk Assessment

Prepared for:	Rebecca Franks, Building Safety Manager
Prepared by:	John Askew, Fire Risk Assessor, Holistic Fire Safety
Date:	07/10/2024
Document Reference:	HFS.HCC.GTS2.FRA.2.0

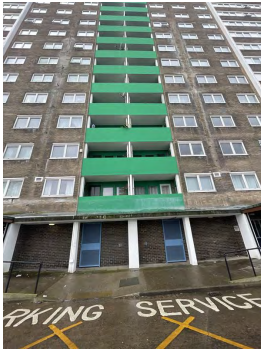
Photo 2

Following the Grenfell Tower tragedy, HCC commissioned UK LPP to complete a series of surveys on external cladding and external wall systems to HRBB's across Hull in 2017. Although findings of surveys confirmed that external walls systems met the functional requirements of Building Regulations and did not contain ACM's, reports provided limited information and potentially fall short of today's benchmarks for a PAS 9980 external wall survey.

Taking into consideration developments within the sector surrounding external wall systems, Holistic Fire Safety feel it would be prudent to undertake further surveys to confirm provisions. Surveys will provide assurances to the Building Safety team that external wall systems are compliant without exposing occupants to unnecessary risk.

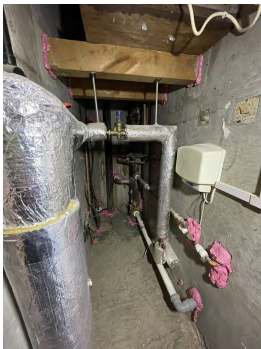
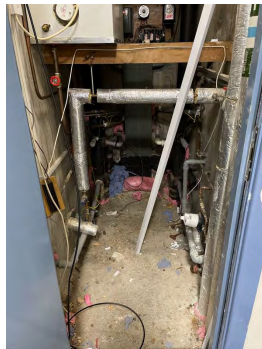
Risers are continuous and extend the full height of the building. Risers contain electrical service cables, soil pipes, immersion heaters, non-combustible pipework and combustible pipework. Risers in common areas are generally a sterile environment, however, there are several breaches which are to be addressed and are highlighted in the compartmentation survey.

Risers in common areas are separated from escape routes by fire resisting construction providing 60 minutes, fire resisting doorsets are notional 54mm with timber toplight, all observed to be in reasonable condition. There are electric service units present in some service risers and electric supply to immersion heaters, however, there are no other combustible items within the area; therefore fire is highly unlikely to spread to adjacent areas.

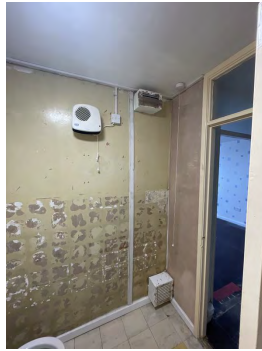
Fire dampers are provided in ductwork at the point extraction exits bathrooms in residential dwellings and enters central shafts. Bathrooms sampled (Flat 664) during the previous assessment gave evidence of x2 vents (high/low level) which have dampers installed which are activated via a fusible link.

Although dampers do not restrict the spread of smoke in the early stages of a fire, it would prevent spread of flames and hot gases.

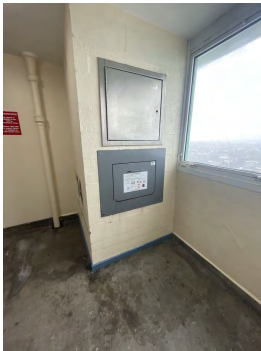
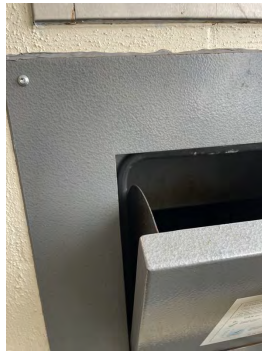
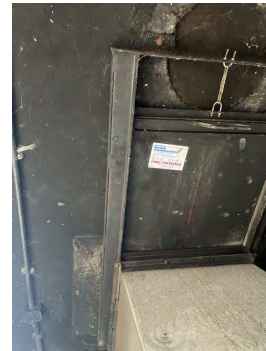
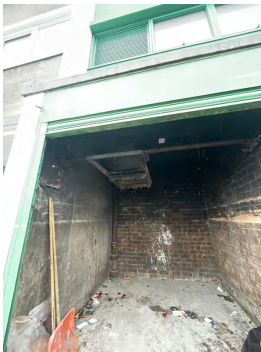
There are x2 refuse chutes provided at Block 2, these are located on each floor in the ventilated staircases that serve the building.

The refuse chutes have undergone refurbishment and now provide adequate protection at all floor levels with self-closing, intumescent lined hopper disposal points and an automatic isolation shutter which is activated by means of fusible link at the base of the chute. The base of the chute is accessed externally.

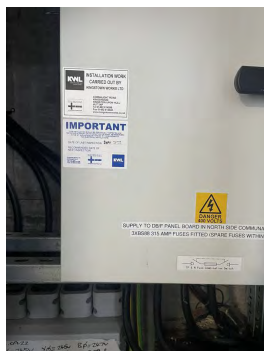
Photo 13

8.2. Are Electrical Installation Condition Report (EICR) labels displayed to indicate the date of the most recent periodic inspection and the date of the next 5-year periodic inspection?

Yes.

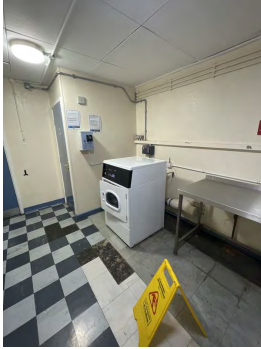
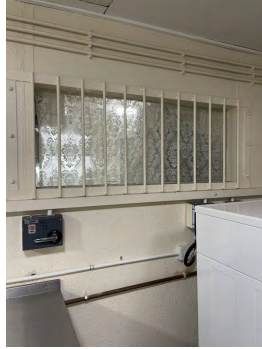
There is a laundry situated on the ground floor with a number of electrical washing machines and dryers; all of which were confirmed to be periodically inspected.

The scheme has implemented a policy within the laundry which includes the removal of lint build-up from tumble driers; at the time of inspection, there was a small amount of lint in the filter. The laundry is also provided with automatic fire detection & warning and is enclosed in fire resisting construction however, there is a glass partition between the laundry and caretakers office which is suspected to be none fire rated glazing - Section 17.

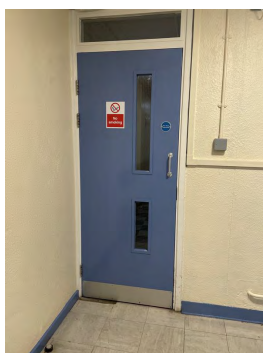
Photo 16

The building complies with current no-smoking legislation with signage displayed prominently throughout the building at all levels. Signage displayed is clearly visible and complies with the Smoke free (signs) Regulations 2012.

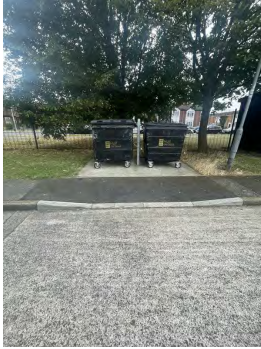
Photo 23

The immediate area around the building was sterile; waste bins were contained within the refuse chute area which is enclosed in a roller shutter and walkways around residents sheds were sterile. Additional waste bins were located clear of the main building and chained to an immovable structure.

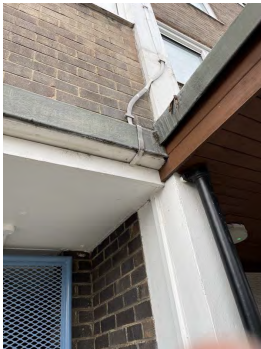
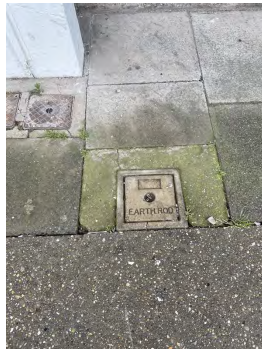
It was confirmed verbally and via physical inspection that a lightning protection system (LPS) is in place.

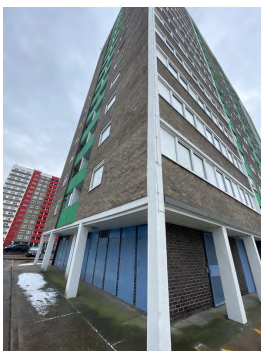
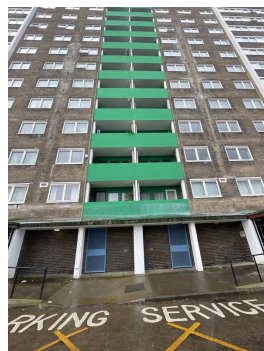
Taking into consideration developments within the sector surrounding external wall systems, Holistic Fire Safety feel it would be prudent to undertake further surveys to confirm provisions. Surveys will provide assurances to the Building Safety team that external wall systems are compliant without exposing occupants to unnecessary risk.

Decision making has been further justified as HCC now have a dedicated BSM and Building Safety team who have realigned their objectives which a specific focus on external walls and fully understanding the structural make up of premises.

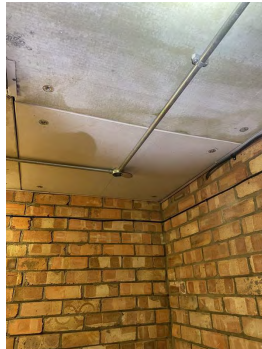
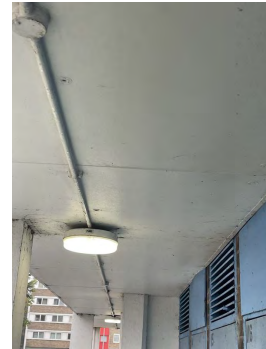
It has been confirmed the insulation present is flammable and should be removed. Any replacement should achieve Class A2-s1, d0 or better.

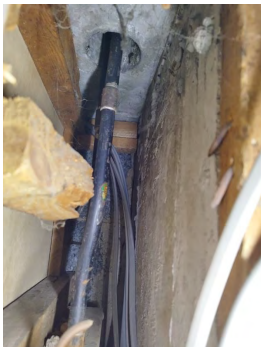
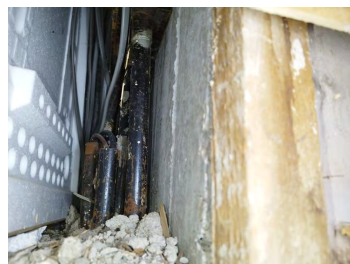
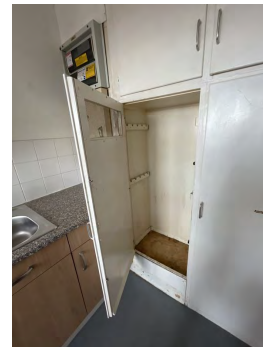
There are however, multiple defects within service risers where services are not adequately fire stopped as they enter adjacent compartments.

Within the kitchen, there are 3 metal pipes penetrating the floor with service cables and 2 metal pipes penetrating the ceiling. These are concealed behind kitchen units with access very restrictive. To remediate this would involve dismantling the kitchen units due to the restrictive nature and access issues. It is recommended that upon any refurbishment of kitchens, remediation of these areas should take place. It is felt the presence of such defects are not considered to be immediately detrimental to life safety.

Fire dampers are present within ventilation extracts within the bathroom of flats.

HCC should refer to the compartmentation survey for evidence of breaches and methods of remediation.

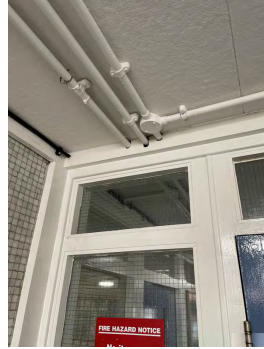
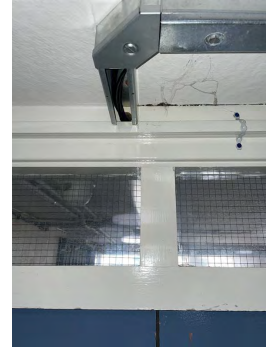
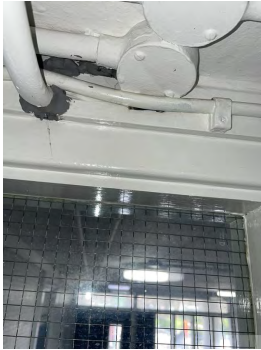
Breaches were present at the point data cables and conduit pass through fire resisting partitions. The majority of these appear to have been fire stopped although there was no test evidence to support this. Remaining defects require fire stopping.

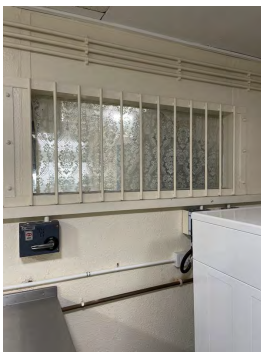
Photo 43

The glazing between the laundry and caretakers office is not suspected to be fire resisting. A fire in the laundry would affect the caretakers office and vice versa therefore, the glass requires replacing with fire rated glass alternatively, install gypsum-based plasterboard or cement board to compartment area.

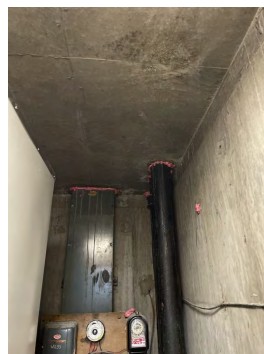
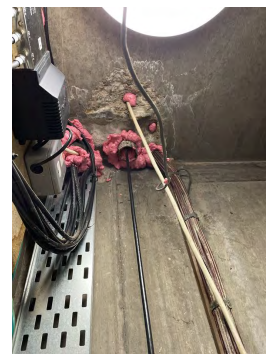
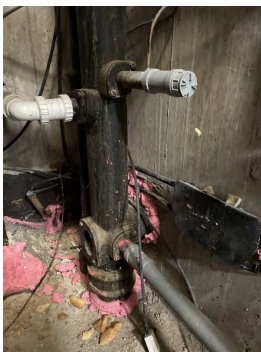
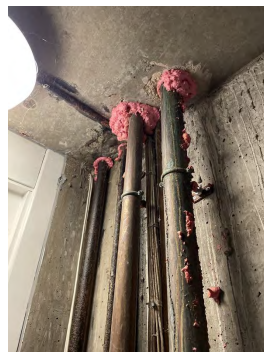
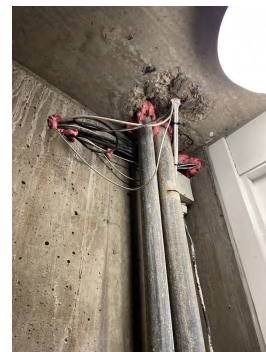
There are circa 70 service risers within the building. Two flats per floor contain internal risers. Breaches/defects are extensive and consistent throughout.

Remediation will generally consist of primarily sealing defects with an ablative coated fire batt and mastic system which will be applied in conjunction with an intumescent wrap/fire collar for combustible pipework. Where annular gaps allow, all isolated non combustible services can be sealed using fire rated mastic which is tested to BS EN 1366-3/4 and classified to 13501-2:2017 + A1:2009.

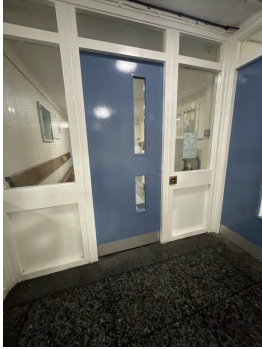
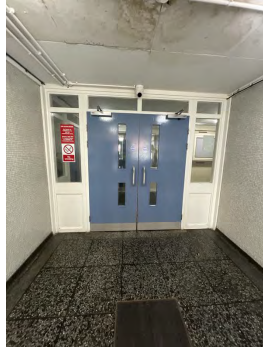
Escape routes are suitably separated and subdivided by fire rated construction which is made up of certified self closing FD30s door assemblies and Georgian wired glazing. Partitions are made up of a part glazed system and fibre board lower panels. Current provisions are considered adequate to protect means of escape.

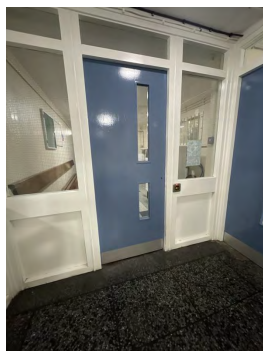
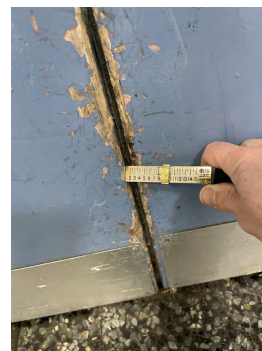
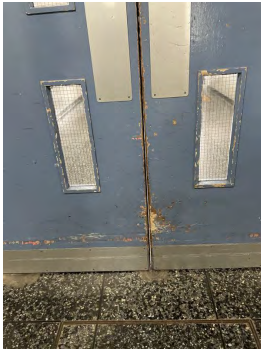
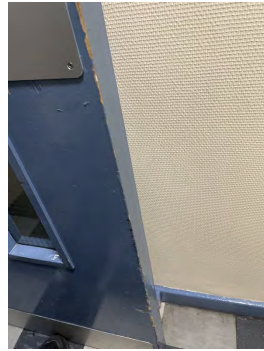
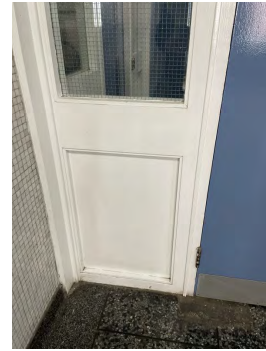
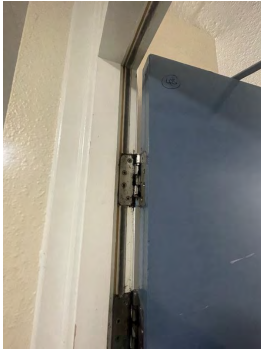
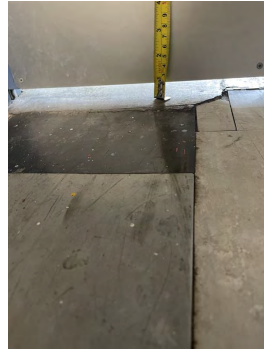
As detailed previously every flat is separated from the common escape stairway by a certified FD30s fire door. All doors which form part of escape routes are self-closing, certified FD30 fire doorsets which are considered to be in excellent condition considering their age and usage; however general maintenance and remediation is required.

- Worn / leaking hinges requiring replacement
- Strips and seals are consistently over painted and occasionally routed too deep (although gap tolerances are negligible which generally enable brush seals to sit against the frame)
- Gaps above acceptable tolerances
- Some door leaves to staircases were missing 'Fire door keep shut' signs.

As a result, given minor defects, a specific fire door inspection is to be undertaken to specify what actions are required.

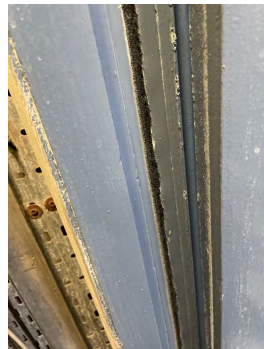
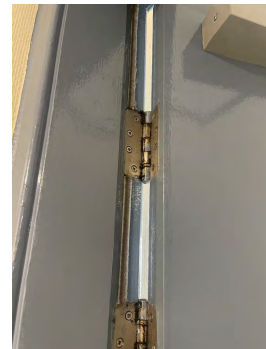
Communal riser doorsets are 54mm, of notional fire resistance with a timber top-light. Leaves were observed to be in good condition and fitted with three BS1935 Grade 13 hinges although these were noted to be leaking and missing screws.

Door frames are fitted with strips and seals however, some were either damaged, missing or painted over.

Ancillary accommodation doors are 44mm certified FD30s doorsets and were generally satisfactory although hinges were observed to be leaking.

As a result, given minor defects, a specific fire door inspection is to be undertaken to specify what actions are required.

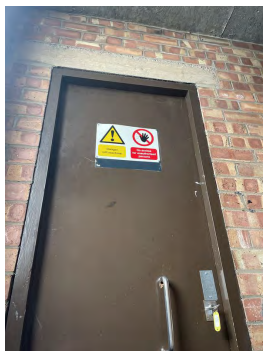
Photo 94

Hazard warning signage is in place on the external face of risk areas such as the lift motor room and the external electrical substation. Each individual ESU within the building is also provided with hazard warning signage to warn both occupants and responding fire crews.

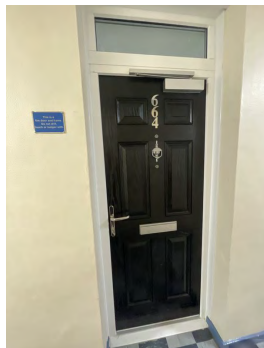
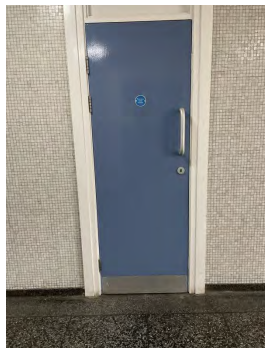
Mandatory signage prescribing a specific behaviour is displayed prominently on all fire doors where necessary (including flat entrance doors) throughout the building.

- Fire doors which are accessible from either side have 'Fire door keep shut' signs attached to both sides of the door leaf
- Fire doors where access is restricted, has 'Fire door keep locked' sign to the open facing leaf of the door only

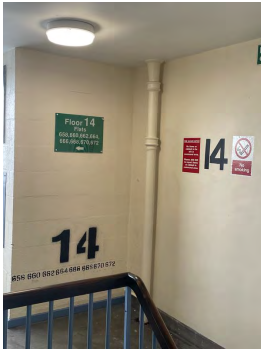
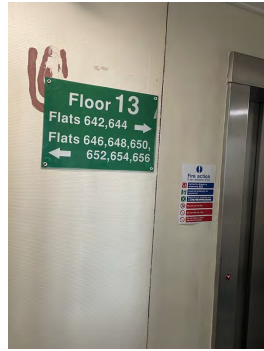
It was noted the Wayfinding sign in the 13th floor north corridor was missing.

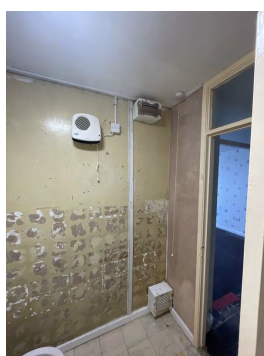
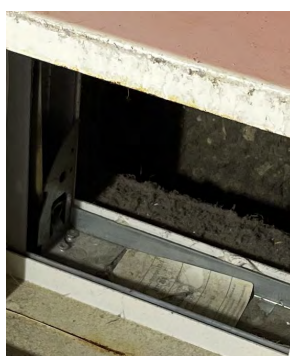
Fire dampers are provided in ductwork at the point extraction exits bathrooms in residential dwellings and enters central shafts. Bathrooms sampled (Flat 664) gave evidence of x2 vents (high/low level) which have dampers installed which are activated via fusible link.

It was confirmed that accessible dampers which are located in service risers are subjected to inspection and testing every four years. As dampers are activated via fusible link, there are no moving parts and therefore no requirement for inspection.

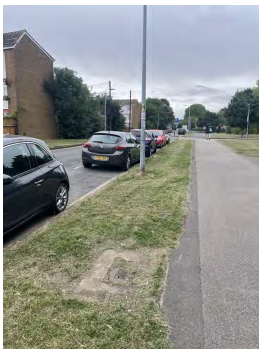
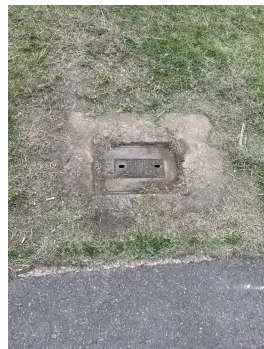
All immediate hydrants are within 90 metres, and are 100mm diameter and are the responsibility of the local water undertaking, via Humberside Fire and Rescue Service, who maintain each hydrant on a two year flow test programme.

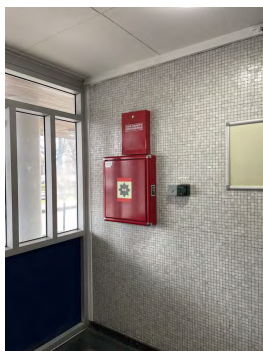
Photo 107

The SIB is located in the ground floor lobby on entry to block on the south east side of building. It has been agreed by all relevant parties that its location is the most suitable - internally.
