GTS3, Hull

Type 3 Fire Risk Assessment

Prepared for:	Rebecca Franks, Building Safety Manager
Prepared by:	John Askew, Fire Risk Assessor, Holistic Fire Safety
Date:	07/10/2024
Document Reference:	HFS.HCC.GTS3.FRA.2.0

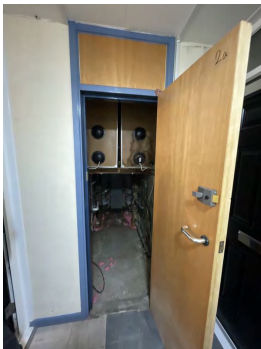
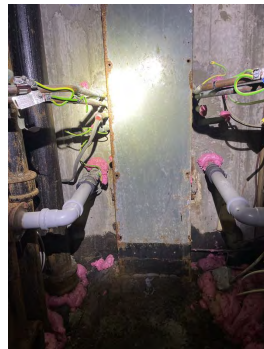
Risers are continuous and extend the full height of the building. Risers contain electrical service cables, soil pipes, immersion heaters, non-combustible pipework and combustible pipework. Risers in common areas are generally a sterile environment, however, there are several breaches which are to be addressed and are highlighted in the compartmentation survey.

Risers in common areas are separated from escape routes by fire resisting construction providing 60 minutes, fire resisting doorsets are certified 54mm with timber toplight, all observed to be in reasonable condition. There are electric service units present in some service risers and electric supply to immersion heaters, however, there are no other combustible items within the area; therefore fire is highly unlikely to spread to adjacent areas.

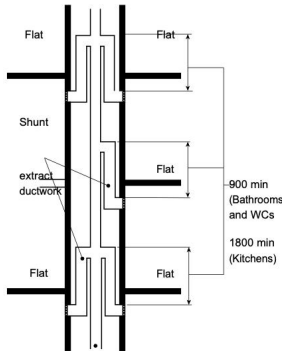
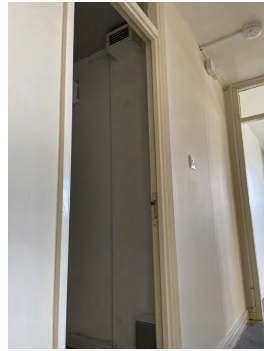
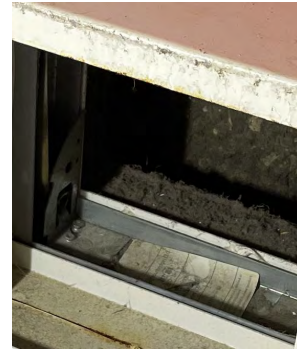
Fire dampers are provided in ductwork at the point extraction exits bathrooms in residential dwellings and enters central shafts. Bathrooms sampled (Flat 808) during the previous assessment gave evidence of x2 vents (high/low level) which have dampers installed which are activated via a fusible link.

Although dampers do not restrict the spread of smoke in the early stages of a fire, it would prevent spread of flames and hot gases.

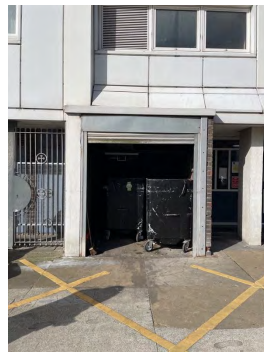
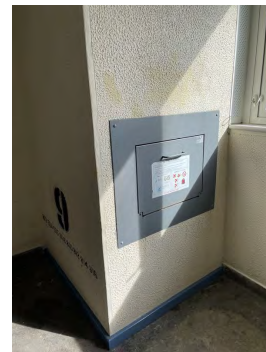
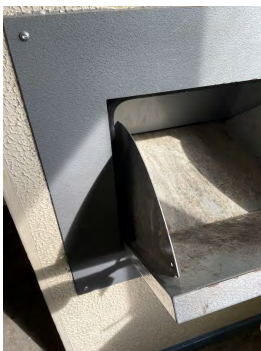
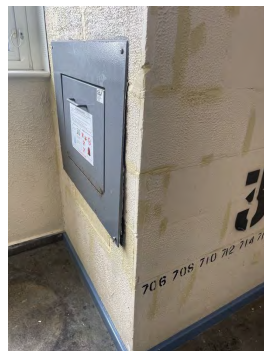
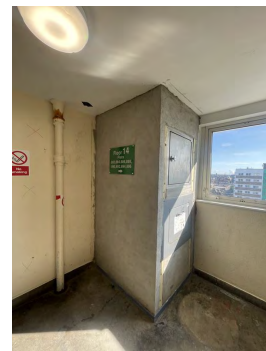
Hopper disposal points on a number of floors were noted to have gaps between the disposal point frame and the wall. This is due to fixings becoming loose resulting in the frame coming away from the substrate.

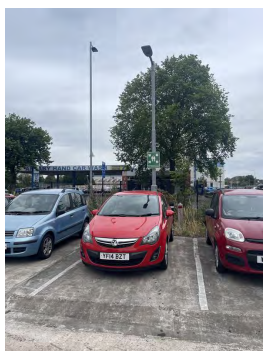
Photo 16

The fire assembly point at Block 3 is in the main car park between GTS 2 and GTS 3 to the west of the building which is defined as a suitable location.

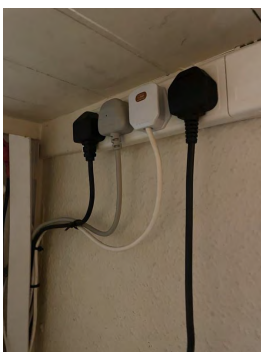
Photo 22

An electrical extension lead was in use in the caretakers office although this appeared mainly to be used to supply IT equipment. Care must be taken not to overload the maximum permitted rating of extension leads. Consideration should be given to removing extension leads and provide additional sockets to supply the equipment in use.

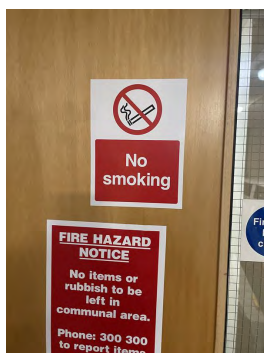
Photo 24

The building complies with current no-smoking legislation with signage displayed prominently throughout the building at all levels. Signage displayed is clearly visible and complies with the Smoke free (signs) Regulations 2012.

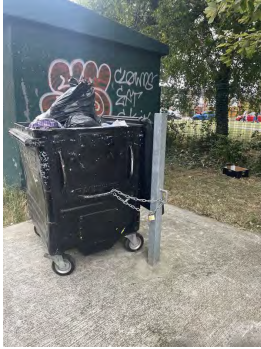
Photo 29

The immediate area around the building was sterile; waste bins were contained within the refuse chute area which is enclosed in a roller shutter and walkways around residents sheds were sterile. Additional waste bins were visible, however they were located clear of the main building and chained to an immovable object.

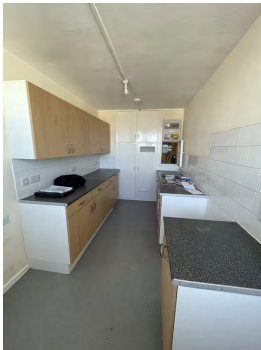
Photo 30

Kitchens are provided with notional FD20 doorsets, heat detection and cooking facilities are remote from the entrance door and do not prejudice the escape route from any point in the flat other than the lounge.

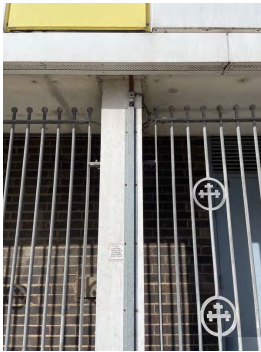
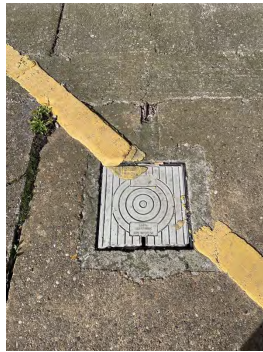
It was confirmed verbally and via physical inspection that a lightning protection system (LPS) is in place.

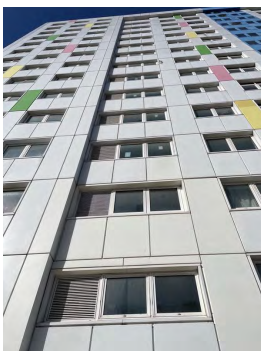
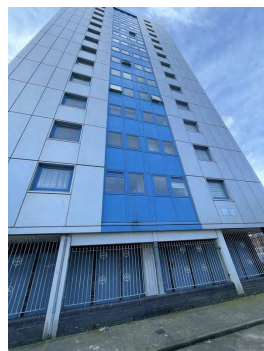
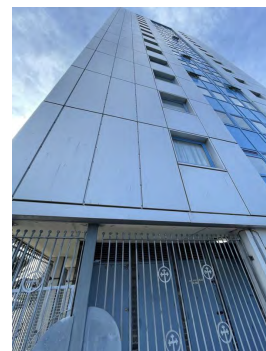
Taking into consideration developments within the sector surrounding external wall systems, Holistic Fire Safety feel it would be prudent to undertake further surveys to confirm provisions. Surveys will provide assurances to the Building Safety team that external wall systems are compliant without exposing occupants to unnecessary risk.

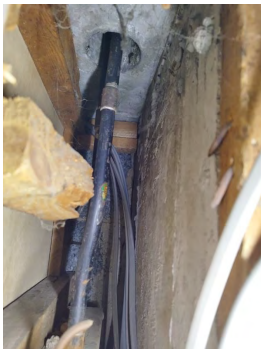
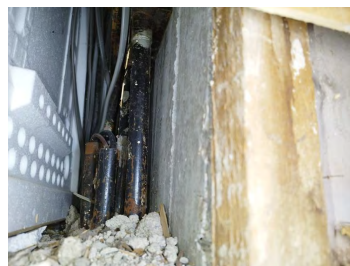
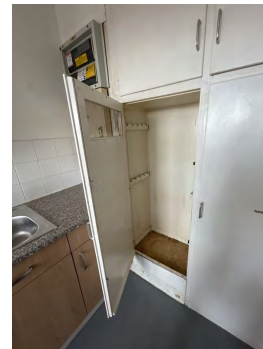
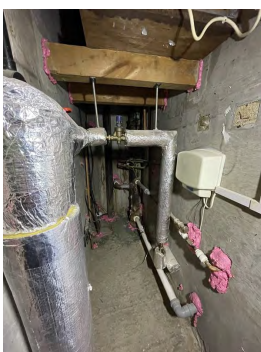
Within the kitchen, there are 3 metal pipes penetrating the floor with service cables and 2 metal pipes penetrating the ceiling. These are concealed behind kitchen units with access very restrictive. To remediate this would involve dismantling the kitchen units due to the restrictive nature and access issues. It is recommended that upon any refurbishment of kitchens, remediation of these areas should take place. It is felt the presence of such defects are not considered to be immediately detrimental to life safety.

Fire dampers are present within ventilation extracts within the bathroom of flats.

HCC should refer to the compartmentation survey for evidence of breaches and methods of remediation.

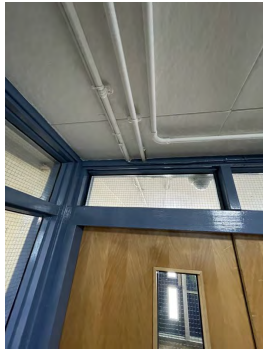
Photo 42

Breaches were present at the point data cables and conduit pass through fire resisting partitions. The majority of these appear to have been fire stopped although there was no test evidence to support this.

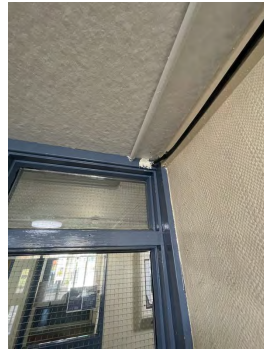
Photo 43

There are circa 70 service risers within the building. Two flats per floor contain internal risers. Breaches/defects are extensive and consistent throughout. The central risers displayed evidence of cable penetrations in toplights which is then encapsulated in plastic conduit in the corridor.

Remediation will generally consist of primarily sealing defects with an ablative coated fire batt and mastic system which will be applied in conjunction with an intumescent wrap/fire collar for combustible pipework. Where annular gaps allow, all isolated non combustible services can be sealed using fire rated mastic which is tested to BS EN 1366-3/4 and classified to 13501-2:2017 + A1:2009.

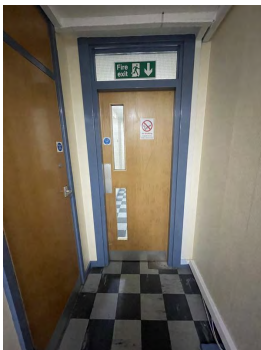
Photo 56

Each floor corridor is separated at the centre by a certified FD30s fire door. Travel distance from the flat furthest from the cross corridor door is 14m.

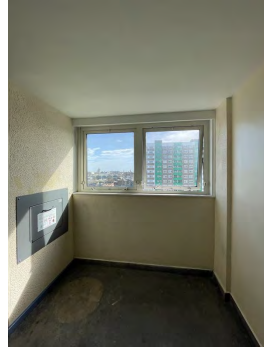
Photo 58

Protected stairways also need means to ventilate any smoke that may enter the stairway during evacuation or fire fighting and allow a route for air to reach ventilated lobbies. A vent of at least 1m² needs to be provided at the head of the stairway for this. Current guidance states in blocks of flats, it is recommended that the vent is operated automatically via an AOV.

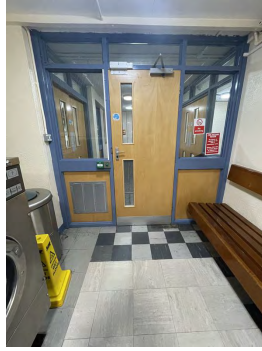
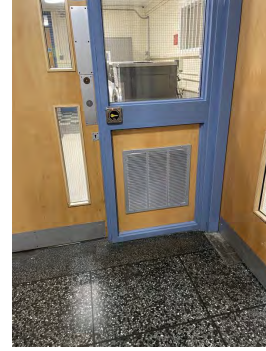
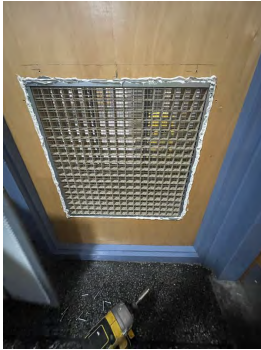
One of the lower panels to the laundry contains an air transfer grill (ATG). Upon inspection, it is not clear if this is an intumescent ATG. HCC should confirm that the ATG is intumescent. If the ATG is found not to be intumescent, the area could be boarded up to provide the necessary level of fire resistance.

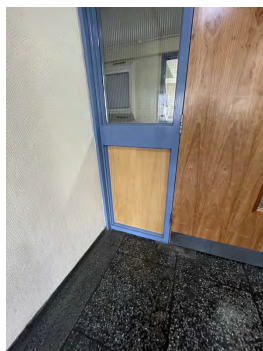
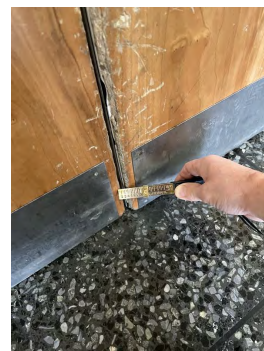
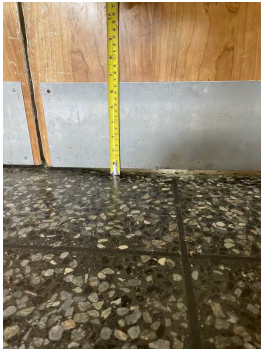
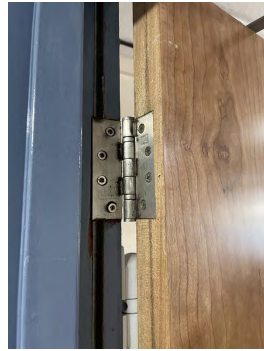
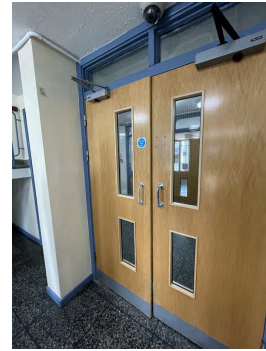
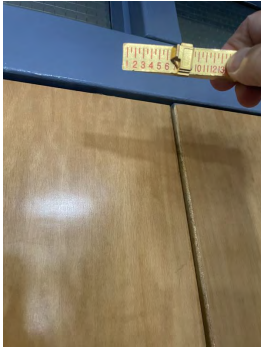
- Good condition certified leaf and frame
- Good condition polished Georgian wired integrity fire resistant glazing
- x3 100mm BS 1935 Grade 13 CE marked hinges
- Frames have a 25mm stop lat
- Appropriate single strip combination cold smoke and intumescent seals fitted into the leaf
- Gaps between leaf and frame are generally not more than 3mm top and side rails, however there are variations to this and gaps at the bottom threshold are consistently >8mm and will require attention
- A BSEN 1154 CE marked self closing device with a minimum power rating 3 (Grade 1) is fitted to all communal doors. A number of samples were taken on different floors with the majority capable of closing from any angle and not taking longer than 25 seconds to overcome the resistance of any seals to close into their frames.

- Worn / leaking hinges requiring replacement
- Strips and seals are consistently over painted and occasionally routed too deep (although gap tolerances are negligible which generally enable brush seals to sit against the frame)
- Some door leaves to staircases were missing 'Fire door keep shut' signs.
- Lobby doors failing to close flush.

As a result, given minor defects, a specific fire door inspection is to be undertaken to specify what actions are required.

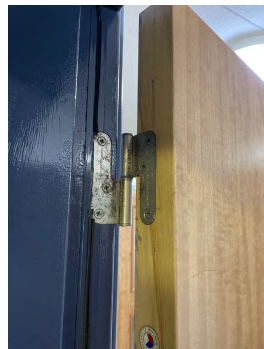
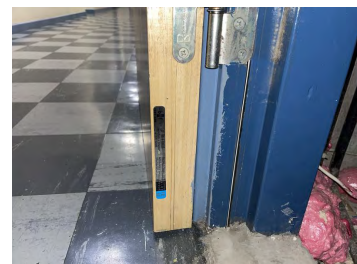
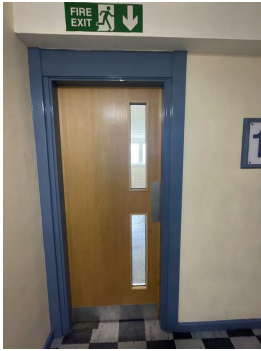
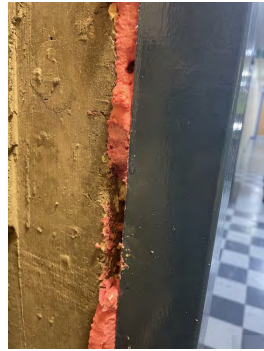
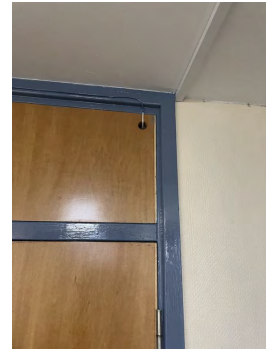
Communal riser doorsets are 54mm, of certified fire resistance with a timber top-light. Leaves were observed to be in good condition and fitted with three BS1935 Grade 13 hinges although these were noted to be leaking and missing screws.

Door frames are fitted with strips and seals however, some were either damaged, missing or painted over. There was evidence of a lack of backfilling/fire stopping between the frame and substrate.

Ancillary accommodation doors are 44mm certified FD30s doorsets and were generally satisfactory although hinges were observed to be leaking.

As a result, given minor defects, a specific fire door inspection is to be undertaken to specify what actions are required.

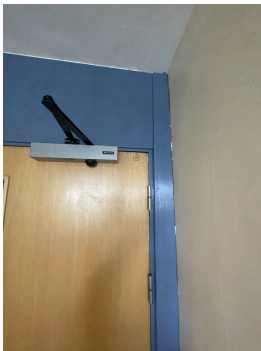
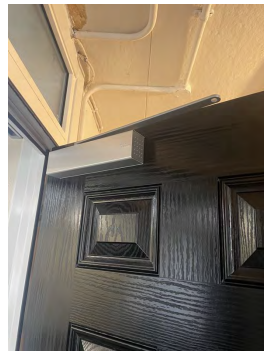
The self-closing device to the caretakers office door was disconnected.

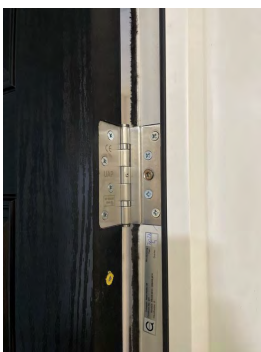
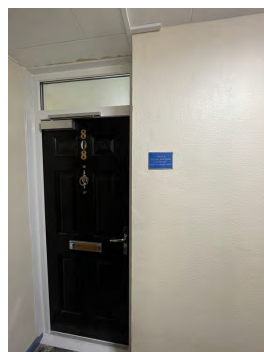
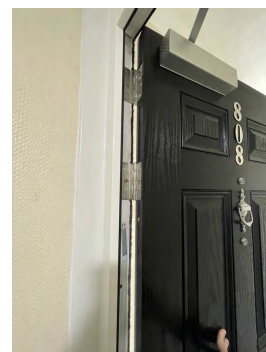
Door-sets have BM Trada Manufacturers plugs installed within the edge of the door leaf, however there is no evidence to suggest that doorsets have been installed by BM Trada certified installers.

Removal of architrave gave evidence of satisfactory backfilling/fire stopping between the doorframe and substrate with 4-6mm linear gaps sealed by fire rated mastic.

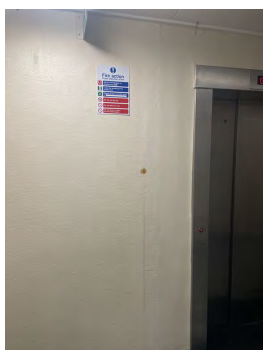
Photo 93

Residential floors are provided with comprehensive instruction on actions to be taken in the event of fire. Fire action notices are displayed prominently opposite/adjacent lift doors although fire action notices were missing on some floors (8th, 11th & 12th) and the location of the fire assembly point had not been completed on the 6th & 13th floors.

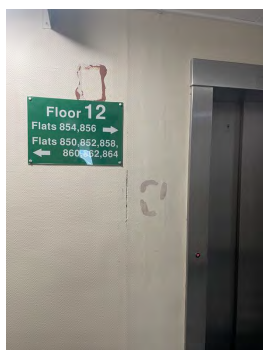
Photo 94

The expectation is that all residents are familiar with the layout of the building and its communal areas, although some signage is technically incorrect in places, current safe condition signage provided is considered to be satisfactory and it is expected that all relevant persons using the building will understand

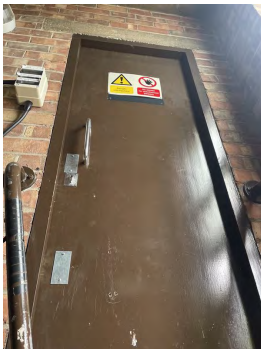
Photo 96

Hazard warning signage is in place on the external face of risk areas such as the lift motor room and the external electrical substation. Each individual ESU within the building is also provided with hazard warning signage to warn both occupants and responding fire crews.

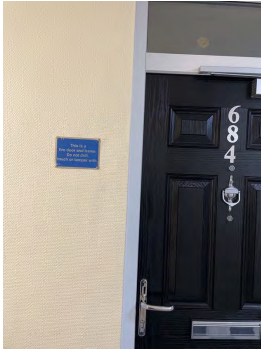
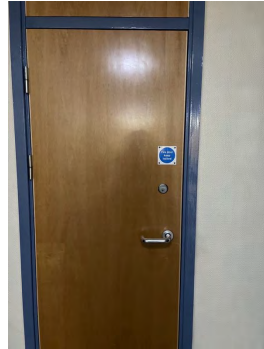
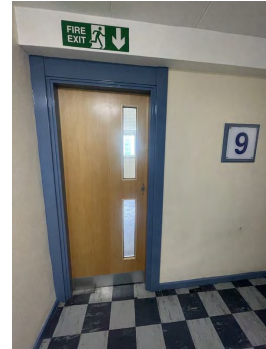
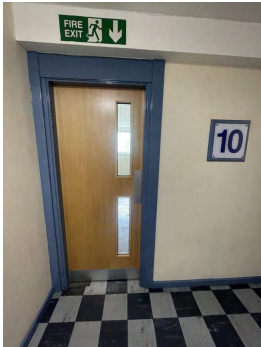
'Fire door keep shut' signs were not displayed on some communal doors.

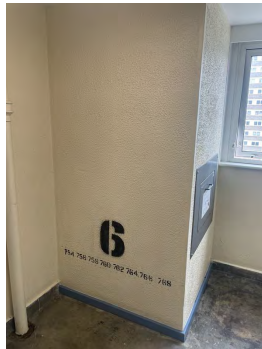
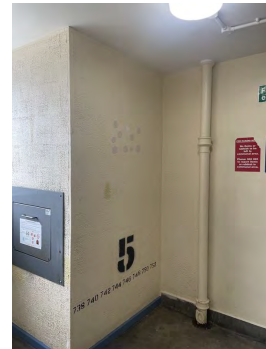
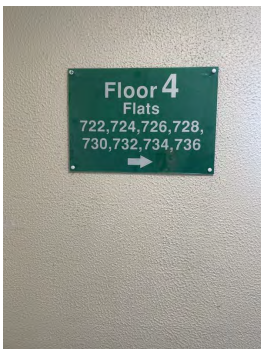
It was noted Wayfinding signs were missing in the 1st, 3rd, 6th, 10th & 13th corridors and the 5th & 6th stairs.

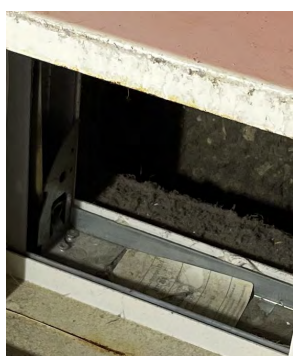
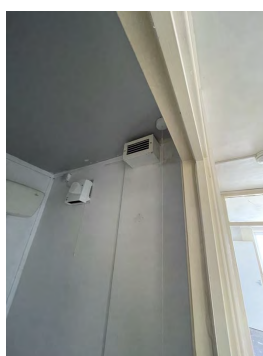
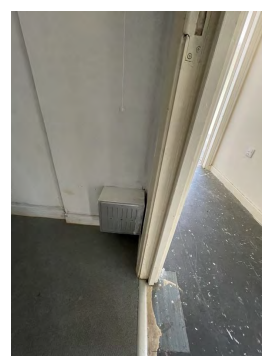
Fire dampers are provided in ductwork at the point extraction exits bathrooms in residential dwellings and enters central shafts. Bathrooms sampled (Flat 808) gave evidence of x2 vents (high/low level) which have dampers installed which are activated via fusible link.

It was confirmed that accessible dampers which are located in service risers are subjected to inspection and testing every four years. As dampers are activated via fusible link, there are no moving parts and therefore no requirement for inspection.

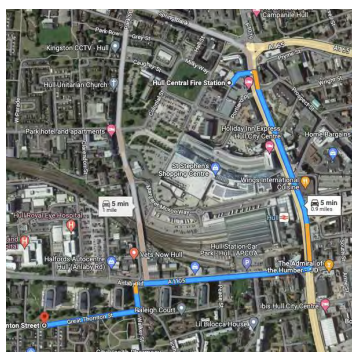
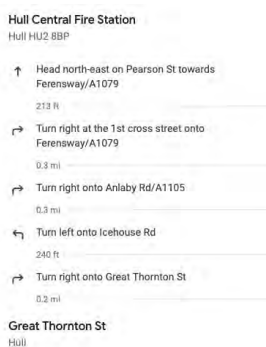
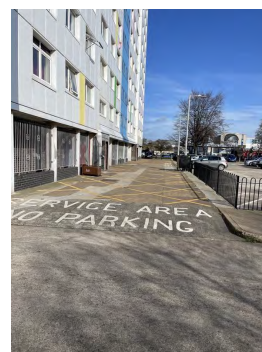
Current provisions provide a minimum of 3.7m in width and 4m in height to allow for unrestricted access for pumping and high reach appliances (ADB Vol 1. B5 Table 13.1).

There are no obvious signs of weight restrictions or anything that could impact appliance approach and positioning. The nearest point at which a fire appliance could position to the building is <18 meters.

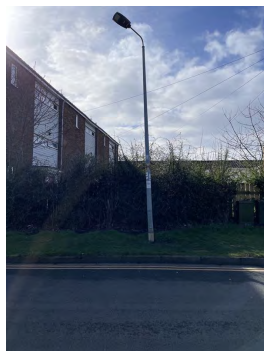
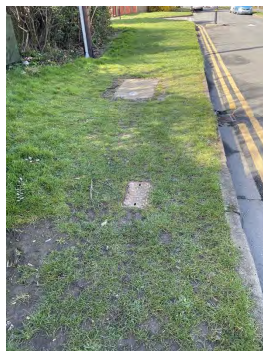
All immediate hydrants are within 90 metres, and are 100mm diameter and are the responsibility of the local water undertaking, via Humberside Fire and Rescue Service, who maintain each hydrant on a two year flow test programme.

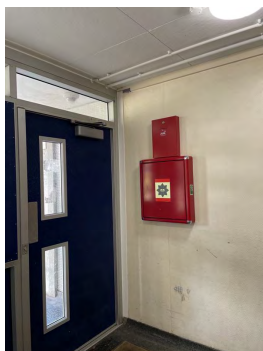
Photo 115

The SIB is located in the ground floor lobby on entry to block on the south west side of building. It has been agreed by all relevant parties that its location is the most suitable - internally.

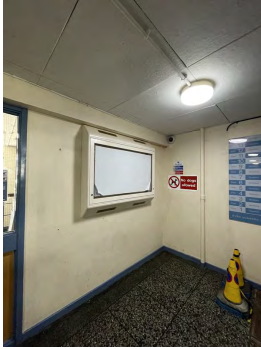
Photo 117

Another clear and defined demonstration of engagement is installing smart tv's on landings which are to be used for communicating with residents.
