# Muswell Court, Hull

## Type 3 Fire Risk Assessment

Prepared for:	Rebecca Franks, Building Safety Manager
Prepared by:	John Askew, Fire Risk Assessor, Holistic Fire Safety
Date:	17/10/2024
Document Reference:	HFS.HCC.MuswellCourt.FRA.2.0

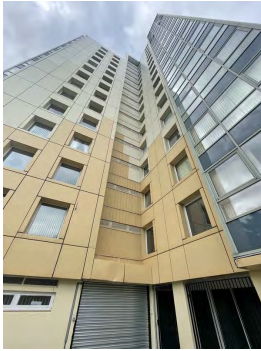
Photo 3

Taking into consideration developments within the sector surrounding external wall systems, Holistic Fire Safety feel it would be prudent to undertake further surveys to confirm provisions. Surveys will provide

assurances to the Building Safety team that external wall systems are compliant without exposing occupants to unnecessary risk.

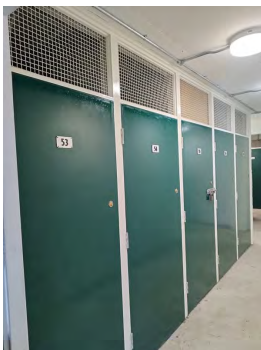
Photo 4

The ground floor comprises of external tenant storage and ancillary accommodation which is accessed from communal areas - See attachment:

Ancillary accommodation consists of staff office, store cupboard, cleaners cupboard, laundry and x2 service risers enclosures, mains electrical enclosure and dry riser inlet valve.

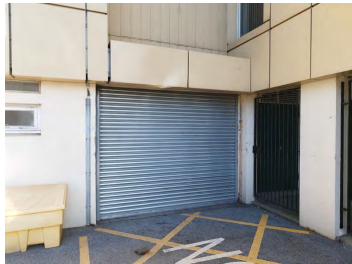
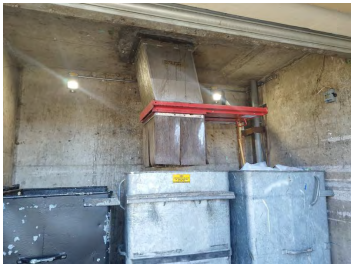
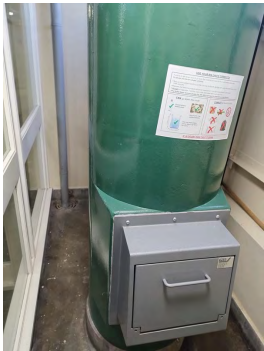
There are x2 refuse chutes provided at Muswell Court, both are located in permanently ventilated areas and separated from escape routes by fire resisting construction providing 30 minutes. The refuse chute has

undergone refurbishment and provides adequate protection at all floor levels with self-closing, intumescent lined hopper disposal points and an automatic isolation shutter which is activated by means of fusible link at the base of the chute. The base of the chute is accessed externally.

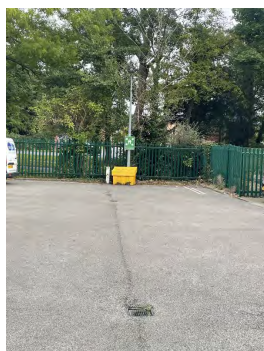
Photo 13

The assembly point at Muswell Court is located within the carpark which is defined as a suitable location.

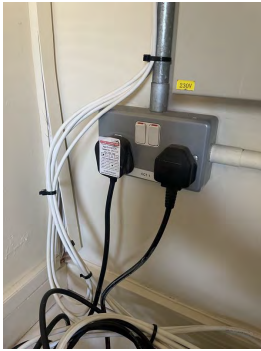
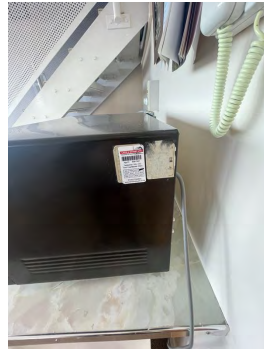
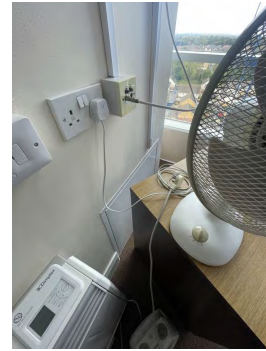
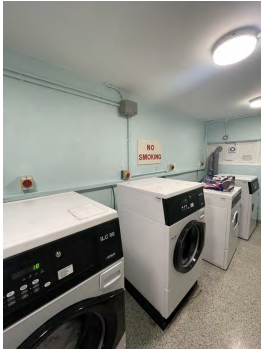
Portable electrical appliances within ground floor ancillary accommodation and the community room gave evidence of out of date PAT labels or no labels at all although it was observed the microwave had been subjected to PAT.

The scheme has implemented a policy within the laundry which includes the removal of lint build-up from tumble driers; at the time of inspection, filters were clean. The laundry is also provided with automatic fire detection & warning and is enclosed in fire resisting construction.

The lift motor room is located on the roof with a fire rated enclosure. The room is provided with excellent provisions for hazard warning signage to warn relevant persons who may enter the area.

Whilst portable appliance testing (PAT) is not a legislative requirement, it is a requirement of Health and Safety at Work legislation under the Electrical at Works Regulations 1989, to periodically check electrical equipment for safe use. Any item which is connected to the main supply falls under Regulation 3 & 5 which places a legal responsibility on the owner, as the duty holder, to ensure that all supplied electrical equipment used within the property is safe and not in a position where they may cause danger to staff or residents.

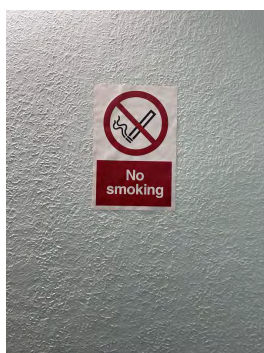
Photo 19

The building complies with current no-smoking legislation with signage displayed prominently throughout the building at all levels. Signage displayed is clearly visible and complies with the Smoke free (signs) Regulations 2012.

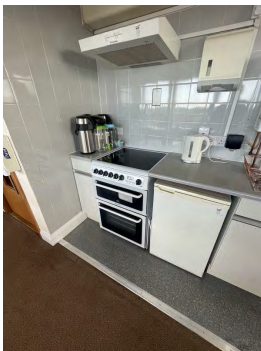
Photo 27

It is considered that HCC are doing all that is reasonable to prevent incidents involving fire from occurring within flats; however, it is advised that the electric oven & hob within the communal lounge is removed as any resident occupying the building could maliciously use the appliance.

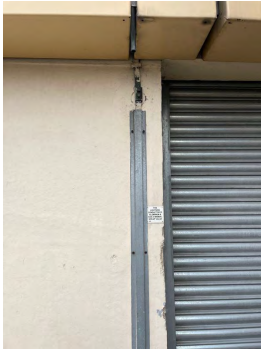
Photo 28

It was confirmed verbally and via physical inspection that a lightning protection system (LPS) is in place.

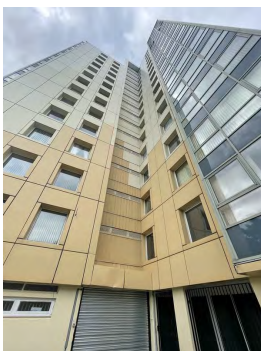
Photo 29

Taking into consideration developments within the sector surrounding external wall systems, Holistic Fire Safety feel it would be prudent to undertake further surveys to confirm provisions. Surveys will provide assurances to the Building Safety team that external wall systems are compliant without exposing occupants to unnecessary risk.

Decision making has been further justified as HCC now have a dedicated BSM and Building Safety team who have realigned their objectives which a specific focus on external walls and fully understanding the structural make up of premises.

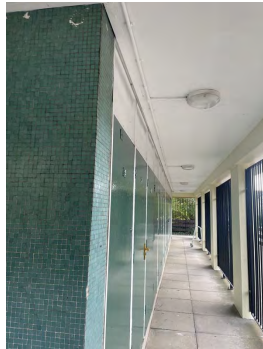
Photo 31

It has been confirmed the insulation present is flammable and should be removed. Any replacement should achieve Class A2-s1, d0 or better.

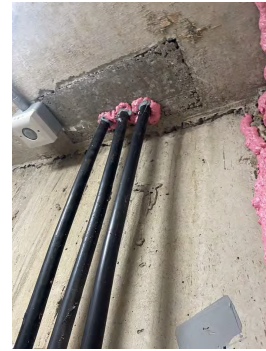
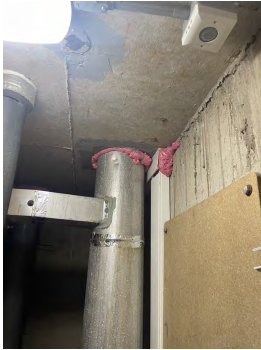
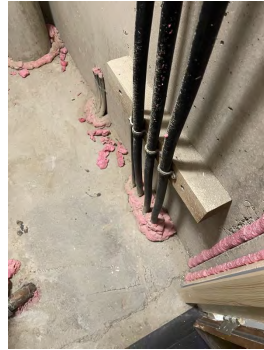
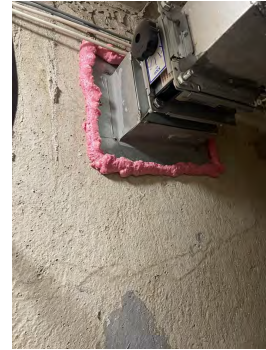
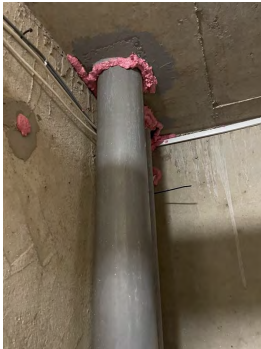
There are however, multiple defects within service risers where services are not adequately fire stopped as they enter adjacent compartments.

There are circa 60 service risers within the building and breaches/defects extensive and consistent throughout. As previously described, the majority of services (soil vent pipes, extraction arrangements, heating services) which supply flats pass freely between risers and dwellings without an effective sealing system in place.

Remediation will primarily consist of sealing defects with an ablative coated fire batt and mastic system applied in conjunction with an intumescent wrap/fire collar for combustible pipework. Where annular gaps allow, all isolated non combustible services can be sealed using fire rated mastic which is tested to BS EN 1366-3/4 and classified to 13501-2:2017 + A1:2009.

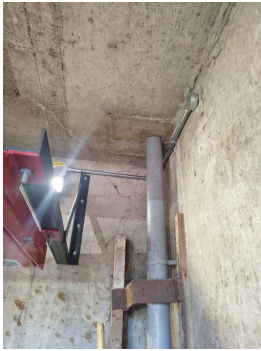
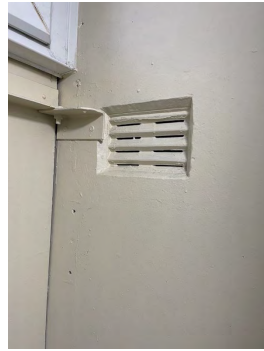
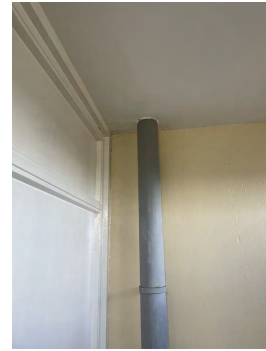
There are two refuse chutes within the building, both of which travel vertically and serve all floors. As described previously the majority of services discharge into service risers, however the disposal enclosure gave evidence of two louvred vents per riser on all floors which appear to lead directly into flats. Should a fire occur within either area, there is the potential for products of combustion to pass between areas. It is unclear whether vents are required for ventilation or whether vents can be made redundant and sealed so that effective compartmentation can be reinstated.

Also within refuse chutes there was a single soil vent pipe which travelled vertically through all floors which was not appropriately fire stopped using a suitable closing device. Remediation is to consist of installing a suitably sized intumescent fire collar.

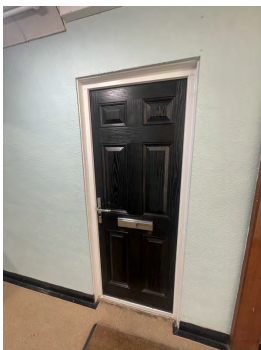
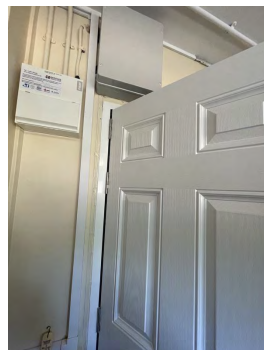
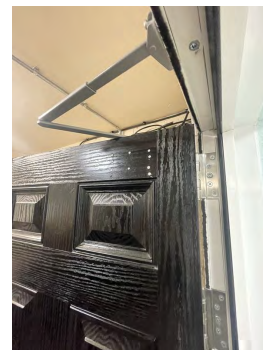
As described previously, there are varying standards of self closing devices on communal doors ranging from pivot hinges, electronic open/closers to cater for mobility impaired residents and traditional overhead mounted devices. All doors sampled returned flush within their rebate when opened, however there was no consistency; as a result, HCC should define standards throughout the building.

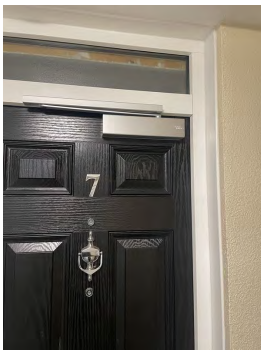
Photo 78

All replacement flat entrance doors are fitted with an appropriate overhead BS 1154 self closing device.

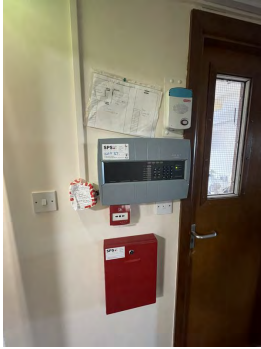
Photo 80

There is a fire alarm panel located on the 14th floor which is linked to detection within the communal lounge only. Should HCC renew automatic fire detection and install provisions within identified risk rooms and escape routes, control indicating equipment should be relocated adjacent to the front entrance on the ground floor.

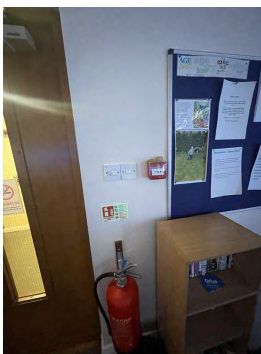
Photo 81

Manual call points are appropriately located within the communal lounge at final exits and outside the staff office.

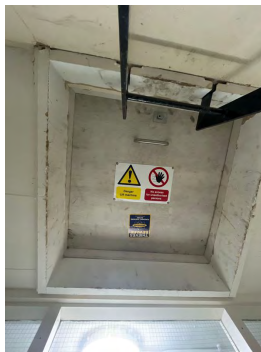
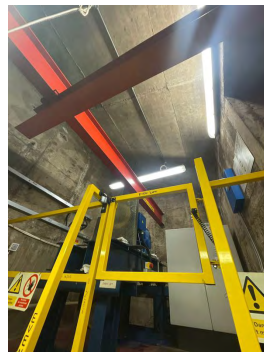
Hazard warning signage is in place on the external face of risk areas such as the lift motor room and the external electrical substation. Each individual ESU within the building is also provided with hazard warning signage to warn both occupants and responding fire crews.

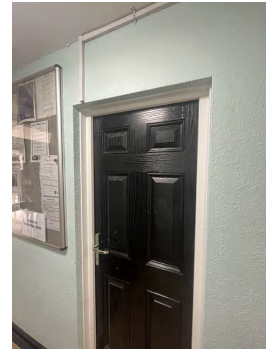
Photo 97

Ancillary room doors were observed to be missing appropriate fire safety signage e.g. 'Fire door keep locked' 'Fire door keep shut'.

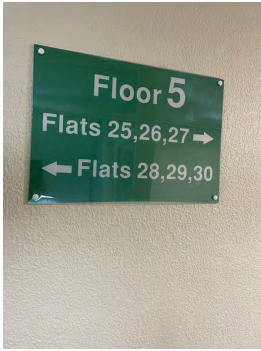
Photo 98

It is a requirement that floor numbers be clearly marked on each landing within the stairways and in a prominent place in all lobbies in such a way as to be visible both in normal conditions and in lowlighting or smoky conditions.

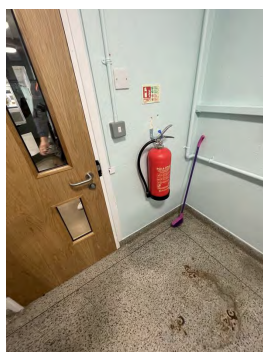
Photo 101

A CO2 fire extinguisher was noted in the cleaner's office which is to be removed.

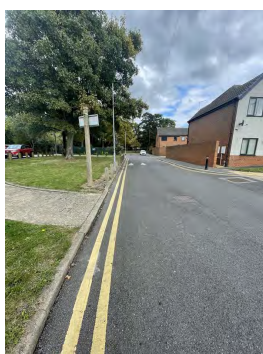
Photo 103

Current provisions provide a minimum of 3.7m in width and 4m in height to allow for unrestricted access for pumping and high reach appliances (ADB Vol 1. B5 Table 13.1).

There are no obvious signs of weight restrictions or anything that could impact appliance approach and positioning. The nearest point at which a fire appliance could position to the building is <18 meters.

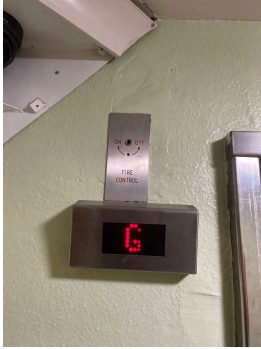
Photo 111

Lifts at Muswell Court are not designated firefighting lifts, however there is an agreement in place that lifts would be utilised by HFRS in the event of an incident.

Signage within communal areas clearly states that lifts are not to be used in the event of an incident by relevant persons and it was confirmed that the lift returns to the ground should the alarm sound within the communal lounge.

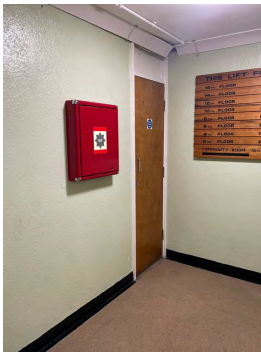
Photo 112

The SIB is located adjacent to lift 1 within the ground floor lobby. Consideration is to be applied as to whether its location is the most suitable. It is the opinion of the assessor that its current location is acceptable, however, HCC may wish to relocate to the external face of the building to ensure the responding emergency services can gain access to the building.
