# 98 - 192 Valiant Drive, Hull

## Type 3 Fire Risk Assessment

Prepared for:	Rebecca Franks, Building Safety Manager
Prepared by:	John Askew, Fire Risk Assessor, Holistic Fire Safety
Date:	17/10/2024
Document Reference:	HFS.HCC.ValiantDrive2.FRA.2.0

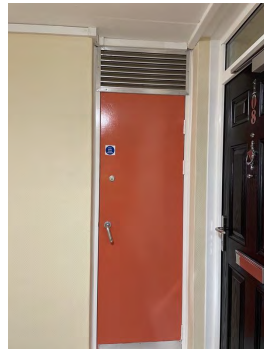
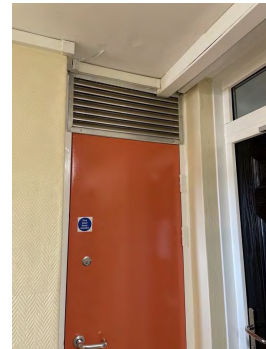
Risers are partially separated from escape routes by fire resisting construction providing 60 minutes, although fire resisting doorsets and fanlights are displaying evidence of significant deterioration/inappropriate construction and ventilation grilles which allow the passage of smoke to enter means of escape in the event of an incident.

It has been confirmed doors are to be replaced, although no date has been set as they are to be part of a larger programme of works which requires approval from the Building Safety Regulator.

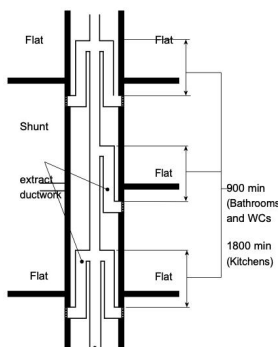
Photo 6

Fire dampers are provided in ductwork at the point extraction exits bathrooms in residential dwellings and enters central shafts. Bathrooms sampled (Flat 12) gave evidence of x2 vents (high/low level) which have dampers installed which are activated via a fusible link.

Although dampers do not restrict the spread of smoke in the early stages of a fire, it would prevent spread of flames and hot gases.

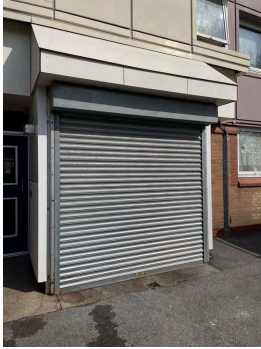
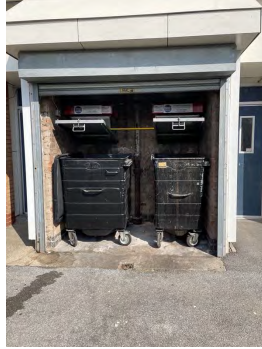
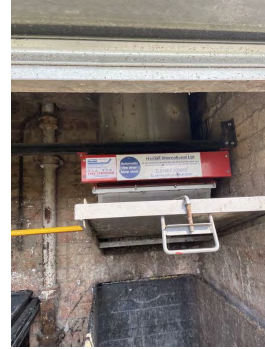
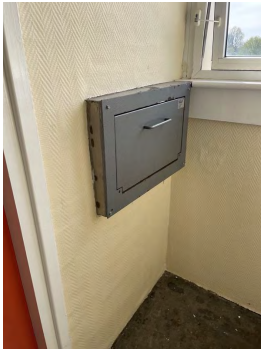
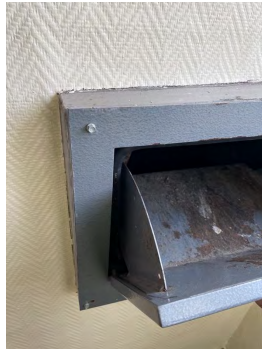
There is a single refuse chute provided at Block 2, however there are disposal points on each floor, located in permanently ventilated areas and separated from the common escape stair by fire resisting construction providing 30 minutes.

The refuse chute has undergone refurbishment and provides adequate protection at all floor levels with self-closing, intumescent lined hopper disposal points and an automatic isolation shutter which is activated by means of a fusible link at the base of the chute. The base of the chute is accessed externally.

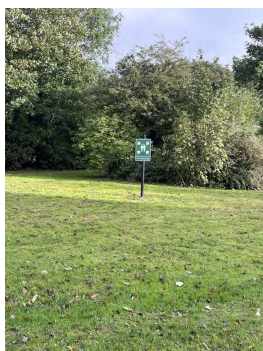
Photo 12

The fire assembly point is located on the grassed area to the front of the blocks.

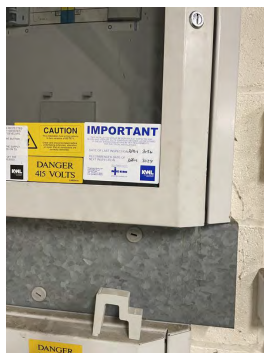
Photo 13

#### 8.2. Are Electrical Installation Condition Report (EICR) labels displayed to indicate the date of the most recent periodic inspection and the date of the next 5-year periodic inspection?

Yes.

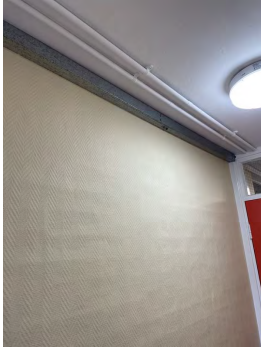
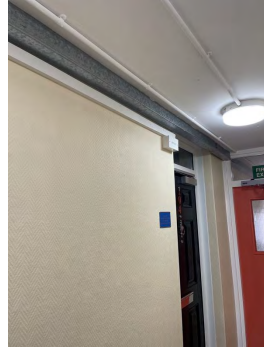
Services run extensively within communal areas, however all cabling is encased within conduit and secured by metal connections preventing them from drooping or falling in the event of fire.

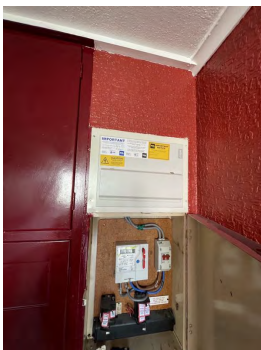
Photo 16

### 8.9. Are distribution boards non-combustible to BS EN 61439-3 as per BS 7671:2018 (18th Edition IET Regulations) Chapter 42 Regulation 421.1.201(i)?

Yes.

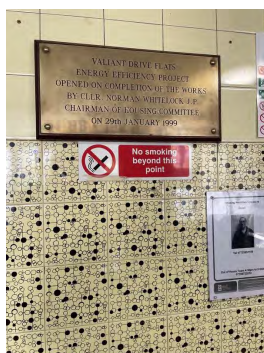
Photo 17

The building complies with current no-smoking legislation with signage displayed prominently throughout the building at all levels. Signage displayed is clearly visible and complies with the Smoke Free (signs) Regulations 2012.

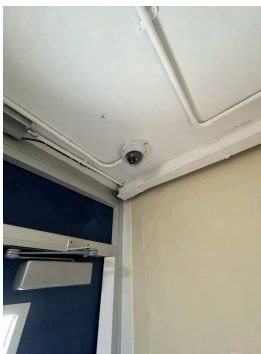
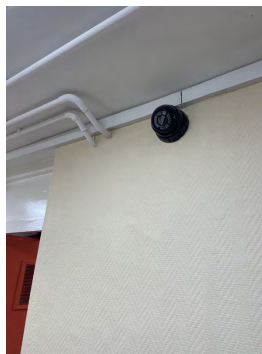
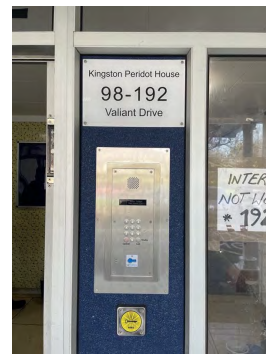
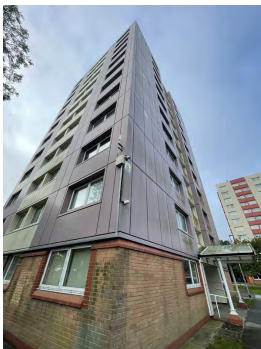
- Access doors are provided with resident access controls
- External floodlighting is provided by streetlights
- The caretaker is a visual presence and carries out daily inspections on the premises - where necessary significant findings are reported to senior management
- There is a steel security fence which runs along a large percentage of the perimeter of the block; provisions are considered to be an additional physical barrier that makes trespassers think twice about gaining entry - its intention is not to guarantee security
- Hull City council employees require key fobs for access and all contractors require permission before access is authorised
- CCTV is installed internally and external to the building, although it only covers the ground floor, lifts and surrounding areas to the building

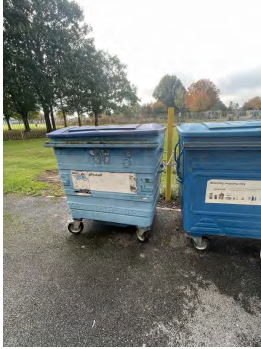
Photo 22

The immediate area around the building was sterile; waste bins were contained within the refuse chute area which is enclosed in a roller shutter and walkways around the block were sterile. Additional waste bins were visible, however they were located clear of the main building and chained to an immovable structure.

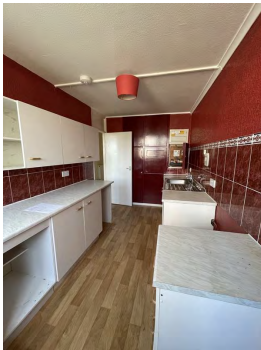
Photo 23

Kitchens are provided with notional FD20 doorsets, heat detection and cooking facilities are remote from the entrance door and do not prejudice the escape route from any point in the flat other than the lounge.

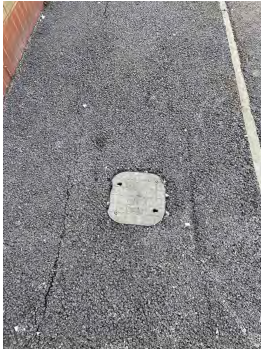
Photo 24

It was confirmed verbally and via physical inspection that a lightning protection system (LPS) is in place.

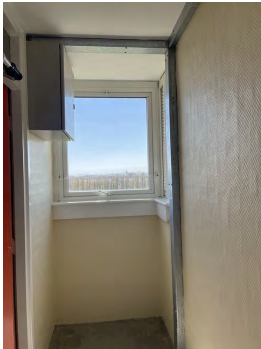
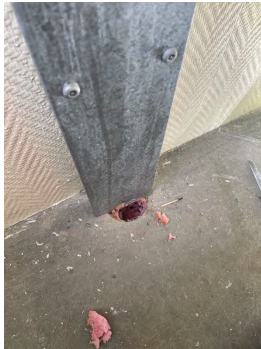
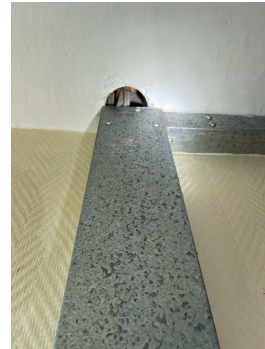
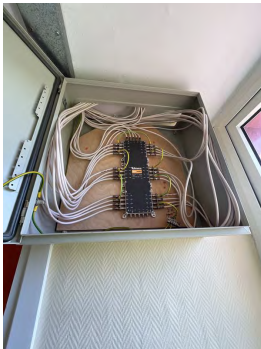
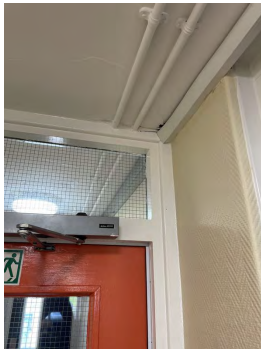
Digital tv cables have penetrated the compartment floor to all levels from the first floor to the lift motor room in the west side staircase lobby.

Breaches were present at the point data cables and conduit pass through fire resisting partitions. The majority of these appear to have been fire stopped although there was no test evidence to support this.

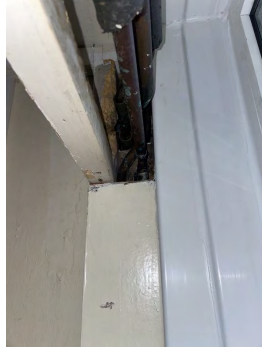
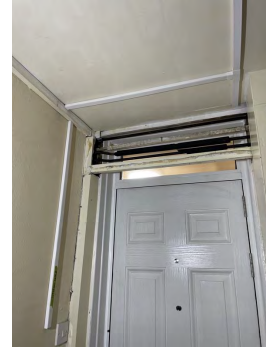
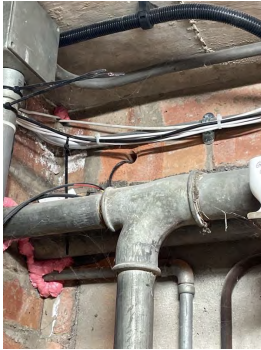
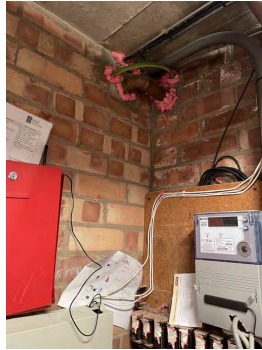
The standard of compartmentation within the water pump room and lift motor room was generally satisfactory with limited evidence of breaches - minor works required however, there is a significant penetration in the pump room where services travel into the adjacent flat (98). It is understood this was created as a result of the replacement of the flat entrance door.

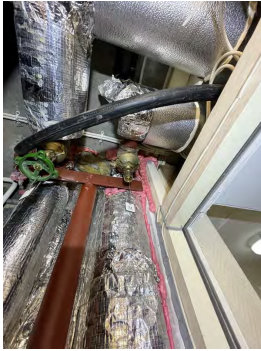
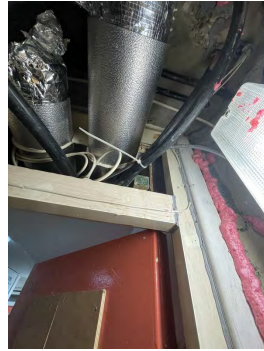
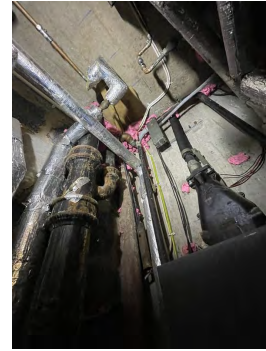
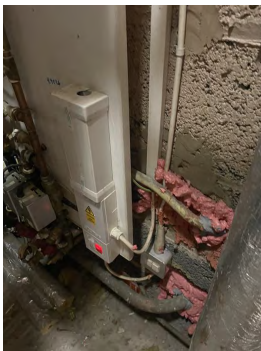
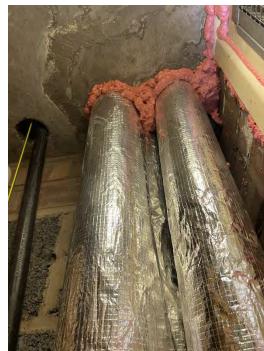
There are x2 service riser shafts within the building which are partially compartmented at all floor levels creating x24 enclosures. Following comprehensive inspections and sampling, breaches/defects are extensive and consistent throughout all areas.

Remediation will primarily consist of sealing defects with an ablative coated fire batt and mastic system applied in conjunction with an intumescent wrap/fire collar for combustible pipework.

Where annular gaps allow, all isolated non combustible services can be sealed using fire rated mastic which is tested to BS EN 1366-3/4 and classified to 13501-2:2017 + A1:2009.

HCC should refer to the compartmentation survey for evidence of breaches and methods of remediation.

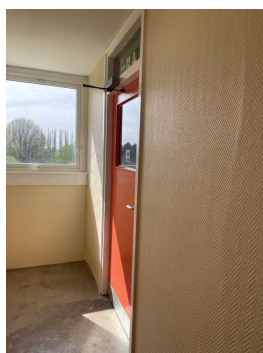
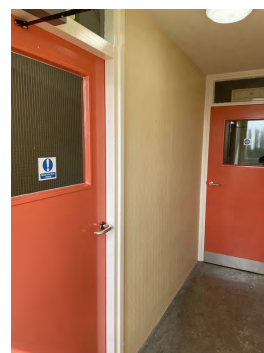
#### **19.12. Is the fire-resisting construction (including any glazing) protecting escape routes and staircases of a suitable standard and maintained in sound condition?**

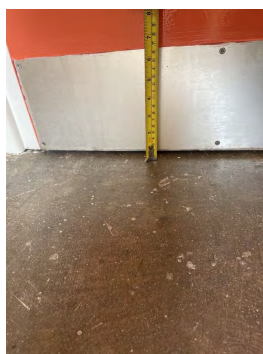
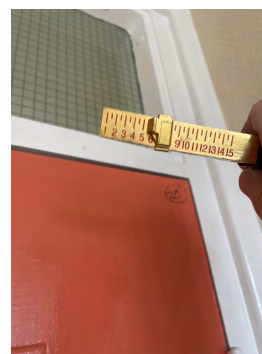
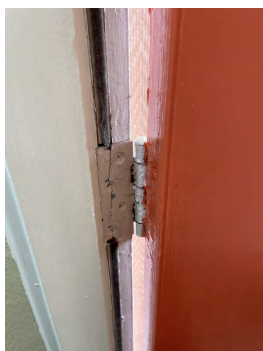
As detailed previously every flat is separated from the common escape stairway by a protected lobby. All doors which form part of escape routes are self-closing, notional FD30 fire doorsets which are considered to be in good condition considering their age and usage; however general maintenance and remediation is required.

Defects consisted of:

- Painted hinges requiring replacement
- Strips and seals are consistently over painted and occasionally routed too deep (although gap tolerances are negligible which generally enable brush seals to sit against the frame)

As a result, given minor defects, a specific fire door inspection is to be undertaken to specify what actions are required.

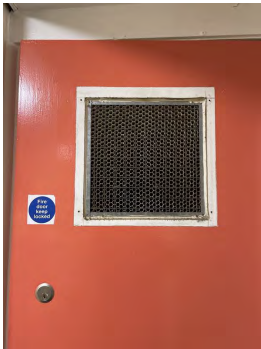
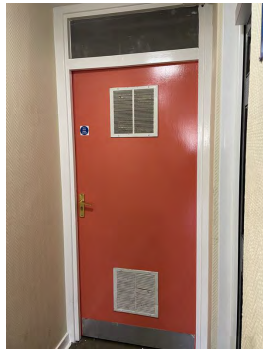
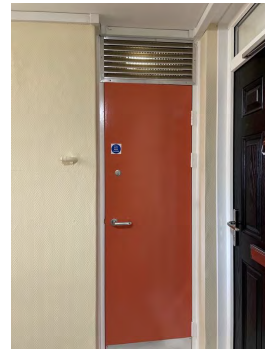
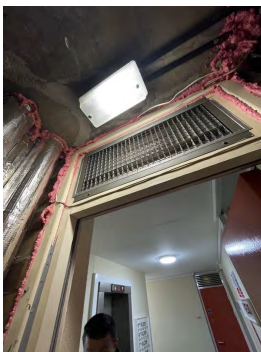
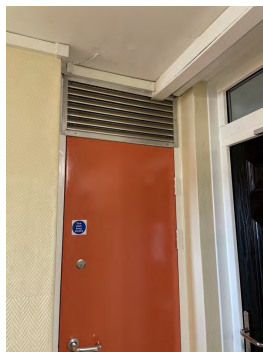
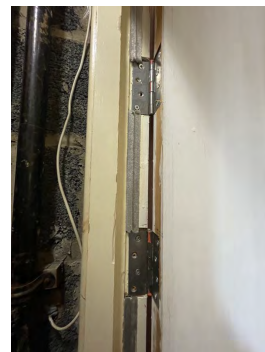
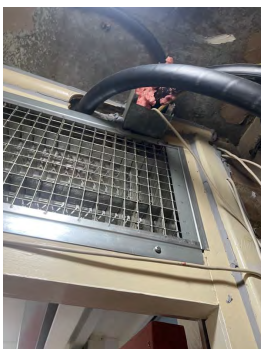
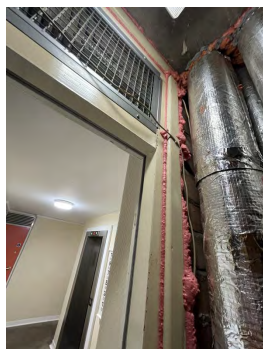
Service riser doors are notional FD60s fire doorsets and they do not provide adequate separation to protect means of escape. Current doorsets are timber 54mm notional doorsets hung by x3 steel hinges which lack BS markings. Both the leaves and frames display evidence of defects, strips and seals are painted over and gaps are generally excessive. Air transfer grills also don't appear to be intumescent lined meaning that there is little to no compartmentation in place.

In addition services also pass through grills confirming their use as unsuitable. Findings are consistent on all residential floors. There was evidence of a lack of backfilling/fire stopping between the frame and substrate.

HCC have reviewed ventilation requirements for riser doors with a specification drawn up which has been submitted to the Building Safety Regulator for approval.

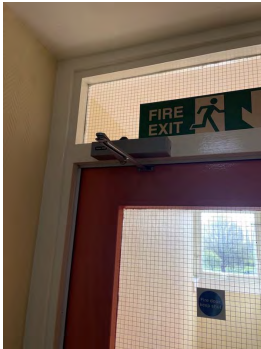
Photo 62

All doors other than those locked shut which form part of, and discharge onto escape routes are provided with overhead, scissor self closing devices.

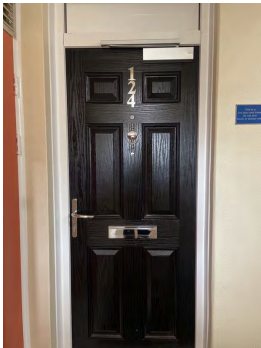
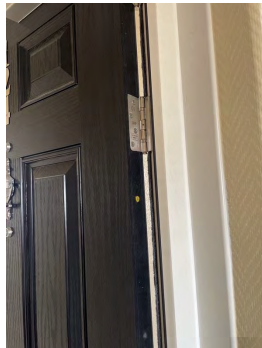
All flat entrance doors have been replaced with third party certified FD30s fire doorsets, which meet the requirements detailed in the ADBVol: 1 Appendix C1 2a for fire resistance and smoke control from both sides, and are fitted with an appropriate positive action self-closing device (BS 1154) and a single action mechanism which does not require the use of a key.

No evidence of certification has been provided, however handover packs are expected to be held by HCC compliance teams.

Door-sets have BM Trada Manufacturers plugs installed within the edge of the door leaf, however there is no evidence to suggest that doorsets have been installed by BM Trada certified installers.

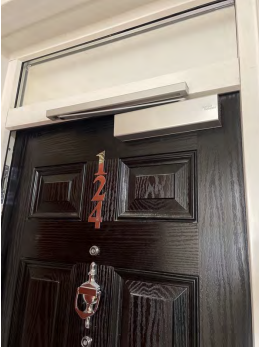
Photo 65

All flat entrance doors are fitted with an appropriate overhead BS 1154 self closing device.

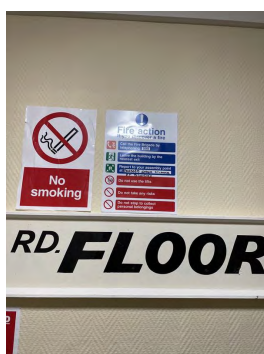
Photo 74

Residential floors are provided with comprehensive instruction on actions to be taken in the event of fire. Fire action notices are displayed prominently opposite/adjacent lift doors.

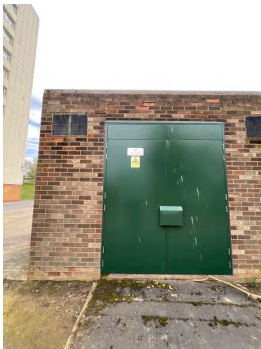
Photo 76

Hazard warning signage is in place on the external face of risk areas such as the lift motor room and the external electrical substation. Each individual ESU within the building is also provided with hazard warning signage to warn both occupants and responding fire crews.

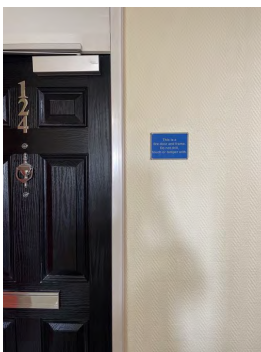
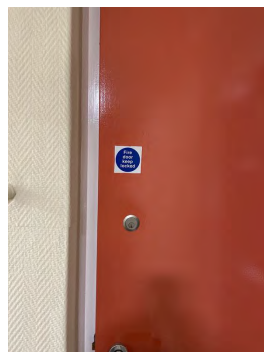
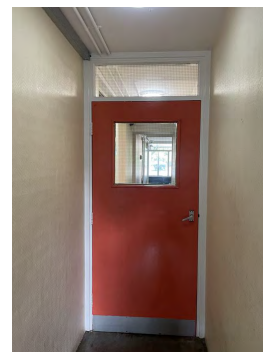
'Fire door keep shut' signs were not displayed on some communal doors.

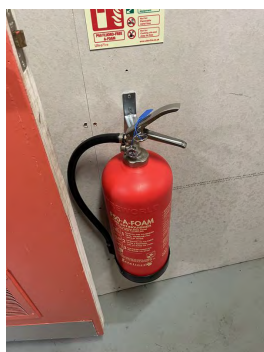
Photo 81

Extinguishers are not present within means of escape.

All extinguishers provided are composite P50 foam extinguishers.

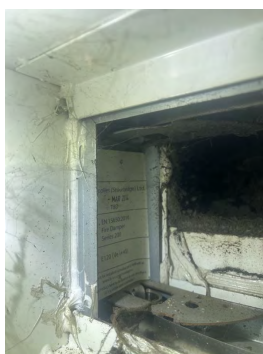
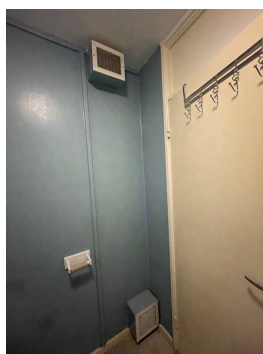
Fire dampers are provided in ductwork at the point extraction exits bathrooms in residential dwellings and enters central shafts. Bathrooms gave evidence of x2 vents (high/low level) which have dampers installed which are activated via fusible link.

It was confirmed that accessible dampers which are located in service risers are subjected to inspection and testing every four years. As dampers are activated via fusible link, there are no moving parts and therefore no requirement for inspection.

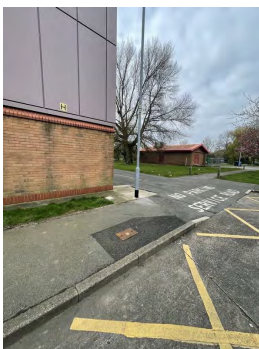
Photo 87

All immediate hydrants are within 90 metres, and are 100mm diameter and are the responsibility of the local water authority undertaking, via Humberside Fire and Rescue Service, who maintain each hydrant on a two year flow test programme.

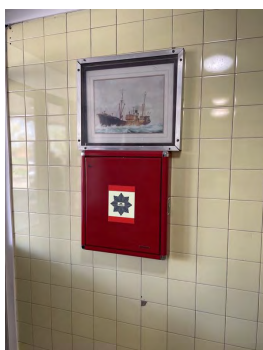
Photo 89

The SIB is located in the main entrance within the ground floor lobby. It has been agreed by all relevant parties that its location is the most suitable - internally.
