**Spring Bank Conservation Area
Management Plan (North side)**
Draft for Review

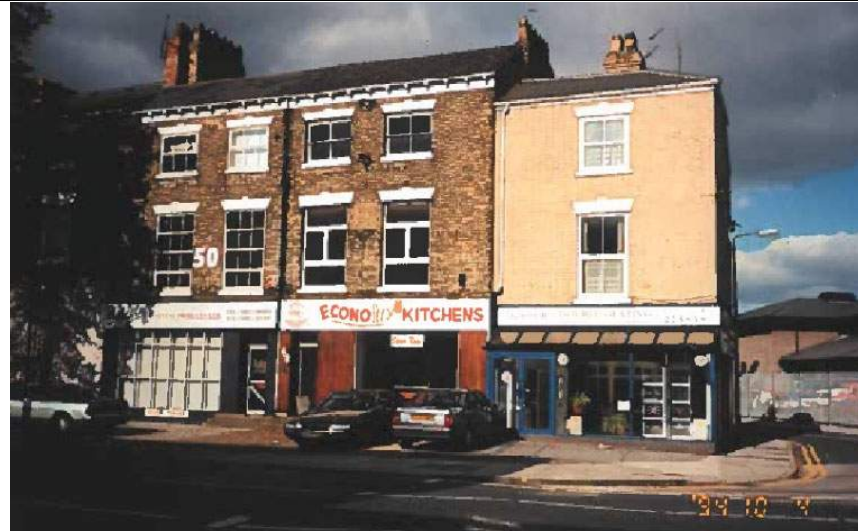
Historic Photo from 04/10/94 (Phil Hampel)

Today, the building has suffered from a series of modifications that have led to the loss of historical features that has been detrimental to the historic character of the Conservation Area. The original sliding sash windows to the first and second floor level have been removed and replaced with timber casement windows that do not reflect the historic proportions of the original windows. These are currently in poor condition. The feature timber brackets and timber gutter to the eaves level have been removed and replaced with a PVC fascia and gutter. The cast iron downpipes have been replaced with PVC downpipes. The slate roof finish has been replaced with concrete pantile roof tiles. The addition of satellite dishes, ariels, brackets and alarm boxes has created visual clutter to the external wall. The low quality timber shopfront is in need of replacement. Externally, the ground level has been elevated to create a raised external seating area and a ramped entrance to provide accessibility to the retail unit with a low level brick wall and iron spearhead railings that do not compliment the simple Georgian style of the building.

Recommended Actions	<p>The recent modifications to No 48 have been detrimental to the character of the Conservation Area. No 48 would benefit from a collective restoration along with the adjacent No 50 Spring Bank as a group.</p> <p>The following works are recommended to restore the historic character :-</p> <ul style="list-style-type: none"> • Removal of the raised external terrace and the lowering of the landscaping to street level • Removal of the existing low level wall and iron railings and replacement with railings that are more appropriate for the simple Georgian style of the building • Removal of the timber casement windows and replacement with new 6 over 6 vertical sliding sash windows to the first floor level and 3 over 3 to the second floor level. • Removal of the concrete pantile roof and replacement with slate roof finish to match the adjacent No 50. • Removal of the PVC gutter, downpipes and fascia and reinstatement of the feature timber brackets, timber gutter and cast iron downpipes. • The removal/ rationalisation of the satellite dishes, alarm boxes, brackets, electrical routes to remove visual clutter from the Spring Bank elevation. • Remove cement mortar to brickwork and undertake lime repointing where required.

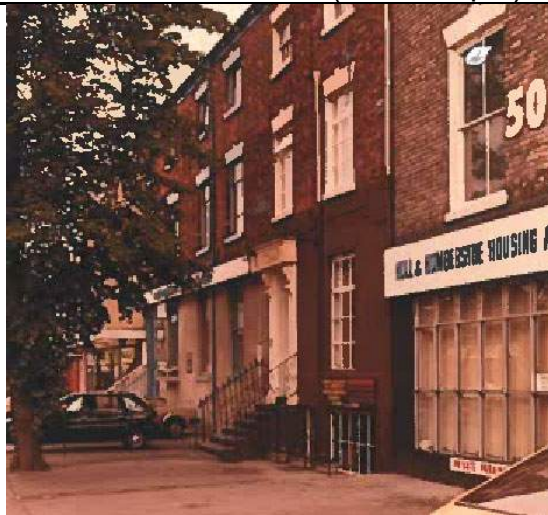
Historic Photo 27/6/84 (Phil Hampel)

Between 1984-2023 the building has been subject to further changes. The basement level has been converted back to residential use and the window size decreased to improve privacy to the basement apartment. The basement level and first floor level have been rendered (likely to be in a cement render system) to conceal the repair of the brickwork following the reduction in the window size. The windows have been replaced with new uPVC double glazed sash windows. Cast iron rainwater goods have been replaced with uPVC and the deep timber fascias at eaves level have been replaced. The stone steps, iron railings and entrance portico have been retained although would benefit from minor repair works. Highly decorative iron railings have been installed to the boundary which do not compliment the simple Georgian style of the building.

Monitoring Notes	The building appears to be structurally stable from the Spring Bank frontage with no immediate cause for concern, although the building has suffered from a lack of general maintenance. Any works to remove the existing stonework lintels and cills or the removal of any details to the original portico should not be permitted.
-------------------------	--------------------------------------------------------------------------------------------------------------------------------------------------------------------------------------------------------------------------------------------------------------------------------------------------------------------------------------

- Removal of the existing highly decorative iron railings and replace with more sympathetic Georgian railings along with a higher quality landscape treatment.
- Removal of the uPVC casement windows and replacement with new timber framed sash windows.
- Removal of the PVC gutter, downpipes and fascia and reinstatement of the cast iron gutter and cast iron downpipes.
- The removal/ rationalisation of the alarm boxes, brackets, electrical routes to remove visual clutter from the Spring Bank elevation.
- The removal of the cement render to the ground floor and basement level.
- The removal of the paint to the brickwork between first and first floor window cill level.

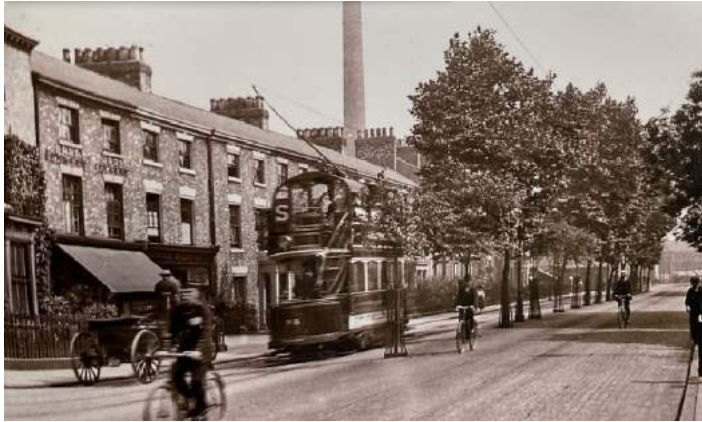
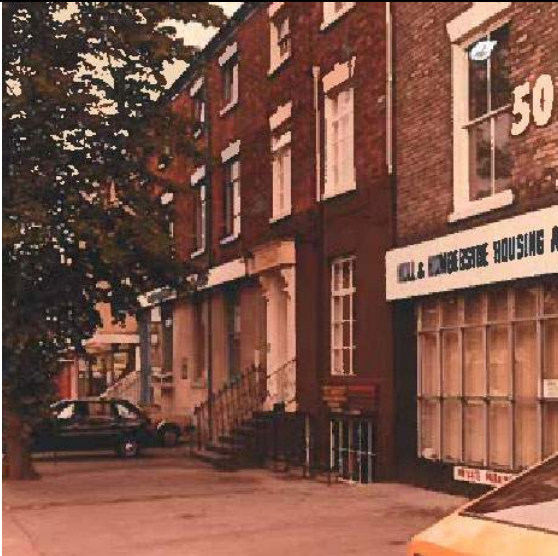
Address: 54 Spring Bank

Between 1984-2023 the building has been subject to further changes. The windows have been replaced with new uPVC double glazed sash windows. Cast iron rainwater goods have been replaced with uPVC and the deep timber fascias at eaves level have been replaced. The entrance portico has been retained but has lost some of its historical details including the cornice at the head of the portico. The stone steps have been replaced with concrete steps and the iron railings have been replaced with low quality metal railings.

The building appears to be structurally stable from the Spring Bank frontage with no immediate cause for concern, although the building has suffered from a lack of general maintenance. Any works to remove the existing stonework lintels and cills or the removal of any details to the original portico should not be permitted.

- Removal of the brickwork and stone slab steps and replacement with stone steps
- Removal of the existing handrails and railings and replacement with more sympathetic Georgian railings along with a higher quality landscape treatment to the front garden.
- Removal of the uPVC casement windows and replacement with new timber framed sash windows.
- Removal of the PVC gutter, downpipes and fascia and reinstatement of the cast iron gutter and cast iron downpipes.
- The removal/ rationalisation of the alarm boxes, brackets, electrical routes to remove visual clutter from the Spring Bank elevation.
- The removal of the cement render to the ground floor and basement level and the repair of the brickwork.
- The removal of the paint to the brickwork between first and first floor window cill level.

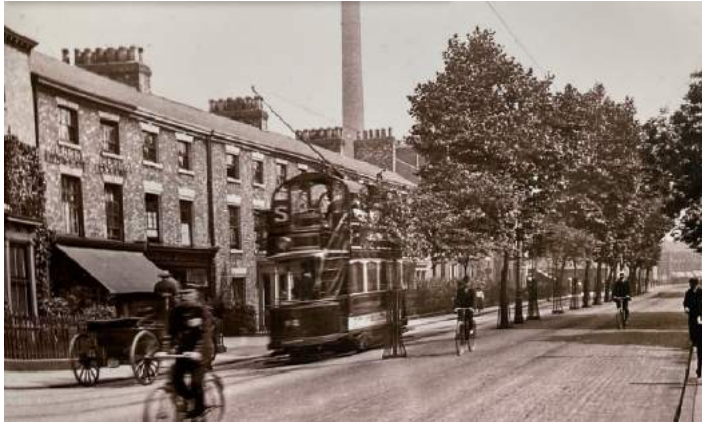
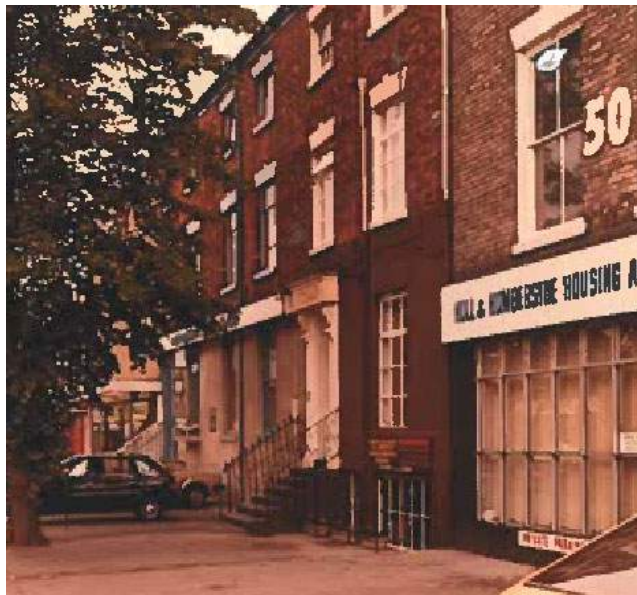
Address 56 Spring Bank

Between 1984-2023 the building has been subject to further changes. The basement level has been converted back to residential use. The basement level and first floor level have been rendered (likely to be in a cement render system) to conceal the repair of the brickwork following the reduction in the window size. The windows have been replaced with new uPVC double glazed sash windows. Cast iron rainwater goods have been replaced with uPVC and the deep timber fascias at eaves level have been replaced. The stone steps, iron railings and entrance portico have been retained although would benefit from minor repair works. Highly decorative iron railings have been installed to the boundary which do not compliment the simple Georgian style of the building.

The building appears to be structurally stable from the Spring Bank frontage with no immediate cause for concern, although the building has suffered from a lack of general maintenance. Any works to remove the existing stonework lintels and cills should not be permitted.

- Removal of the concrete steps and low quality handrail and the replacement with stone steps and replacement with more sympathetic Georgian railings along with a higher quality landscape treatment.
The reinstatement of the cornice detail to the roof level of the portico.
- Removal of the uPVC casement windows and replacement with new timber framed sash windows.
- Removal of the PVC gutter, downpipes and fascia and reinstatement of the cast iron gutter and cast iron downpipes.
- The removal/ rationalisation of the alarm boxes, brackets, electrical routes to remove visual clutter from the Spring Bank elevation.
- The removal of the cement render to the ground floor and basement level.
- The removal of the paint to the brickwork between first and first floor window cill level.

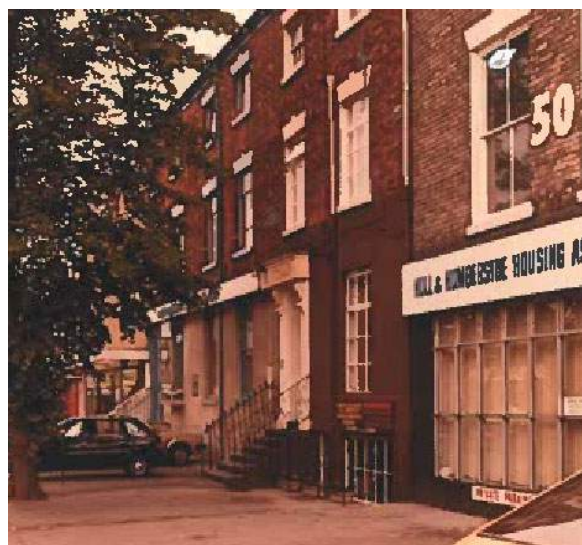
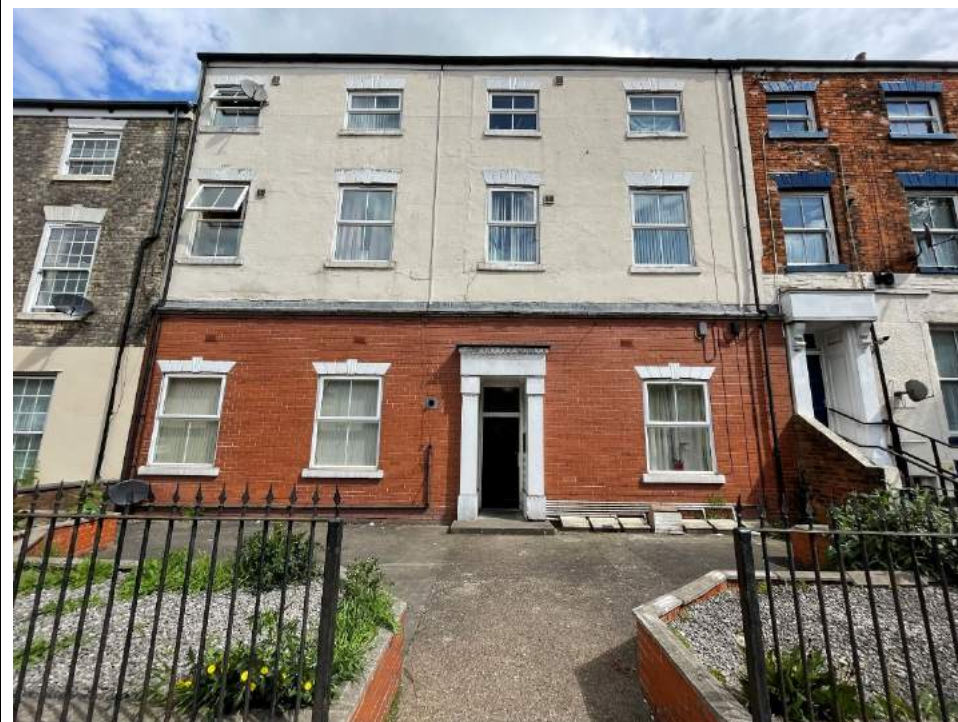
Historic Photo 27/6/84 (Phil Hampel)

The building appears to be structurally stable from the Spring Bank frontage with no immediate cause for concern, although the building has suffered from a lack of general maintenance. Any works to remove the existing stonework lintels and cills to the upper floor levels should not be permitted.

- Removal of the existing railings and a cohesive boundary treatment provided across the group from No 52-60.
- Undertake works to add further detail to the entrance portico.
- Removal of the cement render to the upper floor levels.
- Removal of the uPVC casement windows and replacement with new timber framed sash windows.
- Removal of the PVC gutter, downpipes and fascia and reinstatement of the cast iron gutter and cast iron downpipes.
- The removal/ rationalisation of the alarm boxes, brackets, electrical routes to remove visual clutter from the Spring Bank elevation.
- Replace concrete pantile roof finish with slate.

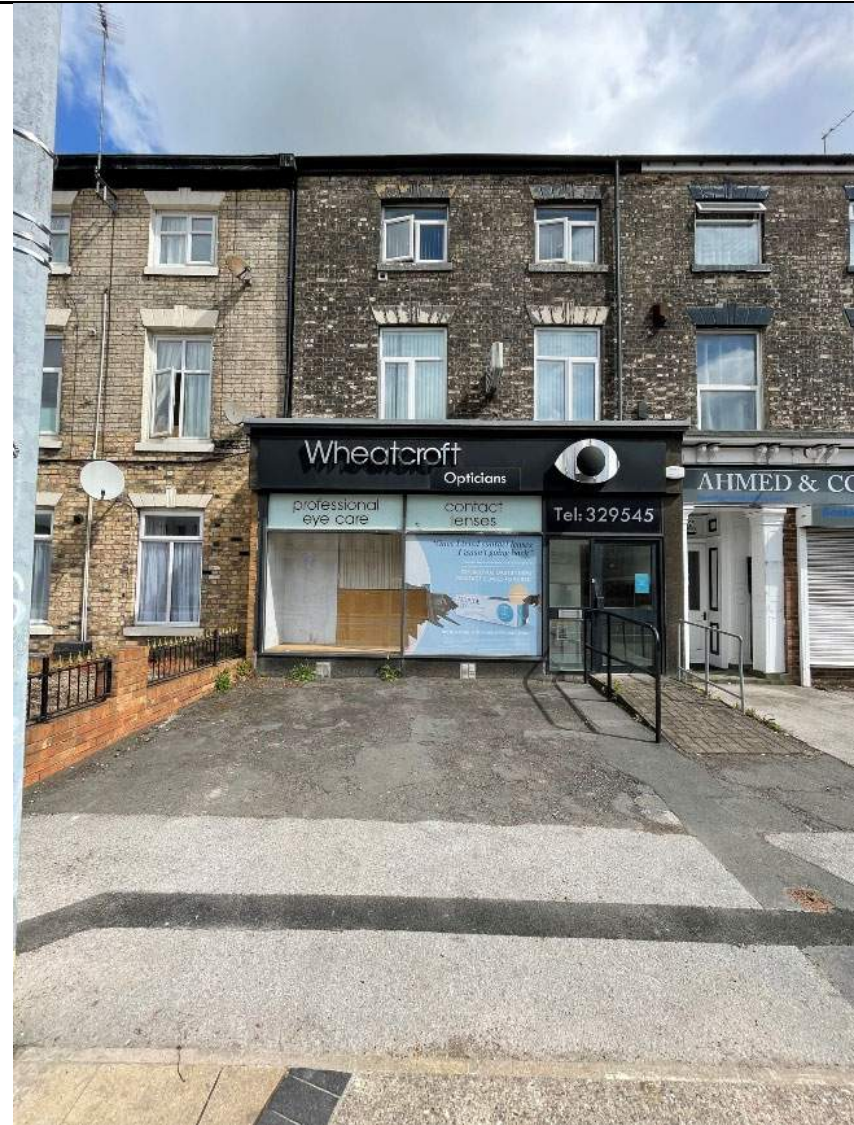
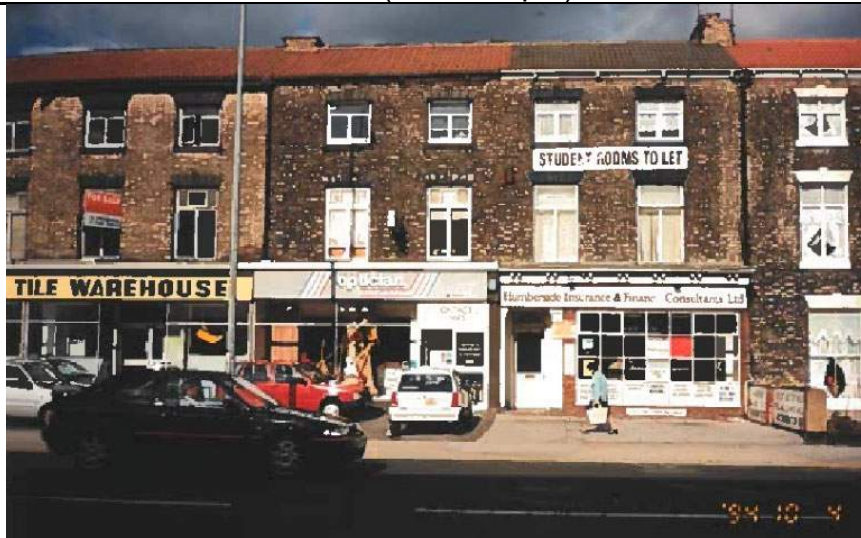
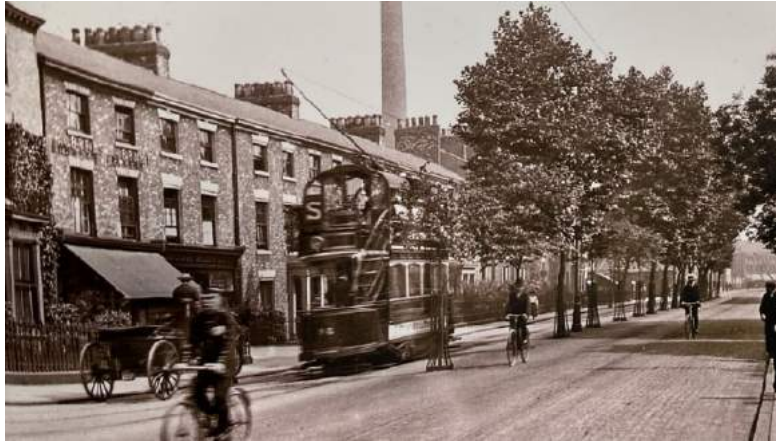
Address: 72 Spring Bank, Wheatcroft opticians

<p>Monitoring Notes</p>	<p>The building appears to be structurally stable from the Spring Bank frontage with no immediate cause for concern. Any works to remove the existing stonework lintels and cills to the upper floor levels should not be permitted.</p>
<p>Recommended Actions</p>	<p>The recent modifications to No 72 have been detrimental to the character of the Conservation Area. No 72 would benefit from a collective restoration along with the adjacent No 62, 64, 66, 68, 72, 74 and 76 Spring Bank as a group.</p>

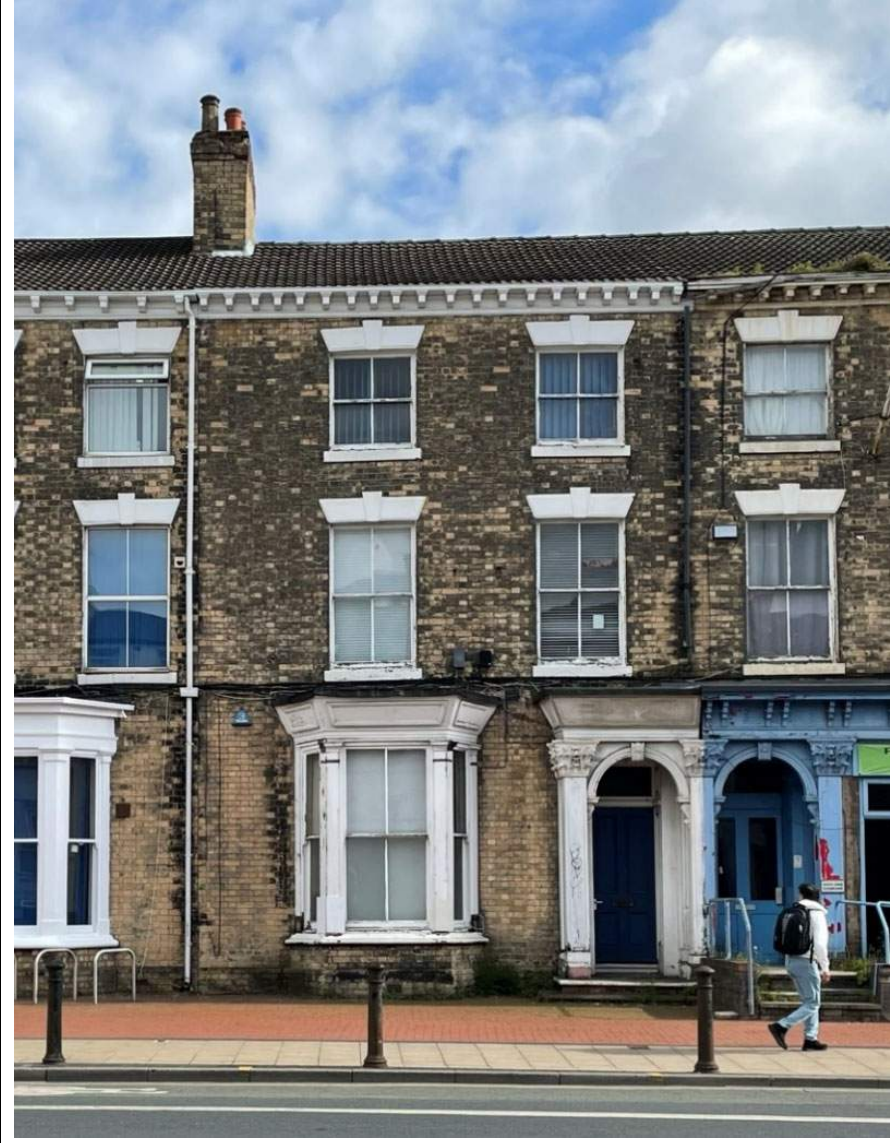
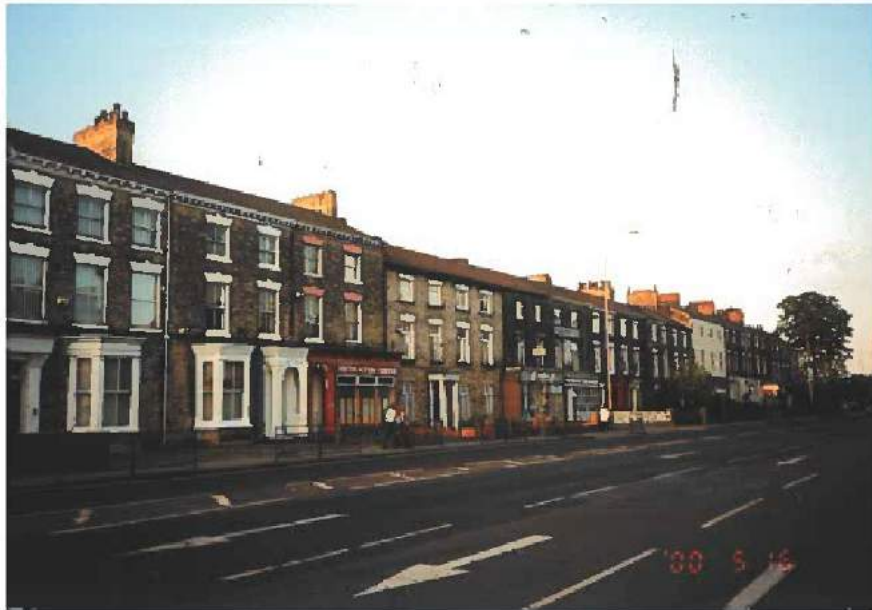
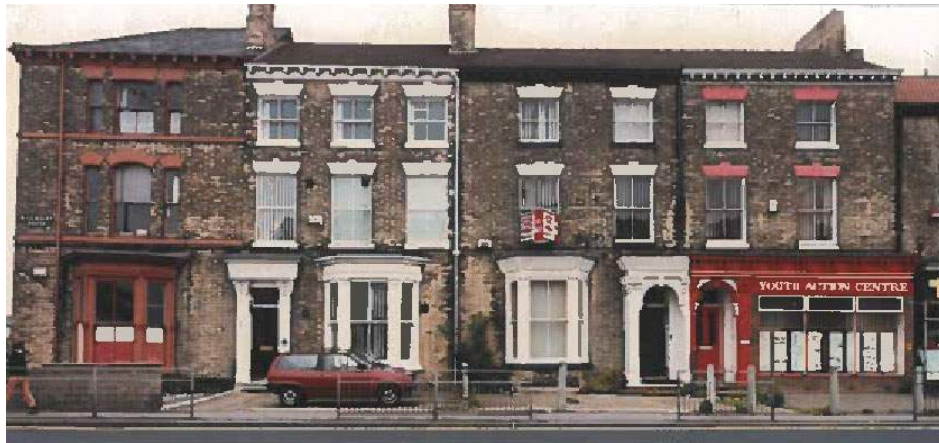
Address: 80 Spring Bank

Monitoring Notes	<p>The building appears to be structurally stable from the Spring Bank frontage and has retained many of the original Georgian features. Any works to remove the original bay windows, timber sash windows, Corinthian columns, portico, decorative timber eaves support brackets, stonework lintels and cills to the upper floor levels should not be permitted. Staining behind the downpipes would suggest that the downpipes need replacing/repairing.</p>
Recommended Actions	<p>No 80 would benefit from a collective restoration along with the adjacent 78 and 82 Spring Bank as a group.</p>

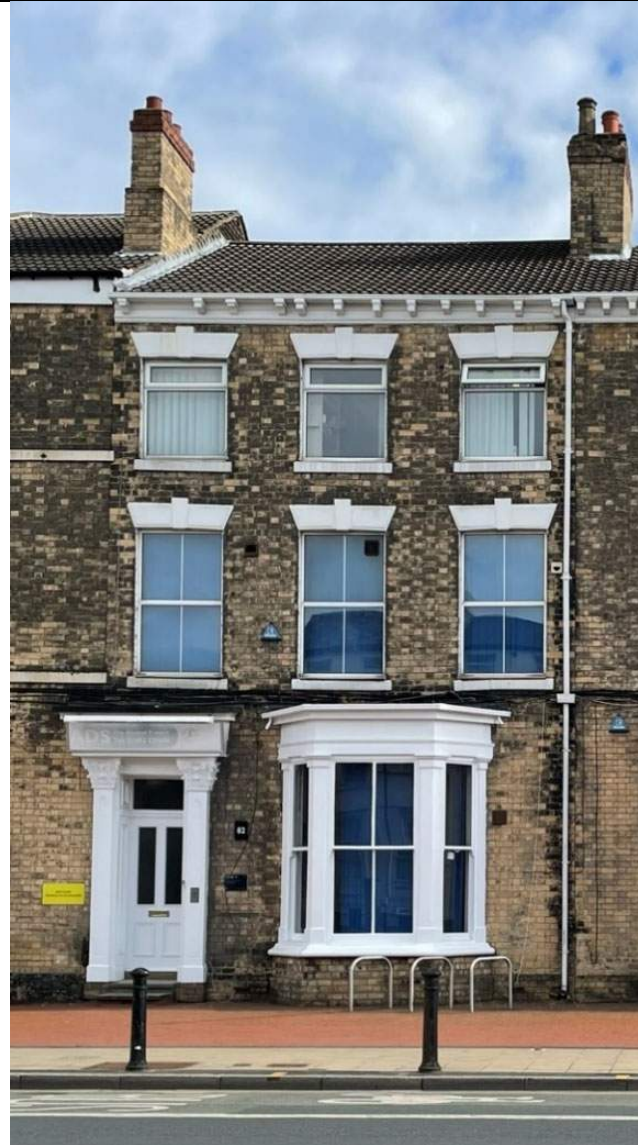
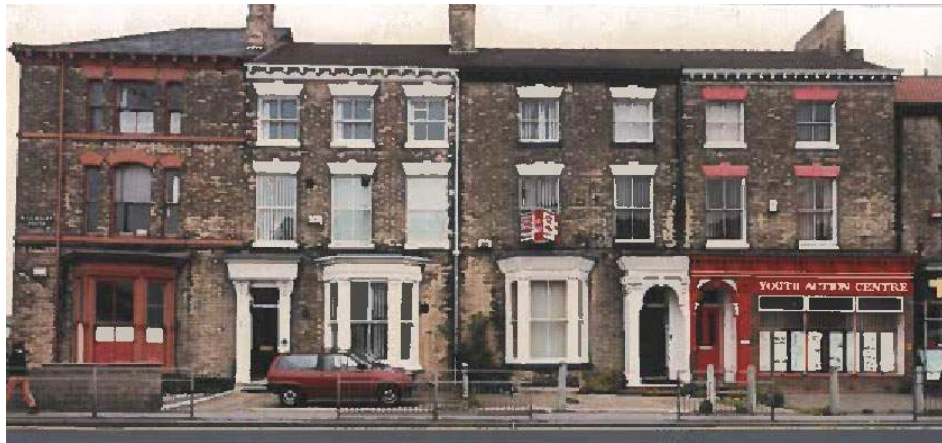
Address: 82 Spring Bank

<p>Monitoring Notes</p>	<p>The building appears to be structurally stable from the Spring Bank frontage and has retained many of the original Georgian features. Any works to remove the original bay window, Corinthian columns, portico, decorative timber eaves support brackets, stonework lintels and cills to the upper floor levels should not be permitted. Staining behind the downpipes would suggest that the downpipes need replacing/repairing.</p>
<p>Recommended Actions</p>	<p>No 82 would benefit from a collective restoration along with the adjacent 78 and 80 Spring Bank as a group. Although the building has retained many of its earlier Georgian features, it would benefit from the following works :-</p> <ul style="list-style-type: none"> • Re-decoration throughout.

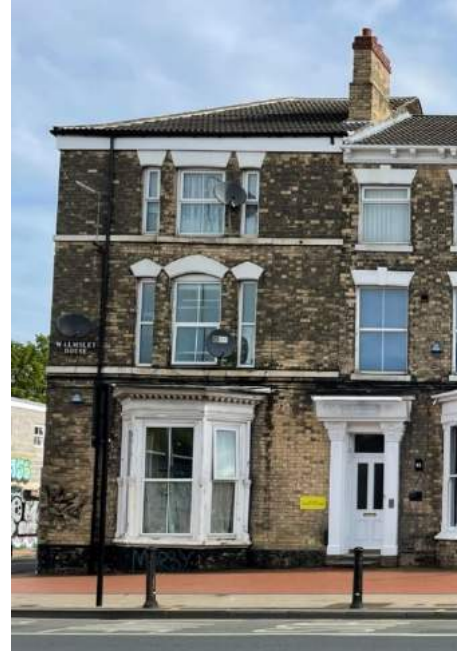
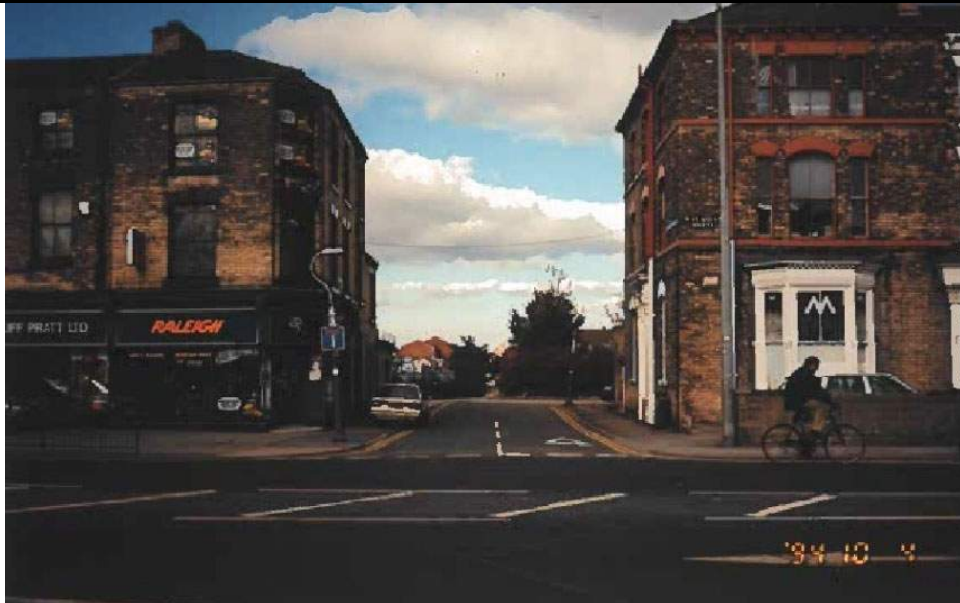
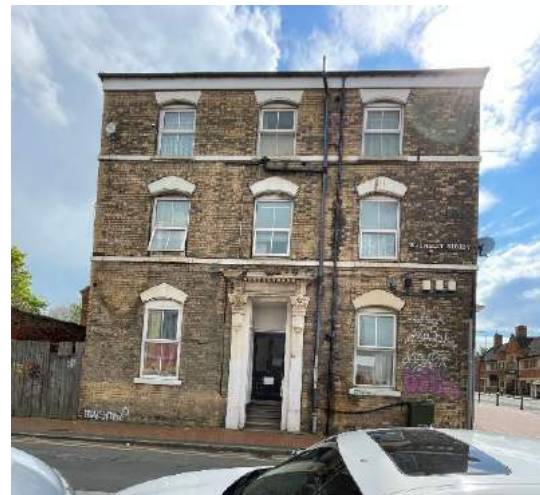
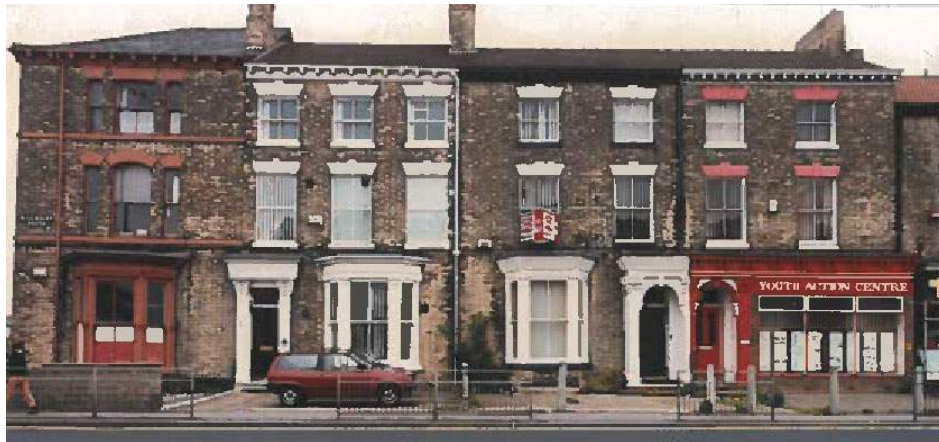
Address: 75 Walmsley Street

Monitoring Notes	<p>The building appears to be structurally stable from the Spring Bank and Walmsley Street frontage and has retained many of the original features. Any works to remove the original bay window, Corinthian columns, portico, stonework lintels and cills to the upper floor levels should not be permitted.</p>
Recommended Actions	<p>Although the building has retained many of its earlier Victorian features, it would benefit from the following works :-</p> <ul style="list-style-type: none"> • Removal of the graffiti to the Walmsley Road elevation. • Replacement of uPVC windows throughout with timber sliding sash (2 over 2). • Re-decoration throughout. • Repair and restoration of the decorative Corinthian columns, portico, timber panelling and door. • Repair and restoration of the existing timber sliding sash windows.

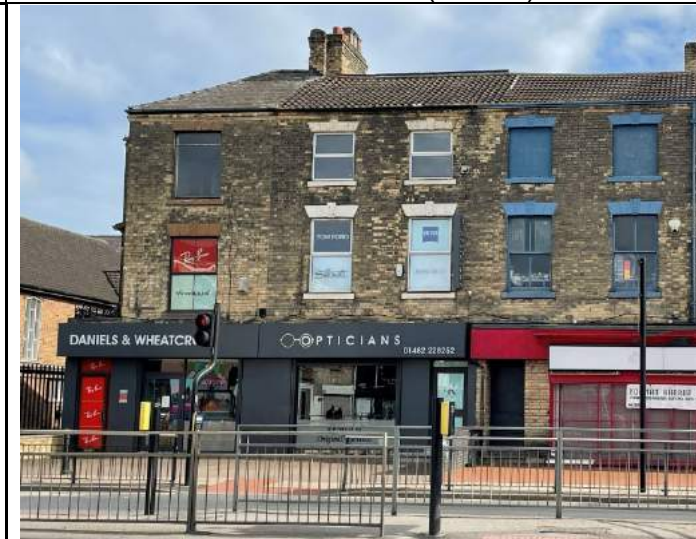
Address 88-90 Spring Bank

<p>Monitoring Notes</p>	<p>The building appears to be structurally stable and has retained many of the original features. Any works to remove the original stonework lintels and cills to the upper floor levels should not be permitted.</p>
<p>Recommended Actions</p>	<p>As part of a group of buildings along with No 84 and 86 Spring Bank, the building would benefit from a collective restoration to achieve a cohesive restoration.</p> <p>Although the building has retained some of its earlier Victorian features, it would benefit from the following works :-</p>

- Reinstatement of the high quality timber entrance doors to the office unit above to the Spring Bank frontage
- Removal of uPVC windows and replacement with timber sliding sash windows.
- Re-decoration throughout.
- Repair and restoration of the existing cast iron rainwater goods.
- Removal of the concrete pantile roof to No 88 and replacement with a new slate roof.
- Rationalisation of the services, electrical conduits and alarm boxes.

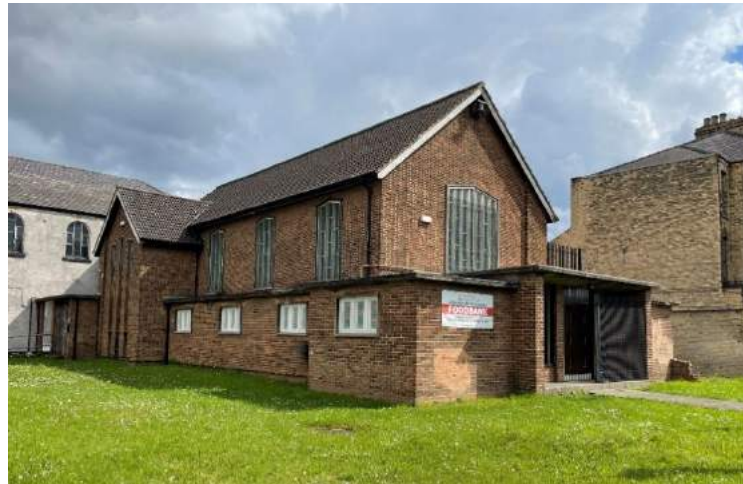
Address: Seventh Day Church, 92

Building Notes	<p>The Jubilee Primitive Methodist Chapel was previously located on this site. This grand four storey building was opened in 1864 and formed a focal point along Spring Bank and at the junction on approach from Park Street. With an elevated ground floor level the chapel could accommodate a congregation of 1,000. Built of red and buff brick with stone dressings it was designed in the Italianate style by Joseph Wright. The Chapel was renovated in 1952 before being demolished shortly after in 1958 to make way for a more modest building for the St Stephen's Anglican Church which was opened in 1972.</p> <p>The building today has undergone limited modifications since its construction in 1972, limited to the installation of the security fence and gate across the recessed entrance porch.</p>
Monitoring Notes	<p>The building is in good condition with no signs of deterioration that put the building at risk.</p>

Recommended Actions	<p>The installation of the security fence and gate has a detrimental impact on the 1970's architectural style of the building and the character of the building would benefit from their removal.</p> <p>The grounds to the Church provide the opportunity to introduce much needed green space to Spring Bank. The existing grassed landscape would benefit from the planting of trees along the site boundary which would contribute positively to the character of the Conservation Area.</p>

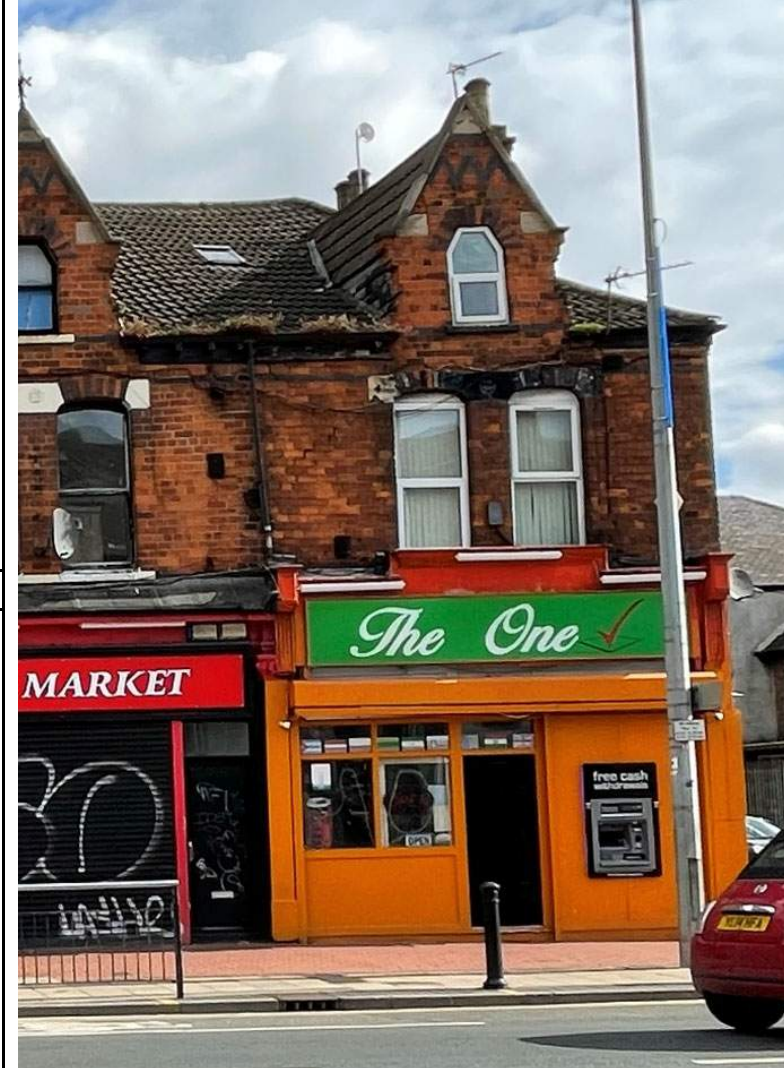
Address: The One, 94

<p>Monitoring Notes</p>	<p>The building is in relatively good condition with limited signs of deterioration that put the building at risk. Any works that involve damage/loss of the decorative stone lintels, cills and decorative brickwork should not be permitted. There is a diagonal crack to the LHS of the building at first floor level from the lintel down toward the party wall line with the adjacent unit that would suggest structural movement and the building is leaning towards Freehold Street. Further investigation by a Structural Engineer is advised. The gutter has extensive debris and fungal growth to the front elevation which needs removing and clearing as soon as possible. This may be contributing to the structural cracking which needs to be addressed. The stone lintel to the first floor LHS window is showing signs of spauling, likely caused by the overflow from the blocked gutters.</p>

<p>Recommended Actions</p>	<p>As part of a group of four buildings along with No 96, 98, 100/102 Spring Bank, the building would benefit from a collective restoration to achieve a cohesive restoration.</p>

- Reinstatement of awning and blind box within shopfront design as shown on 1904 photograph.
- Removal of uPVC windows and replacement with timber sliding sash windows.

- Re-decoration throughout.
- Review of the structural cracking by a Structural Engineer and undertake structural repairs to prevent further movement (eg Helibar ties to secure from future movement).

- Repair and restoration of the existing cast iron rainwater goods.
- Removal of the concrete pantile roof and replacement with a new slate roof.
- Rationalisation of the services, electrical conduits and alarm boxes.

- Remove fungal growth to rear chimney along Freehold Street frontage and review/repair lead flashing and investigate source of water build-up at interface with roof finish.

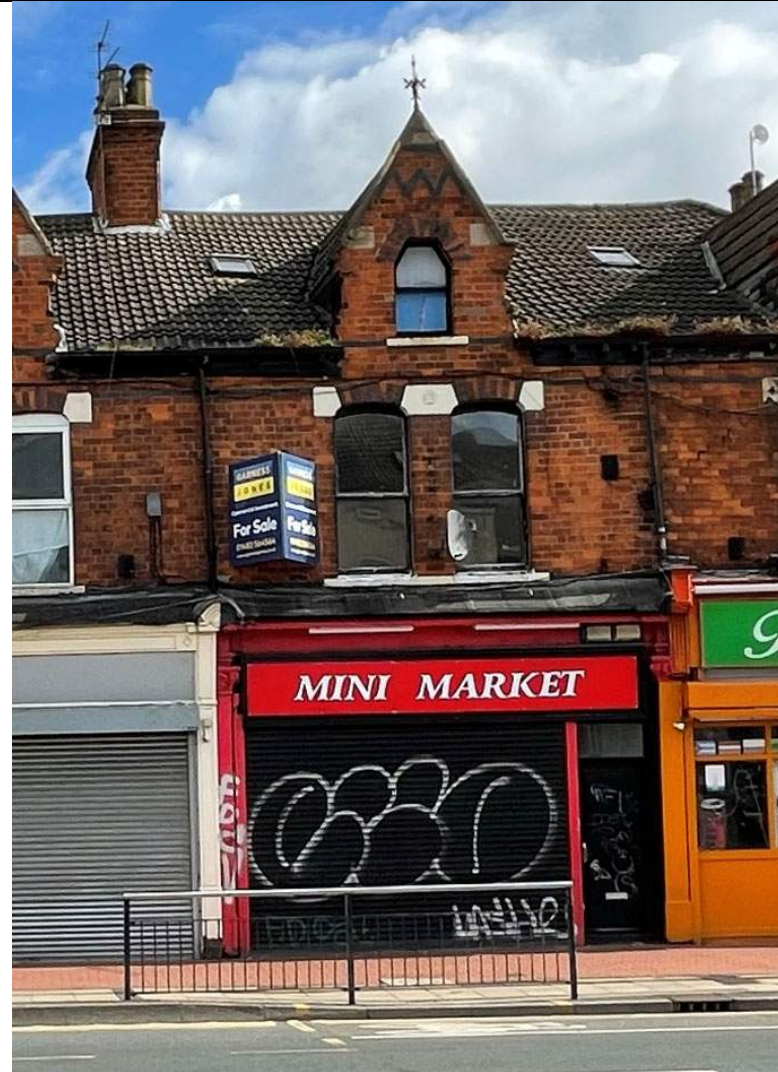
Address: Mini Market, 96

<p>Monitoring Notes</p>	<p>The building is in relatively good condition with limited signs of deterioration that put the building at risk. Any works that involve damage/loss of the decorative stone lintels, cills, remaining corbel and pilaster detail, fascia, cornice and decorative brickwork should not be permitted. The coping stones to the LHS of the projecting gable window at roof level have deteriorated substantially and require immediate attention. The gutter has extensive debris and fungal growth to the front elevation which needs removing and clearing as soon as possible.</p>
<p>Recommended Actions</p>	<p>As part of a group of four buildings along with No 94, 98, 100/102 Spring Bank, the building would benefit from a collective restoration to achieve a cohesive restoration.</p>

- Reinstatement of the original shopfront design using the remnants of the original pilasters, cornice, corbels and fascia still in-situ. Replace doors to both retail unit and residential unit with complementary design.
- Reinststate awning and blind box within shopfront design as shown on 1904 photograph.
- Restoration of the existing timber sliding sash windows.
- Re-decoration throughout.
- Remove debris and fungal growth from gutters and remove PVC downpipes.
- Restore timber gutter supports and replace where missing.
- Repair and restoration of the existing cast iron gutters and replace downpipes with cast iron.
- Removal of the concrete pantile roof to No 88 and replacement with a new slate roof.
- Rationalisation of the services, electrical conduits and alarm boxes.

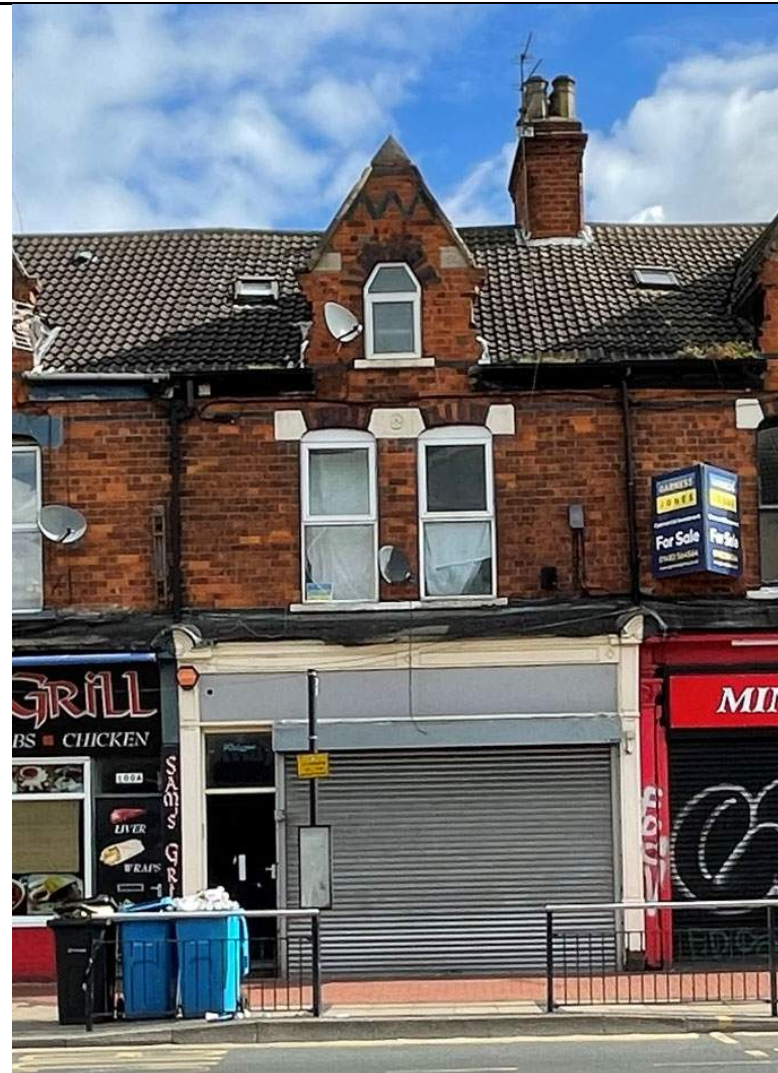
Address: Vacant, 98

<p>Monitoring Notes</p>	<p>The building is in relatively good condition with limited signs of deterioration that put the building at risk. Any works that involve damage/loss of the decorative stone lintels, cills, retained stone corbel details and decorative brickwork should not be permitted.</p>
<p>Recommended Actions</p>	<p>As part of a group of four buildings along with No 94, 96 and 100/102 Spring Bank, the building would benefit from a collective restoration to achieve a cohesive restoration.</p> <p>Although the building has retained some of its earlier Victorian features, it would benefit from the following works :-</p> <ul style="list-style-type: none"> • Reinstatement of the original shopfront design using the remnants of the original pilasters, cornice, corbels and fascia still in-situ at 96 Spring Bank. • Reinststate awning and blind box within shopfront design as shown on 1904 photograph. • Removal of uPVC windows and replacement with timber sliding sash windows (as retained in No 96). • Re-decoration throughout.

- Repair and redecorate decorative timber gutter support brackets.
- Repair and restoration of the existing cast iron rainwater goods.
- Removal of the concrete pantile roof and replacement with a new slate roof.
- Rationalisation of the services, electrical conduits and alarm boxes.

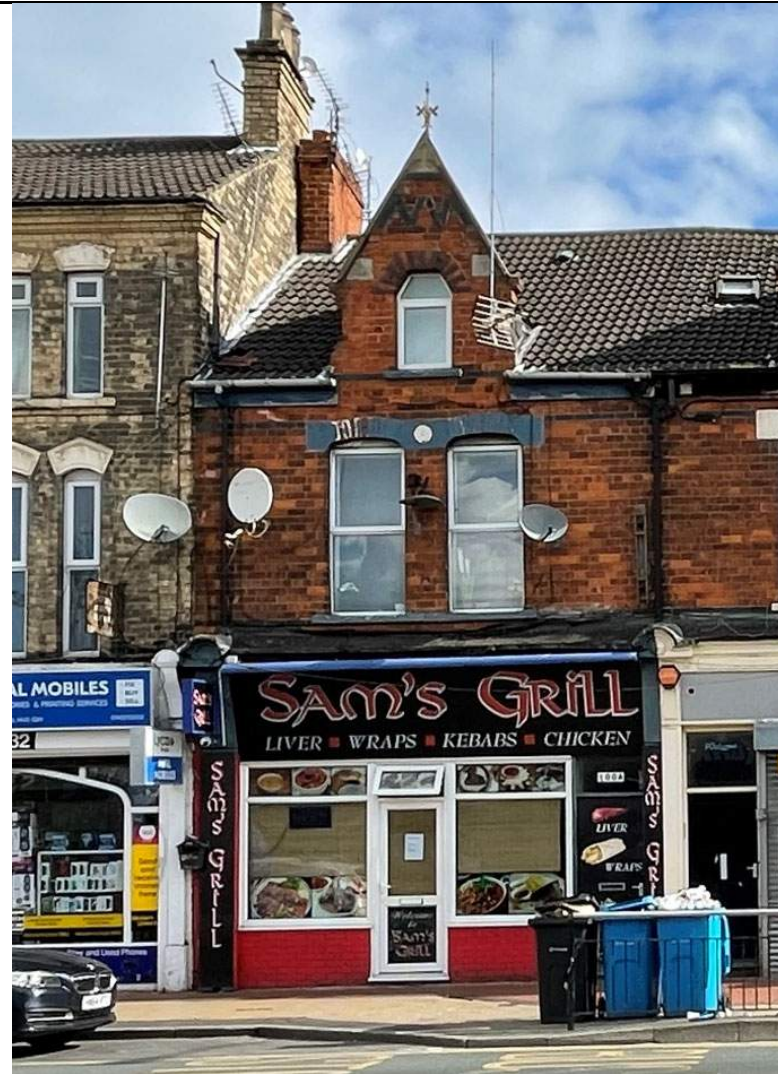
Address: Sam's Grill, 100

<p>Monitoring Notes</p>	<p>The building is in relatively good condition with limited signs of deterioration that put the building at risk. Any works that involve damage/loss of the decorative stone lintels, cills, retained stone corbel details, cornice and decorative brickwork should not be permitted.</p>
<p>Recommended Actions</p>	<p>As part of a group of four buildings along with No 94, 96 and 98 Spring Bank, the building would benefit from a collective restoration to achieve a cohesive restoration.</p>

- Reinstatement of the original shopfront design using the remnants of the original pilasters, cornice, corbels and fascia still in-situ at 96 Spring Bank.
- Reinstatement of awning and blind box within shopfront design as shown on 1904 photograph.
- Removal of uPVC windows and replacement with timber sliding sash windows (as retained in No 96).
- Re-decoration throughout.
- Reinstatement of decorative timber gutter support brackets (as No 96).
- Removal of PVC gutters and downpipes and the replacement with cast iron.
- Removal of the concrete pantile roof and replacement with a new slate roof.
- Rationalisation of the services, electrical conduits, sky dishes and alarm boxes.

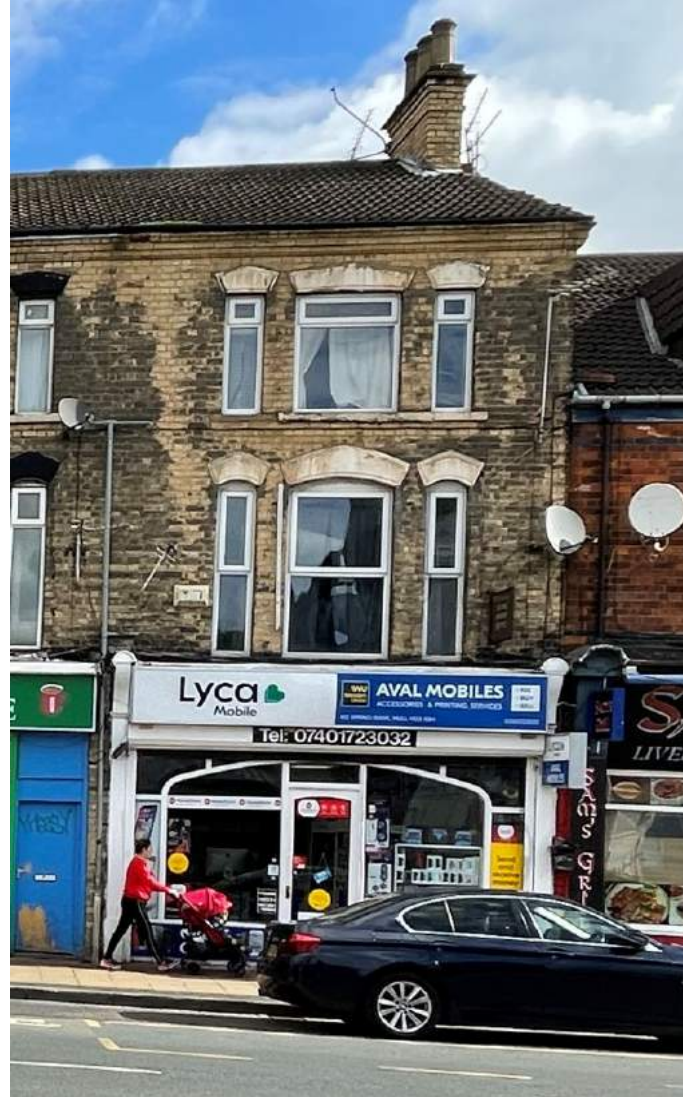
Address Lyca Mobiles and Repair shop, 102

Monitoring Notes	<p>The building is in relatively good condition with limited signs of deterioration that put the building at risk. Any works that involve damage/loss of the decorative stone lintels, cills, cornice and decorative stepped eaves brickwork should not be permitted.</p>
Recommended Actions	<p>As part of a group of six buildings along with No 104,106, 108,110 and 112 Spring Bank, the building would benefit from a collective restoration to achieve a cohesive restoration.</p> <p>Although the building has retained some of its earlier Victorian features, it would benefit from the following works :-</p> <ul style="list-style-type: none"> • Reinstatement of the original shopfront design using the remnants of the original pilasters, cornice, corbels and fascia using the photograph of the original corbel detail to determine the proportions of the shopfront. • Reinststate awning and blind box within shopfront design as shown on 1904 photograph. • Removal of uPVC windows and replacement with timber sliding sash windows to match historic photographs. • Re-decoration throughout. • Repair and restoration of the existing cast iron rainwater goods. • Removal of the concrete pantile roof and replacement with a new slate roof. • Rationalisation of the services, electrical conduits, sky dishes and alarm boxes.

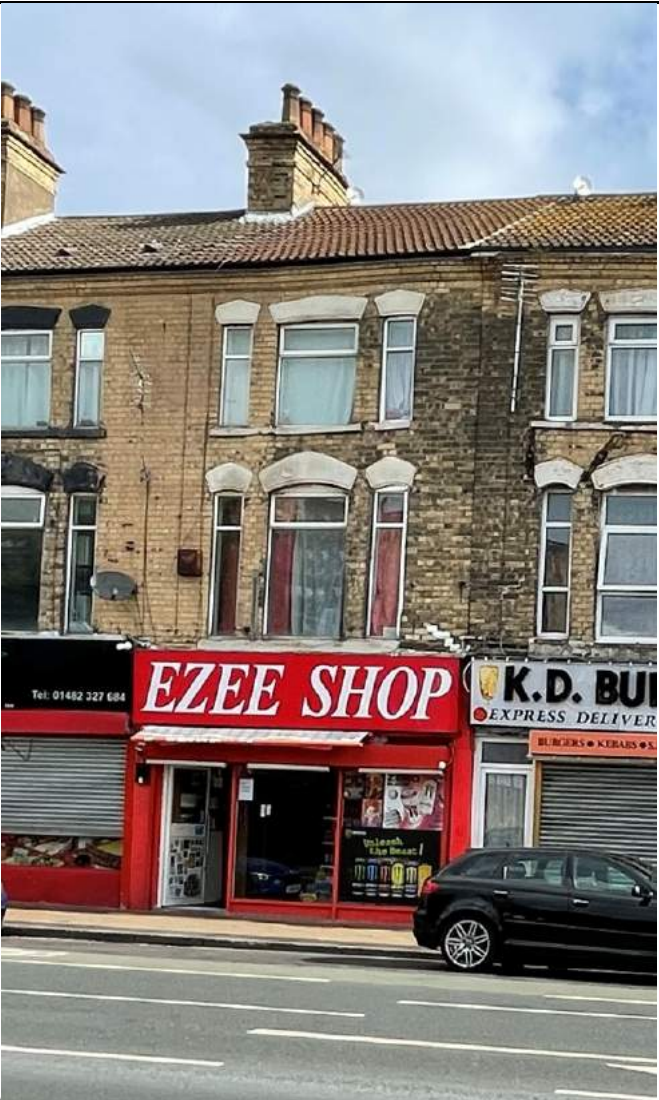
<p>Monitoring Notes</p>	<p>The building is in reasonable condition with limited signs of deterioration that put the building at risk. The building has suffered from structural movement/settlement in the past. Any works that involve damage/loss of the decorative stone lintels, cills, shopfront cornice and decorative stepped eaves brickwork should not be permitted.</p>
<p>Recommended Actions</p>	<p>As part of a group of six buildings along with No 102,104, 106,110 and 112 Spring Bank, the building would benefit from a collective restoration to achieve a cohesive restoration.</p> <p>Although the building has retained some of its earlier Victorian features, it would benefit from the following works :-</p> <ul style="list-style-type: none"> • Reinstatement of the original shopfront design using the remnants of the original pilasters, cornice, corbels and fascia using the photograph of the original corbel detail to determine the proportions of the shopfront. • Reinstatement awning and blind box within shopfront design as shown on 1904 photograph.

- Removal of uPVC windows and replacement with timber sliding sash windows to match historic photographs.
- Re-decoration throughout.
- Repair and restoration of the existing cast iron rainwater goods.
- Removal of the concrete pantile roof and replacement with a new slate roof.
- Rationalisation of the services, electrical conduits, sky dishes and alarm boxes.
