**Spring Bank Conservation Area
Management Plan (North side)**
Draft for Review

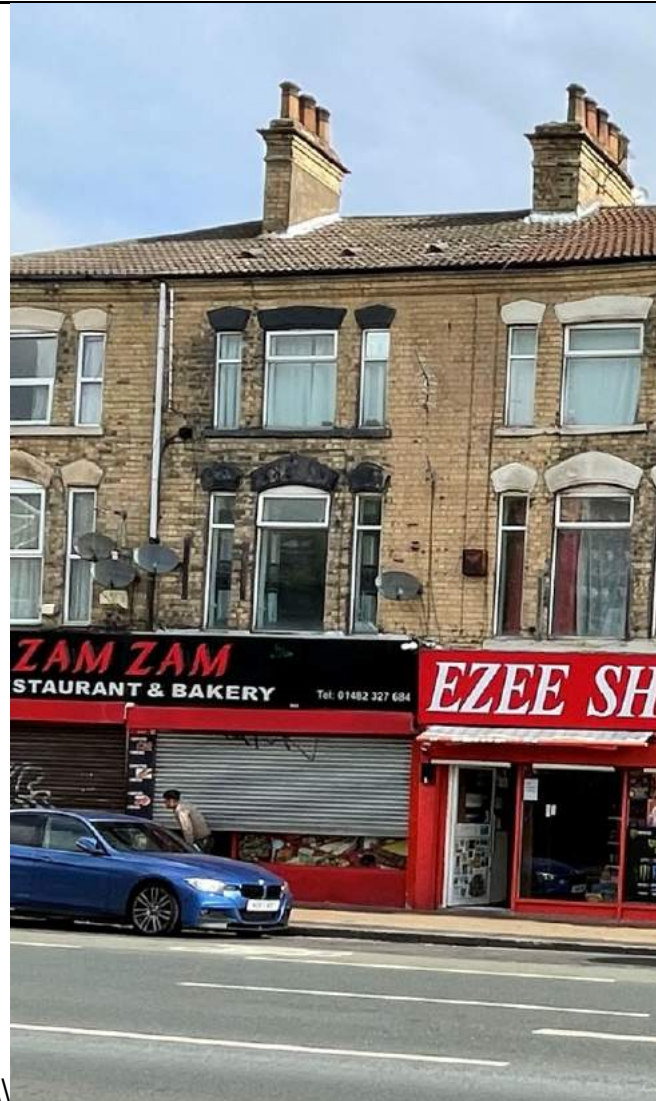
Monitoring Notes	<p>The building is in reasonable condition with limited signs of deterioration that put the building at risk. The building has suffered from structural movement/settlement in the past. Any works that involve damage/loss of the decorative stone lintels, cills, shopfront cornice and decorative stepped eaves brickwork should not be permitted.</p>
Recommended Actions	<p>As part of a group of six buildings along with No 102,104, 106,110 and 112 Spring Bank, the building would benefit from a collective restoration to achieve a cohesive restoration.</p> <p>Although the building has retained some of its earlier Victorian features, it would benefit from the following works :-</p> <ul style="list-style-type: none"> • Reinstatement of the original shopfront design using the remnants of the original pilasters, cornice, corbels and fascia using the photograph of the original corbel detail to determine the proportions of the shopfront. • Reinstatement awning and blind box within shopfront design as shown on 1904 photograph.

- Removal of uPVC windows and replacement with timber sliding sash windows to match historic photographs.
- Re-decoration throughout.
- Repair and restoration of the existing cast iron rainwater goods.
- Removal of the concrete pantile roof and replacement with a new slate roof.
- Rationalisation of the services, electrical conduits, sky dishes and alarm boxes.

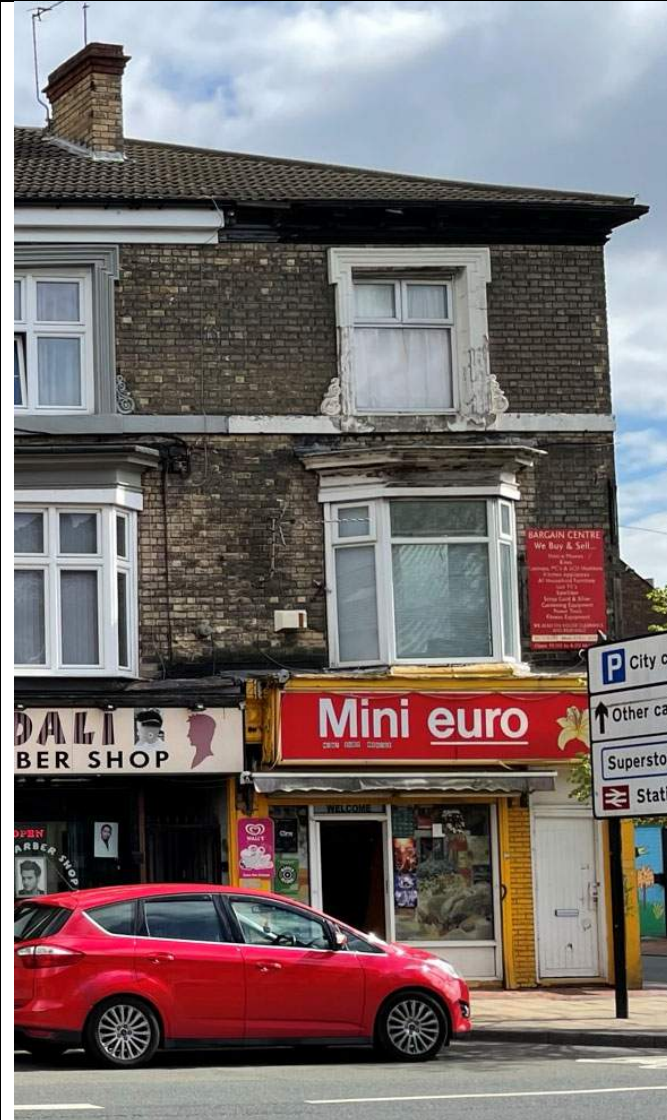
Address: Mini Euro, 114

Today in 2023, the shopfront has been replaced again with a new metal framed shopfront. The two corbel details have been retained but the scroll capital has been removed to the RHS. The upper floor windows have been replaced with uPVC windows with proportions that do not reflect the original design. The slate roof has been replaced with a concrete pantile roof finish. The timber gutter support brackets have been retained and are in good condition but the downpipes have been replaced with PVC downpipes. The door opening to the first floor level to the side elevation off Morpeth Street has been partially bricked up and a window installed.

The building is in reasonable condition but with some signs of deterioration. The staining of the first floor bay window would suggest that works are required to repair the leadwork to the roof of the bay window. The building has suffered from structural movement/settlement in the past. Any works that involve damage/loss of the decorative plaster window surrounds, cills, shopfront cornice and decorative timber eaves support brackets should not be permitted.

- Reinstatement of the original shopfront design using the remnants of the original pilasters, cornice, corbels (as retained between No 114 and 116) and fascia retained behind existing fascia signs.
- Removal of uPVC windows and replacement with timber casement windows to match historic photographs from 1994.
- Repair/replacement of leadwork to the bay window and the top of the shopfront cornice and fascia.
- Re-decoration throughout.
- Repair of the retained decorative timber eaves support brackets.
- Repair and restoration of the existing cast iron rainwater goods.
- Removal of the concrete pantile roof and replacement with a new slate roof.
- Rationalisation of the signage, services, electrical conduits, sky dishes and alarm boxes.

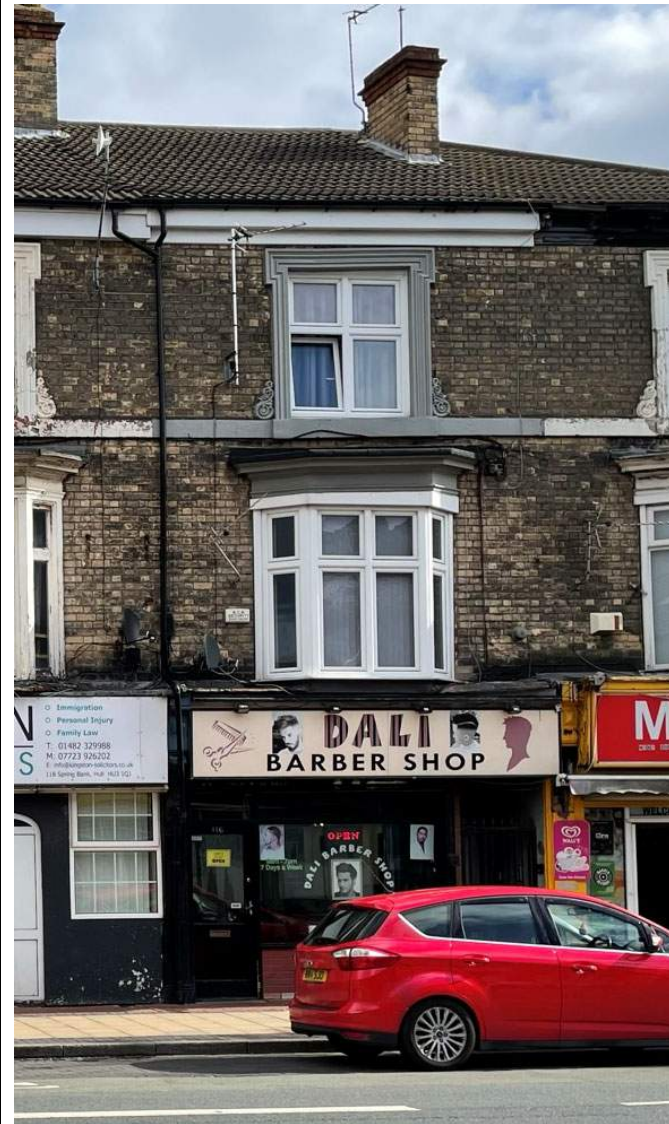
Address: Dali Barber Shop, 116

<p>Monitoring Notes</p>	<p>The building is in reasonable condition but with some signs of deterioration. The staining of the first floor bay window would suggest that works are required to repair the leadwork to the roof of the bay window and the leadwork flashings to the shopfront cornice. The building has suffered from considerable structural movement/settlement in the past. Any works that involve damage/loss of the decorative plaster window surrounds, cills, shopfront cornice and decorative timber eaves support brackets should not be permitted.</p>
<p>Recommended Actions</p>	<p>As part of a group of five buildings along with No 114,118, 120 and 122 Spring Bank, the building would benefit from a collective restoration to achieve a cohesive restoration.</p> <p>Although the building has retained some of its earlier Victorian features, it would benefit from the following works :-</p> <ul style="list-style-type: none"> • Reinstatement of the original shopfront design using the remnants of the original pilasters, cornice, corbels (as retained between No 114 and 116) and fascia retained behind existing fascia signs.

- Removal of uPVC windows and replacement with timber casement windows to match historic photographs from 1994.
- Repair/replacement of leadwork to the bay window and the top of the shopfront cornice and fascia.
- Re-decoration throughout.
- Removal of the timber fascia at eaves level and repair/reinstatement of the decorative timber eaves support brackets.
- Repair and restoration of the existing cast iron gutter and replacement of PVC downpipes with cast iron downpipes.
- Removal of the concrete pantile roof and replacement with a new slate roof.
- Rationalisation of the signage, services, electrical conduits, sky dishes and alarm boxes.

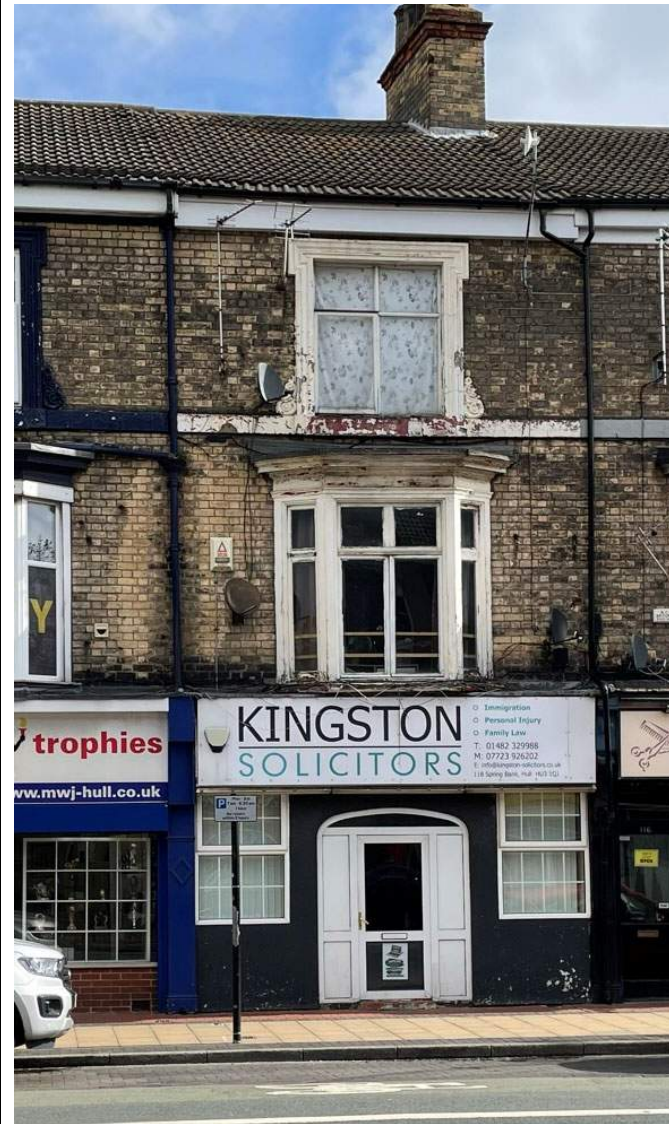
Address: Kingston Solicitors, 118

<p>Monitoring Notes</p>	<p>The building is in reasonable/poor condition with some signs of deterioration. The timber windows to the upper floor level have deteriorated and require repair. The decorative plasterwork has been damaged. The staining of the first floor bay window would suggest that works are required to repair the leadwork to the roof of the bay window and the leadwork flashings to the shopfront cornice. The building has suffered from considerable structural movement/settlement in the past. Any works that involve damage/loss of the decorative plaster window surrounds, cills, shopfront cornice and decorative timber eaves support brackets should not be permitted.</p>
<p>Recommended Actions</p>	<p>As part of a group of five buildings along with No 114,116, 120 and 122 Spring Bank, the building would benefit from a collective restoration to achieve a cohesive restoration.</p> <p>Although the building has retained some of its earlier Victorian features, it would benefit from the following works :-</p>

- Reinstatement of the original shopfront design using the remnants of the original pilasters, cornice, corbels (as retained between No 114 and 116) and fascia retained behind existing fascia signs.
- Removal of the low quality opening windows and replacement with timber casement windows to match historic photographs from 1994.
- Repair/replacement of leadwork to the bay window and the top of the shopfront cornice and fascia.
- Re-decoration throughout.
- Removal of the timber fascia at eaves level and repair/reinstatement of the decorative timber eaves support brackets.
- Repair and restoration of the existing cast iron gutter and replacement of PVC downpipes with cast iron downpipes.
- Removal of the concrete pantile roof and replacement with a new slate roof.
- Rationalisation of the signage, services, electrical conduits, sky dishes and alarm boxes.

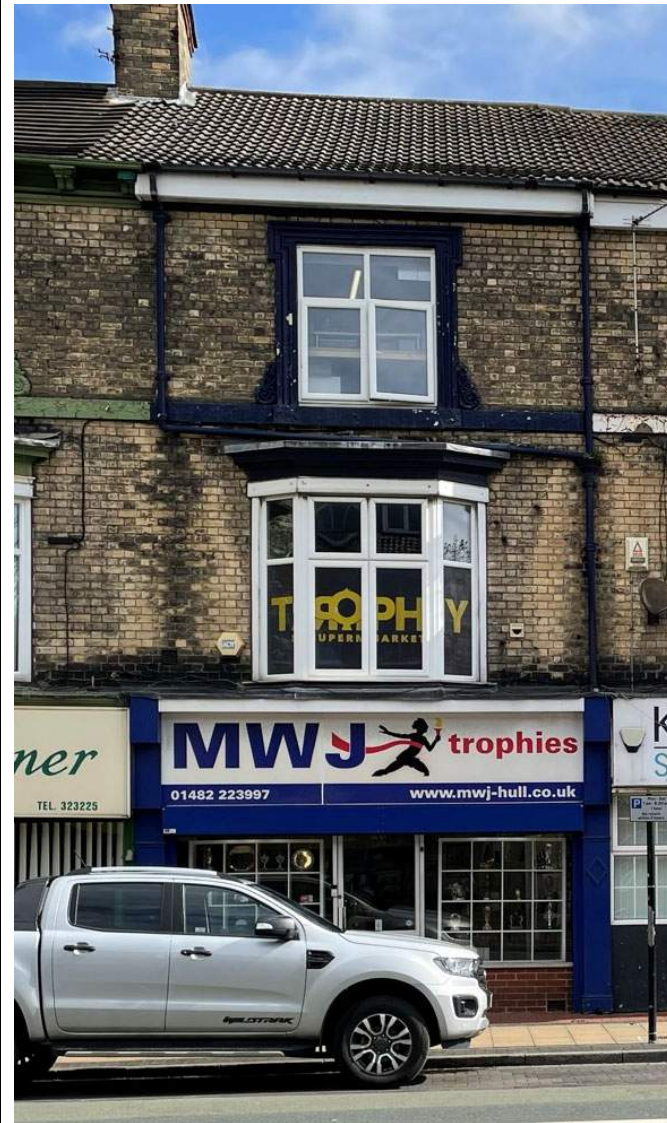
Address: MWJ Trophies, 120

<p>Monitoring Notes</p>	<p>The building is in reasonable/poor condition with some signs of deterioration. The timber windows to the upper floor level have deteriorated and require repair. The decorative plasterwork has been damaged. The staining of the first floor bay window would suggest that works are required to repair the leadwork to the roof of the bay window and the leadwork flashings to the shopfront cornice. The building has suffered from considerable structural movement/settlement in the past. Any works that involve damage/loss of the decorative plaster window surrounds, cills, shopfront cornice and decorative timber eaves support brackets should not be permitted.</p>
<p>Recommended Actions</p>	<p>As part of a group of five buildings along with No 114,116, 118 and 122 Spring Bank, the building would benefit from a collective restoration to achieve a cohesive restoration.</p> <p>Although the building has retained some of its earlier Victorian features, it would benefit from the following works :-</p> <ul style="list-style-type: none"> • Reinstatement of the original shopfront design using the remnants of the original pilasters, cornice, corbels (as retained between No 114 and 116) and fascia retained behind existing fascia signs.

- Removal of the low quality opening windows and replacement with timber casement windows to match historic photographs from 1994.
- Repair/replacement of leadwork to the bay window and the top of the shopfront cornice and fascia.
- Repair of the decorative plasterwork scrolls and mouldings.
- Re-decoration throughout.
- Removal of the timber fascia at eaves level and repair/reinstatement of the decorative timber eaves support brackets.
- Repair and restoration of the existing cast iron gutter and replacement of PVC downpipes with cast iron downpipes.
- Removal of the concrete pantile roof and replacement with a new slate roof.
- Rationalisation of the signage, services, electrical conduits, sky dishes and alarm boxes.

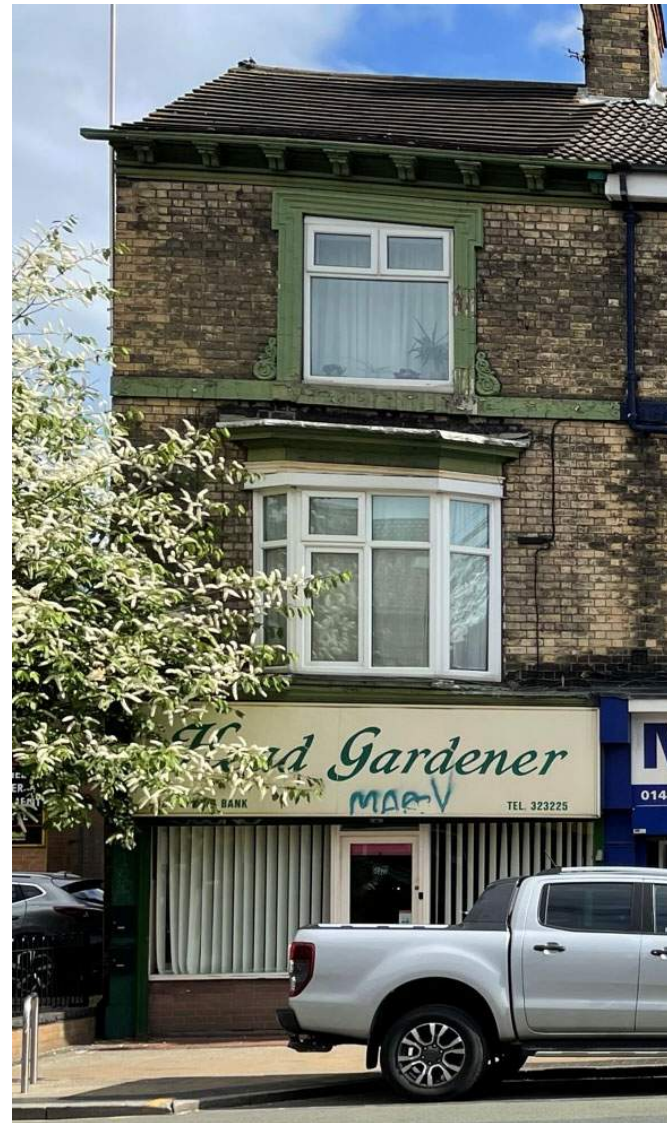
Monitoring Notes	<p>The building is in reasonable/poor condition with some signs of deterioration. The decorative plasterwork has been damaged. The staining of the first floor bay window would suggest that works are required to repair the leadwork to the roof of the bay window and the leadwork flashings to the shopfront cornice. The building has suffered from considerable structural movement/settlement in the past. Any works that involve damage/loss of the decorative plaster window surrounds, cills, shopfront cornice and decorative timber eaves support brackets should not be permitted.</p>
Recommended Actions	<p>As part of a group of five buildings along with No 114,116, 118 and 120 Spring Bank, the building would benefit from a collective restoration to achieve a cohesive restoration.</p> <p>Although the building has retained some of its earlier Victorian features, it would benefit from the following works :-</p> <ul style="list-style-type: none"> • Reinstatement of the original shopfront design using the remnants of the original pilasters, cornice, corbels (as retained between No 114 and 116) and fascia retained behind existing fascia signs. • Removal of the low quality uPVC windows and replacement with timber casement windows to match historic photographs from 1994. • Repair/replacement of leadwork to the bay window and the top of the shopfront cornice and fascia.

- Re-decoration throughout.
- Repair of the decorative plasterwork scrolls and mouldings.
- Removal of the timber fascia at eaves level and repair/reinstatement of the decorative timber eaves support brackets.
- Repair and restoration of the existing cast iron gutter and replacement of PVC downpipes with cast iron downpipes.
- Repair of the existing slate roof where damaged/slates are missing.
- Rationalisation of the signage, services, electrical conduits, sky dishes and alarm boxes.

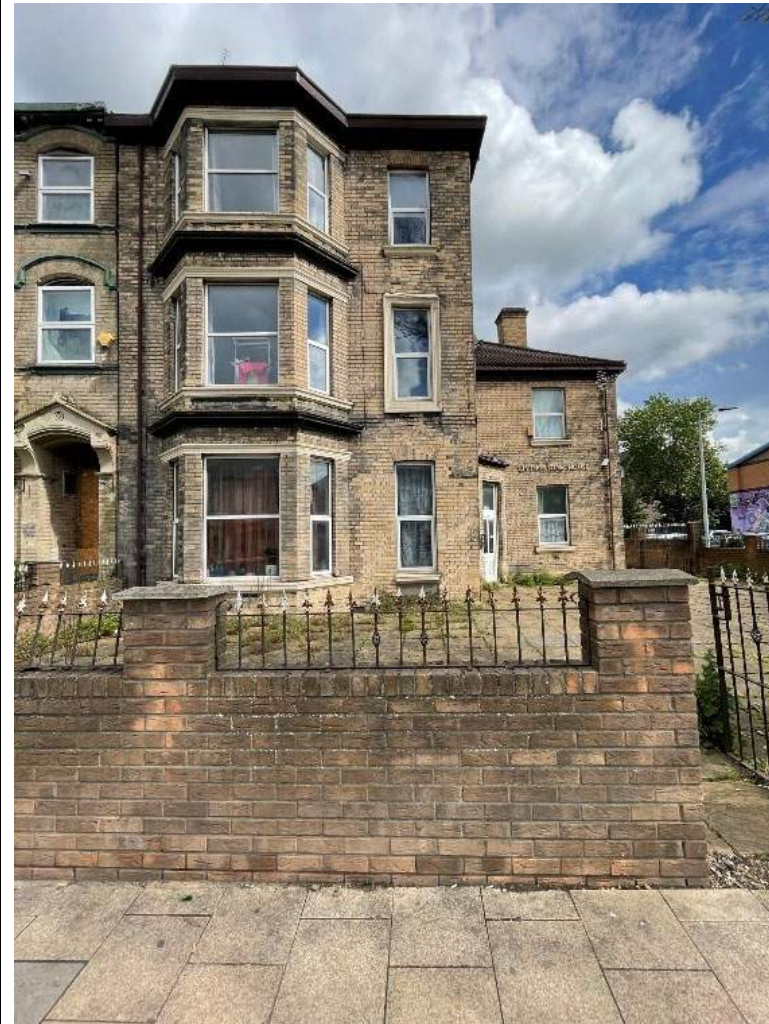
Address: Elderley Care Home, Livingstone House 136

Monitoring Notes	<p>The building is in reasonable condition with limited signs of deterioration. Any works that involve damage/loss of the decorative stone window cills, lintels and decorative plaster surrounds to windows should not be permitted.</p>
Recommended Actions	<p>Although the building has retained some of its earlier Victorian features, it would benefit from the following works :-</p> <ul style="list-style-type: none"> • Removal of the uPVC windows and replacement with timber sash windows to match historic photographs. • Repair of the decorative plasterwork window surrounds. • Removal of the timber fascia at eaves level and repair/reinstatement of the decorative timber eaves support brackets. • Replacement of PVC downpipes and gutters with cast iron. • Removal of the concrete pantile roof finish and reinstatement of the slate tile finish. • Rationalisation of the signage, services, electrical conduits, sky dishes and alarm boxes. • Replacement of the hedge planting to the boundary with Spring Bank and Hutt Street.

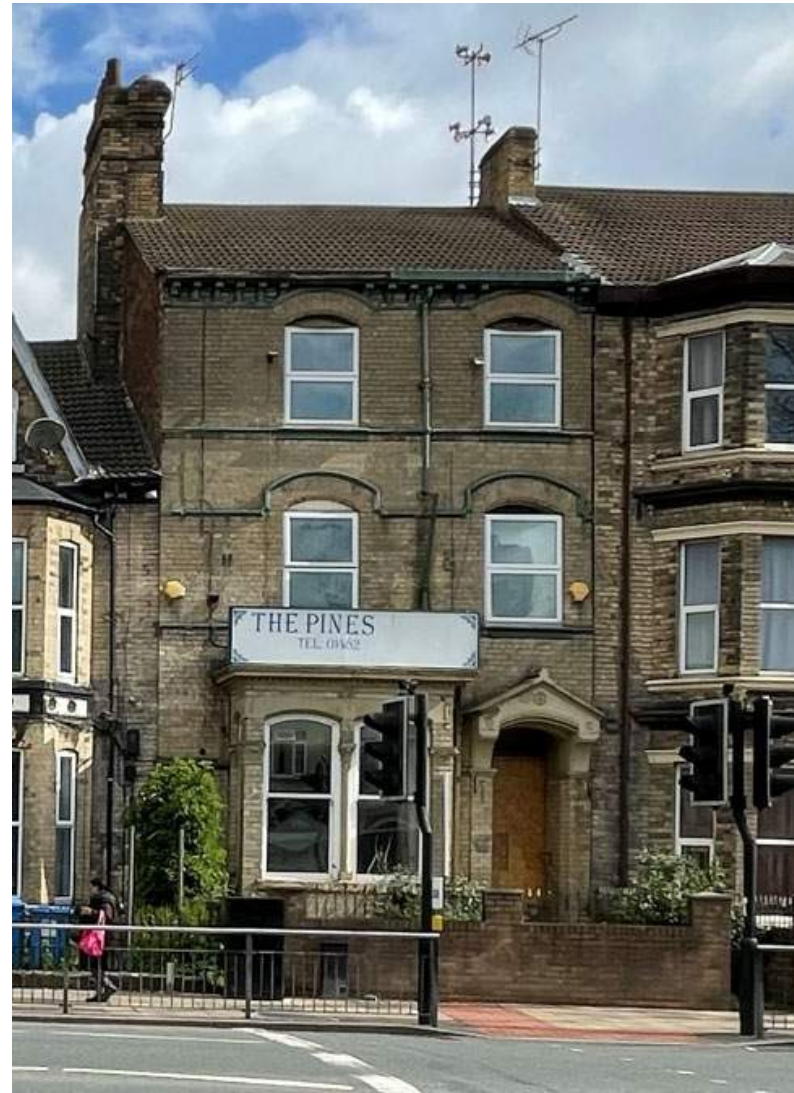
Monitoring Notes	<p>The building is in a poor condition having been left unoccupied since 2012. The gutters and downpipes are particularly defective and may cause increased rate of deterioration if not addressed. Any works that involve damage/loss of the decorative stonework, arched brick lintels, decorative stone portico, timber sliding sash windows and carved stone features should not be permitted.</p>
Recommended Actions	<p>Although the building has retained some of its earlier Victorian features, it would benefit from the following works :-</p> <ul style="list-style-type: none"> • Removal of the uPVC windows and replacement with timber sash windows to match historic photographs to the first and second floor level. • Repair of the decorative stone detailing. • Repair/replacement of the cast iron downpipe. • Removal of the defective timber fascia at eaves level and repair/reinstatement of the decorative timber eaves support brackets and fascias. • Removal of the concrete pantile roof finish and reinstatement of the slate tile finish. • Rationalisation of the signage, services, electrical conduits, sky dishes and alarm boxes.

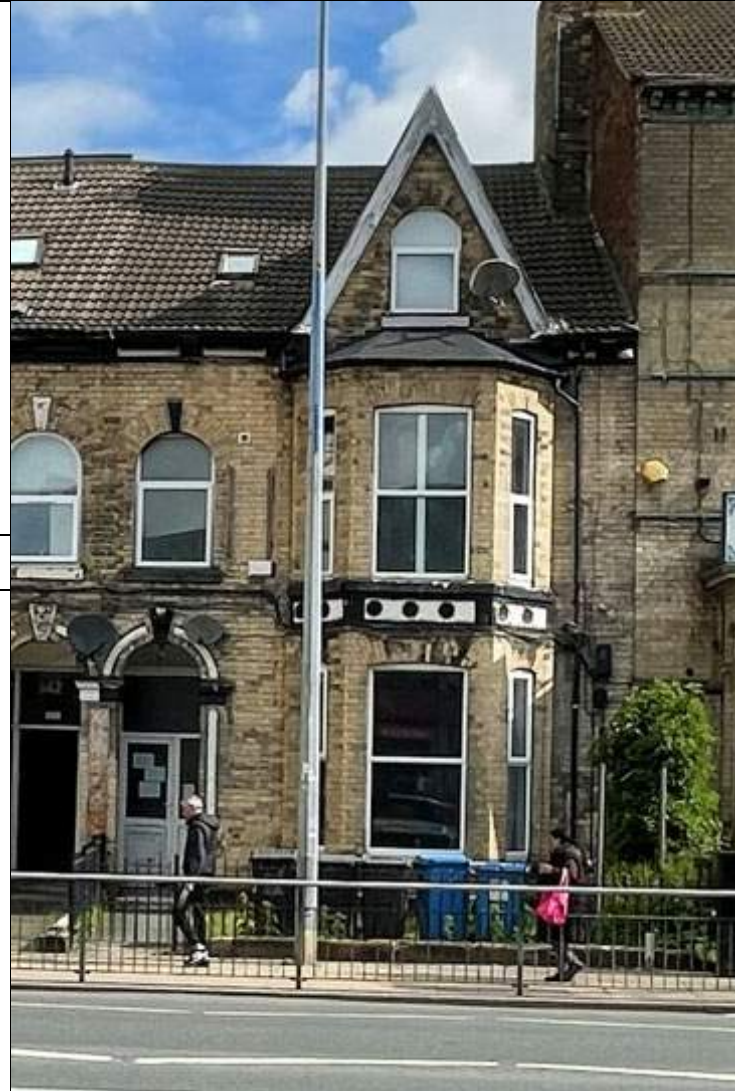
Kelvin House, 140

The building is in a reasonable condition although it has lost some of its original features. Any works that involve damage/loss of the decorative stonework, arched brick lintels and stone keystones, decorative plaster arched porch details should not be permitted.

- Removal of the uPVC windows and replacement with timber sash windows to match historic evidence (as No 142 adjacent).
- Repair of the decorative stone detailing and removal of layers of paint.
- Repair/replacement of the cast iron downpipe and gutters where required.

- Removal of the simple timber fascia at eaves level to the feature gable and replacement with a decorative cut-out fascia and timber carves spire at the ridge (as No 142).
- Removal of the concrete pantile roof finish and reinstatement of the slate tile finish.
- Rationalisation of the services, electrical conduits, sky dishes and alarm boxes.
- Removal of the uPVC entrance door and glazed screen and replacement with a new timber door and glazed screen surround to match the adjacent No 142 original detail.
- Removal of paint/repair/reinstatement of the glazed tile details to the entrance porch recess (as No 142).
- Installation of a consistent boundary treatment with low level wall and railings across the group.

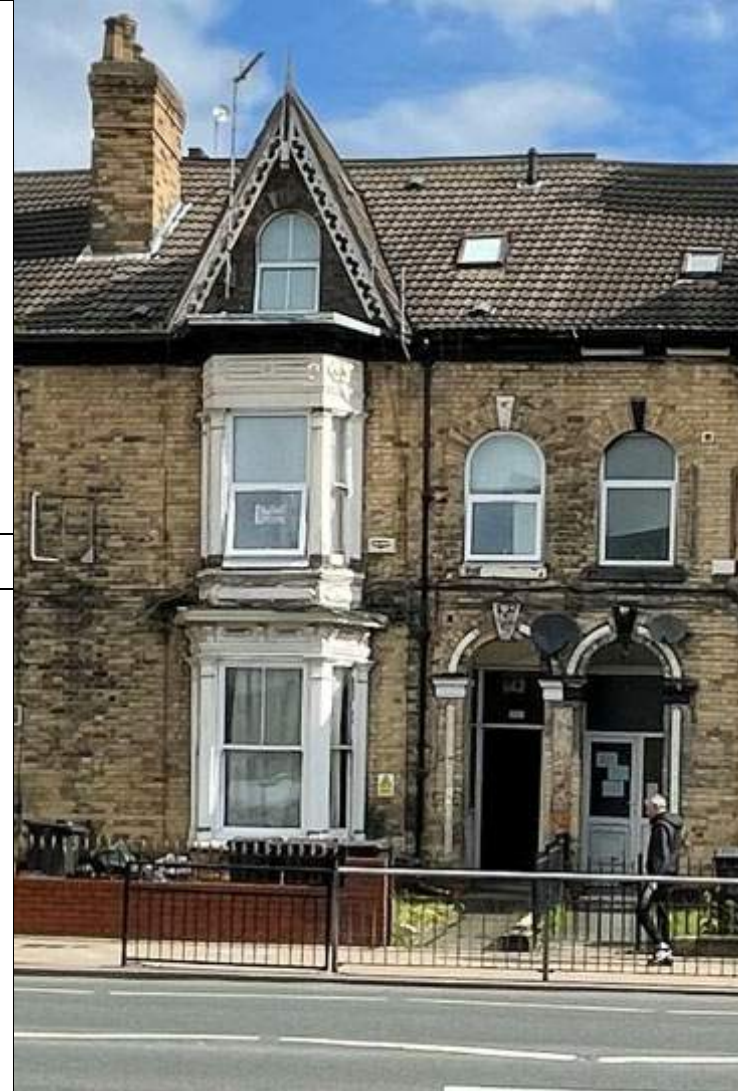
<p>Monitoring Notes</p>	<p>The building is in a reasonable condition although it is showing signs of continued deterioration and lack of maintenance, particularly to the bay window at first floor level. No 142 has retained the majority of original features from the overall group and therefore any works that involve damage/loss of the decorative stonework, arched brick lintels and stone keystones, decorative stone arched porch details or the timber details to the bay window should not be permitted.</p>
<p>Recommended Actions</p>	<p>Although the building has retained many of its earlier Victorian features, it would benefit from the following works :-</p> <ul style="list-style-type: none"> • Repair and redecoration of the timber sash windows and the timberwork to the bay window. • Repair/replacement of the lead flashing detail to the ground floor bay window to take water away from the brick wall.

- Reinstatement of the decorative plaster frieze to the arched door surround (using No 140 as the template).
- Repair of the decorative stone detailing and removal of layers of paint.
- Repair/replacement of the cast iron downpipe and gutters where required.
- Repair of the lower finial to the spire at the ridge (as No 144).
- Removal of the concrete pantile roof finish and reinstatement of the slate tile finish.
- Rationalisation of the services, electrical conduits, sky dishes and alarm boxes.
- Repair and redecoration of the original timber door and glazed screen surround.
- Removal of paint/repair/reinstatement of the glazed tile details to the entrance porch recess.
- Reinstatement of the decorative Victorian tiles to the porch threshold (as No 140)
- Installation of a consistent boundary treatment with low level wall and railings across the group.

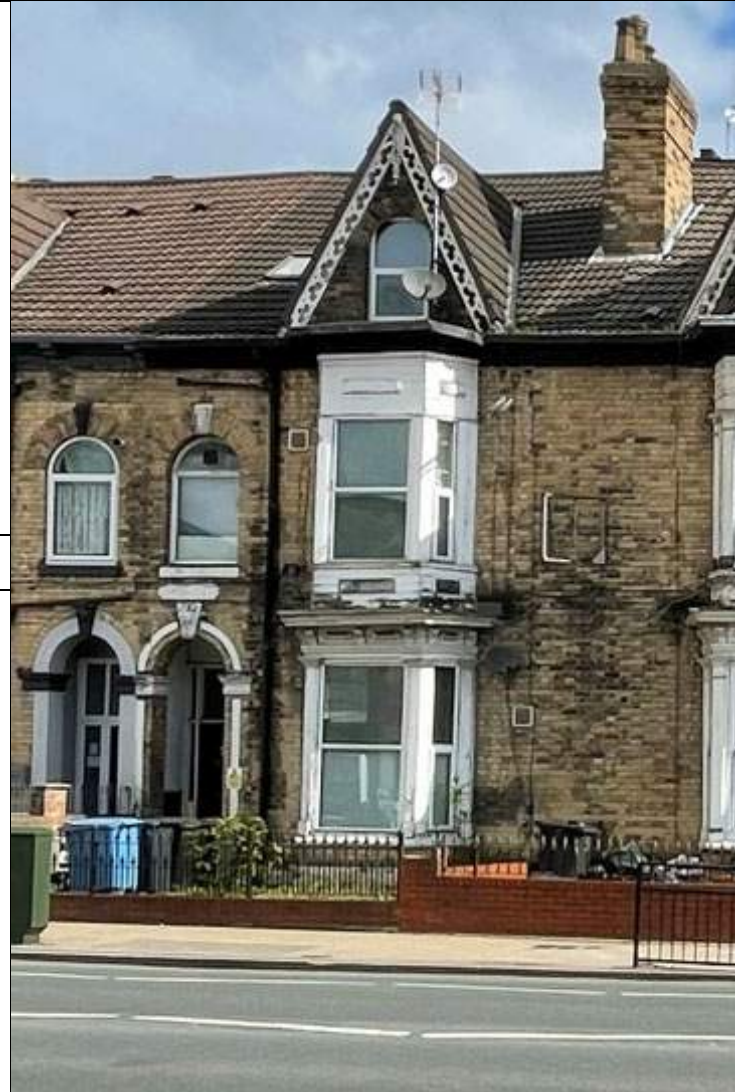
Jigsaw House, 144

The 2023 photograph shows that many of the original features have been retained including the decorative stone keystone to the arched entrance portico, the original glazed screen surround (although the door has been replaced), elements of the original timber detailing and panelling to the bay window, the decorative eaves supports, the cut-out timber fascia and decorative timber spire to the gable dormer (albeit the top section has been removed). The decorative plaster frieze to the arched door surround has been removed and the windows have been replaced with uPVC. Staining on the brickwork would suggest that the downpipes require repair or replacement.

The building is in a reasonable condition although it is showing signs of continued deterioration and lack of maintenance, particularly to the bay window at first floor level. No 144 has retained some of its original features from the overall group and any works that involve damage/loss of the decorative stonework, arched brick lintels and stone keystones or timber details to the bay window, should not be permitted.

- Repair and redecoration of the timberwork to the bay window.
- Remove the uPVC windows and replace with timber sash windows.
- Reinstatement of the decorative plaster frieze to the arched door surround (using No 140 as the template).

- Repair of the decorative stone detailing and removal of layers of paint.
- Repair/replacement of the cast iron downpipe and gutters where required.
- Repair of the upper finial to the spire at the ridge (as No 142).
- Removal of the concrete pantile roof finish and reinstatement of the slate tile finish.
- Rationalisation of the services, electrical conduits, sky dishes and alarm boxes.
- Repair and redecoration of the original timber glazed screen and replacement of the door with a new timber door with glazed upper panels (using 142 as the template).
- Removal of paint/repair/reinstatement of the glazed tile details to the entrance porch recess (if retained).
- Reinstatement of the decorative Victorian tiles to the porch threshold (as No 140).

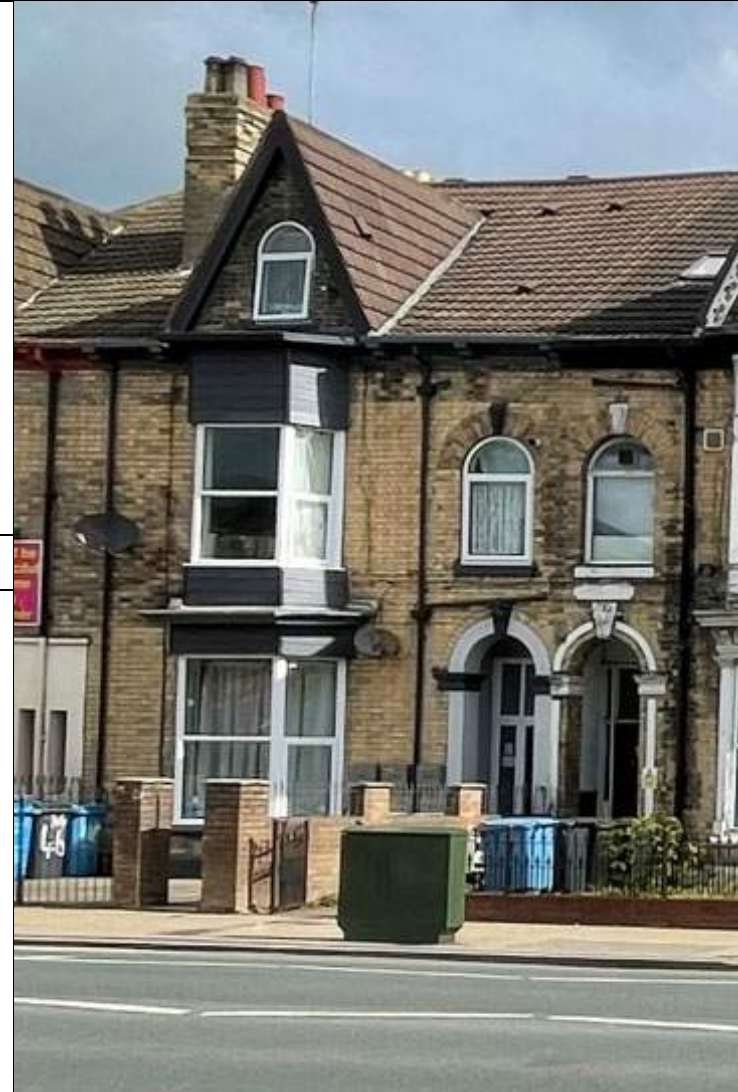
<p>Monitoring Notes</p>	<p>The building is in a reasonable condition and has recently been renovated and redecorated. No 146 has retained some of its original features from the overall group and any works that involve damage/loss of the decorative stonework, arched brick lintels and stone keystones or timber details to the bay window, should not be permitted.</p>
<p>Recommended Actions</p>	<p>Although the building has retained some of its earlier Victorian features, it would benefit from the following works :-</p> <ul style="list-style-type: none"> • Removal of the timber cladding, repair and redecoration of the timberwork to the bay window. • Remove the uPVC windows and replace with timber sash windows. • Reinstatement of the decorative plaster frieze to the arched door surround (using No 140 as the template). • Repair of the decorative stone detailing and removal of layers of paint.

- Repair of the cast iron downpipe and gutters where required.
- Reinstatement of the spire at the ridge (as No 142).
- Reinstatement of the decorative timber cut-out fascia (as No 142).
- Removal of the concrete pantile roof finish and reinstatement of the slate tile finish.
- Rationalisation of the services, electrical conduits, sky dishes and alarm boxes.
- Reinstatement of the original timber glazed screen and timber door with glazed upper panels (using 142 as the template).
- Removal of paint/repair/reinstatement of the glazed tile details to the entrance porch recess (if retained).
- Reinstatement of the decorative Victorian tiles to the porch threshold (as No 140).

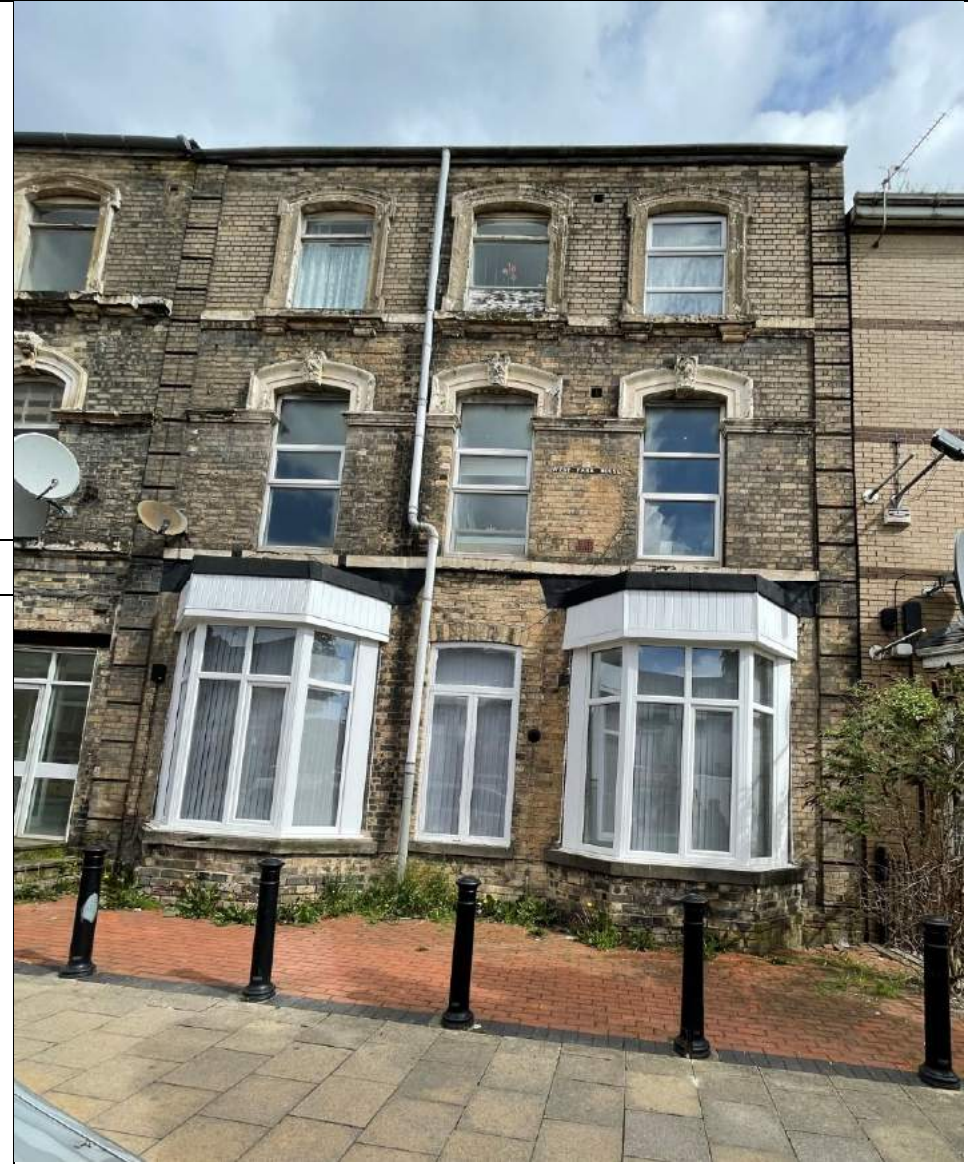
West Park House, 154

<p>Monitoring Notes</p>	<p>The building is in a generally poor condition and is suffering from a lack of general maintenance. Weed and vegetation growth around the perimeter of the building would suggest that external falls are not taking water away from the building. The decorative stone string course and stone window surrounds require repair and redecoration and possible reprofiling to take surface water away from the building more effectively.</p>
<p>Recommended Actions</p>	<p>Although the building has retained some of its earlier Victorian features, it would benefit from the following works :-</p> <ul style="list-style-type: none"> • Removal of the timber cladding to the bay windows and reinstatement of the arched window lintels. • Removal of the uPVC windows and replacement with timber casement windows with proportions to match historical photographs. • Removal of the PVC rain water goods and replacement with cast iron rainwater goods.

- Repair/reprofile of the stone cills and string course to take surface water away from the brickwork and windows.
- Redecoration throughout.
- Reinstatement of the original door opening to provide access to the garden area.
- Improved boundary treatment and the introduction of soft planting.

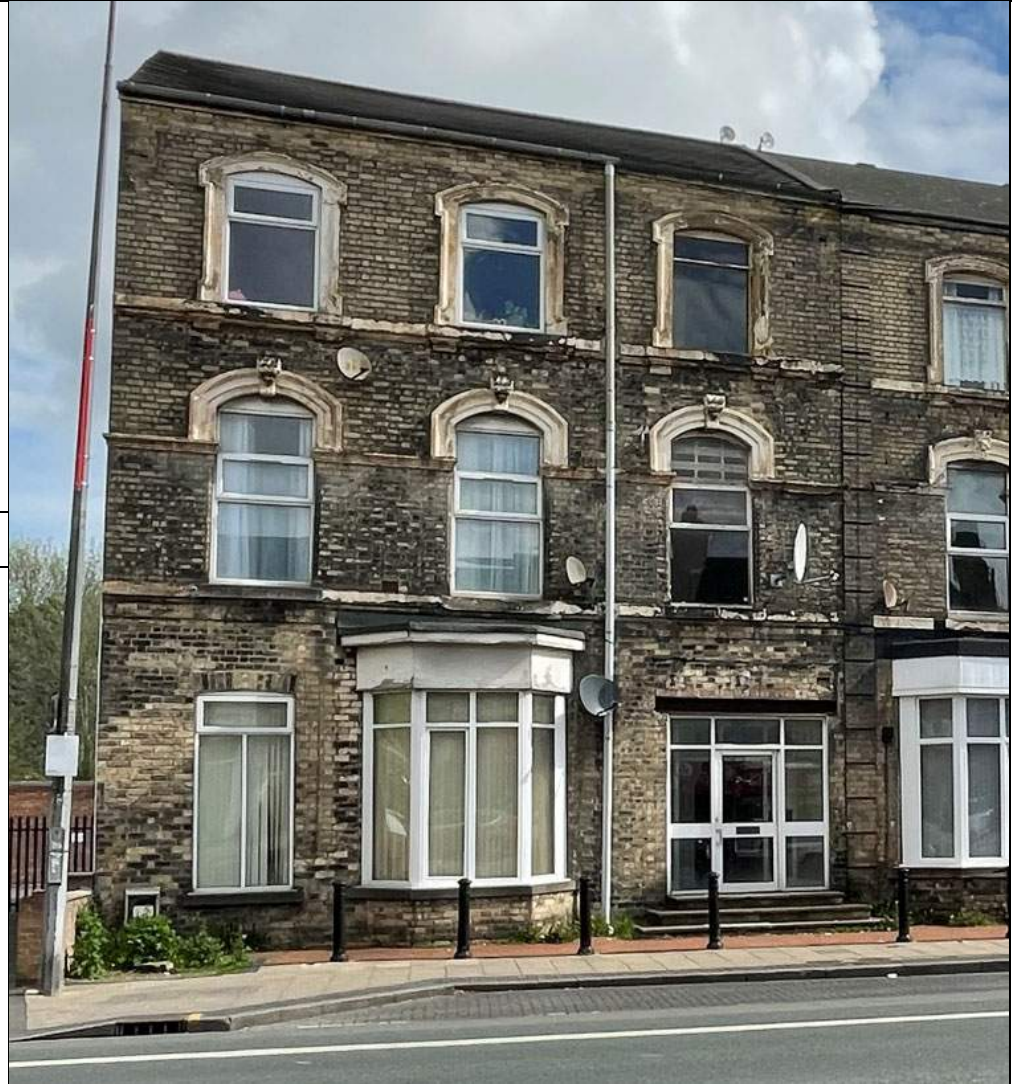
<p>Monitoring Notes</p>	<p>The building is in a generally poor condition and is suffering from a lack of general maintenance. Weed and vegetation growth around the perimeter of the building would suggest that external falls are not taking water away from the building. The decorative stone string course and stone window surrounds require repair and redecoration and possible reprofiling to take surface water away from the building more effectively.</p>
<p>Recommended Actions</p>	<p>Although the building has retained some of its earlier Victorian features, it would benefit from the following works :-</p> <ul style="list-style-type: none"> • Removal of the timber cladding to the bay windows and reinstatement of the original window lintels. • Removal of the uPVC windows and replacement with timber casement windows with proportions to match historical photographs. • Removal of the PVC rain water goods and replacement with cast iron rainwater goods. • Repair/reprofile of the stone cills and string course to take surface water away from the brickwork and windows. • Reinstatement of the original door opening. • Improved boundary treatment and the introduction of soft planting.

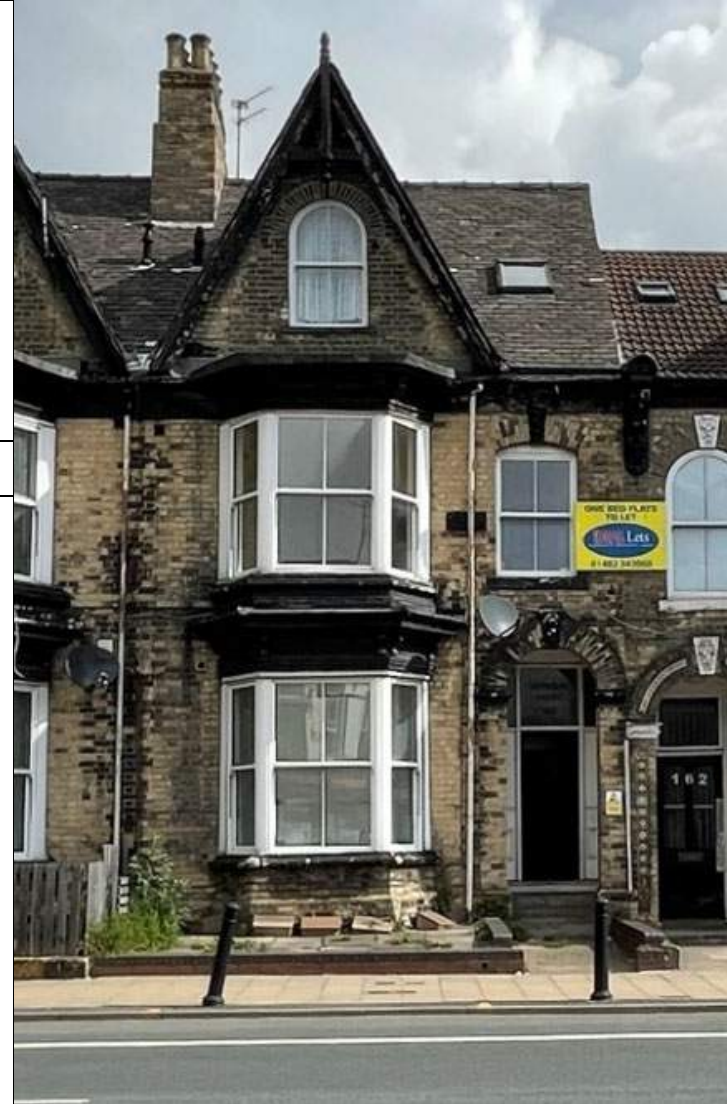
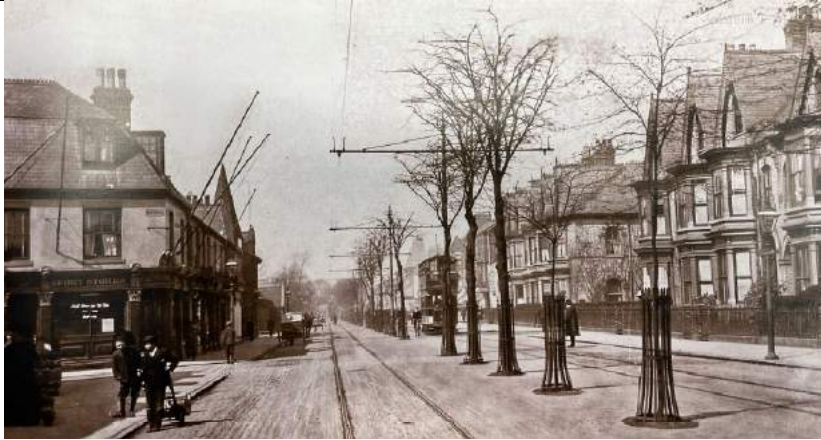
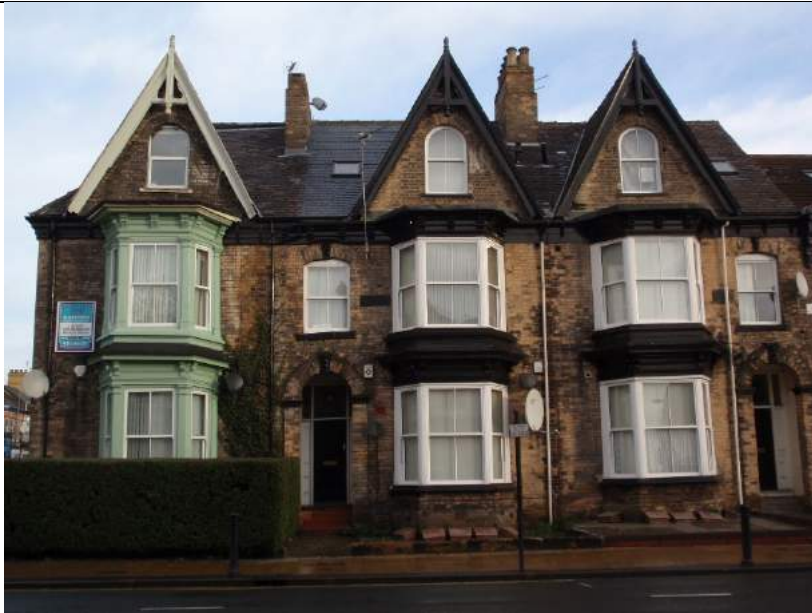
Seymour House, 164

Monitoring Notes	<p>The building is generally in a reasonable condition although the removal of the boundary stone plinth, cast iron railings and hedge has a detrimental impact on the buildings setting. Any proposals to remove the retained Victorian glazed screen to the entrance should not be supported.</p>
Recommended Actions	<p>164 has retained many of it's original late Victorian features but would benefit from the following works :-</p>

- Removal of the uPVC windows throughout and the replacement with timber sash windows to reflect the proportions of the 1904 photograph showing the original windows.

- Reinstatement of the timber pilasters to the bay windows (to match 168).
- Repair and redecoration of the timber glazed screen and the replacement of the door with a new timber glazed door to match the original design with the central rail aligned with the retained glazed screen surround.

- Redecoration throughout with a lighter colour (currently black) to allow the detail at roof level to be clearly visible.
- Repair of leadwork flashings to the bay window.

- Repair of the timber spire to replace the top section.
- Removal of PVC rainwater goods and replacement with cast iron.
- Installation of a stone boundary plinth (to match 166) with iron railings.

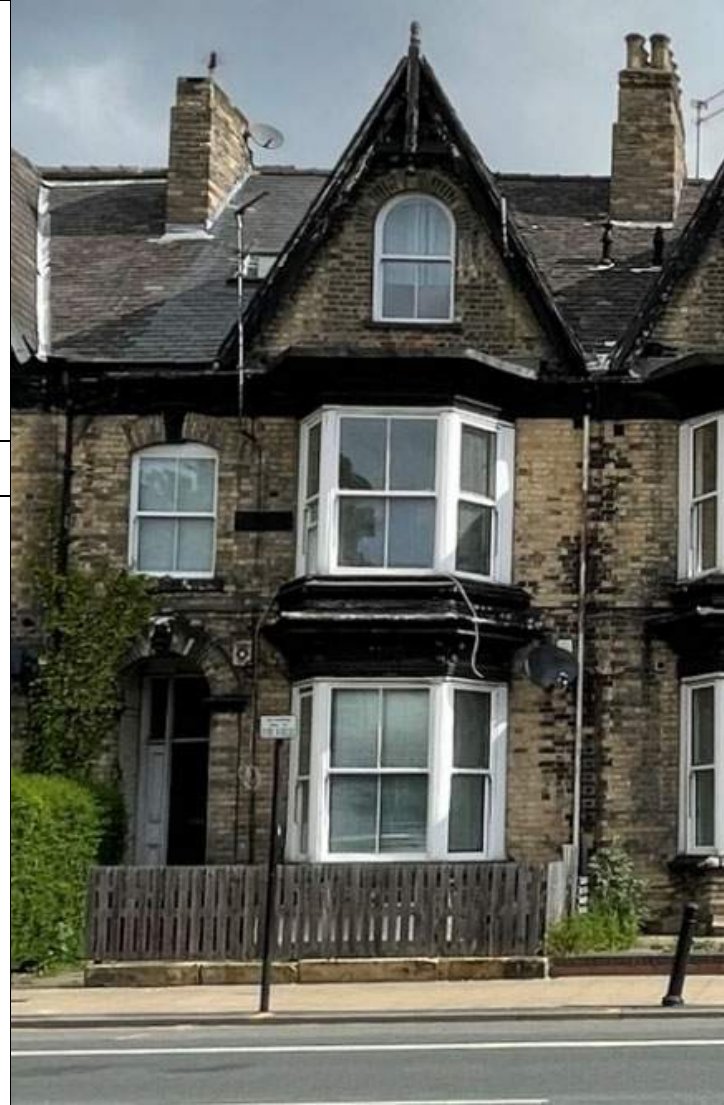
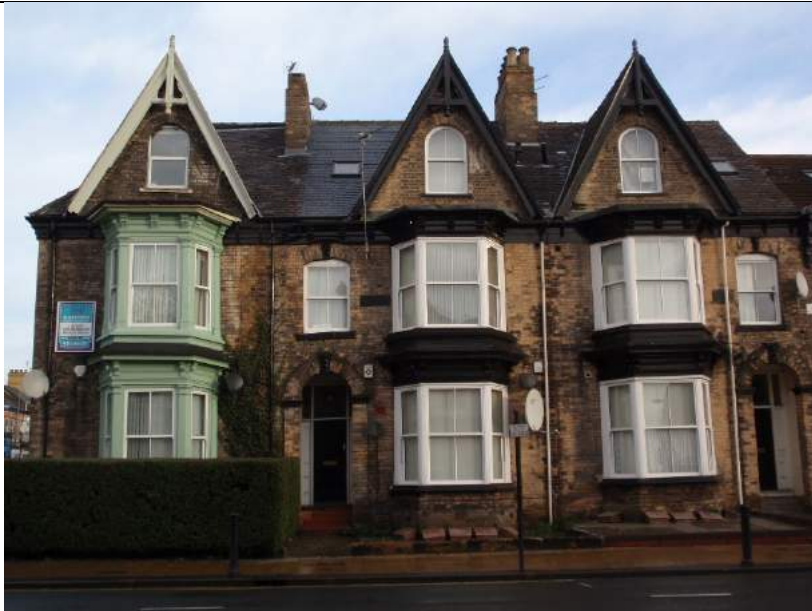
166

Monitoring Notes	<p>The building is generally in a reasonable condition although the removal of the cast iron railings and hedge has a detrimental impact on the buildings setting. Any proposals to remove the retained Victorian glazed screen to the entrance should not be supported.</p>
Recommended Actions	<p>166 has retained many of its original late Victorian features but would benefit from the following works :-</p> <ul style="list-style-type: none"> • Removal of the uPVC windows throughout and the replacement with timber sash windows to reflect the proportions of the 1904 photograph showing the original windows. • Reinstatement of the timber pilasters to the bay windows (to match 168).

- Repair and redecoration of the timber glazed screen and the replacement of the door with a new timber glazed door to match the original design with the central rail aligned with the retained glazed screen surround.
- Redecoration throughout with a lighter colour (currently black) to allow the detail at roof level to be clearly visible.
- Repair of leadwork flashings to the bay window.
- Repair of the timber spire and restraint ties.
- Removal of PVC rainwater goods and replacement with cast iron.
- Repair of the stone boundary plinth (to match 166) and reinstate iron railings.
- Soft planting to the front garden to provide privacy to the ground floor apartment and enhance the character of the Conservation Area.
