**Spring Bank Conservation Area
Management Plan (North side)**
Draft for Review

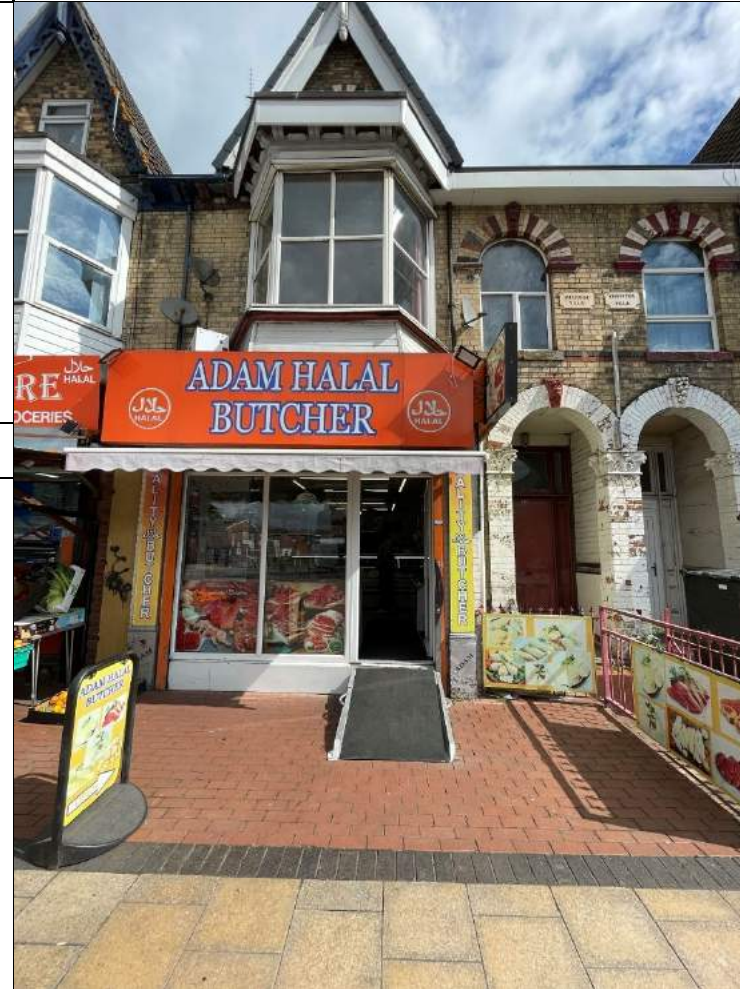
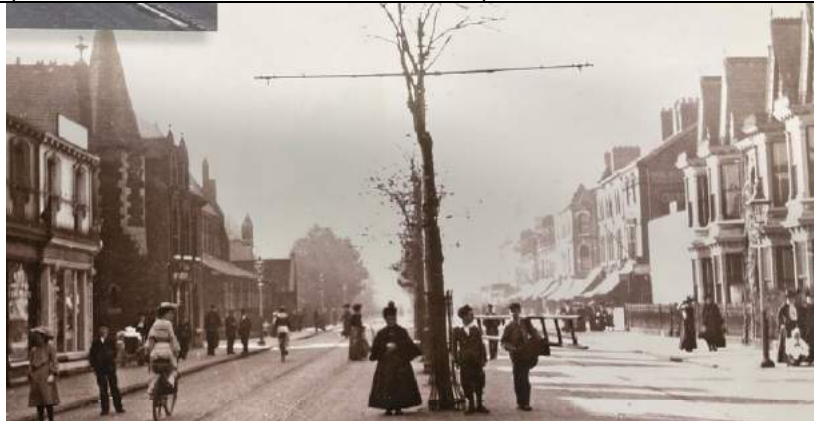
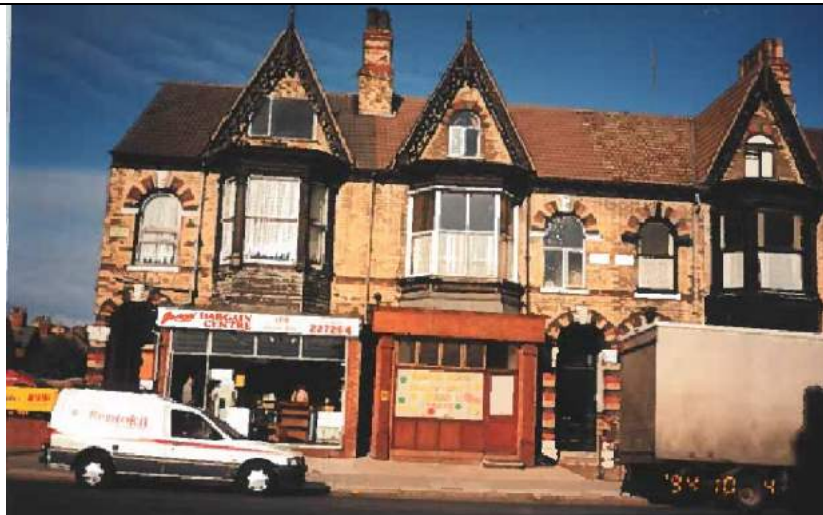
Street: Spring Bank	Melrose Villa, 176
Historic Photo – 1904 (Hull Then and Now, Paul Gibson)	Current Photo – 11/05/2023 (author)

Monitoring Notes	<p>The building is generally in a reasonable condition with no immediate risks identified. Any proposals to remove the retained (but concealed) bay window details along with the removal of contrasting brickwork, stone carved keystones, Corinthian details to entrance arch, glazed timber framed screen and original entrance door, Victorian tiles to the porch, cut-out timber fascia to the feature gable and decorative timber eaves supports should not be permitted.</p>
Recommended Actions	<p>As part of a group of buildings along with 170, 172, 174 and 178, they would benefit from a collective restoration as a group.</p> <p>176 has retained many of its original late Victorian features but would benefit from the following works :-</p>

- Removal of the uPVC windows throughout and the replacement with timber sash windows to reflect the proportions of the 1904 photograph showing the original windows.
- Removal of the fascias to the decorative cut-out timber gable fascia to match the retained detail to 178.
- Repair of the decorative timber spire (to match the retained detail at 178).
- Removal of the eaves level fascia, repair of the decorative eaves supports and the replacement of PVC rainwater goods with cast iron.
- Removal of the PVC cladding to the bay windows to reveal the decorative details and reinstate decorative pilasters.
- Redecoration throughout.
- Removal of the paint to the glazed tiles in the entrance porch.
- Reduction in the extent of signage.

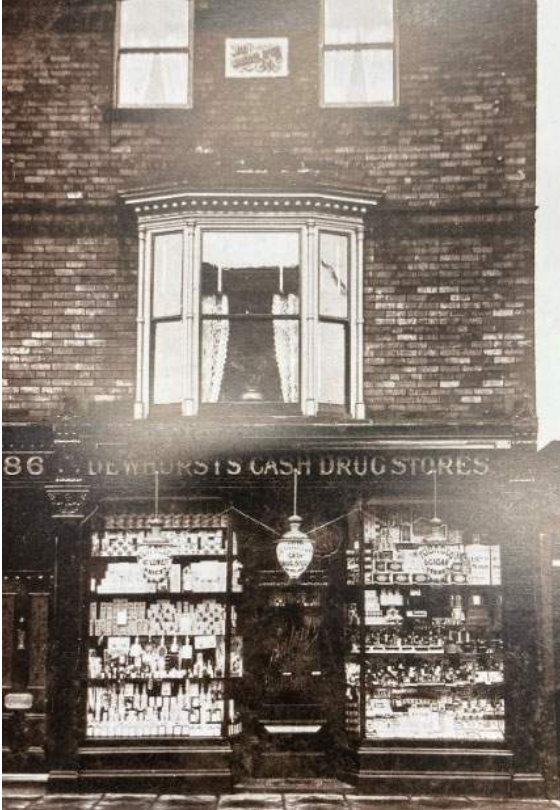
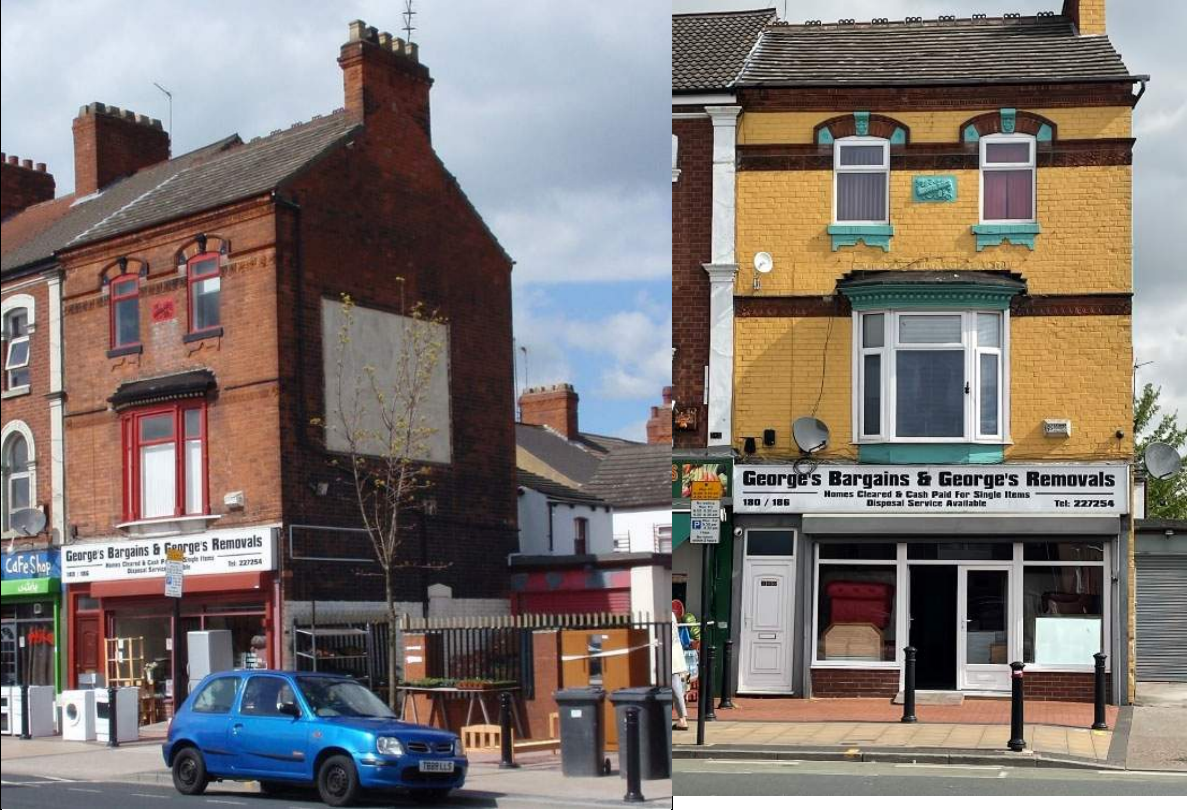
Street:	Spring Bank	George's Bargains & Georges Removals, Horwood House, 180-186	
Historic Photo – 1904 (Hull Then and Now, Paul Gibson)		Historic Photo 26/04/2010 (Phil Hampel)	Current Photo – 11/05/2023 (author)

<p>Monitoring Notes</p>	<p>The building is generally in a reasonable condition with no immediate risks identified. Any proposals to remove the retained bay window details along with the removal of terracotta feature details, stone carved keystones should not be permitted.</p>
<p>Recommended Actions</p>	<p>186 has retained many of its original late Victorian features but would benefit from the following works :-</p> <ul style="list-style-type: none"> • Removal of the uPVC windows throughout and the replacement with timber sash windows to reflect the proportions of the 1904 photograph showing the original windows.

- Removal of the existing modern shopfront and reinstatement of the original shopfront design including high quality timber glazed doors to the retail unit and residential unit above as shown in the 1904 photograph.
- Removal of the paint finish to the brickwork to fully reveal the quality of the brickwork.
- Removal of PVC rainwater goods and replacement with cast iron.
- Removal of the PVC cladding to the bay windows to reveal the decorative details and reinstate decorative pilasters.
- Redecoration throughout.
- Rationalisation of services including alarm boxes, satellite dishes, etc.

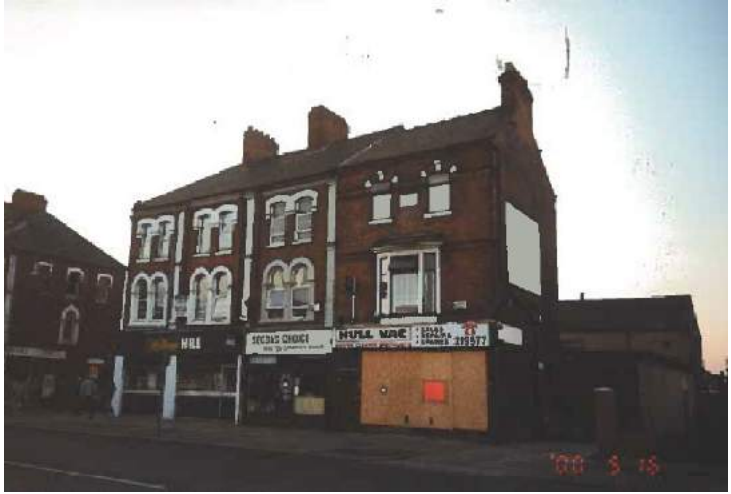
Street: Spring Bank	World of Fruit & Vegetables, 188
Historic Photo – 1904 (Hull Then and Now, Paul Gibson)	Current Photo – 11/05/2023 (author)

Monitoring Notes	<p>The building is generally in a reasonable condition with no immediate risks identified. Any proposals to remove the retained details including the vertical pilasters between buildings, the decorative plaster/stone lintels and surrounds to the upper floor windows should not be permitted.</p>
Recommended Actions	<p>As part of a group of buildings along with 190 and 192, 194, 196 and 198 they would benefit from a collective restoration as a group.</p> <p>188 has retained many of its original late Victorian features but would benefit from the following works :-</p> <ul style="list-style-type: none"> • Removal of the uPVC windows throughout and the replacement with timber sash windows. • Removal of the fascias at eaves level and the reinstatement/repair of the decorative frieze and timber eaves supports. • Replacement of PVC rainwater goods with cast iron. • Repair of the vertical pilasters where damaged. • Removal of the pantile roof tiles and replacement with slate tiles. • Removal of the low quality timber shopfront and vinyl signage fascia and replacement with a new, high quality timber shopfront with fully integrated design including a retractable awning. • Removal of the permanent metal awning and replacement with an integrated retractable awning. • Redecoration throughout.

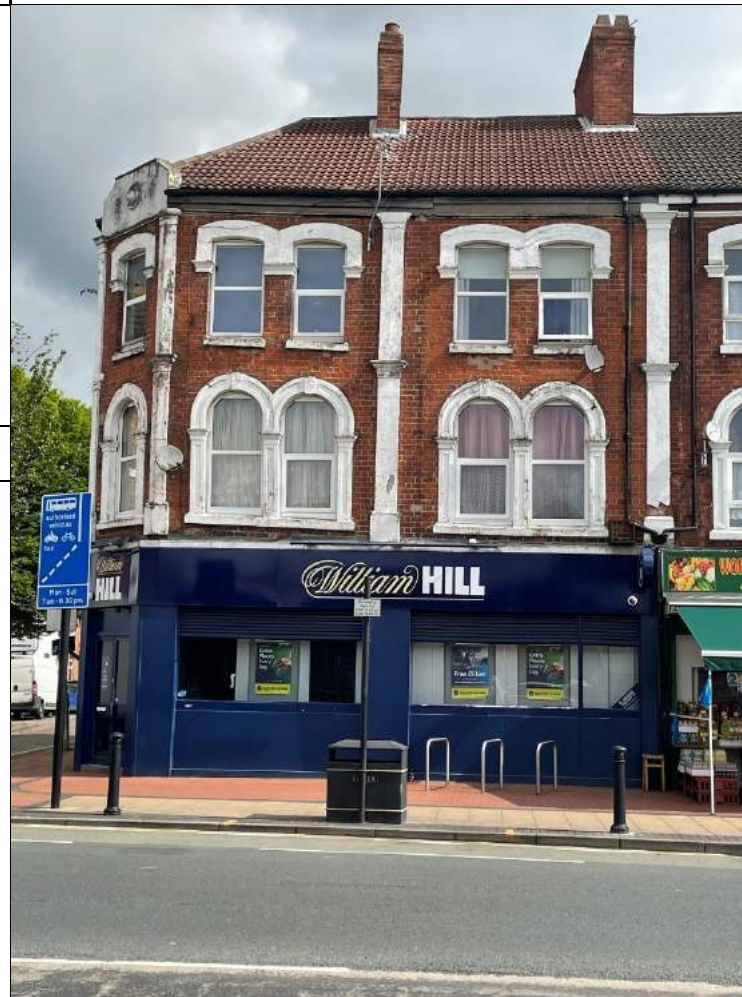
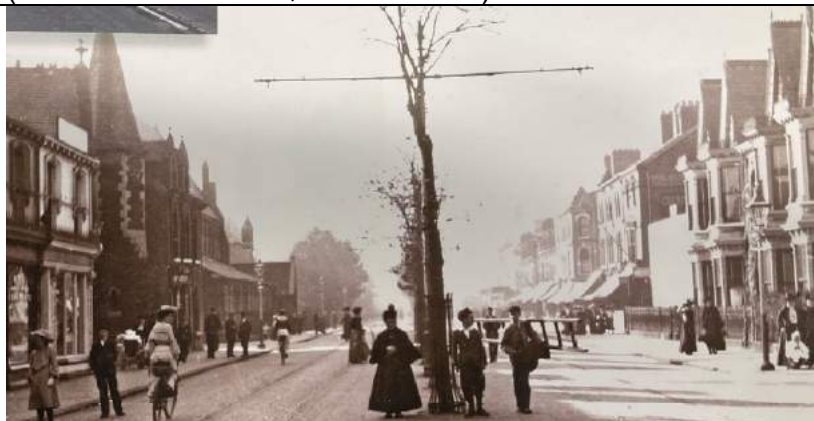
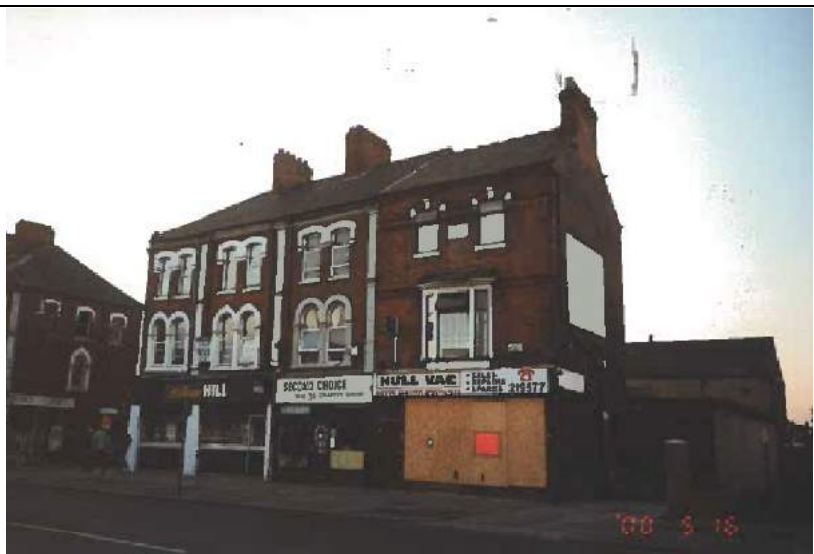
William Hill, 190-192

Monitoring Notes	<p>The building is generally in a reasonable condition with no immediate risks identified. There are signs of considerable structural movement to the wall between 190 and 192. Cement mortar repairs and repointing to brickwork is damaging and should be removed. Any proposals to remove the retained details including the vertical pilasters between buildings, the decorative plaster/stone lintels and surrounds to the upper floor windows should not be permitted.</p>
Recommended Actions	<p>As part of a group of buildings along with 188, 194, 196 and 198, they would benefit from a collective restoration as a group.</p> <p>190 and 192 have retained many of their original late Victorian features but would benefit from the following works :-</p> <ul style="list-style-type: none"> • Reinstatement of the upper section of the feature gable at roof level on the corner of Mayfield Street with restraint support ties back to the primary roof structure. • Removal of the uPVC windows throughout and the replacement with timber sash windows. • Removal of the fascias at eaves level and the reinstatement/repair of the decorative frieze and timber eaves supports. • Replacement of PVC rainwater goods with cast iron.

- Repair of the vertical pilasters and plasterwork generally where damaged/deteriorated.
- Removal of the low quality timber shopfront and vinyl signage fascia and replacement with a new, high quality timber shopfront with fully integrated design including a retractable awning (if required).
- Removal of poor quality cement mortar repairs and repointing to brickwork and repair and repointing in a lime mortar.
- Removal of the pantile roof tiles and replacement with slate tiles.
- Redecoration throughout.
- Rationalisation of all services, antennas, alarm boxes, lighting, etc.

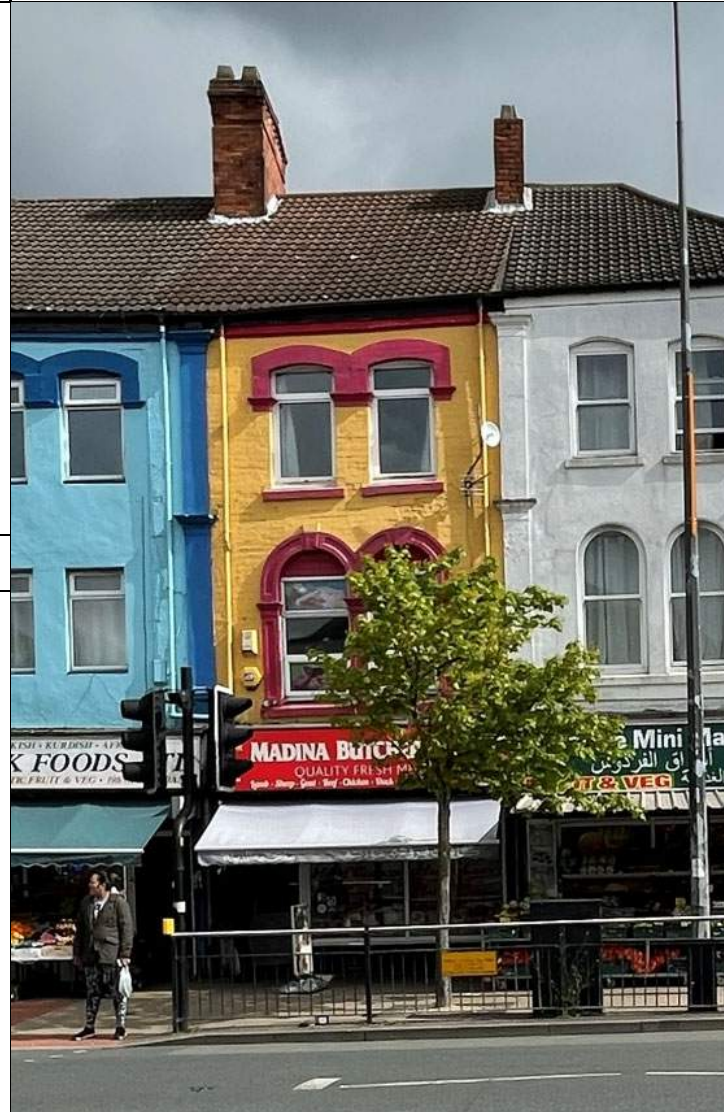
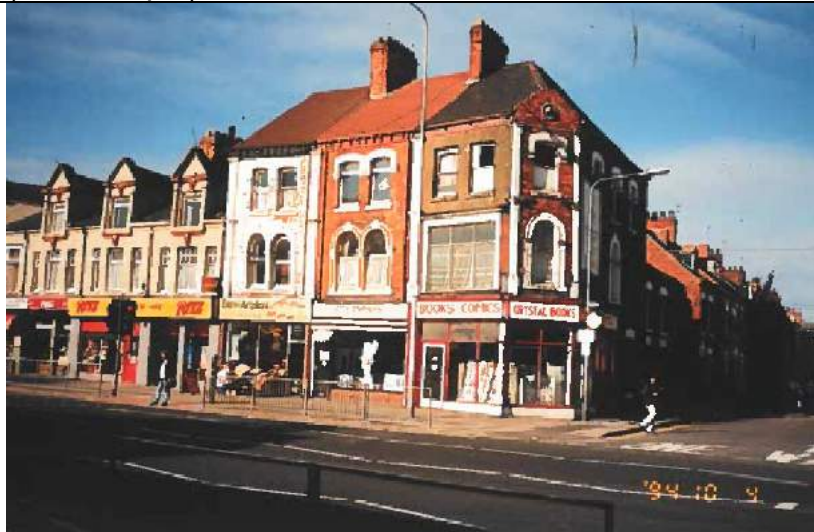
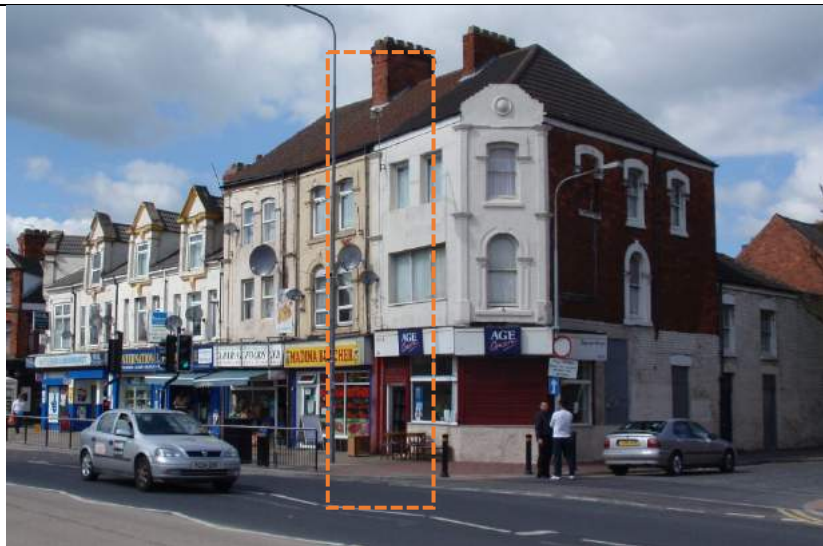
Madina Butchers, 196

Monitoring Notes	<p>The building is generally in a reasonable condition with no immediate risks identified. There is evidence of structural settlement to the party wall between 196 and 198. A Structural survey is recommended. Any proposals to remove the retained details including the vertical pilasters between buildings, the decorative plaster/stone lintels and surrounds to the upper floor windows should not be permitted.</p>
Recommended Actions	<p>As part of a group of buildings along with 194 and 198 along with the wider group including 188, 190 and 192 they would benefit from a collective restoration as a group.</p> <p>196 has retained many of the original late Victorian features but would benefit from the following works :-</p> <ul style="list-style-type: none"> • Removal of the paint to the brickwork. • Brickwork repairs/repointing as required following removal of paint. • Removal of the low quality timber shopfront and vinyl signage fascia and replacement with a new, high quality timber shopfront with fully integrated design including a retractable awning. • Removal of the pantile roof tiles and replacement with slate tiles. • Redecoration throughout. • Removal of the fascias at eaves level and the reinstatement/repair of the decorative frieze and timber eaves supports (see 1994 photo).

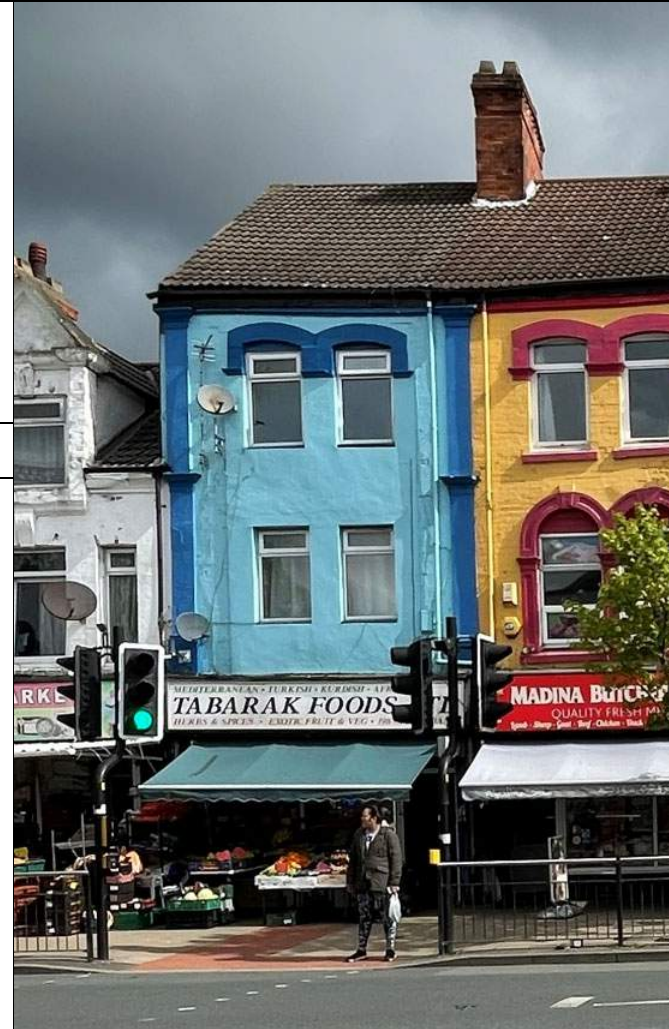
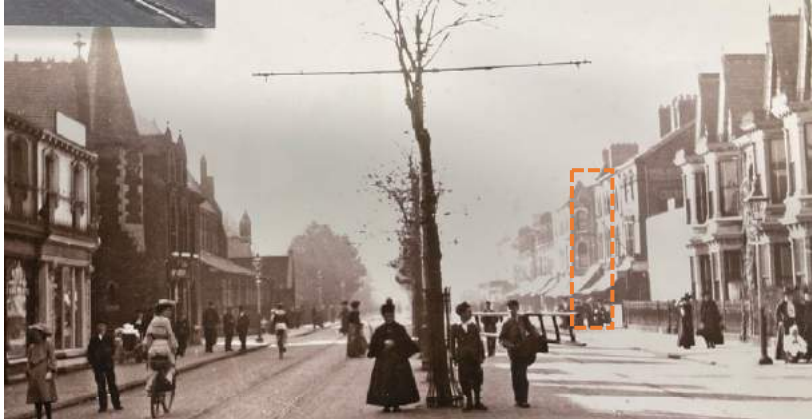
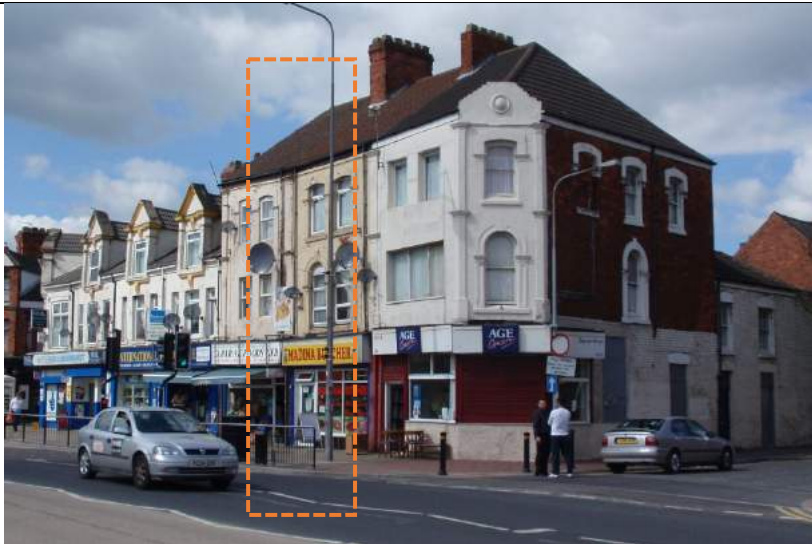
Tabarak Foods Ltd, 198

<p>Monitoring Notes</p>	<p>The building is generally in a reasonable condition with no immediate risks identified. There is evidence of structural settlement to the party wall between 196 and 198. A Structural survey is recommended. Any proposals to remove the retained details including the vertical pilasters between buildings, the decorative plaster/stone lintels and surrounds to the upper floor windows should not be permitted. Repairs or reinstatement of the second floor window surrounds may be required upon removal of the render.</p>
<p>Recommended Actions</p>	<p>As part of a group of buildings along with 194 and 196 along with the wider group including 188, 190 and 192 they would benefit from a collective restoration as a group.</p> <p>198 has retained some of the original late Victorian features but would benefit from the following works :-</p> <ul style="list-style-type: none"> • Structural investigation to establish if settlement has halted.

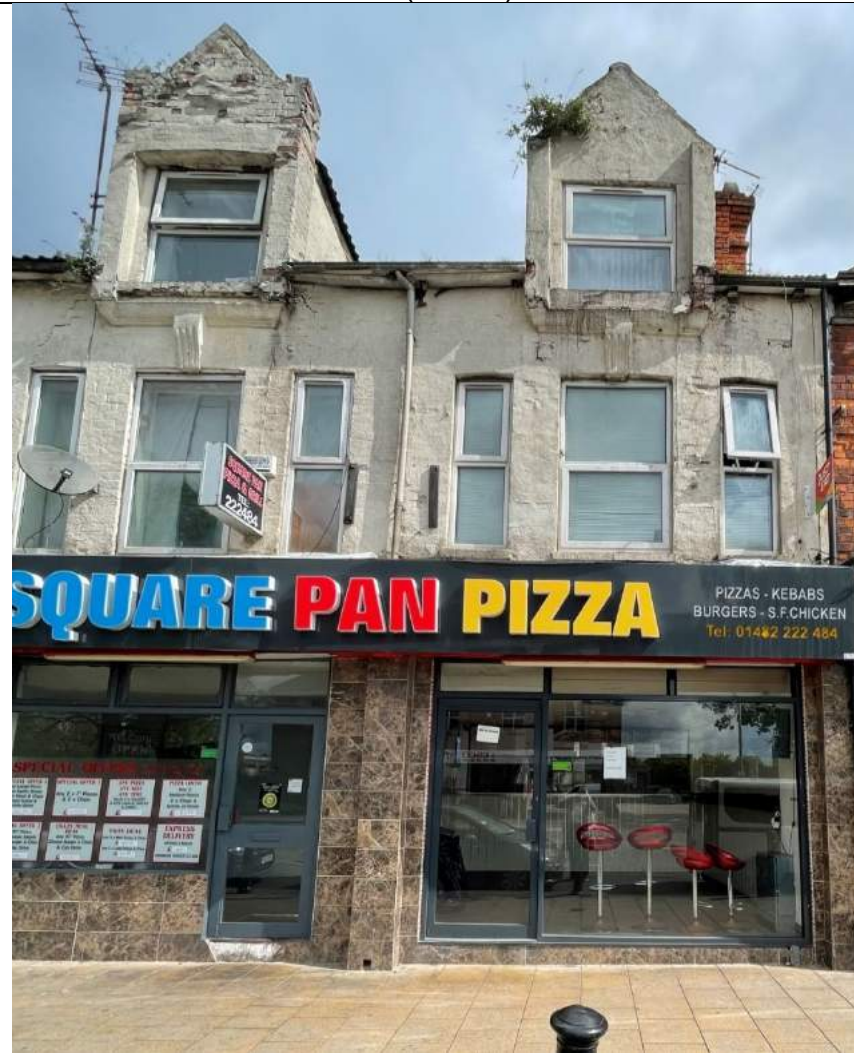
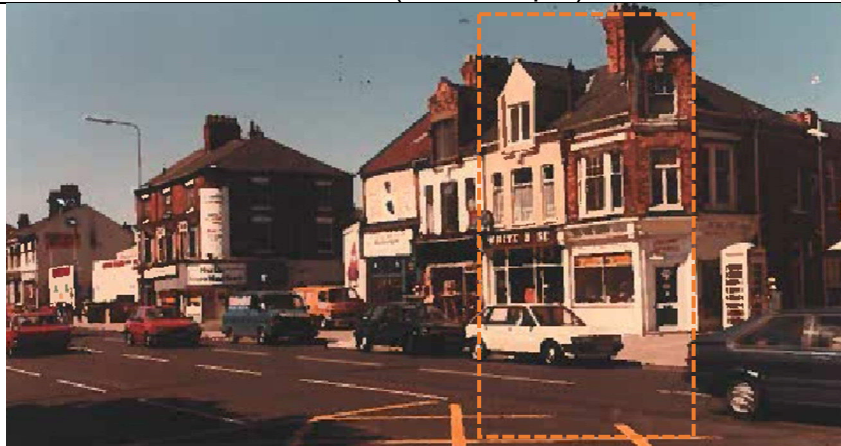
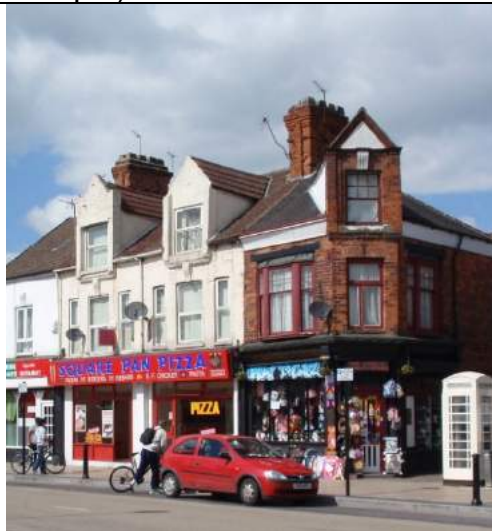
Square Pan Pizza, 210 and 212

<p>Monitoring Notes</p>	<p>The building is generally in a poor condition and requires attention, particularly to the dormer and eaves level where blocked/defective gutters and defective flashings are causing water ingress into the structure causing cracking of the brickwork. Vegetation is also growing out of the coping to the dormer window.</p>
<p>Recommended Actions</p>	<p>As part of a group of buildings along with 208 and 214 along with the wider group including 200, 202, 204 and 206, they would benefit from a collective restoration as a group.</p> <p>210 and 212 have retained some of the original late Victorian features but would benefit from the following works :-</p> <ul style="list-style-type: none"> • Removal of the paint, brickwork repairs and repointing. • Provide new lead/turn coated steel flashings to dormer and cornice.

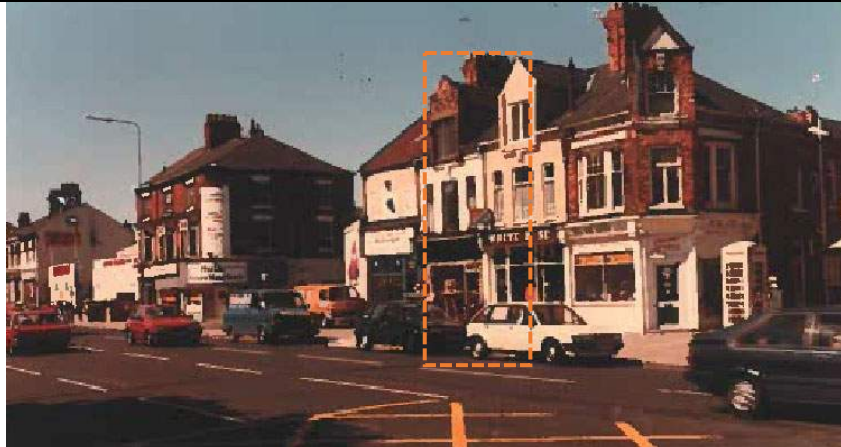
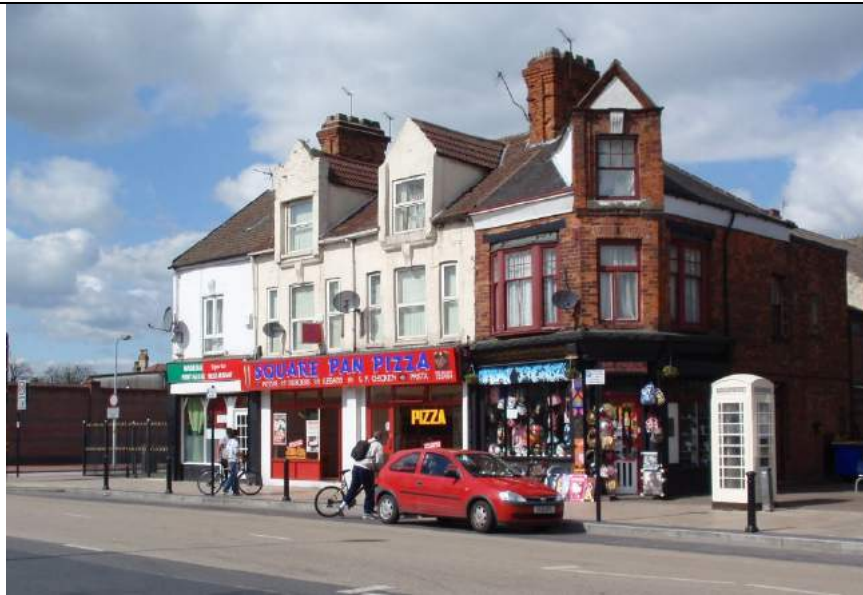
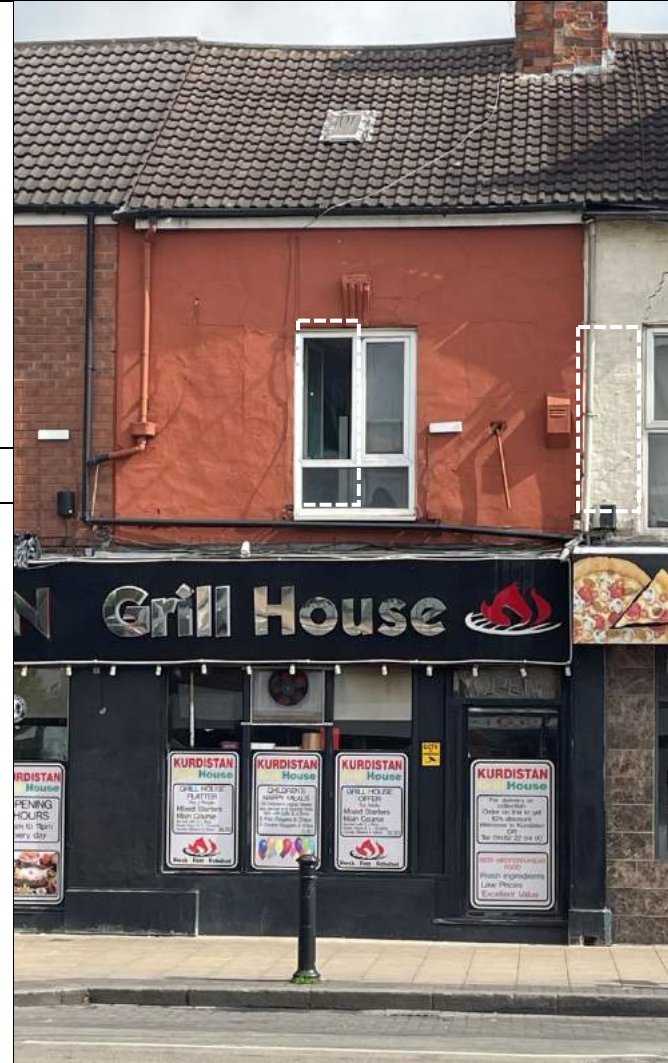
Kurdistan Grill House, 214

The 1994 photograph illustrates the substantial changes that have occurred during the late 1980's. The earlier shopfront, including the fascia and cornice have been removed and replaced with a new metal shopfront. The two narrow windows to each side of the first floor window have been blocked up (still visible in the render) and the elevation rendered, the sliding sash windows have been removed and replaced with a uPVC window. The dormer window and associated brickwork detailing has been removed in its entirety. The brickwork has been rendered concealing the brickwork. The gutters and downpipes have been replaced with PVC. The slate roof finish was removed and replaced with grey concrete pantiles. The scroll keystone detail to the head of the first floor window has been crudely cut short and retained.

<ul style="list-style-type: none"> • 2016 – Erection of single storey rear extension, re-positioning of external staircase (16/00691/FULL)
Monitoring Notes	The building is generally in a reasonable condition with no immediate risk items identified.
Recommended Actions	<p>As part of a group of buildings along with 208, 210 and 212 along with the wider group including 200, 202, 204 and 206, they would benefit from a collective restoration as a group.</p> <p>214 have lost many of the original late Victorian features and would benefit from the following works :-</p> <ul style="list-style-type: none"> • Removal of the render, brickwork repairs and repointing. • Opening up of the two first floor narrow windows and reinstatement of the timber sash windows throughout. • Rebuilding of the original dormer window to match the group adjacent. • Removal of the low quality metal shopfront and vinyl signage fascia and replacement with a new, high quality timber shopfront including the reinstatement of the historical corbels (using 208 as the template) with fully integrated design including a retractable awning. • Repair/repointing of the decorative pilaster details and eaves level details to the second floor dormer. • Redecoration throughout. • Removal of the terracotta coloured pantiles and replacement with slate tiles. • Reinstatement/repair of the decorative frieze. • Replacement of PVC rainwater goods with cast iron and re-routing to align with new shopfront pilasters. • Rationalisation of all services, antennas, alarm boxes, lighting, etc.

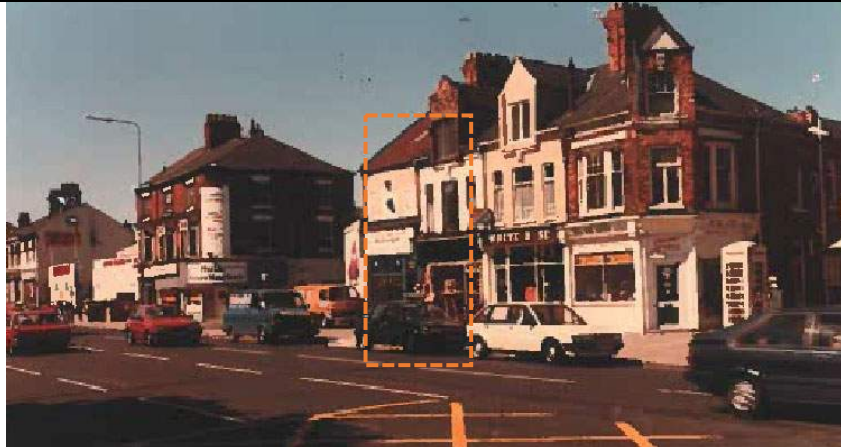
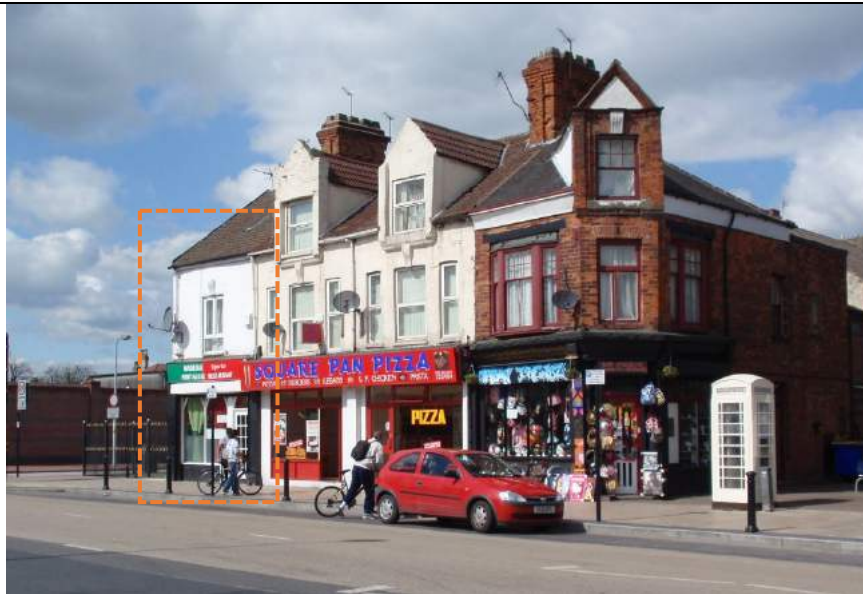
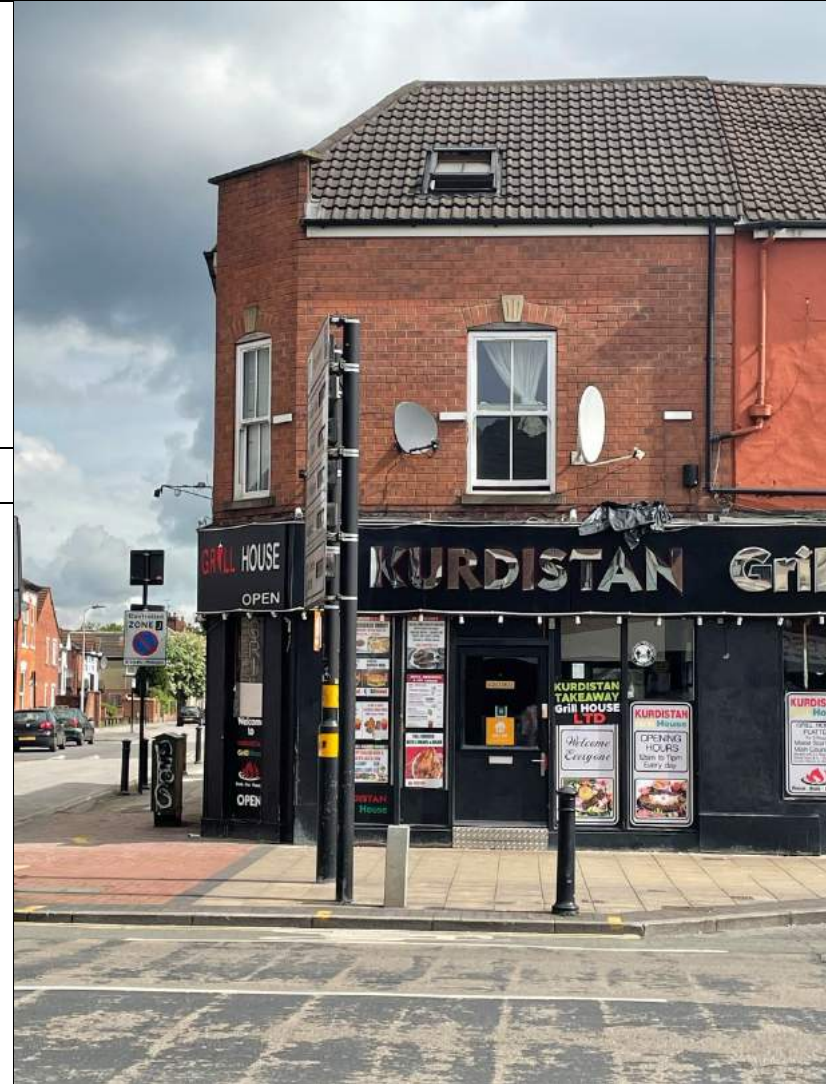
Kurdistan Grill House, 216

216 Spring Bank was built after Planning Approval was approved in 2013 and is an extension to the group along with No 208, 210, 212 and 214 Spring Bank directly adjacent.

Monitoring Notes	The building is generally in a reasonable condition with no immediate risk items identified.
Recommended Actions	<p>As a modern building the design is subservient to the wider context and replacement with a Victorian style shop frontage is not considered appropriate. The building would however benefit from the following works :-</p> <ul style="list-style-type: none"> • Replacement of PVC rainwater goods with cast iron/metal and re-routing to align with new shopfront pilasters. • Rationalisation of all services, antennas, alarm boxes, lighting, etc.

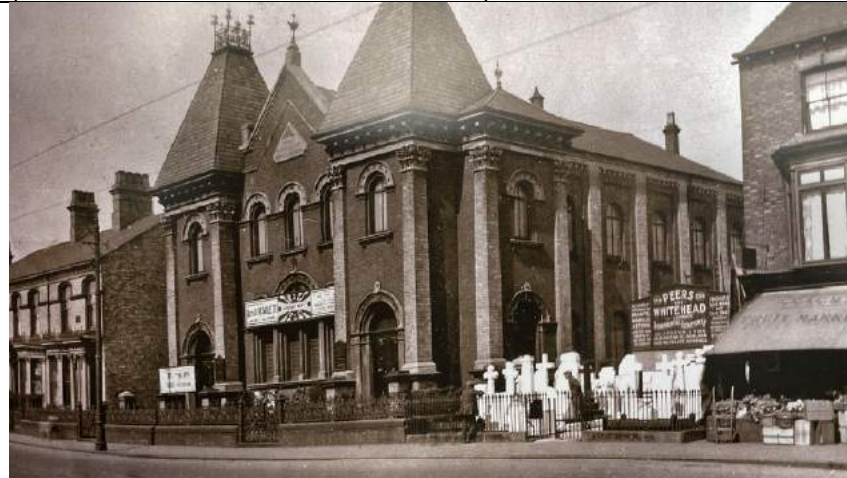
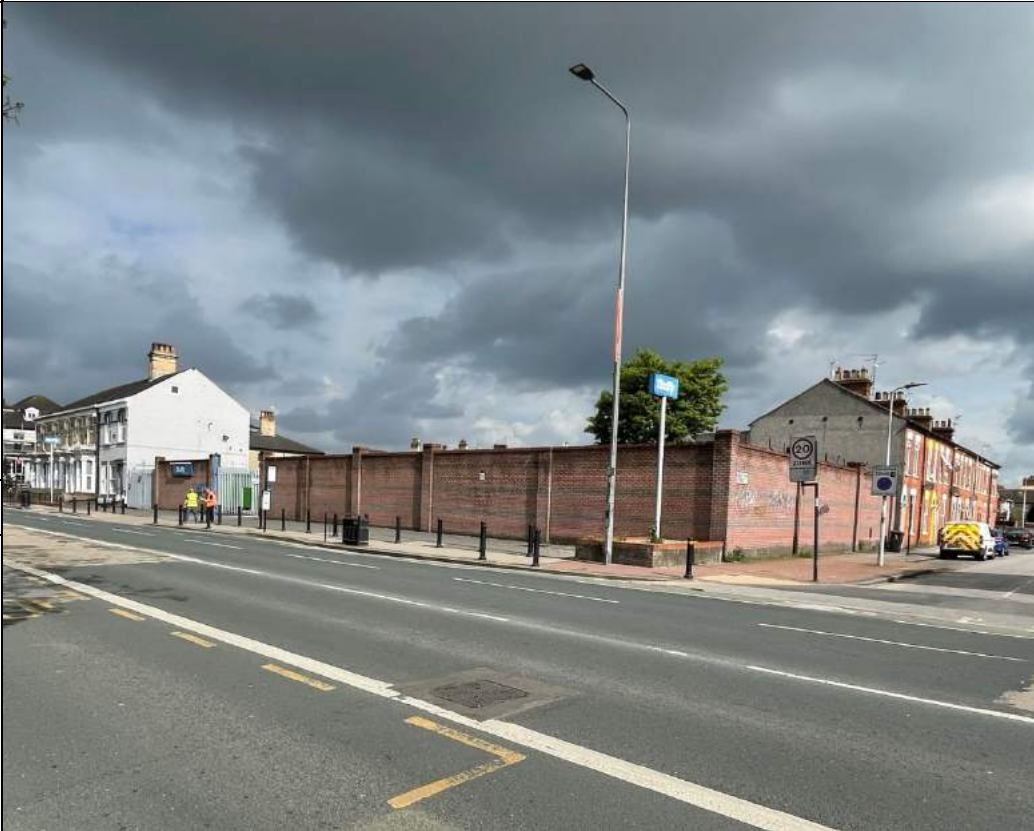
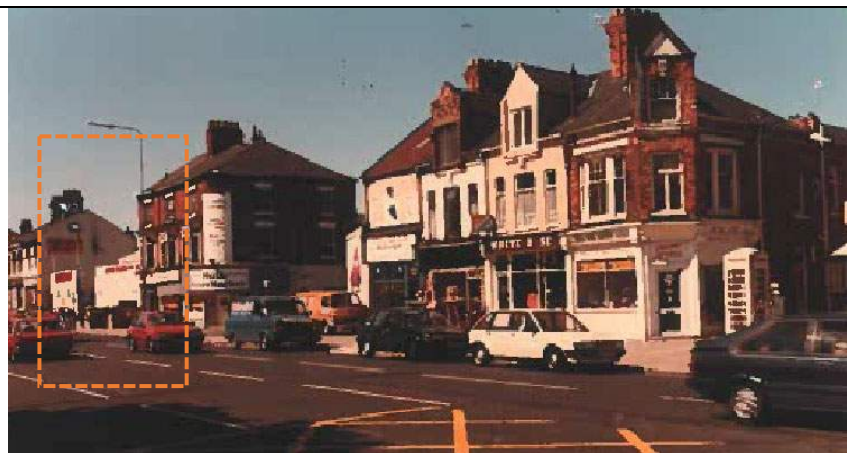
Street:	Spring Bank	Thrifty Car Rentals, 218-222
----------------	--------------------	-------------------------------------

The site of 218-222 Spring Bank on the corner with Mayfield Street was developed in the late 1800's and opened in 1878. The site comprised of three retail and residential buildings on the corner of Middleton Street along with the Ebenezer Chapel and Sunday School. The 1904 photograph shows the Ebenezer Chapel with its stone masonry yard directly adjacent and 226-228 Spring Bank in the background. In the foreground, the three storey red brick buildings can be seen to the right with ground floor retail use with a

Monitoring Notes	No immediate action required. Site identified as a potential future development site for buildings of 3 storey in height.
Recommended Actions	Site identified as a potential future development site for buildings of 3 storey in height.

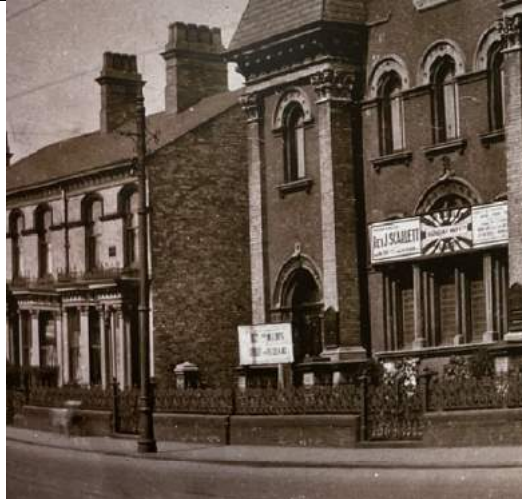
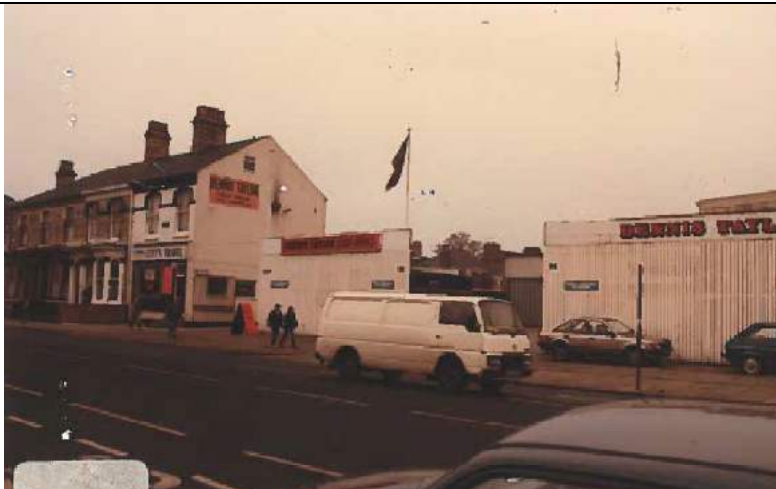
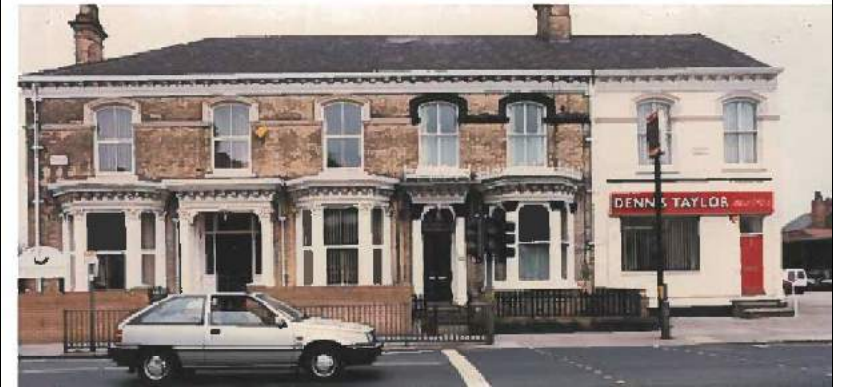
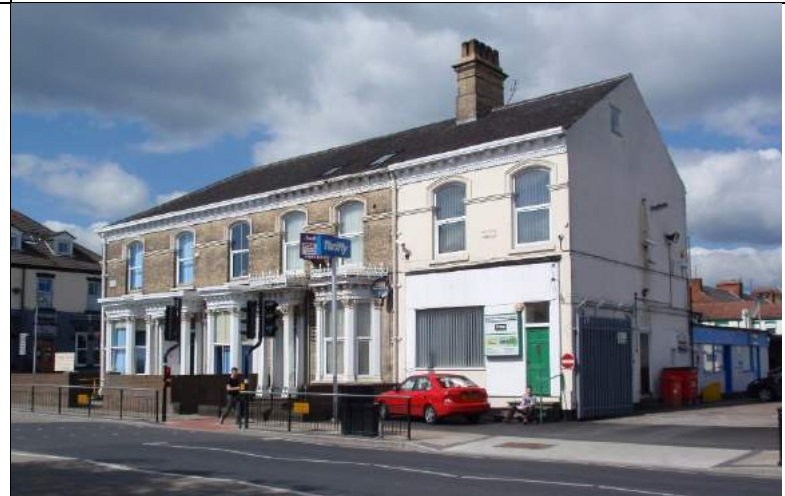
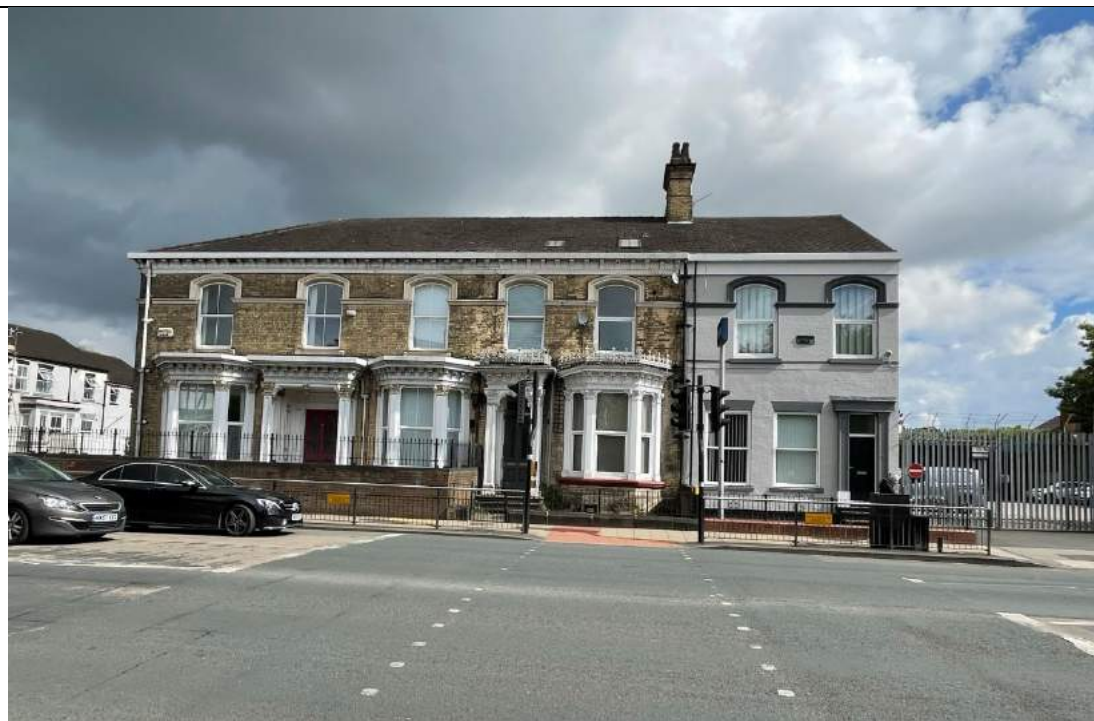
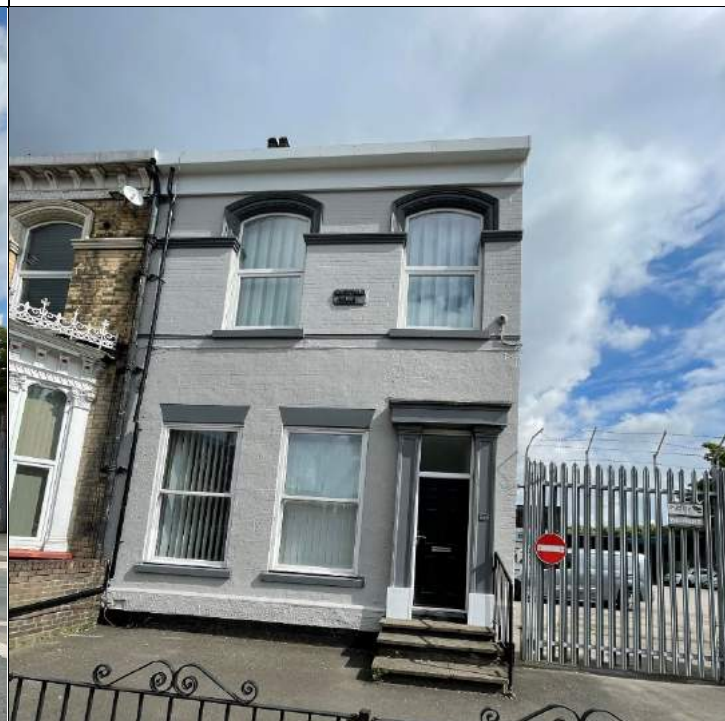
Comrie Holiday Park offices, 224

224 Spring Bank forms part of a wider group with 226 and 228 Spring Bank. No 224 Spring Bank can be seen in the background of the 1905 photograph. Ebenezer Chapel closed in 1955 and was later demolished in 1976. The building is designed as part of the wider group of 226 and 228 Spring Bank with a consistent eaves level with decorative eaves support brackets, decorative arched first floor windows, with plaster hoodmoulds. The 1904 photograph shows that 224 originally had the same highly decorative bay window and entrance portico as found at 226. Since its construction a number of alterations have been made. By the 1980's the highly decorative bay window and entrance portico have been removed and replaced with a low quality shopfront. The brickwork was painted and the boundary wall and iron railings were removed. In 2012 further external alterations were made to the facades including the removal of timber cladding, replacement of windows with vertical PVC sliding sash windows, a new entrance door and canopy. The large ground floor window was replaced with two vertically proportioned windows more in keeping the Victorian street frontage. More recently fascia's have been applied to the

<p>eaves level decorative timber supports. The facades have also been rendered which has led to the loss of cohesion in the group of buildings with 226 and 228.</p> <p>224 Spring Bank and has been subject to the following Planning Applications :-</p> <ul style="list-style-type: none"> • 1989 - Use of land for the parking of vehicles as an extension to the adjoining vehicle hire use, erection of 3.5m high boundary wall to Spring Bank and Middleton Street (89/00324/PF). • 2012 – External alterations to front elevation comprising removal of timber cladding, installation of PVC vertical sliding sash windows, new entrance door and canopy. Erection of front boundary wall. (Ref No : 12/00434/FULL).
Monitoring Notes	No immediate action required.
Recommended Actions	<p>The building would benefit from the following works :-</p> <ul style="list-style-type: none"> • Removal of the PVC fascias to the eaves level to reveal the decorative eaves supports. • Removal of the render and undertake brickwork repairs and repointing where required. Reinstatement of the original timber sash windows with vertically proportioned windows. • Reinstatement of the bay window to match the adjacent No 226.
