**Spring Bank Conservation Area
Management Plan (North side)**
Draft for Review

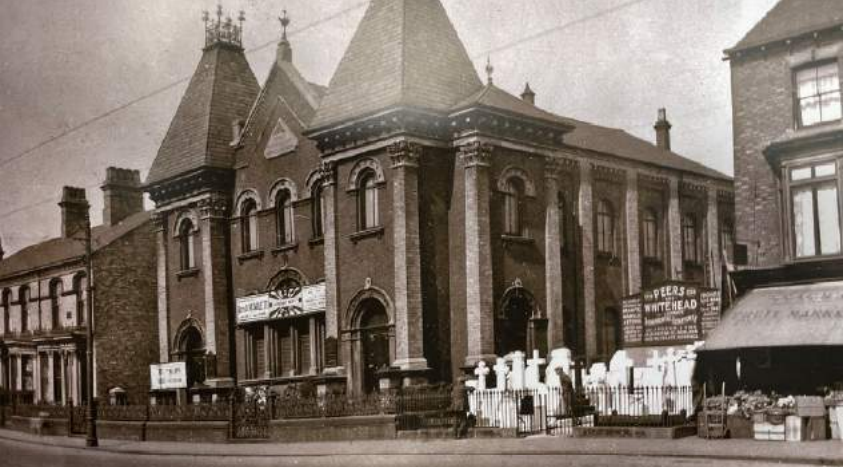
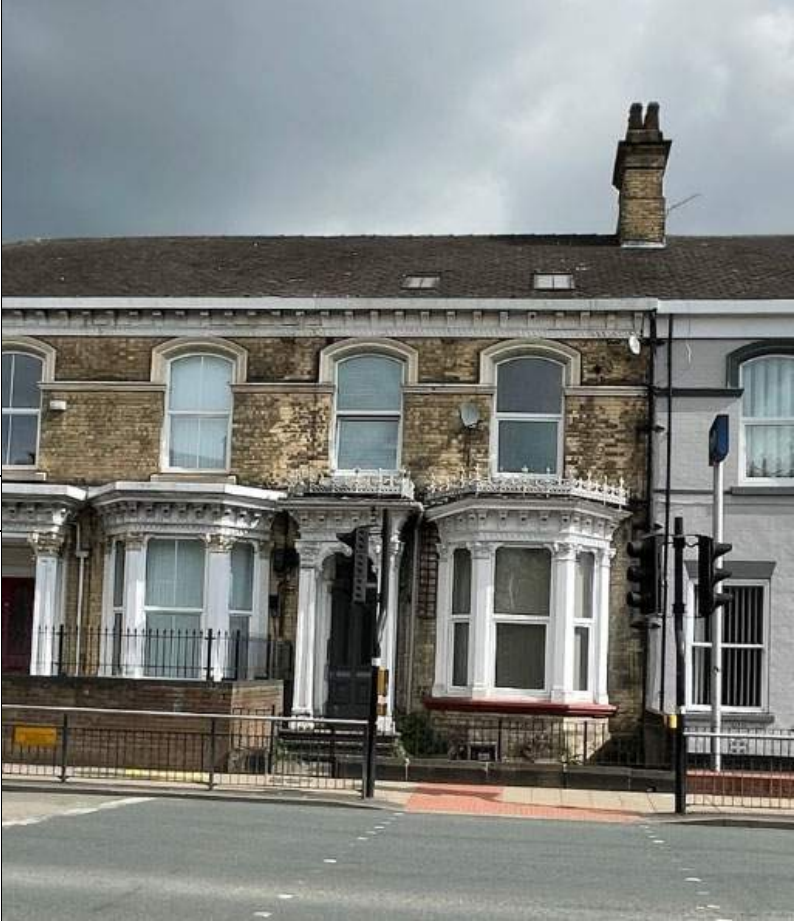
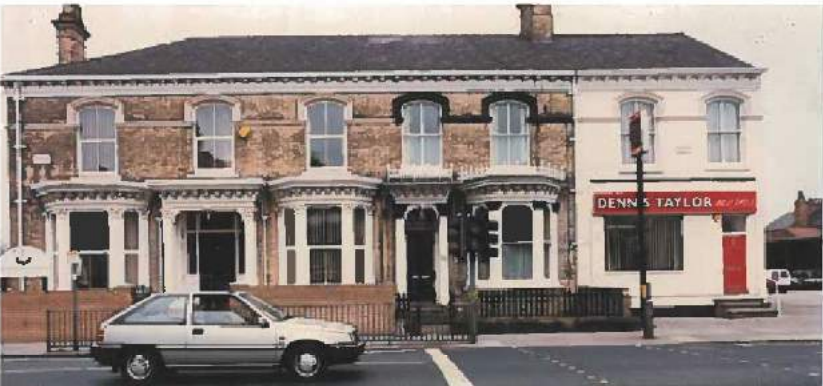
Street:	Spring Bank	226
Historic Photo – 1904 (Hull Then and Now, Paul Gibson)		Current Photo – 11/05/2023 (author)

Building Notes	<p>226 Spring Bank forms a group with the adjacent 224 and 228 Spring Bank. 226 was built between 1853 and 1858.</p> <p>The 1904 photograph shows Ebenezer Chapel with 224-228 Spring Bank in the background. 226 comprises of a two storey buff brick building with highly decorative projecting bay windows with Corinthian details to the pilasters and decorative cast iron railings to the edge of the bay roof and the</p>

<p>entrance portico. The entrance portico is also highly decorative with dentil details to the eaves level and Corinthian details to the column heads. The first floor windows are grouped with a continuous string course and hood mould. The roof finish was slate with a decorative timber eaves support detail supporting a timber gutter.</p> <p>The 2012 photograph shows the earlier timber sash windows with the vertical mullion creating a more vertical emphasis.</p> <p>In 2003, an application was approved for change of use from office to residential use (flats).</p> <p>Today in 2023, 226 has retained many of the original late Victorian details including the highly decorative bay window and portico details. The original entrance door has also been retained.</p> <p>The building has been subject to the following Planning Applications :-</p> <ul style="list-style-type: none"> • 2003 - Change of use from office, maisonette and 2 flats to 5 self-contained flats. (04/00008/COU).

Monitoring Notes	<p>No immediate action required. Building in very good condition. Any works to remove the decorative details including the portico, bay window and eaves level detail should not be permitted.</p>
Recommended Actions	<p>The building forms part of the wider group including 224 and 228 Spring Bank. The building therefore benefit from a collective restoration to the group as a whole.</p> <p>The building would benefit from the following works :-</p> <ul style="list-style-type: none"> • Replacement of uPVC windows with timber sliding sash windows. • A consistent colour scheme applied to the group.

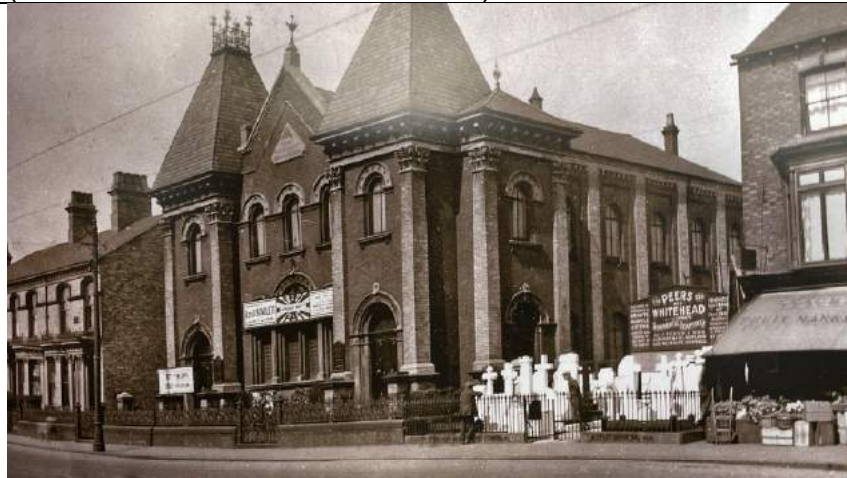
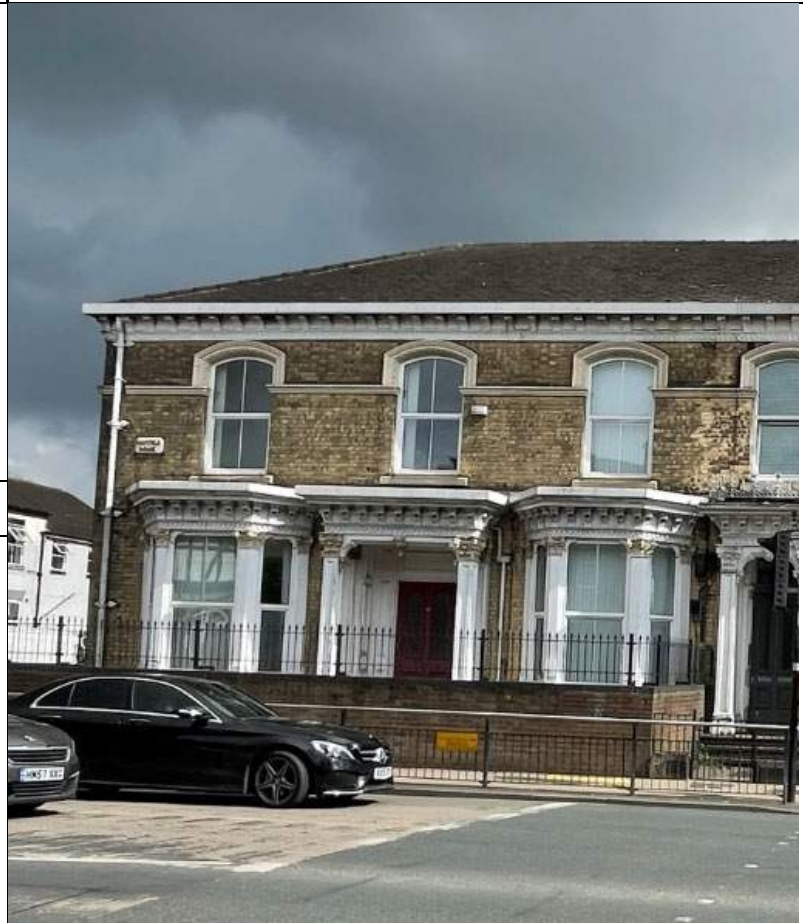
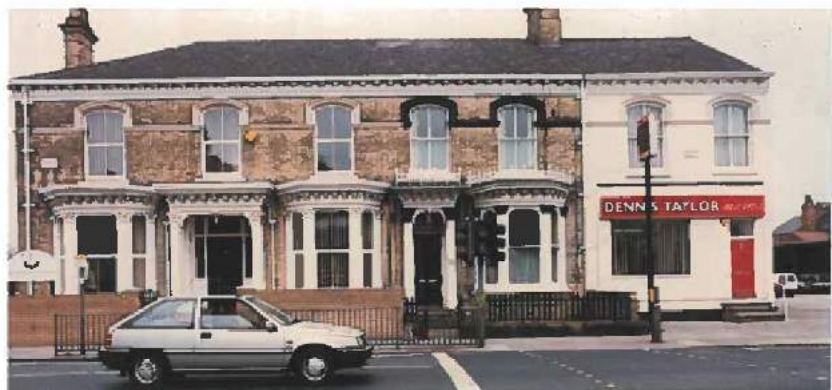
Building Notes 228 Spring Bank forms a group with the adjacent 224 and 226 Spring Bank. 228 was built between 1853 and 1858. The 1904 photograph shows Ebenezer Chapel with 224-228 Spring Bank in the background. 226 comprises of a two storey buff brick building with highly decorative projecting bay windows with Corinthian details to the pilasters and decorative cast iron railings to the edge of the bay roof and the

<p>entrance portico. The entrance portico is also highly decorative with dentil details to the eaves level and Corinthian details to the column heads. The first floor windows are grouped with a continuous string course and hood mould. The roof finish was slate with a decorative timber eaves support detail supporting a timber gutter.</p> <p>The 2012 photograph shows the earlier timber sash windows with the vertical mullion creating a more vertical emphasis.</p> <p>In 2003, an application was approved for change of use from office to residential use (flats). Today in 2023, 228 has retained many of the original late Victorian details including the highly decorative bay window and portico details. The decorative iron railings to the roof of the bay windows and portico have been removed. The original entrance door has also been retained.</p> <p>The building has been subject to the following Planning Applications :-</p> <ul style="list-style-type: none"> • 1990 – Change of use of dwelling to form offices involving laying out of car park to rear. (Ref No :090/01695/PF). • 1992 – Use of premises as a School of Music (Ref No : 92/00949/PF). • 2006 – Erection of boundary wall and fencing (Ref No : 06/00867/FULL) • 2013 – Change of use from offices to 4 self contained flats (13/00728/PCOU). • 2013 – Erection of 2 x 2 storey rear extensions to form two further flats (Ref No : 13/00884/FULL). • 2014 – Erection of pair of semi-detached dwellings (Ref No: 14/01388/FULL).

Monitoring Notes	No immediate action required. Building in very good condition. Any works to remove the decorative details including the portico, bay window and eaves level detail should not be permitted.
Recommended Actions	<p>The building forms part of the wider group including 224 and 228 Spring Bank. The building therefore benefit from a collective restoration to the group as a whole.</p> <p>The building would benefit from the following works :-</p> <ul style="list-style-type: none"> • Replacement of uPVC windows with timber sliding sash windows. • A consistent colour scheme applied to the group. • Reinstatement of the decorative iron railings to the bay windows and portico to match 226.

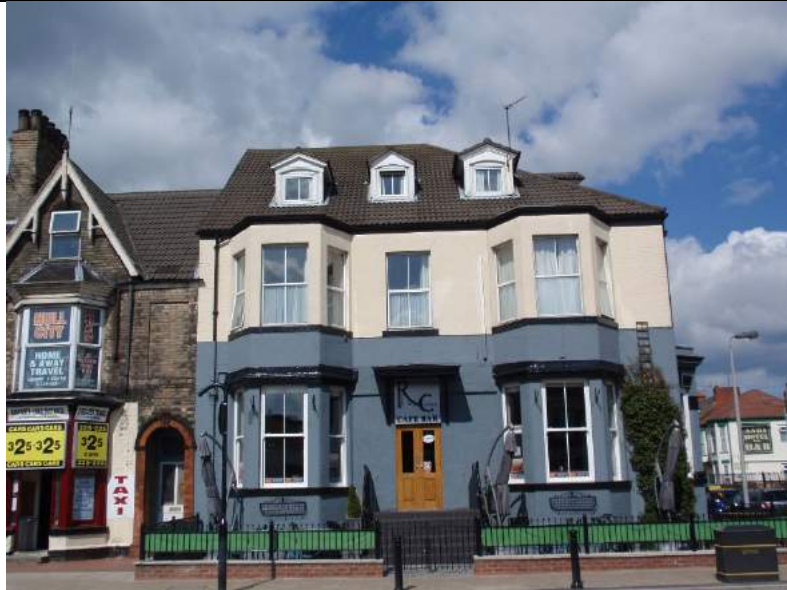
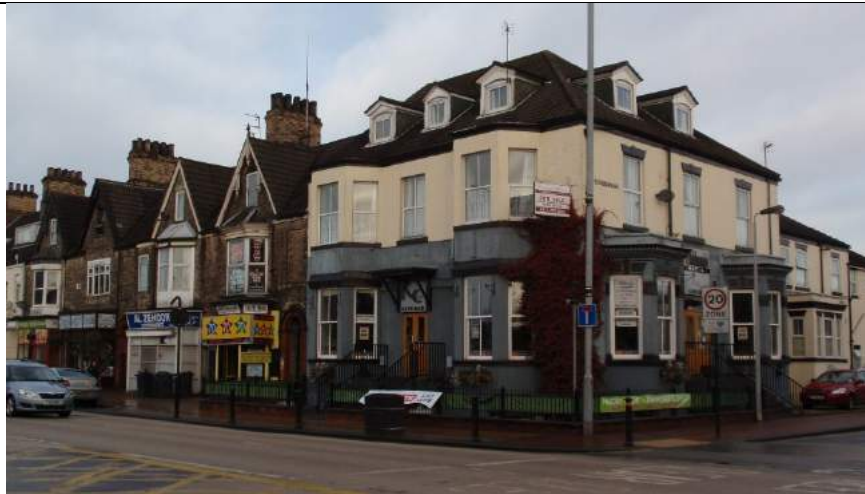
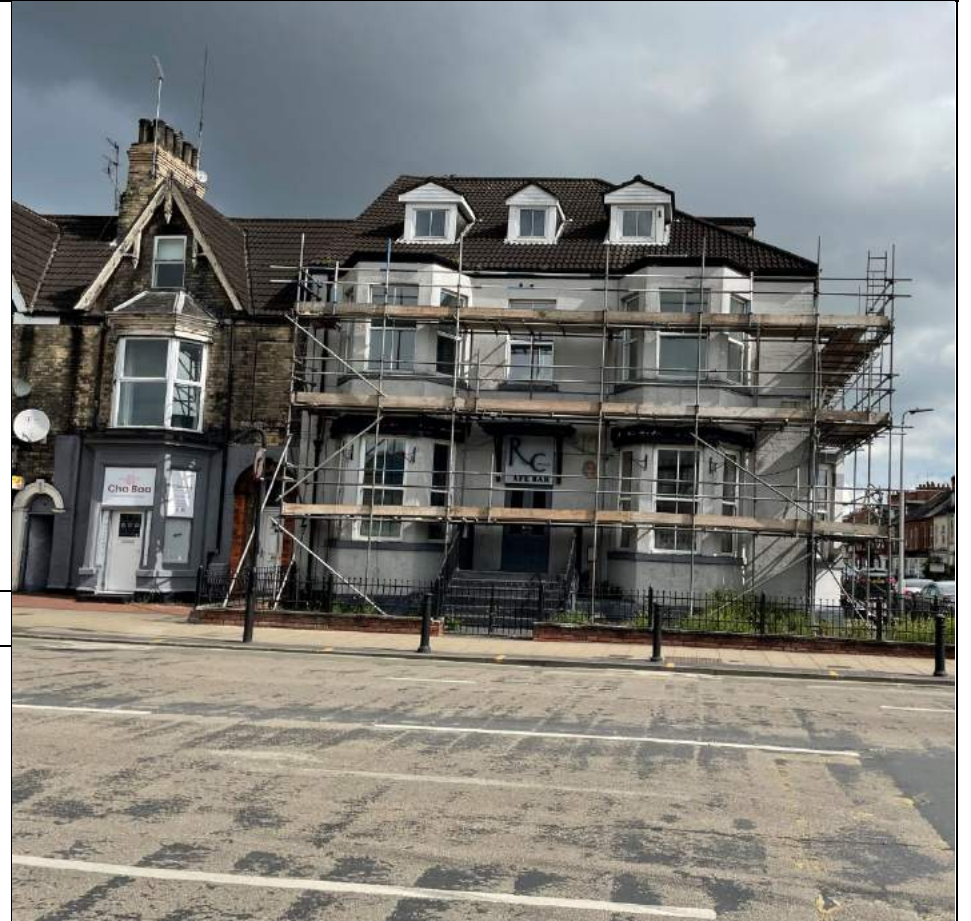
Marlborough Hotel, 232

The Marlborough Hotel (232) was built between 1853 and 1893 at the corner of Louis Street and Spring Bank, The building was designed to turn the corner with bay windows and dormer window features incorporated to both elevations. The building has been used predominantly as a hotel and bar. The building comprises of a two storey brick building with roof level accommodation. The roof was originally slate and gutters and downpipes would have been cast iron.

No immediate action required. Building in good condition. Any works to remove the decorative details to the Louis Street elevation including the decorative bay window details and feature stone lintels should not be permitted.

- Replacement of all windows with timber framed sash windows
- The rationalisation of sky dishes, services, light fittings, alarm boxes.
- Removal of artificial grass to front gardens and the introduction of soft planting to the gardens.
- Installation of boundary treatment to the Louis Street elevation.
- Removal of the pantile roof finish and replacement with slate roof tiles.
- Removal of paint finish to brickwork and stone work, particularly to the Louis Street elevation.

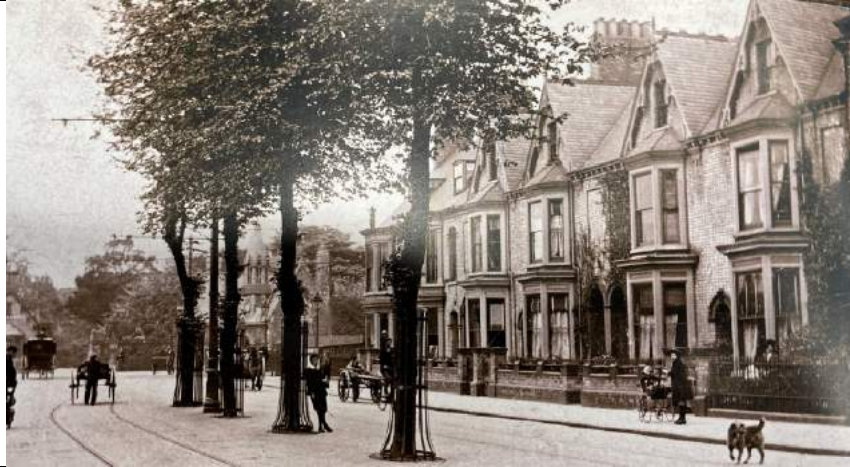
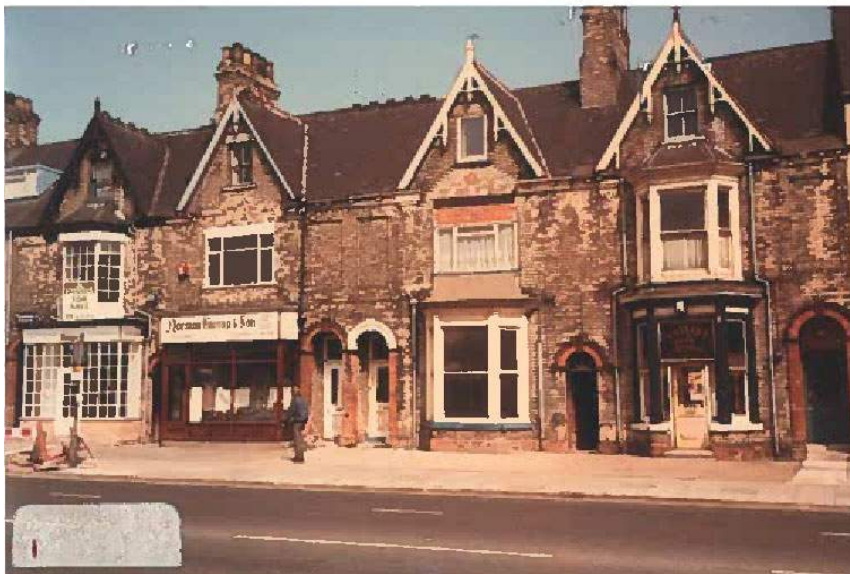
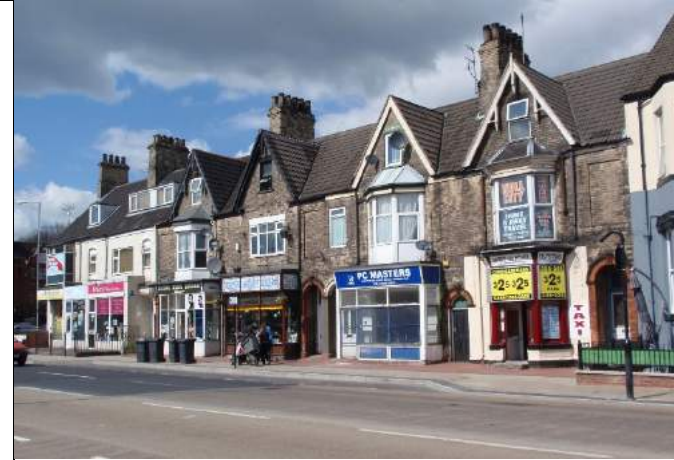
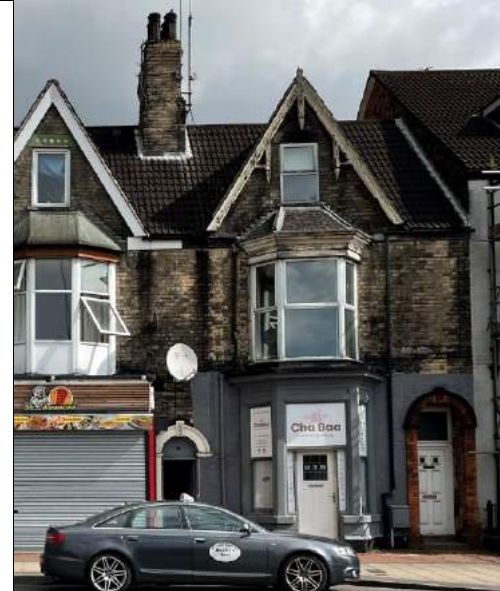
Cha Baa Thai Massage, 234

<p>Building Notes</p>	<p>234 Spring Bank forms a group with the adjacent 236, 238 and 240 Spring Bank. 234 was built between 1856 and 1893 as a group of large residential dwellings with generous front gardens bound by garden walls topped with cast iron railings. The property comprises of two storey buff brick buildings with feature gable dormers to the second floor roof level accommodation. The building was designed with two storey bay windows with decorative details including pilasters, panelling and cornice details and a lead roof to the bay. The entrance door features a terracotta arched surround with decorative keystones. The roof finish was slate and the eaves level featured dentil timber eaves support brackets to the cast iron gutters and downpipes. The gabled dormer has three feature spires providing further detail to the roof level. The 1904 photograph illustrates the building shortly after construction with all details in place.</p> <p>By the 1980's the bay window had been adapted to drop the cill to the front window to provide a door opening to a retail unit. The main entrance door is retained to provide access to the first and second floor residential accommodation.</p> <p>By 2010 the windows have been replaced with uPVC windows, the slate roof finish replaced with grey concrete pantiles. The decorative timber gutter supports have been removed.</p> <p>Today, in 2023, the building has retained most of its original features but has been painted at ground floor level.</p> <p>The building has been subject to the following Planning Applications :-</p> <ul style="list-style-type: none"> • 2013 – Display of internally illuminated 3 panel fascia sign (Ref No : 13/00263/ADV) (refused)

<p>Monitoring Notes</p>	<p>No immediate action required. Building in reasonably good condition. As the last remaining building within the group that has retained its original two storey bay window and details, terracotta arched entrance, the decorative spires to the gable, any works that proposed their removal should not be permitted.</p>
<p>Recommended Actions</p>	<p>The building forms part of the wider group including 236, 238 and 240 Spring Bank. The building would therefore benefit from a collective restoration to the group as a whole.</p> <p>The building would benefit from the following works :-</p> <ul style="list-style-type: none"> • Removal of the paint finish to the ground floor level facades. • Remove the uPVC gutters and downpipes and reinstate the cast iron gutters and downpipes. • Remove the uPVC windows and replace with new timber sash windows. • Remove the pantile roof and replace with slate roof finish. • Reinstall the timber eaves support details (as the 1904 photograph). • Remove the door entrance to the bay window and reinstate the cill and sash window. • Repair the ridge level spire to reinstate the top section (as the 1980's photograph).

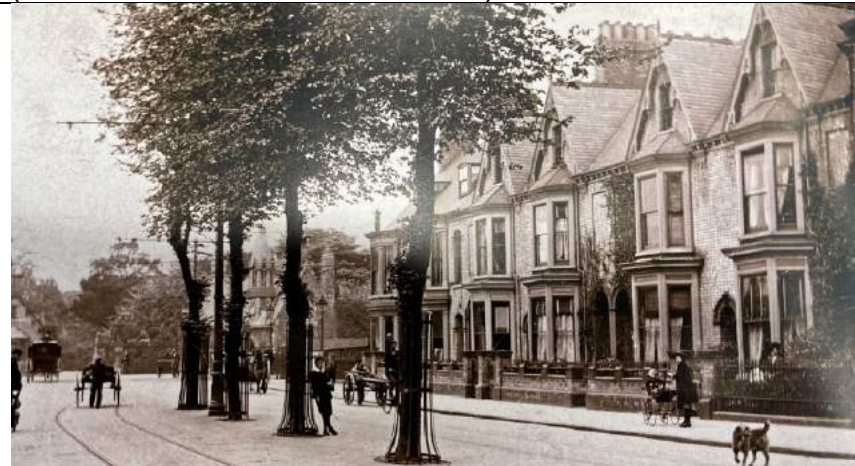
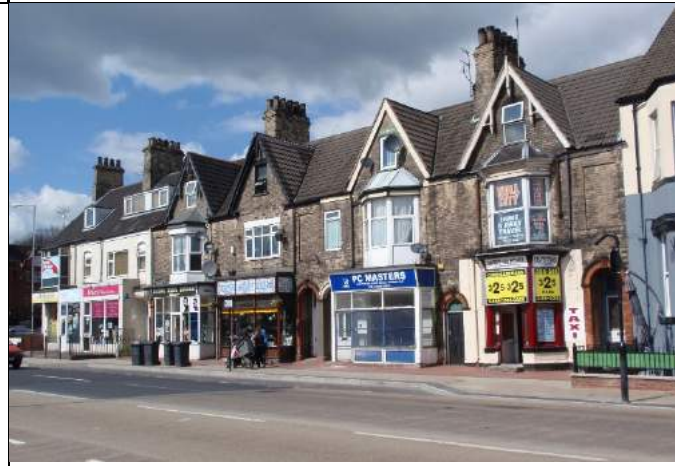
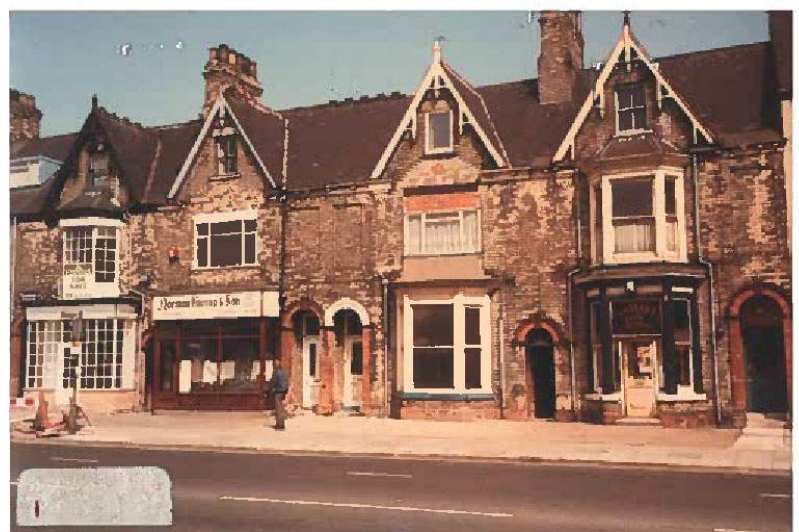
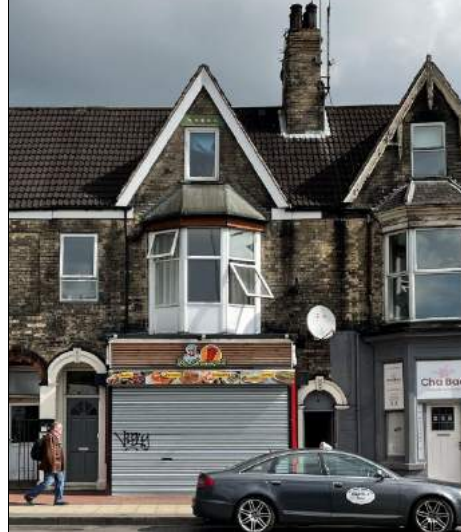
236 Spring Bank forms a group with the adjacent 234, 238 and 240 Spring Bank. 236 was built between 1856 and 1893 as a group of large residential dwellings with generous front gardens bound by garden

Monitoring Notes	<p>No immediate action risk items identified, although the building is in a relatively poor condition. Any works to remove the limited original details retained including the terracotta archway should not be permitted.</p>

- Remove the uPVC gutters and downpipes and reinstate the cast iron gutters and downpipes.
- Remove the uPVC windows and replace with new timber sash windows.
- Remove the metal framed shopfront and external shutter and replace with a new, high quality, modern timber shopfront with integrated security and awning.
- Reinststate the details to the bay window to the first floor level.
- Remove the pantile roof and replace with slate roof finish.
- Reinststate the timber eaves support details (as the 1904 photograph).
- Reinststate the three spires to the second floor gable (as the 1980's photograph).

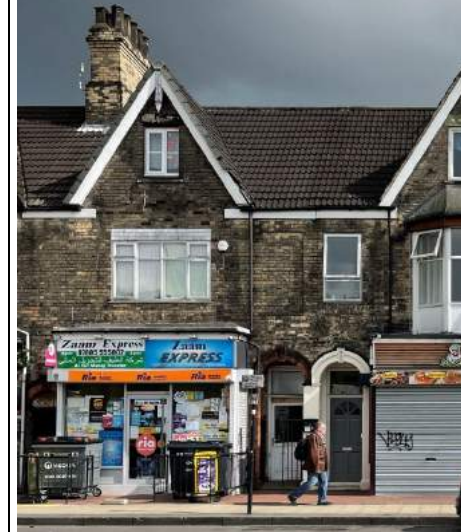
238 Spring Bank forms a group with the adjacent 234, 236, and 240 Spring Bank. 238 was built between 1856 and 1893 as a group of large residential dwellings with generous front gardens bound by garden

Monitoring Notes	No immediate action risk items identified, although the building is in a relatively poor condition. Any works to remove the limited original details retained including the terracotta archway should not be permitted.
Recommended Actions	The building forms part of the wider group including 234, 236 and 240 Spring Bank. The building would therefore benefit from a collective restoration to the group as a whole.

- Remove the uPVC gutters and downpipes and reinstate the cast iron gutters and downpipes.
- Remove the uPVC windows and replace with new timber sash windows.
- Remove the metal framed shopfront and external shutter and replace with a new, high quality, modern timber shopfront with integrated security and awning.
- Reinstall the details to the bay window to the first floor level.
- Remove the pantile roof and replace with slate roof finish.
- Reinstall the timber eaves support details (as the 1904 photograph).
- Reinstall the three spires to the second floor gable (as the 1980's photograph).

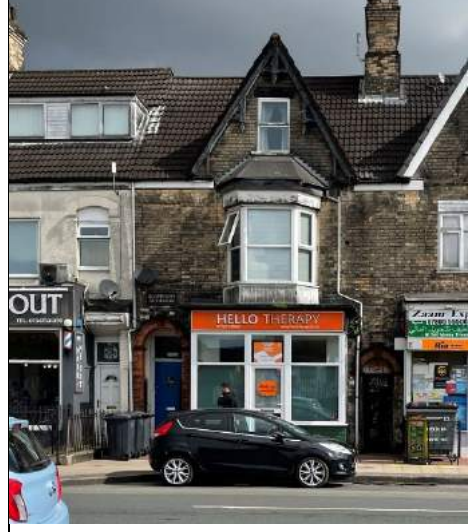
240 Spring Bank forms a group with the adjacent 234, 236 and 238 Spring Bank. 240 was built between 1856 and 1893 as a group of large residential dwellings with generous front gardens bound by garden

Monitoring Notes	<p>No immediate action risk items identified, although the building is in a relatively poor condition. Any works to remove the limited original details retained including the terracotta archway should not be permitted.</p>
Recommended Actions	<p>The building forms part of the wider group including 234, 236 and 238 Spring Bank. The building would therefore benefit from a collective restoration to the group as a whole.</p> <p>The building would benefit from the following works :-</p> <ul style="list-style-type: none"> • Remove the uPVC gutters and downpipes and reinstate the cast iron gutters and downpipes.

- Remove the uPVC windows and replace with new timber sash windows.
- Remove the metal framed shopfront and external shutter and replace with a new, high quality, modern timber shopfront with integrated security and awning.
- Reinststate the details to the bay window to the first floor level.
- Remove the pantile roof and replace with slate roof finish.
- Reinststate the timber eaves support details (as the 1904 photograph).
- Repair and redecorate the three spires to the second floor gable (as the 1980's photograph).

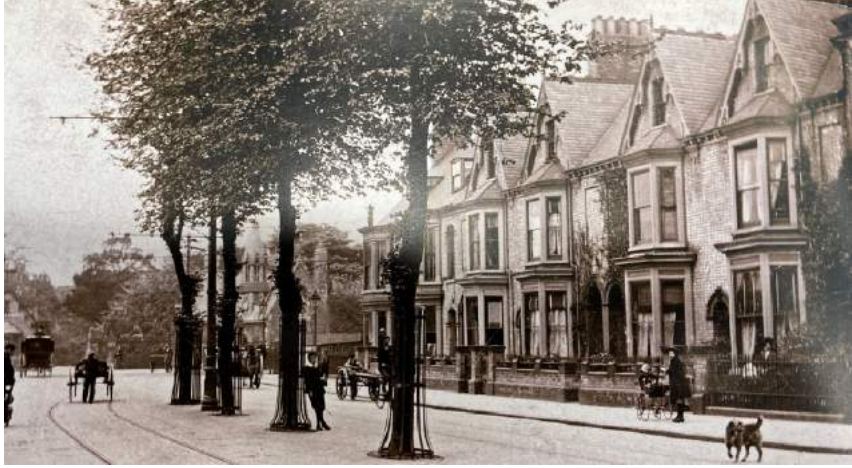
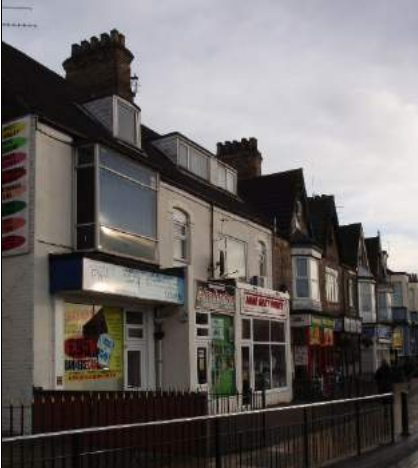
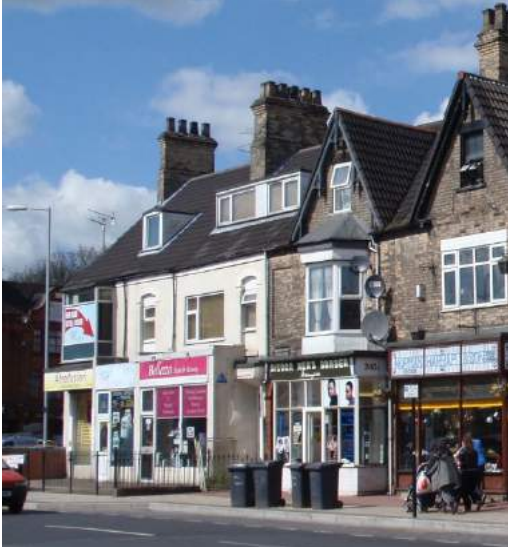
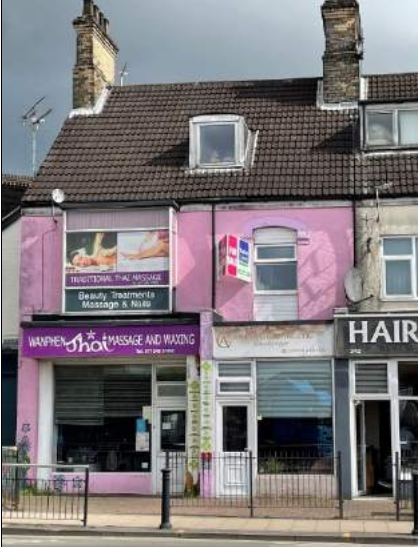
Street: Spring Bank	Thai Massage and Waxing, 246-248
Historic Photo – 1904 (Hull Then and Now, Paul Gibson)	Historic Photo 22/11/2012 (Phil Hampel)

<p>Building Notes</p>	<p>246 Spring Bank forms a group with the adjacent 244 Spring Bank. 246 was built between 1856 and 1893. The group were originally two storey buff brick residential properties with highly decorative double height bay windows and single dormer windows to the roof level accommodation.</p> <p>The 1904 photograph shows how 244 was a high quality residential property located directly adjacent to the Botanical Gardens. The property had a brickwork boundary wall with iron railings and brick gate piers. The two storey bay windows (seen behind/between the trees) had decorative features and detailing and sliding sash timber windows. The entrance door and the window directly above had feature stone arched lintels and inposts. The single dormer windows were glazed to both the front and sides. The roof finish was slate and the gutters were cast iron with decorative timber supports.</p> <p>By 2010, radical alterations had occurred. Following a planning approval in 1999 to convert both ground and first floor to retail use, the boundary wall and piers to the front gardens was removed and with the two storey bay window and a new single storey extension added to the ground floor level to create a new shopfront. The windows were replaced with uPVC and the bay window replaced with a new metal framed bay window. The first floor arched window was partially infilled at the head and base. The dormer window was retained but the window replaced with uPVC and the sides covered in uPVC cladding. The external walls were rendered. These alterations were detrimental to the character of the building and the Conservation Area.</p> <p>Today in 2023, very little has changed since the 1985 works with the exception of the replacement of the slate tile with grey concrete pantiles and the painting of the render a bright pink colour.</p> <p>The building has been subject to the following Planning Applications :-</p> <ul style="list-style-type: none"> • 1999 - Change of use of first floor and second floor to retail use with residential above including new windows to first and second floor (Ref No : 99/00853/PF) • 2007 – Change of use of first and second floor from furniture shop to 6 self contained flats including external alterations to rear elevation (Ref No : 07/00155/COU) Permitted • 2007 – Change of use of ground floor of properties from furniture shop to mixed use brasserie/wine bar, installation of new shopfront, use of yard as beer garden (07/00156/COU) Withdrawn • 2008 – Retention of external alterations to front elevation at ground floor including new timber fascia incorporating blue metal cladding (08/00780/FULL) Refused • 2016 – Change of use from A1 (shop) to A1(shop)/A3 (restaurant/café) mixed use (Ref No : 08/00780/FULL) Permitted

<p>Monitoring Notes</p>	<p>The building is generally in a poor condition and has retained very little historic features to the Spring Bank frontage. Any works to remove the stone arched lintels to the first floor window (still in-situ) should</p>

<p>not be permitted. The building currently has a negative impact on the Conservation Area and is located at a key junction so forms a focal point when entering the Conservation Area.</p>
<p>Recommended Actions</p>	<p>The building forms part of the wider group including 244 Spring Bank. The building therefore benefit from a collective restoration to the group as a whole.</p> <p>The building would benefit from the following works :-</p> <ul style="list-style-type: none"> • Replacement of the existing shopfront with a high quality shopfront. • Removal of the rendered finish and first floor bay window, undertake repairs to match in brickwork where bay was removed and replace the first floor bay window with a canted bay window. • Replacement of the first floor windows with sliding sash windows including a full height window to the arched window above the door. • Replacement of the dormer window with sliding sash and the sides finished in lead/turncoated steel. • Removal of the pantile roof finish and replacement with slate tiles. • Removal of the PVC rainwater goods and replacement with cast iron. • Rationalisation/removal of services including satellite dishes, aerials, cables, air conditioning units, alarm boxes.
