# GTS1, Hull

## Type 4 Fire Risk Assessment

Prepared for:	Rebecca Franks, Programme Manager
Prepared by:	John Askew, Fire Risk Assessor, Holistic Fire Safety
Date:	26/03/2023
Document Reference:	HFS.HCC.GTS1.FRA.1.0

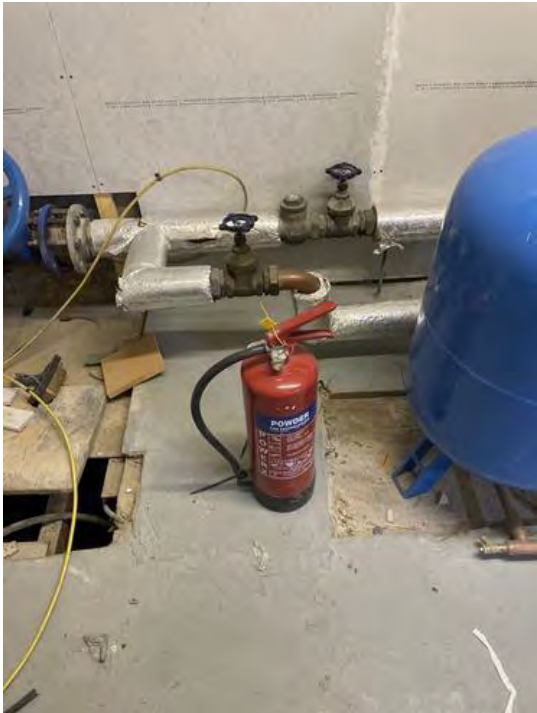
Photo 107

Extinguishers were observed to be on the floor and missing appropriate signage.
