# GTS3, Hull

## Type 4 Fire Risk Assessment

Prepared for:	Rebecca Franks, Programme Manager
Prepared by:	John Askew, Fire Risk Assessor, Holistic Fire Safety
Date:	17/04/2023
Document Reference:	HFS.HCC.GTS3.FRA.1.0

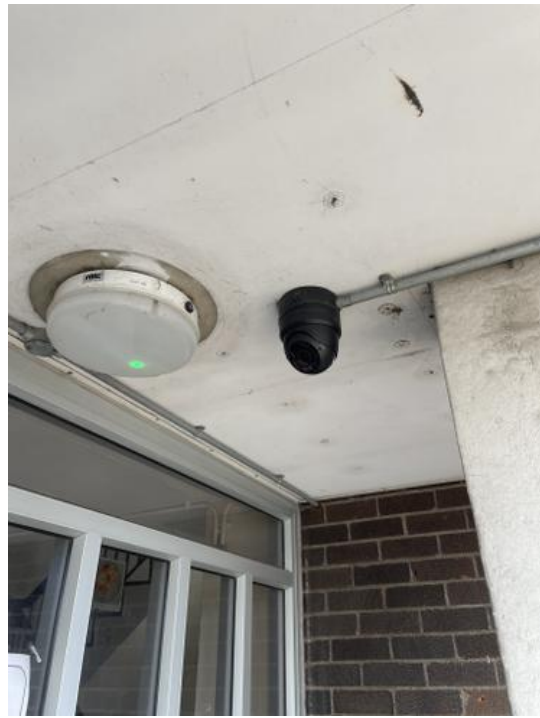
BS 9999 Table 8

Table 8 Provisions for emergency escape lighting	
Occupancy characteristic	Areas needing emergency escape lighting
A	Underground or windowless accommodation Stairways in a central core or serving storey(s) more than 18 m above ground level Internal corridors more than 30 m long Open-plan areas of more than 60 m <sup>2</sup>
B <sup>A)</sup>	All escape routes <sup>B)</sup> (except in shops of three or fewer storeys with no sales floor more than 280 m <sup>2</sup> provided that the shop is not a restaurant or bar)
C	All common escape routes <sup>B)</sup> , except in two-storey blocks of flats
Any use	All sanitary accommodation with a floor area over 8 m <sup>2</sup> Windowless sanitary accommodation with a floor area not more than 8 m <sup>2</sup> Electricity and generator rooms Switch room/battery room for emergency lighting system Emergency control room
<small>A) In areas of shops where the public are not admitted use occupancy characteristic A. B) Including external escape routes.</small>
