VERIFICATION REQUIREMENTS FOR GAS PROTECTION SYSTEMS

Technical Guidance for
Developers,
Landowners and
Consultants

Yorkshire and Lincolnshire
Pollution Advisory Group

Version 1.1 – December 2016

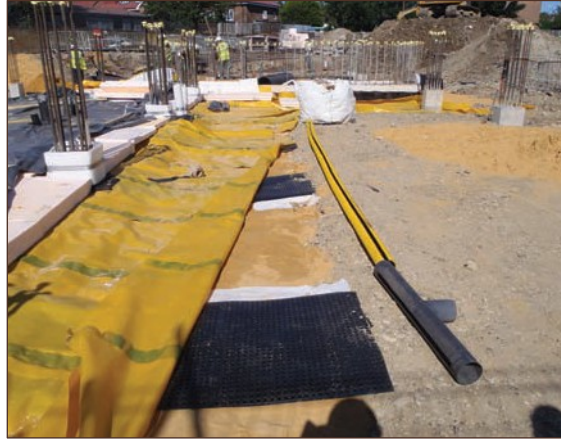
Figure A4.8 Geotext beneath the 2000g taped gas membrane lined up with collector pipes (courtesy Alderburgh Group)

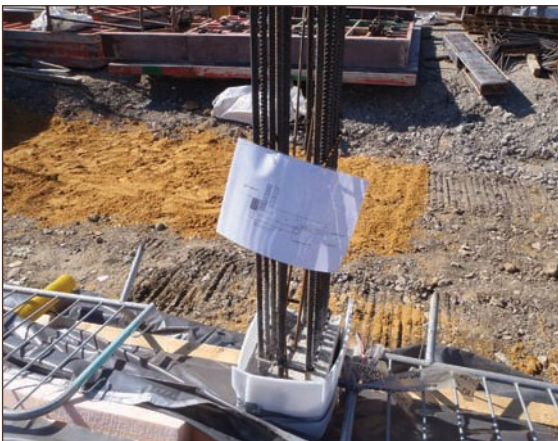
Figure A4.9 On site schematics to aid construction workers build the gas protection system (courtesy Alderburgh Group)

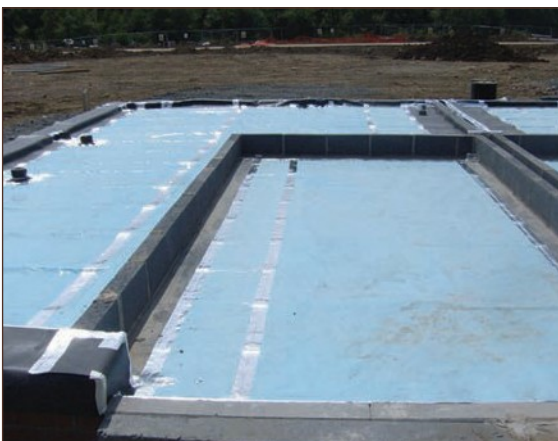
Figure A4.11 Gas membrane continued through cavity wall and above air bricks (courtesy Hydrock)

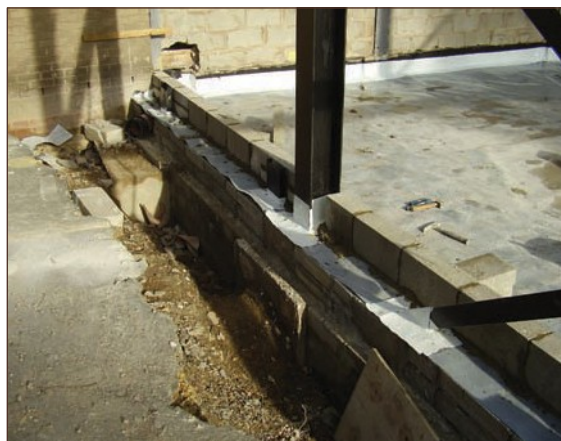
Figure A4.12 Good edge detail across cavity (courtesy PAGEotechnical Ltd)

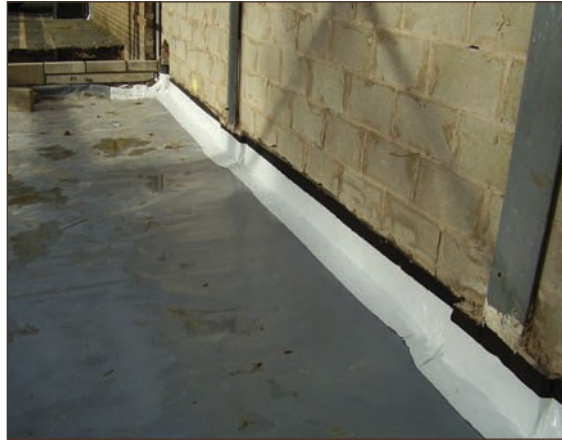
Figure A4.14 Good perimeter seal (courtesy PAGEotechnical Ltd)

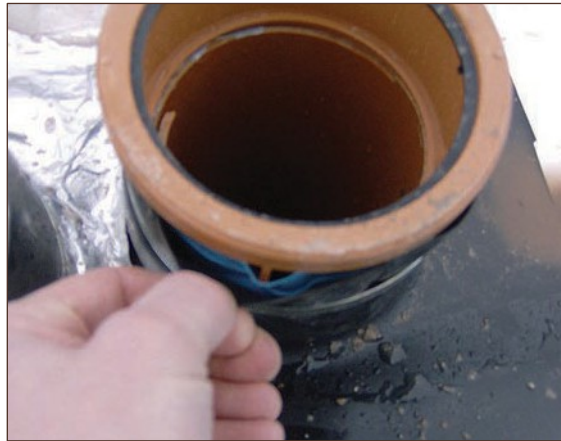
Figure A4.28 Bead of double sided butyl tape provided between interfaces of ID top hat and OD service pipe. When compressed with jubilee clip, forms an effective seal (courtesy Smith Grant)

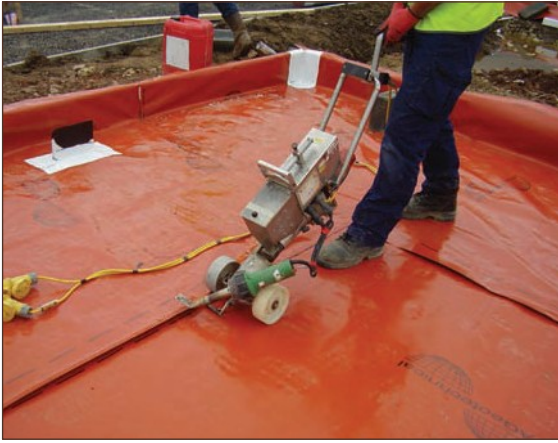
Figure A4.31 *Extrusion welding (courtesy PAGeotechnical Ltd)*

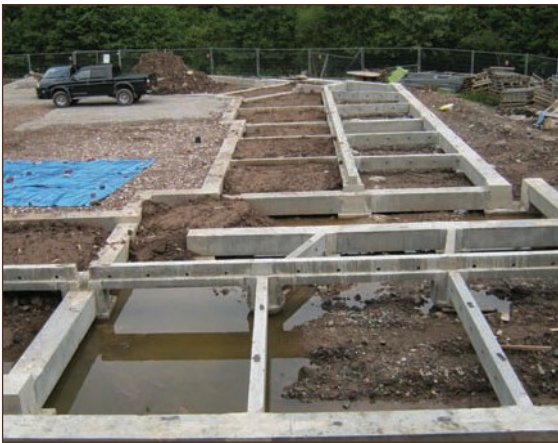
Figure A4.33 *Good ventilation in internal sleeper walls, cast into prefabricated beams (courtesy Smith Grant)*

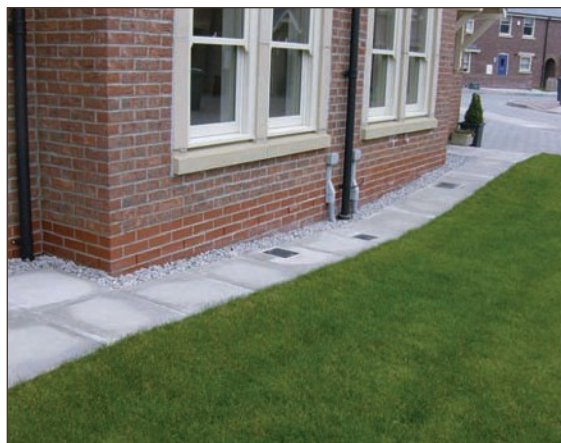
Figure A4.36 *Raised air bricks are preferable due to the reduced potential for blockage but the vent trench specified is provided with clean single sized stone (courtesy Smith Grant)*

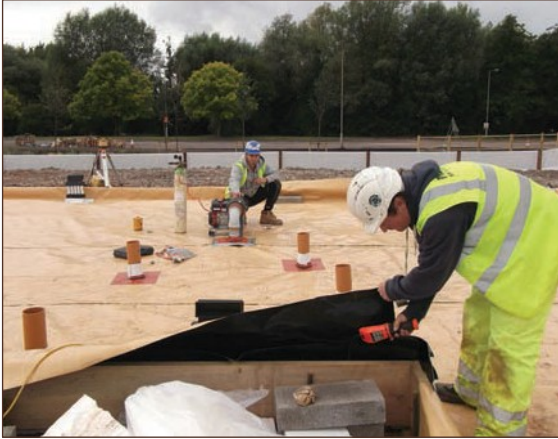
Figure A4.37 Tracer gas testing, whereby gas or smoke is applied under pressure beneath the installed gas membrane and detectors are used to screen for leaks above (courtesy NHBC)

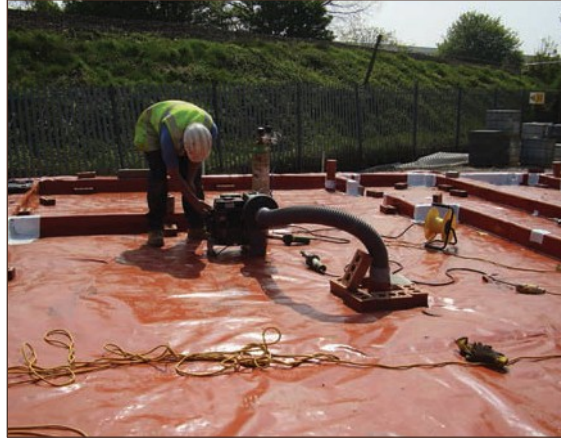
Figure A4.38 Tracer gas testing (courtesy PAGEotechnical Ltd)

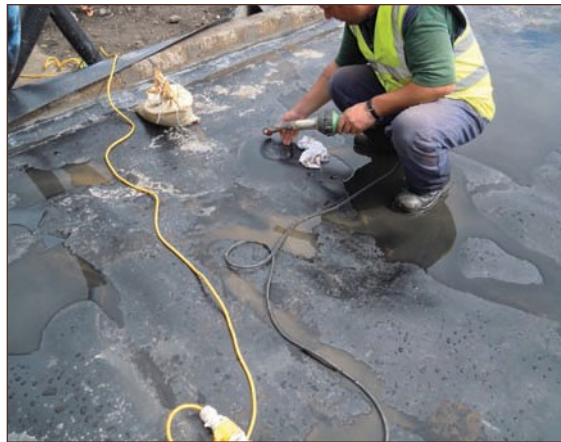
Figure A4.40 CO₂ injection integrity testing (courtesy Landline Ltd)

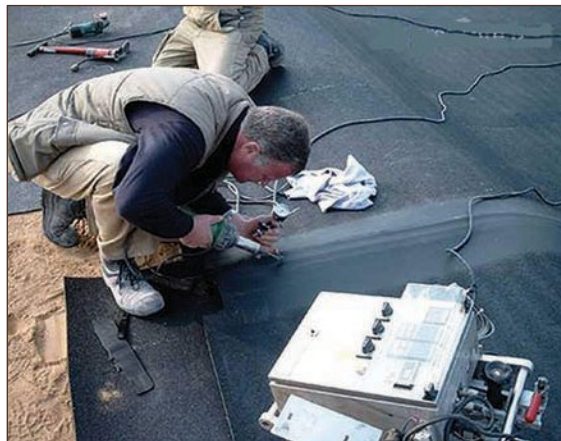
Figure A4.42 Air pressure testing (courtesy GSE Environmental)

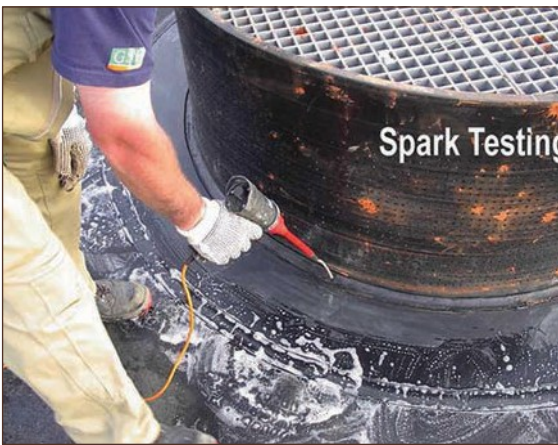
Figure A4.45 Spark testing (courtesy GSE Environmental)

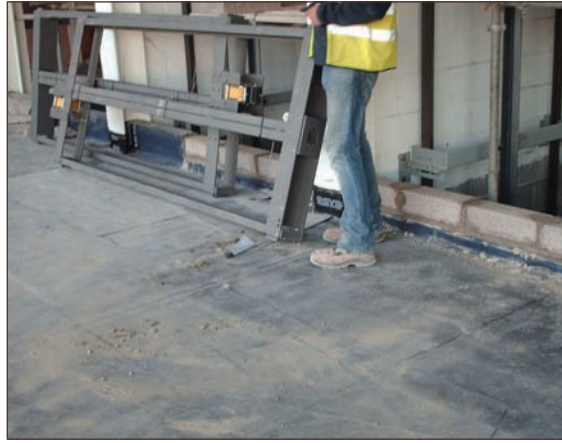
Figure A4.50 *Large/heavy/sharp objects being moved over unprotected gas membrane (courtesy Card Geotechnics Limited)*

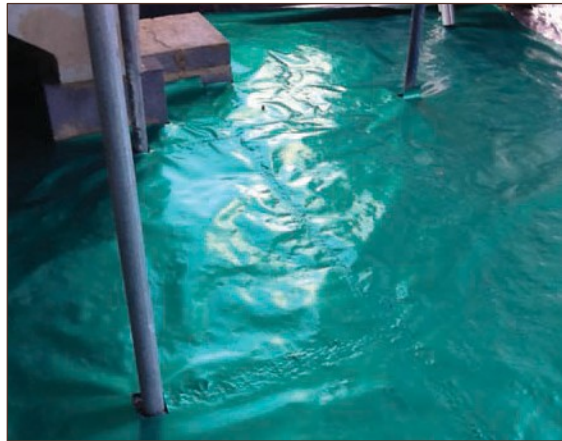
Figure A4.52 *Gas membrane cut by scaffolders and bricklayers after installation (courtesy MEC Environmental Ltd)*

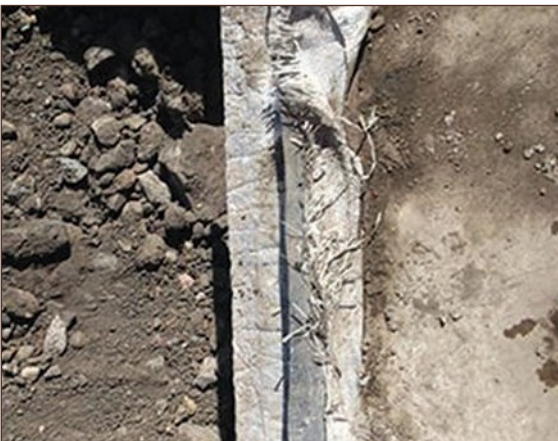
Figure A4.53 *Gas membrane left exposed for long period of time, shows significant fraying at cavity edge (courtesy NHBC)*

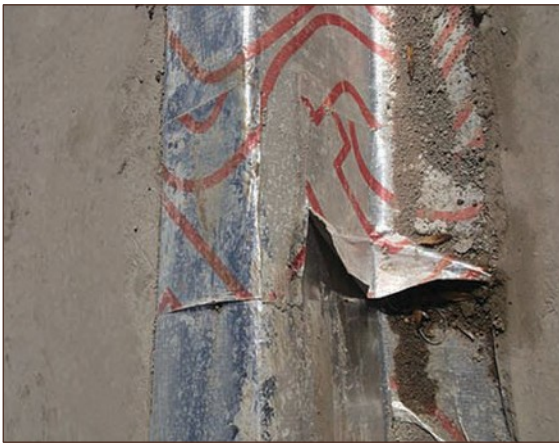
Figure A4.55 Gas membrane at stepped junction of slab to integral garage, appears to be susceptible to tearing when screed is poured. Screed may also weigh down on gas membrane if fitted too tight (courtesy NHBC)

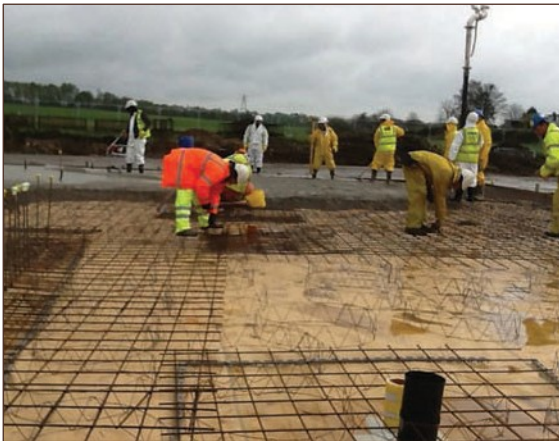
Figure A4.57 Unprotected gas membrane damaged by heavy traffic (courtesy MEC Environmental Ltd)

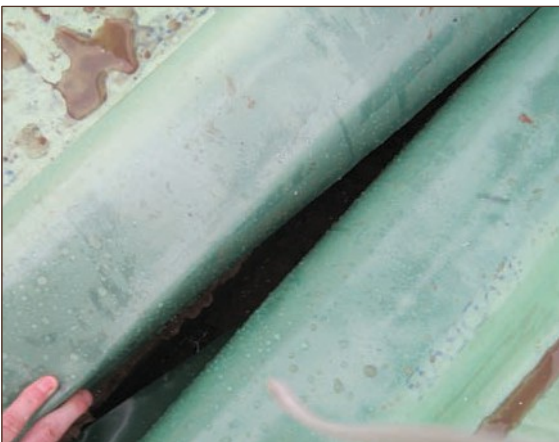
Figure A4.59 Gas membrane slit at the bottom of a cavity tray to enable water to drain away (courtesy Smith Grant)

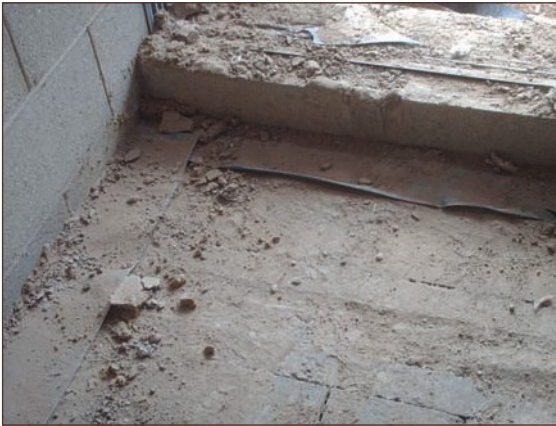
Figure A4.63 Absence of surface preparation prior to laying of gas membrane, debris likely to pierce gas membrane (courtesy Card Geotechnics Limited)

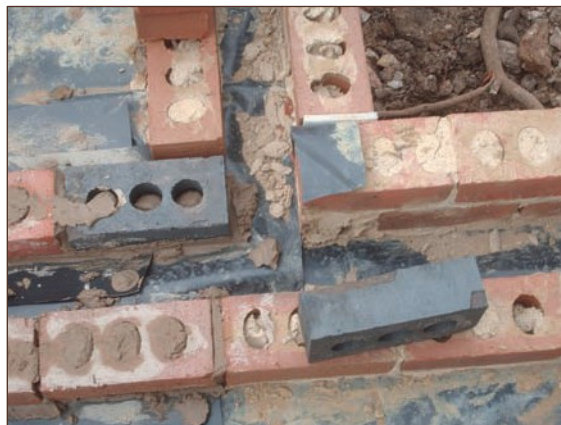
Figure A4.66 Follow-on trades proceeded work before gas membrane joints sealed (courtesy Card Geotechnics Limited)

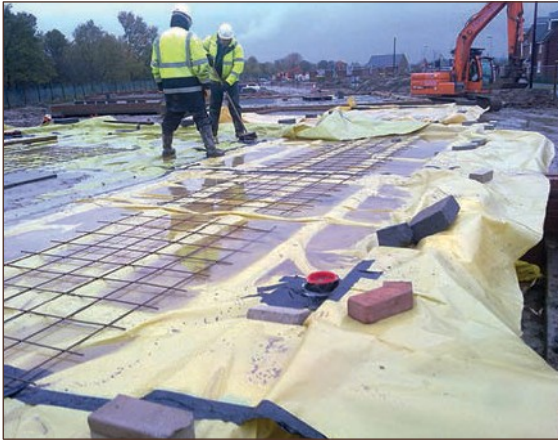
Figure A4.67 Traffic over mesh resulted in several punctures, in addition most joints were found to be poorly constructed. Taped joints are difficult to construct in adverse weather (courtesy Smith Grant)

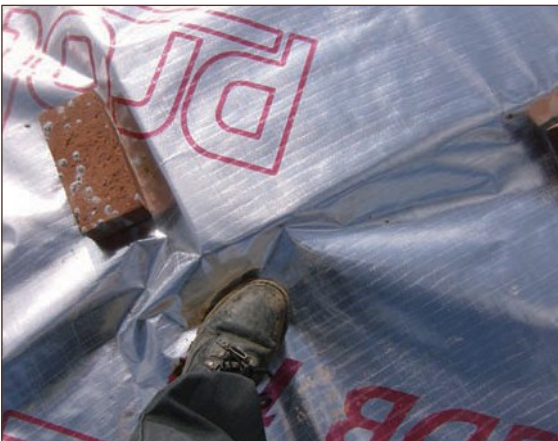
Figure A4.71 No corner detailing leading to stress point on gas membrane (courtesy Smith Grant)

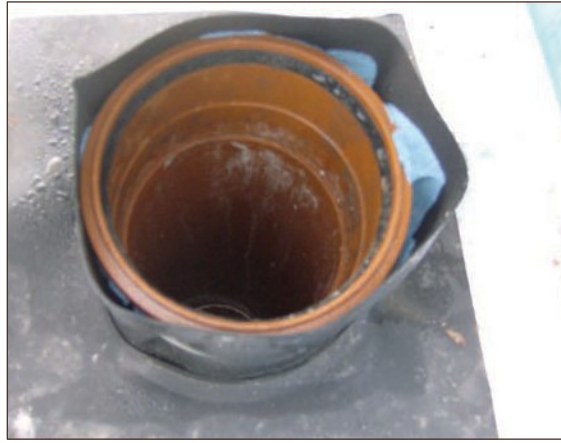
Figure A4.74 Gap between OD of service pipe and ID of top hat too large: cannot be compressed enough to form seal, even with the application of additional tape (courtesy Smith Grant)

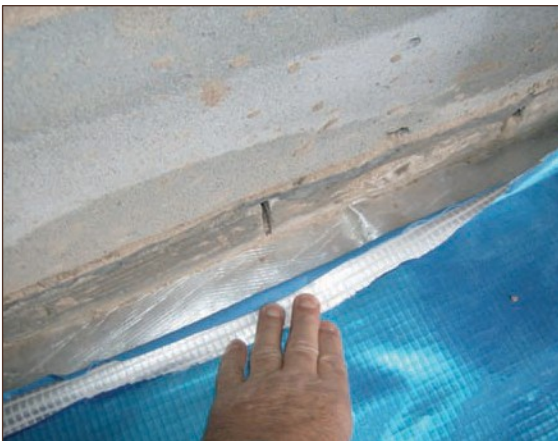
Figure A4.77 Small lap and no single sided tape used to achieve secondary seal (courtesy Smith Grant)

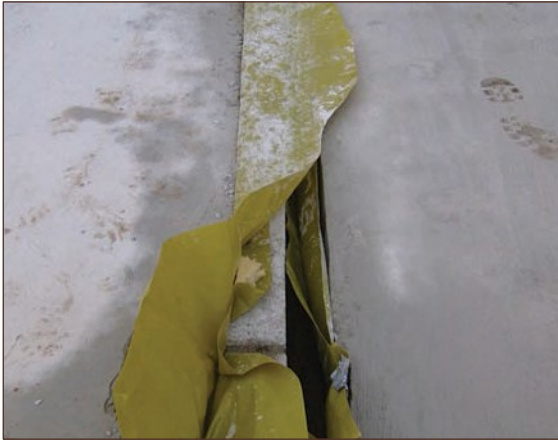
Figure A4.79 Gas membrane not continuous over internal wall. It had been deliberately cut open for unknown purpose (courtesy Smith Grant)

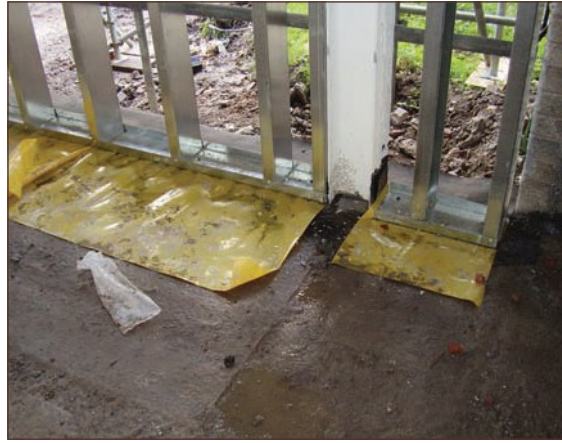
Figure A4.80 Column left unsealed (courtesy PAGEotechnical Ltd)

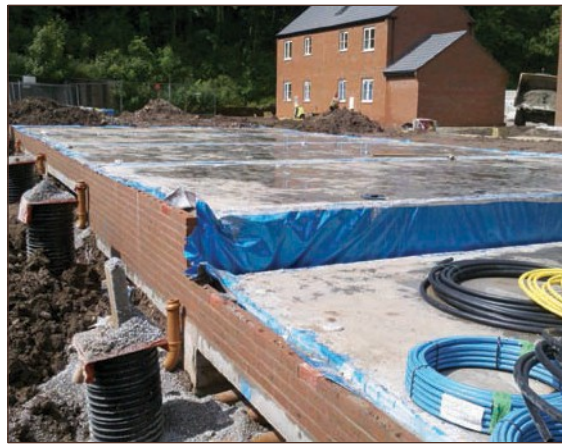
Figure A4.82 Gas membrane used to bridge cavity wall instead of DPC, leaving it exposed to damage by follow-on trades (courtesy Smith Grant)

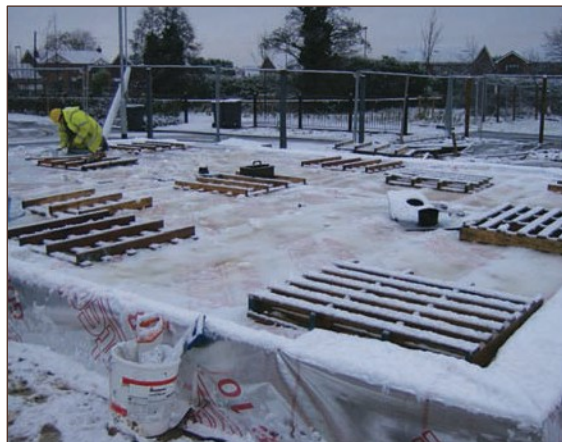
Figure A4.84 Taped joints are difficult to construct in adverse weather. Also difficult to inspect if covered with snow (courtesy Smith Grant)

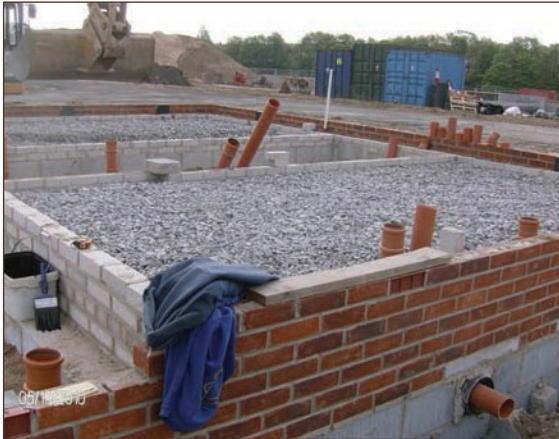
Figure A4.85 Clean single sized stones with no fines acting as venting media, however no ventilation gaps in internal sleeper walls (courtesy Smith Grant)

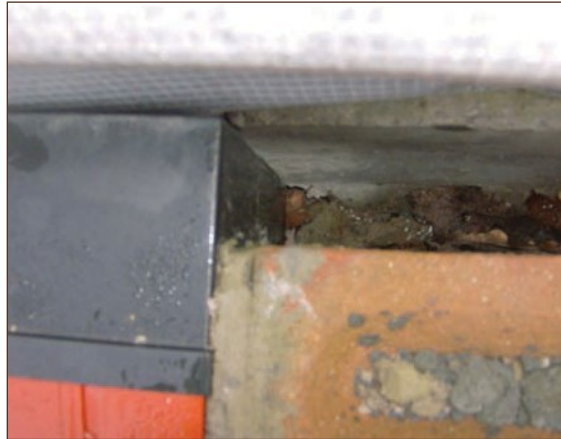
Figure A4.86 Cavity is becoming blocked with detritus. The vent holes in the beam are no longer visible (courtesy Smith Grant)
