Boulevard

Conservation Area Character Appraisal

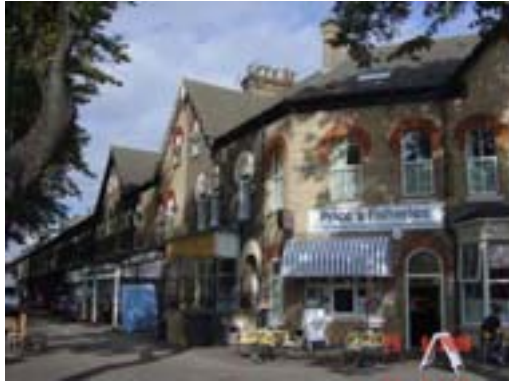
fig1 Entrance from Hessle Road, east side

- 5.6 Entering Boulevard from the southern end, high three storey gabled buildings are angled towards the corners on both sides of the road. These buildings are effectively part of the Hessle Road Shopping Centre, but the liveliness imparted by cafes and shops with outdoor seating and displays quickly gives way to a quieter atmosphere. Both corners have attractive arched window heads and decorative bargeboarded gables but an interesting quirk is that the 'folds' in the frontage relate differently to the gables on each side.

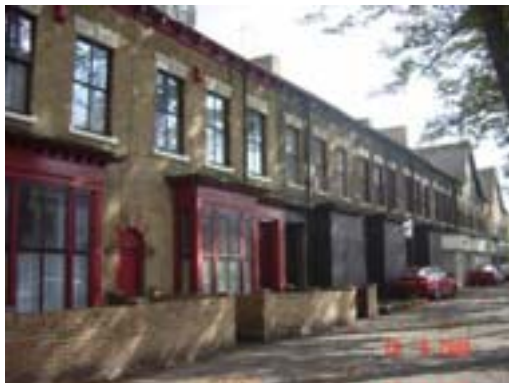
fig 2 Nos 247-253 boarded up frontages.

- 5.8 The first few buildings on the east side have shop units and bay windows which are boarded up. These appear to be used as storage by the Hessle Road shops, but they impart a lifeless image to this part of Boulevard.

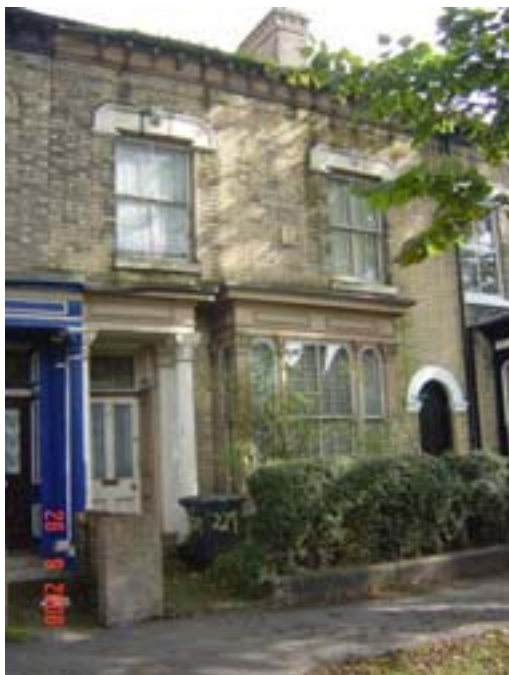
- 5.9 The next section north to Boynton Street on the east side [Nos 253 to 223] are among the earliest houses built in the street, already existing by 1888. Some [eg No 231] have retained classical detailing around the door cases more reminiscent of a Regency style, which seem to have remained fashionable in Hull well into Victorian times.

fig 3 No 229 Where original features survive they can provide guidance for repairs to neighbouring properties.

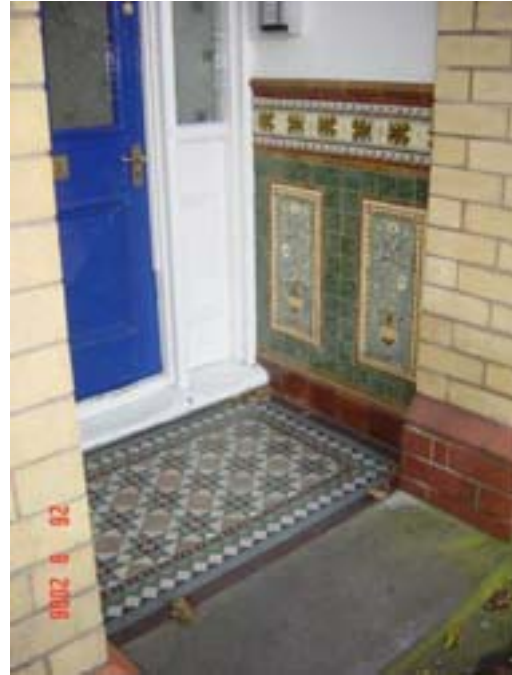
- 5.4 Hull has a notable tradition of attractive patterned floor and wall tiles in doorways and there are some particularly fine examples in Boulevard. Examples can be seen at Nos 69, 73, 79, 163, 234, 150 and 128.
- 5.5 Given the linear nature of the Conservation Area, it is logical to consider the area in stages from one end to the other.

fig 4 No 163 Decorative tiled porches are a feature of the Conservation Area.

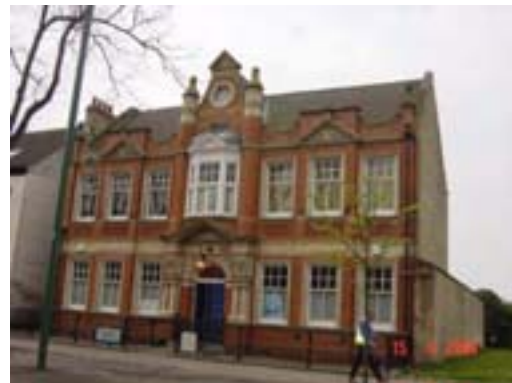
fig 5 Western Branch Library [Listed Grade 2]

- 5.11 The most prominent building in this section of frontage is the **Western Library** [Listed grade 2] 1894 by W Alfred Gelder, one of the first of Hull's branch libraries. Described as a 'Northern Renaissance' style, recent cleaning has brought out the attractive mellow red brick, decorative terracotta panels and contrasting stone. A wealth of carved stone round the entrance including shields with the three crowns demonstrates the civic pride of the time. Inside the building has retained many original features and furnishings. Recently reinstated railings complete the attractive frontage.

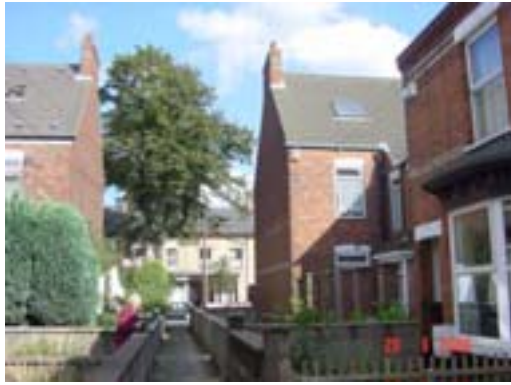
fig 7 Albert Avenue

- 5.13 Entered by a path between side gardens of Nos 228 and 230 Boulevard is 'Albert Avenue', a 'court' typical of Hull's characteristic form of working class housing development and one of the few to be within a Conservation Area. Built around the 1890s, it is one of the better quality courts which improved on the minimum requirements of the 1875 by-laws, with rear pedestrian access, front gardens and bay windows on the ground floor. No. 2 has retained original windows. The houses on the Boulevard frontage which frame the entrance to the court have attractive yellow brick fronts with contrasting red brick bands. This brick pattern is reversed on the gables with yellow bands on red, a scheme which continues on the fronts of the Albert Avenue houses. Throughout the Conservation Area [and commonly throughout Hull for houses of this early 20th century period] yellow brick front elevations tend to be used to denote a better class of housing.

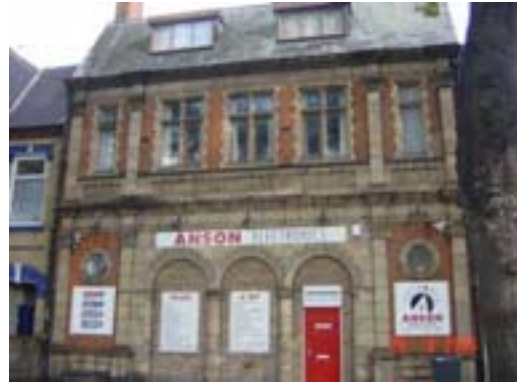
fig 10 Former Western Hull and Sculcoates Dispensary.

- 5.17 The most prominent building along this stretch is the **former Hull and Sculcoates Dispensary, Western Branch** [built 1898]. This red brick and terracotta building with mansard roof was designed by Smith, Brodrick and Lowther, a prominent Hull architects' firm. It had an open colonnade at the front [now bricked in] where people queued for their medicines. Now an electronics firm it has retained many original features.

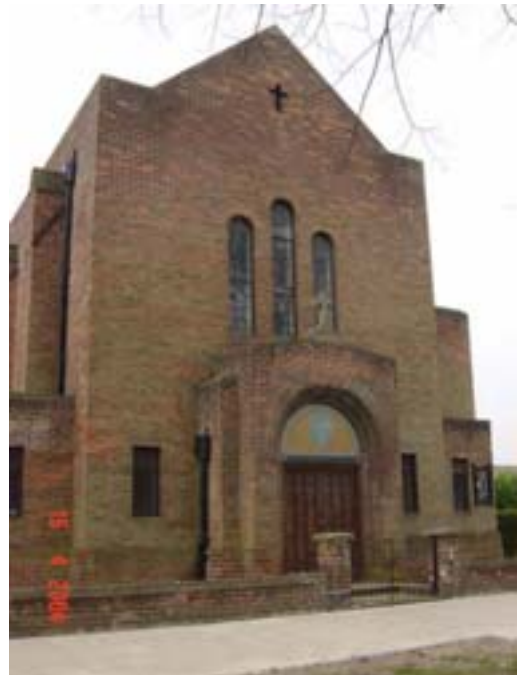
fig 11 St. Wilfred's RC Church

- 5.19 St Wilfred's Church hall, now called '**The Village Hall**' is a modern, low red brick building which has picked up the local tradition of contrasting yellow brick details. **St. Wilfred's Church**, 1956 by Williams Sleight and Company replaced one from 1896 destroyed by a land mine in 1941. It has a lofty, rather severe, brick frontage relieved by rounded features on north and south elevations, rounded doorways and a blue and yellow mosaic feature over the front entrance. The north elevation in particular can be appreciated because the **Presbytery** is set well back behind a long front garden, a welcome green break in the urban character of the area. The presbytery itself is in a pleasing 1950s version of an Arts and Crafts style, and has retained its metal leaded windows and clay tiled roof.

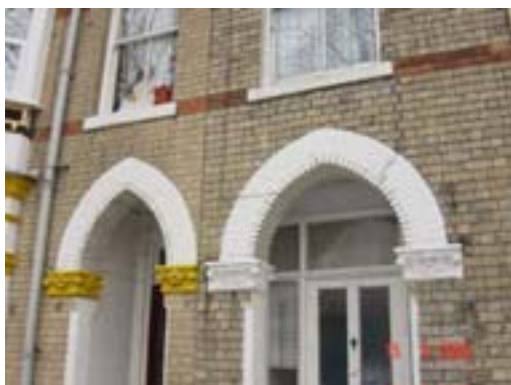
fig 9 'Gothic' doorways.

- 5.16 The east side, Nos 213 to 221a, are 3-storey gabled houses in yellow brick with red banding and have unusual entrance porches with fluted gothic arches. North of these [Nos 211 to 185] were some of the last houses to be built [1910-20]; 2-storey with stone bays rather than the

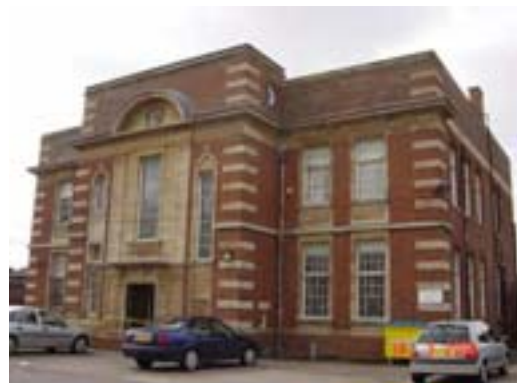
fig 12 Former School for Fishermen, now Schoolgirl Mums Unit [Listed Grade 2]

- 5.20 **The former School for Fishermen [Listed grade2]** of 1914 is by the first City Architect Joseph Hirst in a mixture of Neo-Georgian and Edwardian Baroque styles, with an unusual flat roof behind a high parapet from which students practiced signalling. The purpose of the school was to train boys joining the burgeoning fishing industry and ensure that they continued their education between trips. It later became a general nautical college and is now a resource centre for the Youth Service, providing for schoolgirl mothers. It is set back behind a large yard with high railings, part of which appear to be original and part a recent well matched reinstatement.

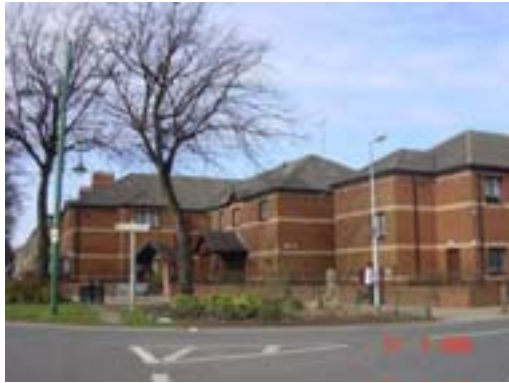
- 7.2 **Queensgate Nursing Home on Boulevard/ Chomley Street corner** and the **1950s council houses on Boulevard/Newton Street**, while varying from the characteristic form and scale of the area, might now be considered to be characteristic of their periods of development and to add some variety to the street scene.

fig 13 Queensgate Nursing Home with street furniture and planting at roundabout, corner with Chomley Street.

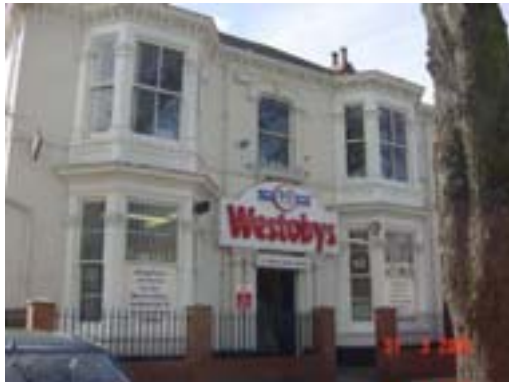
fig 15 Villa at No 124.

5.25 North of the junction, development generally took place earlier on the west side of the road than the east. Consequently there are a number of larger villas and more varied architectural styles on the west side. The semi detached pair 142 and 144 is an early survivor; gothic arches over the doors yet rounded window heads and large timber 2 storey bays similar to some found in the Avenues show the confidence with which designers mixed popular styles. No 124, now **Westoby's paint**

suppliers, is the kind of large detached double fronted villa which it was hoped to attract when the street was first developed. Despite a concrete tiled roof and over- large signage, it has retained its original windows. The rubbish strewn vacant site to its south detracts from its appearance and would benefit from appropriate new development.

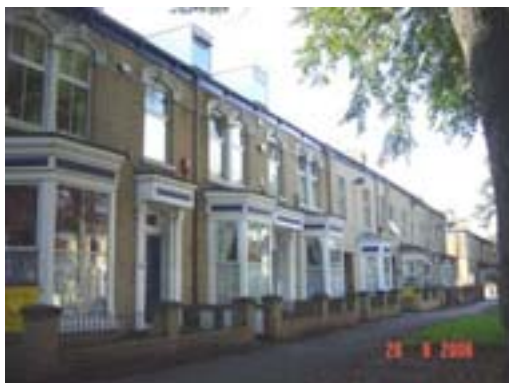
- 5.26 Apart from the villas already mentioned, houses on the west side are predominantly large terraced houses with bay windows, but there is a great variety of details in the form of stone lintels, timber eaves details and timber or brick bays. The unifying feature is a predominance of white/cream bricks for front elevations. Because of the large size of the buildings many have been converted to flats and some [eg Nos 104 and 106] have suffered from loss of architectural details due to neglect or poor quality alterations. Some frontages have inappropriate boundary walls; however, 98 to 104 show a form of brick dwarf wall and railings which could set an appropriate form for other boundaries.

fig 16 Nos 98-102, dwarf walls with railings.

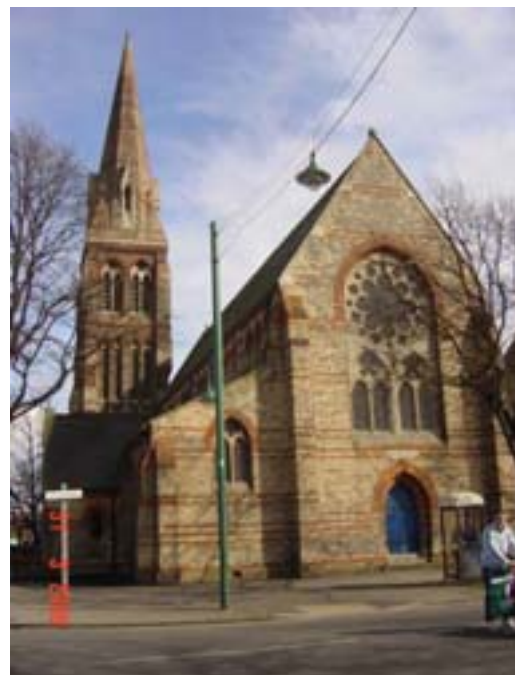
fig 18 St. Matthew's Church [Listed Grade 2]

- 5.37 **St. Matthews Church** [1870] is a major landmark, with its elegant broached spire visible from a considerable distance. Built of creamy-white brick with subtle contrasting bands of red brick and stone dressings in an Early English style, it is said to have some of the finest plate tracery windows. It was designed by Adams and Kelly who had worked with leading Gothic Revival architect G.E. Street. The two storey **Parish Hall** of 1904 on the opposite side of the street with its attractive timbered gable is very similar to a church hall on Princes Road and might be by the same architect John Prossor. Part is now used as a pharmacy.

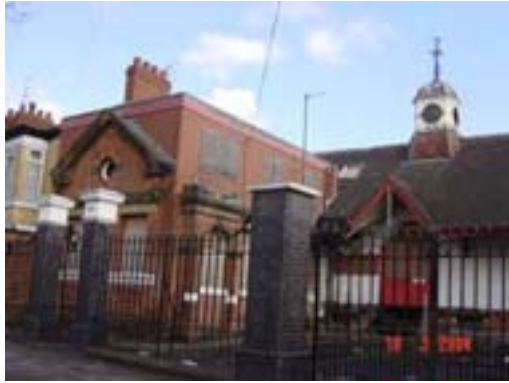
fig 19 Former Whitbread Brewery Depot.

- 5.33 The former **Whitbread's brewery depot** with pitched roofs, clock tower and elaborate cast iron gates is currently vacant and deteriorating but potentially attractive.

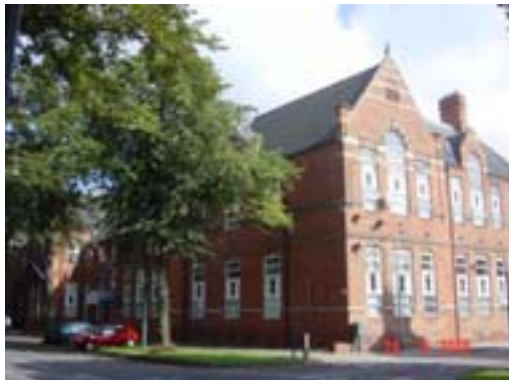
fig 20 Former school, now Rosedale Mansions [Local List]

- 5.35 The former **Boulevard Higher Grade School** of 1895 was one of only 3 such schools built by the Hull School Board for children staying on beyond the statutory leaving age of 12. It has the distinctive design features recognisable in other Hull Board Schools designed by John Bilson who had previously designed schools in London, including rooftop timber cupolas which served as ventilators [one now capped off but the other restored in 2004], steeply pitched roofs, red brick walls with contrasting bands of stone and lofty storey heights. It boasted modern facilities including a science laboratory; the entrance to this is still identified by a carved stone lintel over a doorway in Malm Street. Unfortunately the windows have been unsympathetically altered in converting the building to flats. However, the conversion has helped to secure a future for this example of a building type considered among Hull's best Victorian buildings.

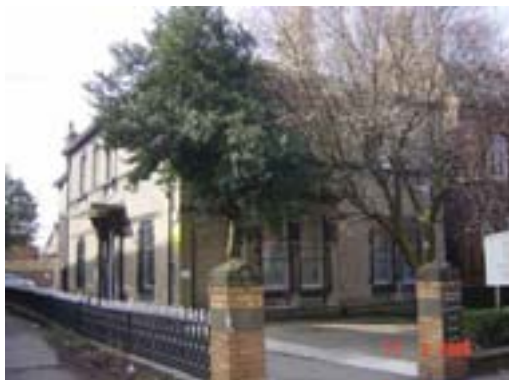
fig 21 Sydenham House doctors' surgery.

- 5.36 **Sydenham House** was built as a **doctor's surgery** in 1876, surely the oldest surviving purpose built surgery in the city. Although for security it has been fitted with metal grills to the ground floor windows, it remains a fine villa with many original features and attractive railings. Cream brick with stone dressings indicate quality. A two storey square plan building with its main door at the side, it contrasts with the taller red brick **vicarage** next door, built in 1878, which has a high gable and mansard roof to the second floor.

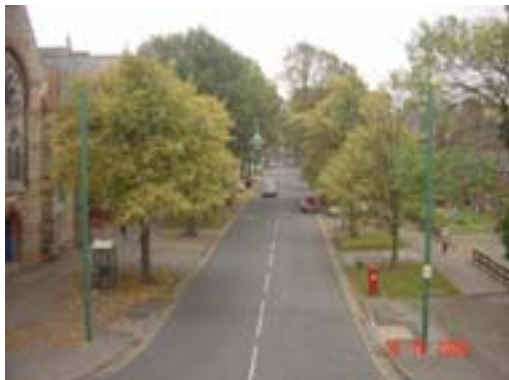
5.39 The vista north along Boulevard is closed by the early 1960s concrete viaduct ['flyover' in Hull parlance] which takes a realigned Anlaby Road over the main railway line. This is outside the Conservation Area but has an obvious dominant effect on the character of this end of the Boulevard. The disregard which the flyover pays in scale and form to its surroundings is typical of engineering structures of this period. However, it was part of the solution to a problem perceived at the time as stifling the development of the city, namely the way in which the network of railway lines crossing main roads into the city caused long delays to road traffic at level crossings. The area under the flyover on each side of the railway tends to attract rubbish, to the detriment of views out of the Conservation Area. However, the raised road and footway provide a high vantage point from which to enjoy views into the Conservation Area, and as such high vantage points are a rarity in this flat city that could be considered a positive aspect of this feature.

fig 22 View south along Boulevard from Anlaby Road Flyover.

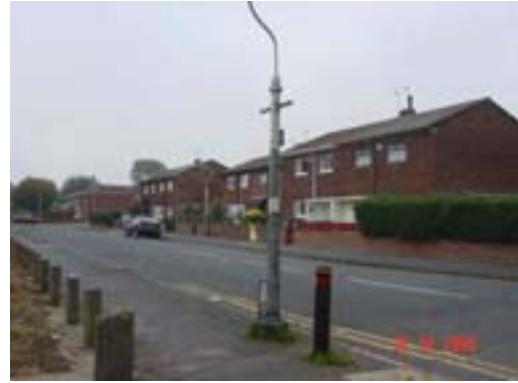
fig 23 'Weak' corner Boulevard/Newton Street, 1950s Council houses and converted gas lamp standards.

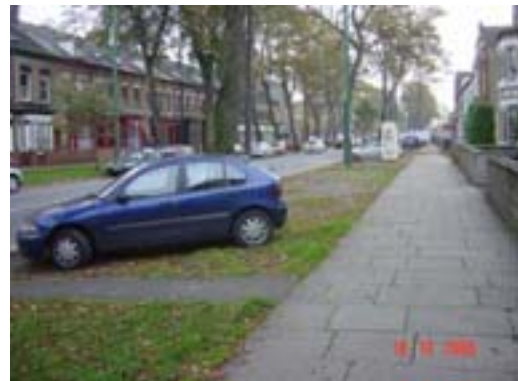
- Verges where eroded by parked cars and delivery vehicles, especially at the south end of the street.
- Poorly maintained front gardens or yards.
- Missing and poor quality front walls and fences.

fig 24 York stone pavers, south of Newton Street, erosion of verges by parked cars.

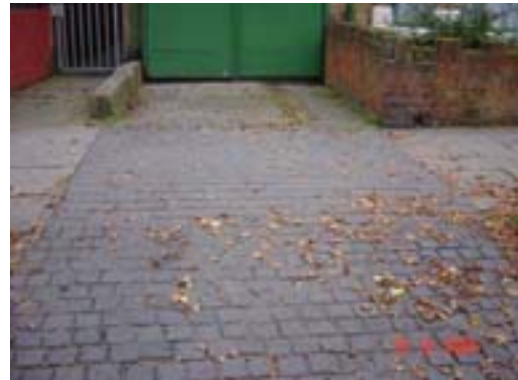
fig 25 Two types of setts in vehicle crossing.

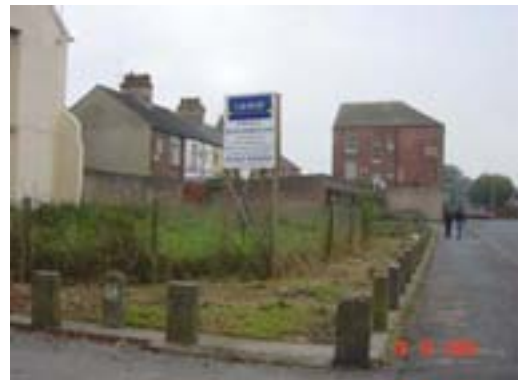
- 5.14 Sites on the corners of Newton Street were bombed during the Second World War. The south side has never been redeveloped but is currently being advertised as a development site with consent for 6 flats. The north side was redeveloped in the 1950s with low density semi-detached houses with gardens. Together they create a weak corner. The 'portholes' adjacent to the front doors of Nos 220 and 222 are a characteristic 1950s detail. The Lion public house, just outside the Conservation Area is the only item of interest in the view along Newton Street. [There are no pubs on Boulevard itself, possibly a reflection of the hold non-conformist religion had until recently.]

fig 26 Development site, corner with Newton Street.

8.1 The appropriate redevelopment of these sites will be encouraged:

- Grassed site on corner Boulevard/Newton St. south side
- Site south of Westoby's [No124]
- Site adjacent to No 55
