Paragon Conservation Area
Character Appraisal & Management Plan
Published May 2024

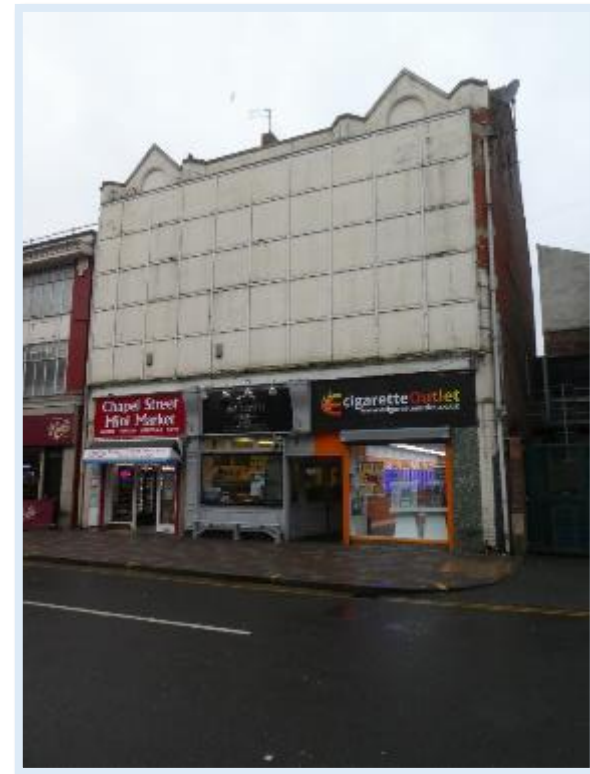
Figure 86 Potential to restore the 19th century frontage of the 'Archeron shop', Chapel Street.

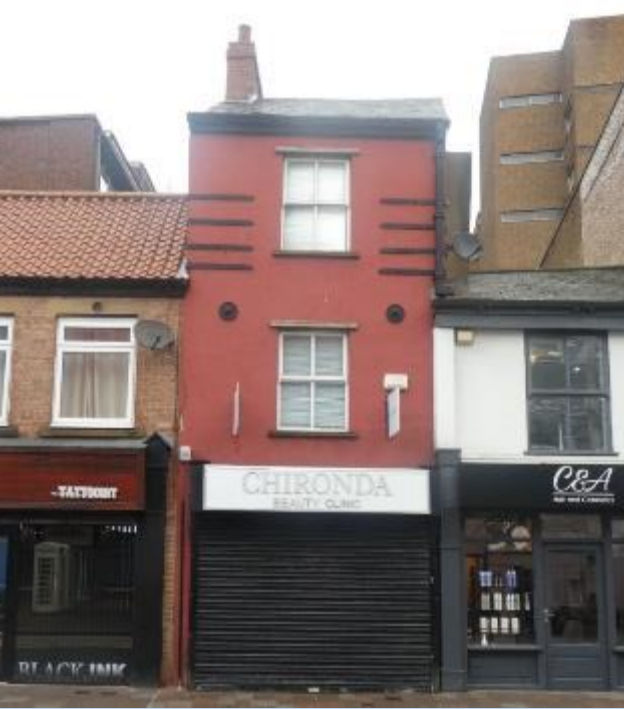
Street:	Carr Lane	Address:	42 - Chironda
	Historic Photo – May 2019 (Google)		Current Photo (03.01.2023)

Building Notes	<p>Building dates to the early 19th century and is constructed over three storeys, across one bay. The second floor straps are a distinctive features. The buildings retains 2/2 timber modern casement windows. The slate roof positively contributes towards the character of the area. Three-storey red brick Victorian building with pitched roof. The ground floor shop front dates to the 1990s restoration scheme of the building (94/00378/PF) and positively contribute towards the character of the area. The building positively contributes towards the special interest of the conservation area.</p>		
Monitoring Notes	<p>Satellite dish has been in place since 2008 so is immune.</p> <p>Projecting box fascia sign and external roller shutter added since May 2019. The installations cover over feature of architectural interest and negatively contribute towards the character of the area.</p>

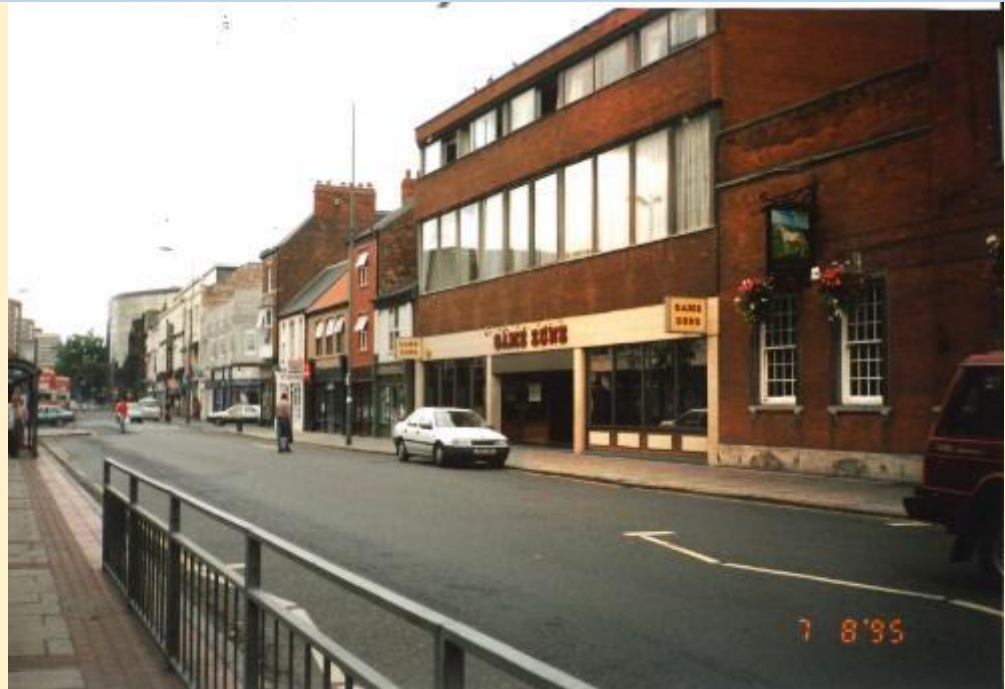
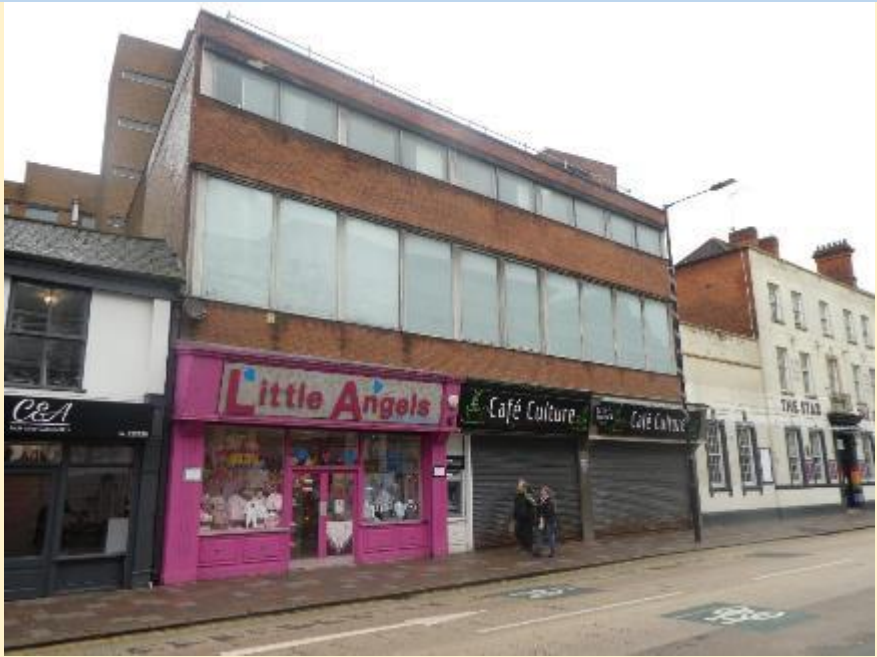
Building Notes	<p>3 storey late 1950s building, which form a part of the Portland Hotel. The architectural design does not fit into the character of the area. Shop fronts, installed post-August 1995, have some traditional elements but have oversize fascia. Part of shop front clad in metal.</p> <p>The external roller shutters on the building are a negative feature but have been in place for over 19 years.</p>
Monitoring Notes	Introduction of ATM & alterations to shop front at Café Culture.
Recommended Actions	Review enforcement action.

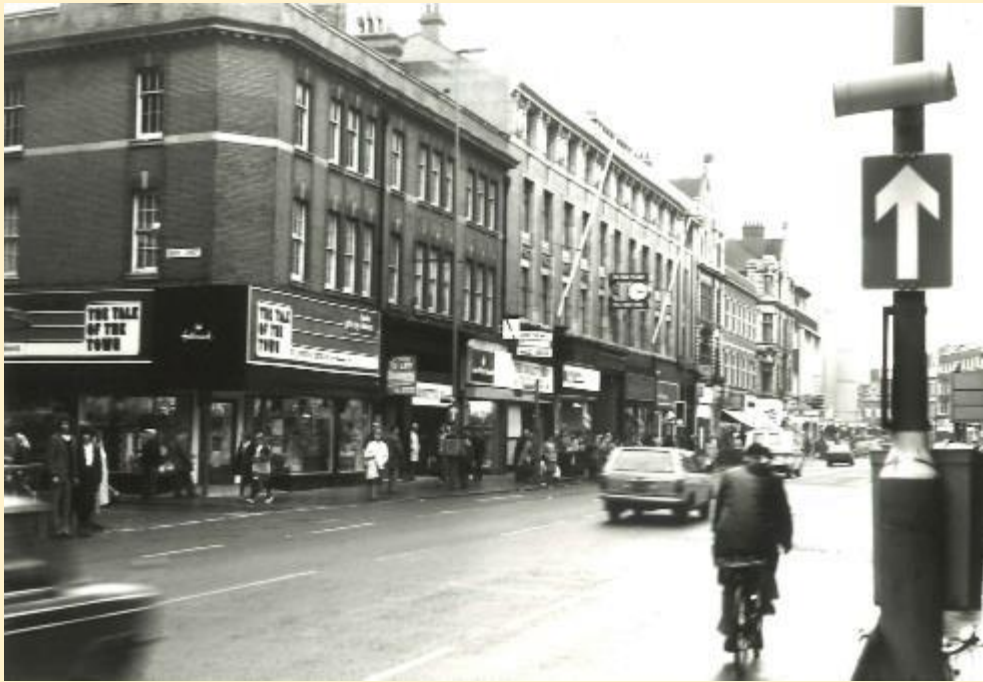
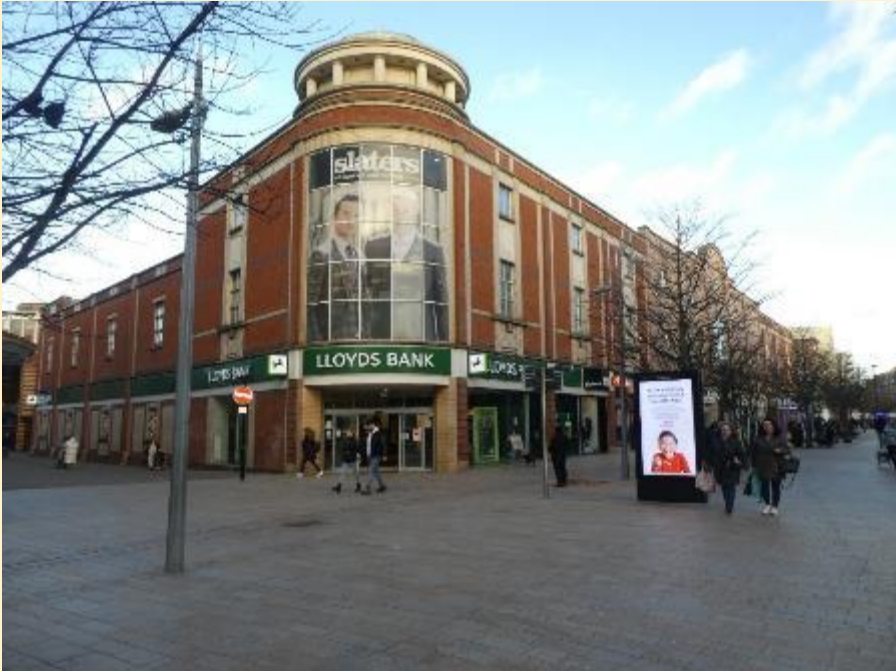
Building Notes	Grand Buildings are a 1990s and post-conservation area adoption development. They are built over three stories with four storey feature corner. The building is broken into bays. In total there are ten shop fronts, of which 7 having projecting fascia signs. The stone carvings which adorned the parapet of the former Hull Daily Mail building are now displayed along the South Street frontage.
Monitoring Notes	The removal of the 1930s Hull Daily Mail Building and adjoining buildings have reduced the architectural interest of Jameson Street.
Recommended Actions	None

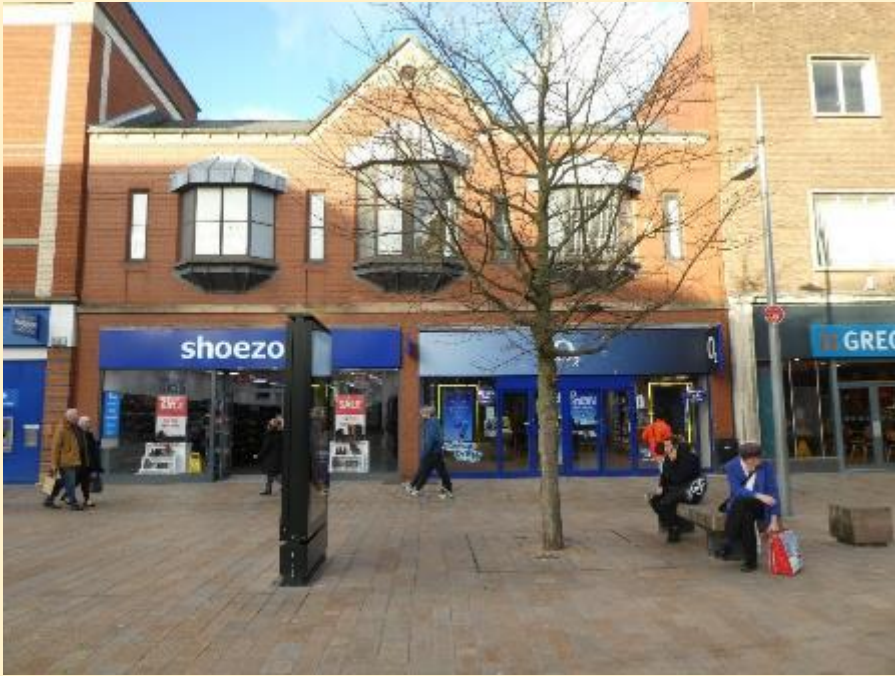
Street:	Jameson Street	Address	58-6
Historic Photo		Current Photo

Building Notes	1990s building built over two stories with feature oriel windows and gable. Is a pastiche design of limited value to the conservation area and does not replicate the architectural quality of the early 20 th century building it replaced.		
Monitoring Notes	Loss of Edwardian buildings previously located on site have reduced the architectural interest of the building.		
Recommended Actions	None

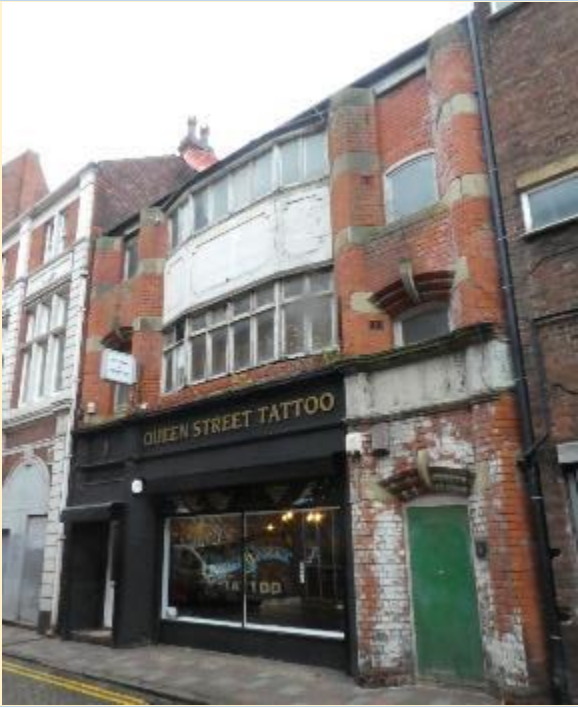
Building Notes	<p>As per 3 Chapel Street the building dates to c.1890 and was formerly a display garage. It is an important reminder of the 1890s period of commercial development in Hull, but in a poor condition. The shop frontage negatively contributes towards the character of the area. At first floor the building retains timber windows and lead light glass. In 2005 a survey identified the retention of an Art Nouveau lobby mosaic but this has subsequently been lost.</p>		
Monitoring Notes	<p>No negative change but condition of the building impacts upon the character of the area.</p>		
Recommended Actions	<p>Consider serving a S215 notice.</p>

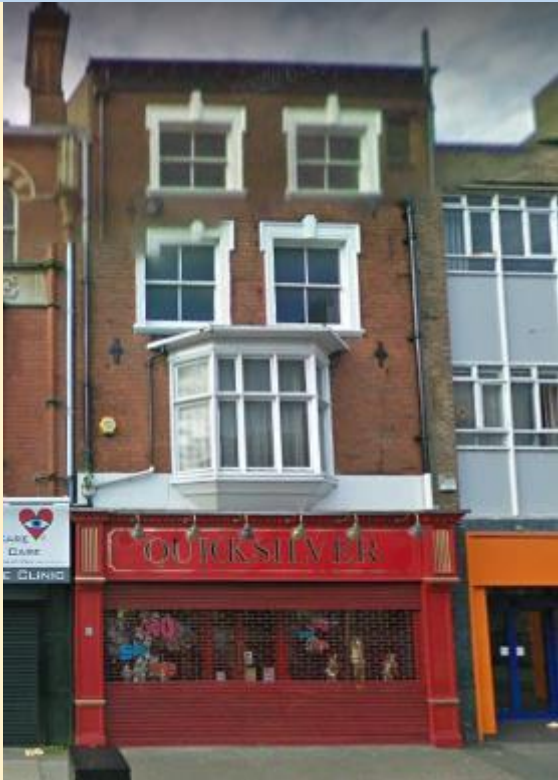
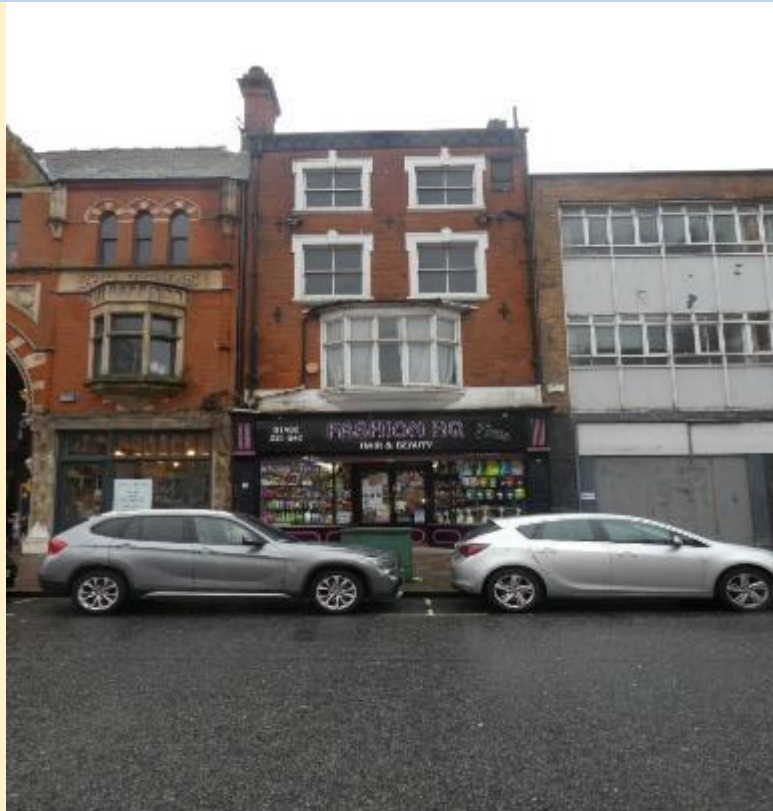
Building Notes	Positive red brick building, with timber 2/2 sashes. Features an oriel window. Positive contribution to conservation area due to age and design. Features bracketed eaves detail and a slate roof. The modern shop frontage has architectural detailing, but is in poor condition. The service boxes to left column of the shop front are a poor feature. The fascia sign is too big and plastic.		
Monitoring Notes	Condition of the shop front eroding.		
Recommended Actions	Consider serving a section 215 to address condition issues.

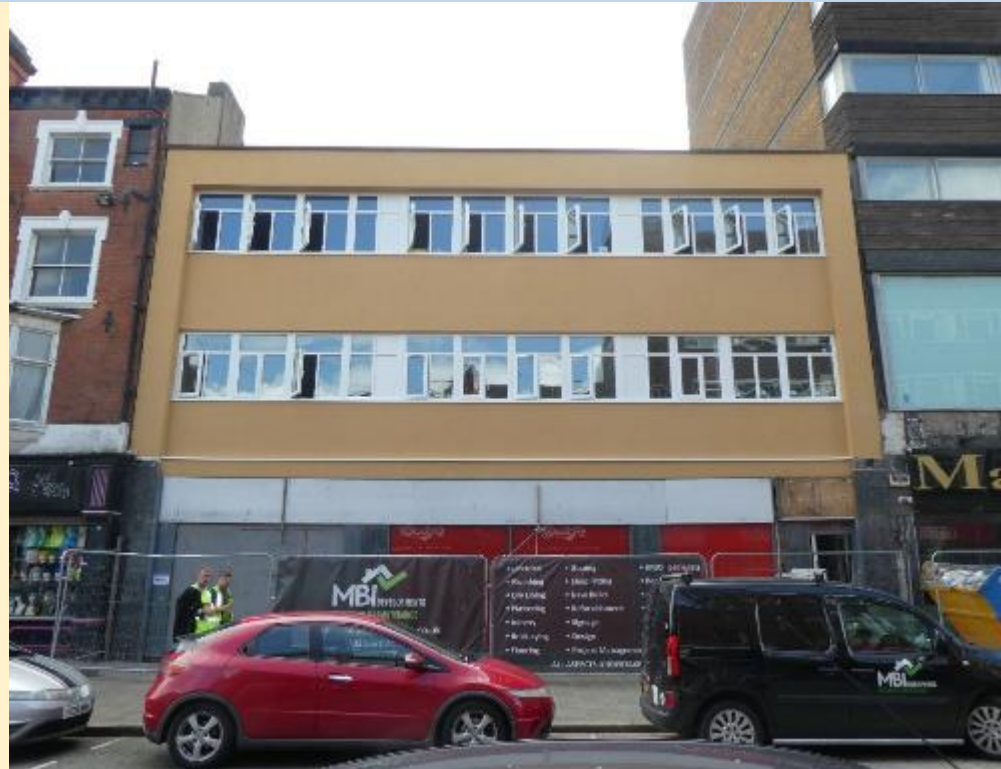
<p>Building Notes</p>	<p>Three storey 1950s building constructed in brick, with principal façade of classing and windows. The building does not respond to the street scene and has limited architectural interest. At time of surveying current subject to applications 23/00548/FULL and 23/00553/ADV.</p>
<p>Monitoring Notes</p>	<p>Building now redundant and condition eroding. Building has been re-clad during survey of the conservation area.</p>
<p>Recommended Actions</p>	<p>Review colour of the cladding.</p>

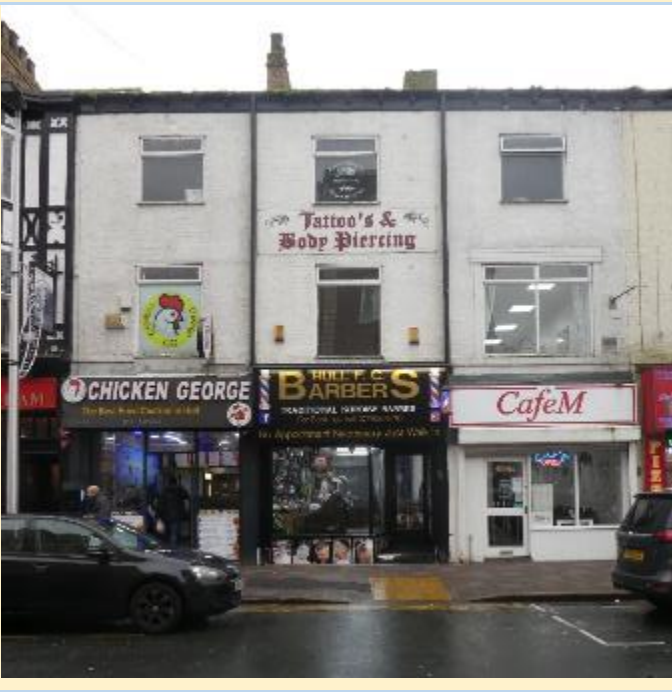
Building Notes	<p>Early 19th century brick building. It is a positive building to the area because of its age. Three stories and one bay wide and finished in painted brick. The building Features timber soffet board and brackets. The modern windows contribute negatively. It retains lobby to shop front but the shop fittings are modern replacement. The fascia advertisement is too large for the building. Negative features are a trough light and box shutter. Part of grouping of 19th century buildings along Paragon Street and Paragon Square. The building would benefit from a shop front enhancement scheme.</p>		
Monitoring Notes	<p>Oversize fascia and trough light introduced but with no record of planning history.</p>		
Recommended Actions	<p>Enforcement period expired.</p>

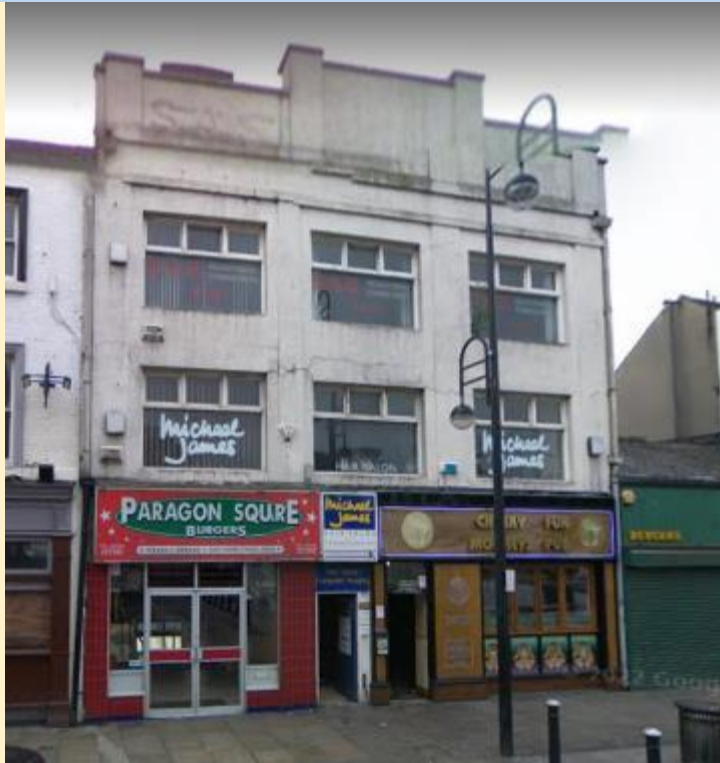
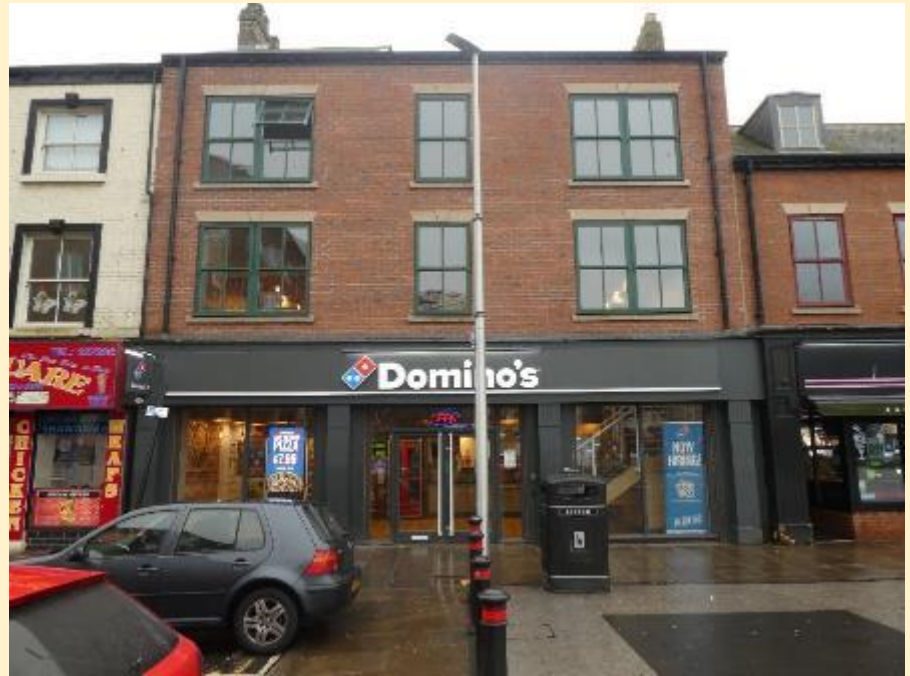
Building Notes	1920s building replaced with modern replacement since 2010. Shop front has negative elements due to the proportions of the columns and details to the fascia.
Monitoring Notes	Neutral change.
Recommended Actions	None

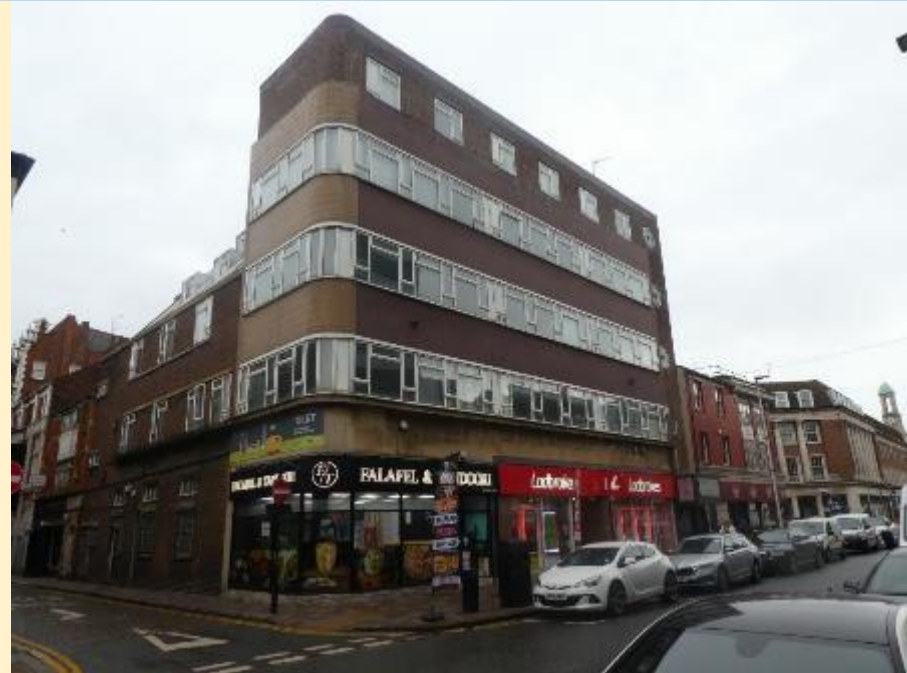
Building Notes	1950s development of a good quality construction and design. The five storey development does however mean it is out of scale with the street scene and dominates the surroundings 19 th century developments. Features poor quality modern shop fronts, with illuminated fascia advertising.
Monitoring Notes	Recent shop fronts & advertisements are more prominent on the building and do not have planning permission.
Recommended Actions	Review potential enforcement action.

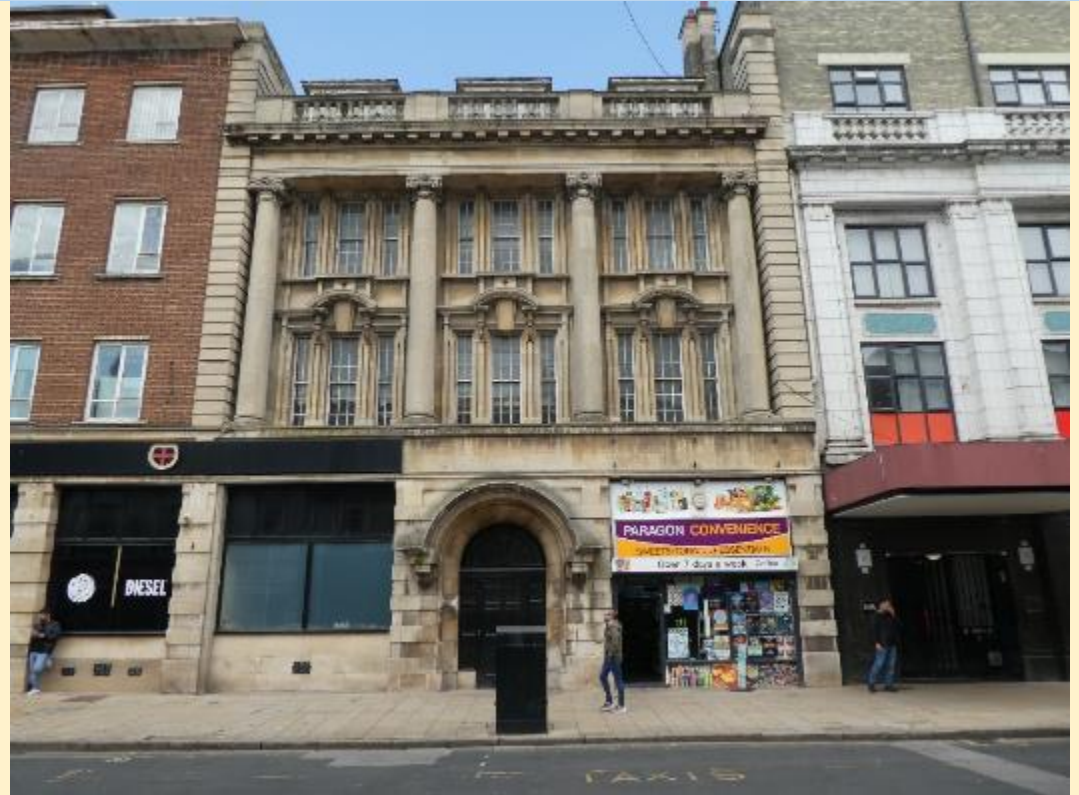
Building Notes	Key building to the area constructed in the baroque revival style. The character of the building is harmed by the poor quality shop front and advertising to No.82. Retains features an interesting panelled door. It is noted that the building forms part of the remaining façade of the Seaton Buildings, constructed in 1914. The building was bombed in May 1941. After the war this four story section was retained and the ground floor section fronting Paragon Street retained and its upper floors re-built in a more restrained style.
Listing Description	Offices, now offices and shop. Architects Gelder & Kitchen, c1914, with late C20 alterations. Brick with ashlar front and plain tile mansard roof with a coped side wall stack. Classical Revival style. Plinth, ground floor band, rusticated angle pilasters, dentillated main cornice, coped parapet with balustrade panels. Three storeys plus attics; 3-window range. First and second floors are articulated by giant Ionic columns. Recessed between them,

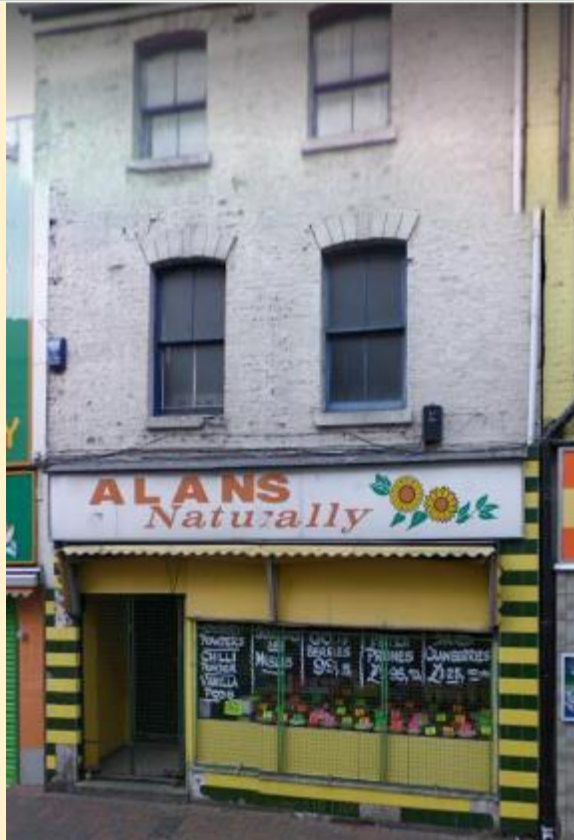
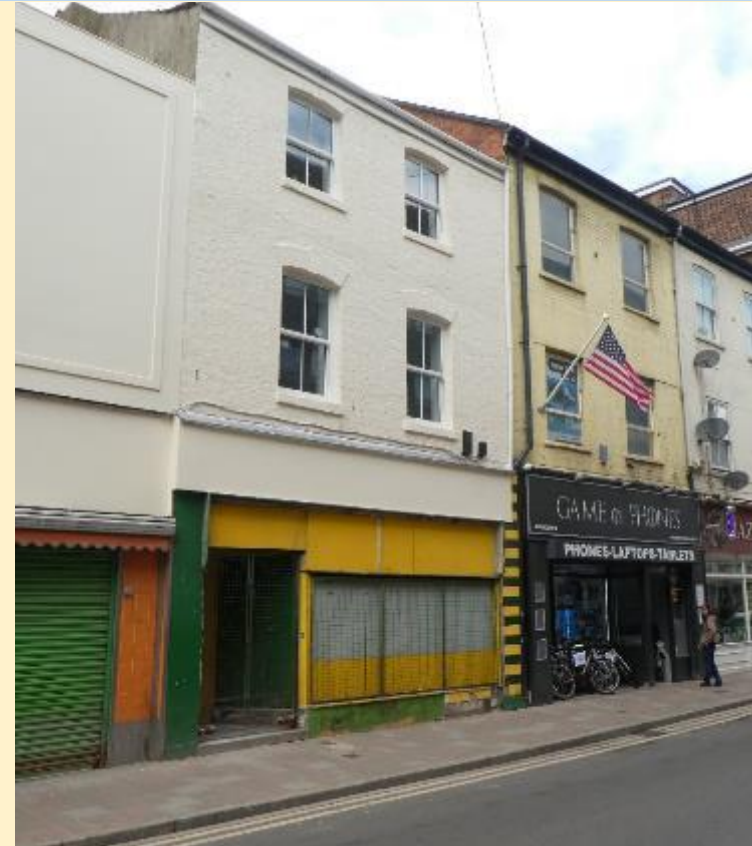
Building Notes	One of the original early 19 th century properties of the area, and therefore positively contributes towards the area. The building has lost its timber 2/2 sash windows during time of survey, but retains segmental window headers. Shop front does not respond to the historic age of the building.
Monitoring Notes	Condition of the building is poor. Building is currently under restoration works (22/01673/FULL).
Recommended Actions	Improvements made to condition of the building during survey of the conservation area.
