1 - 96 Denaby Court, Hull

Type 3 Fire Risk Assessment

Prepared for:	Rebecca Franks, Building Safety Manager
Prepared by:	John Askew, Fire Risk Assessor, Holistic Fire Safety
Date:	17/10/2024
Document Reference:	HFS.HCC.DenabyCourt.FRA.2.0

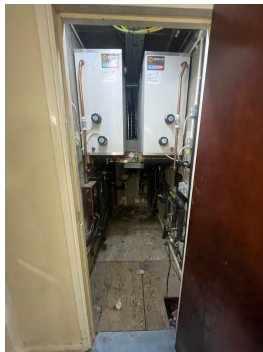
Photo 3

Risers in common areas are separated from escape routes by fire resisting construction providing 30 minutes, fire resisting doorsets are certified 44mm with what appear to be timber fanlights, all observed to be in reasonable condition although breaches were observed to some fan-lights. There are electric service units present in some service risers and electric supply to immersion heaters, however, there are no other combustible items within the area; therefore fire is highly unlikely to spread to adjacent areas.

It has been confirmed doors are to be replaced, although no date has been set as they are to be part of a larger programme of works which requires approval from the Building Safety Regulator.

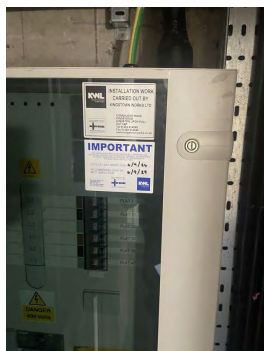
Photo 15

8.2. Are Electrical Installation Condition Report (EICR) labels displayed to indicate the date of the most recent periodic inspection and the date of the next 5-year periodic inspection?

Yes.

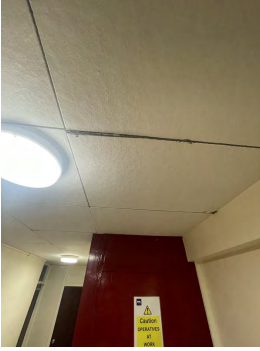
Photo 32

Ceilings within escape routes with the exception of the ground floor however are lined with ceiling tiles which are suspected to be of a combustible nature. Although there is a concrete slab which separates floors, should tiles be subjected to ignition, it is foreseeable that they would contribute towards fire growth; as a result and as a low priority action, tiles should be removed / enclosed.

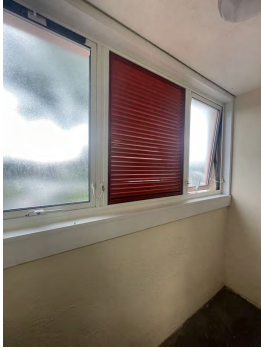
Photo 56

Current guidance states that vents in lobbies or corridors adjoining stairways should be operated automatically, however the installation of Automatic Opening Vent (AOV's) are not considered reasonably practicable. In addition, although current openings do not provide a minimum free area of 1.5 metres squared (m²), current provisions are considered adequate given other mitigation measures in place.

Protected stairways also need means to ventilate any smoke that may enter the stairway during evacuation or fire fighting and allow a route for air to reach ventilated lobbies. A vent of at least 1m² needs to be provided at the head of the stairway for this. Current guidance states that in blocks of flats with a single stairway, it is recommended that the vent is operated automatically via an AOV.

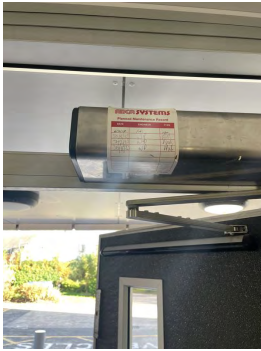
Photo 58

Final exits doors are manually operated and fail safe in the open position during a power failure.

Doors fitted with magnetic locks fail safe in the open position during a power failure i.e. the laundry and caretaker office lobby doors.

Ground floor doors are electrically operated automatic doors. The maintenance label indicated these were last inspected in August 2023.

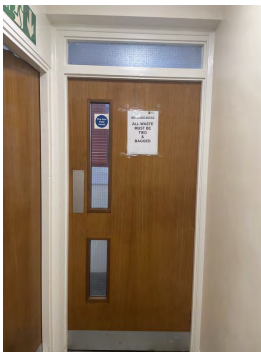
Photo 59

Escape routes are suitably separated and subdivided by fire rated construction which is made up of certified self closing FD30s door assemblies and Georgian wired glazing. Partitions are made up of a part glazed system and fibre board lower panels. Current provisions are considered adequate to protect means of escape.

Air transfer grilles (ATG) were present in the lower part of curtain walling to the laundry and laundry/caretaker lobby. HCC to confirm if these are intumescent air transfer grilles. Upon inspection, it is not clear if these are intumescent ATG. HCC should confirm that the ATG is intumescent. If the ATG's are found not to be intumescent, the areas could be boarded up to provide the necessary level of fire resistance.

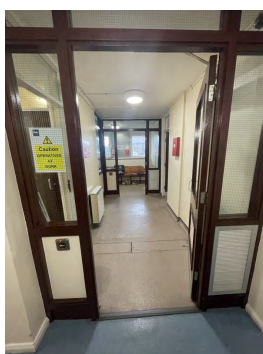
Photo 65

- Good condition leaf and frame
- Good condition polished Georgian wired integrity fire resistant glazing
- x3 100mm BS 1935 Grade 13 CE marked hinges
- Frames have a 25mm stop lat
- Appropriate single strip combination cold smoke and intumescent seals fitted into the leaf
- Gaps between leaf and frame are generally more than 3mm to top and side rails, however there are variations to this and gaps at the bottom threshold are consistently >8mm and will require attention
- A BSEN 1154 CE marked self closing device with a minimum power rating 3 (Grade 1) is fitted to all communal doors. A number of samples were taken on different floors with the majority capable of closing from any angle and not taking longer than 25 seconds to overcome the resistance of any seals to close into their frames.

Defects consisted of:

- Worn / leaking hinges requiring replacement
- Hinges painted over and missing screws
- Strips and seals are consistently over painted and occasionally routed too deep
- Strips and seals missing

All curtain walling and partitions which form escape routes are made up of timber frames which are completed by large georgian wired glazed apertures at upper levels and fibreboard panels below. Samples were taken throughout the building, with all floors displaying satisfactory findings.

As a result, given minor defects, a specific fire door inspection is to be undertaken to specify what actions are required.

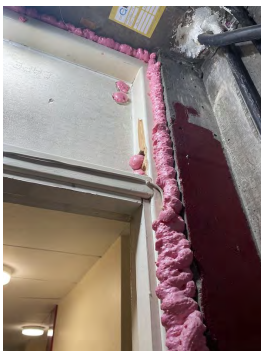
Photo 72

Communal riser doorsets are 44mm, of notional fire resistance with some having timber fan-lights with evidence of penetrations. Leaves were generally observed to be in good condition and fitted with x3 100mm none BS CE marked hinges which were often noted to be leaking.

Ancillary accommodation doors are 44mm certified FD30s doorsets and were generally satisfactory although hinges were observed to be leaking or painted and excessive threshold gaps were noted.

Door frames are fitted with strips and seals however, some were either damaged, missing or painted over. There was evidence of a lack of backfilling/fire stopping between the frame and substrate.

As a result, given minor defects, a specific fire door inspection is to be undertaken to specify what actions are required.

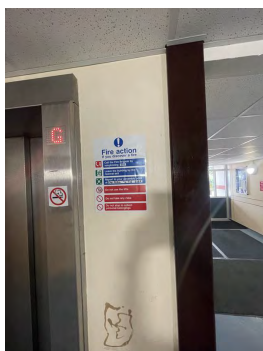
Photo 91

Residential floors are provided with comprehensive instruction on actions to be taken in the event of fire. Fire action notices are displayed prominently opposite/adjacent lift doors.

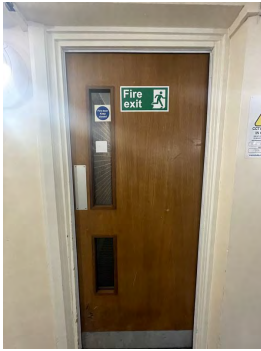
Photo 92

The expectation is that all residents are familiar with the layout of the building and its communal areas, although some signage is technically incorrect in places, current safe condition signage provided is considered to be satisfactory and it is expected that all relevant persons using the building will understand signage in place.

It is advised that all replacement safe condition escape route signage should be photo luminescent as manufactured by Jailite. Signs should be rigid or semi rigid PVC fixed by 4 x screws in each corner of the sign or with appropriate adhesive.

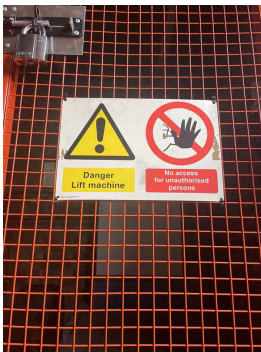
Photo 95

Hazard warning signage is in place on the external face of risk areas such as the lift motor room and the external electrical substation. Each individual ESU within the building is also provided with hazard warning signage to warn both occupants and responding fire crews.

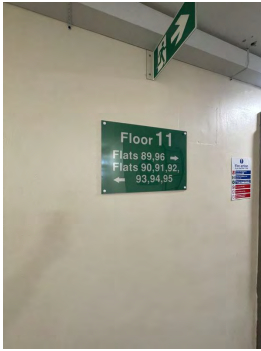
Photo 98

- J. The signs should be sited immediately below the floor identification signs, such that the top edge of the sign is no more than 50mm below the bottom edge of the floor identification sign.
- K. The wording should take the form Flats X-Y, with the lowest flat number first.
- L. The text should be in sans serif typeface with a letter height of at least half that of the floor indicator sign.
- M. The wording should be supplemented by arrows when flats are in more than one direction.
- N. The text and arrows should be on a contrasting background, easily legible and readable in low level lighting conditions or when illuminated with a torch.

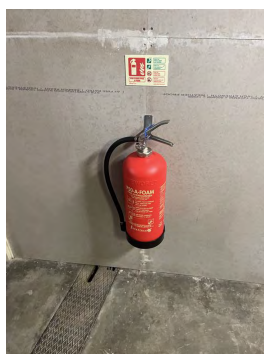
Photo 99

Extinguishers are not present within means of escape.

Extinguishers provided are composite P50 foam extinguishers. A CO2 extinguisher was noted which is to be replaced with a P50 foam extinguisher.
