## Purpose of the Conservation Area

Hessle Road Conservation Area was designated in 1994, owing to the area's architectural importance as a mix of residential and commercial areas, formed by an array of late-Victorian, and Edwardian architecture. A survey undertaken between May and June 2024 revealed the current condition of the character area and helped identify the key elements that contribute towards the character of the area.

## HESSLE ROAD CONSERVATION AREA

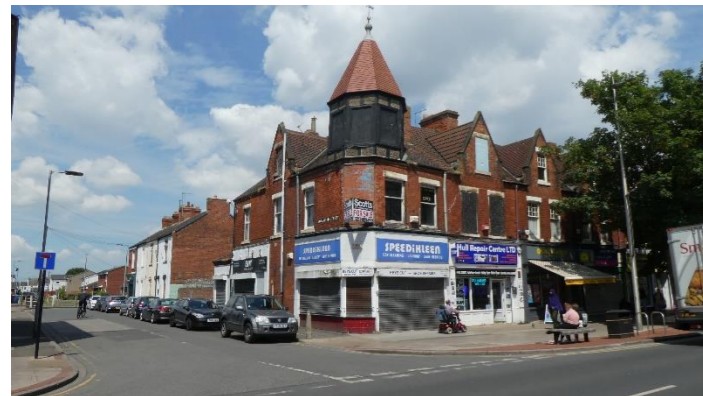
Mix of housing and retail along Hessle Road

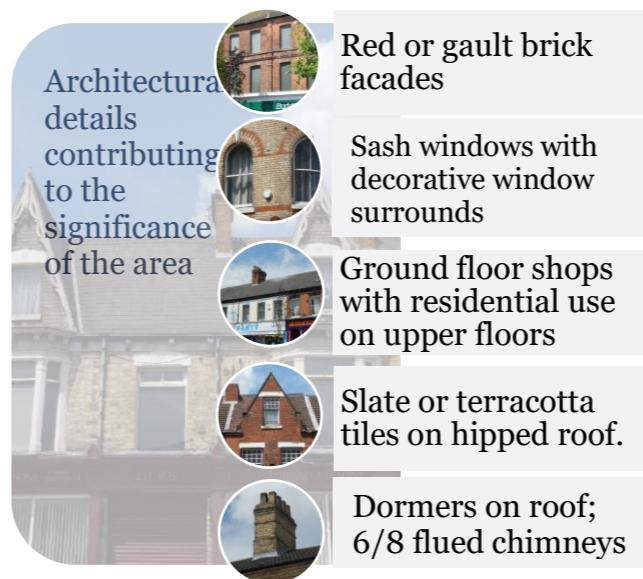
Architectural details contributing to the significance of the area

Red or gault brick facades

Sash windows with decorative window surrounds

Ground floor shops with residential use on upper floors

Slate or terracotta tiles on hipped roof.

Dormers on roof; 6/8 flued chimneys
